## Landscape & Visual Impact Assessment

Proposed small scale standby embedded power plant

Tofts Lane, Hunshelf, Barnsley, S36 2BS

July 2010

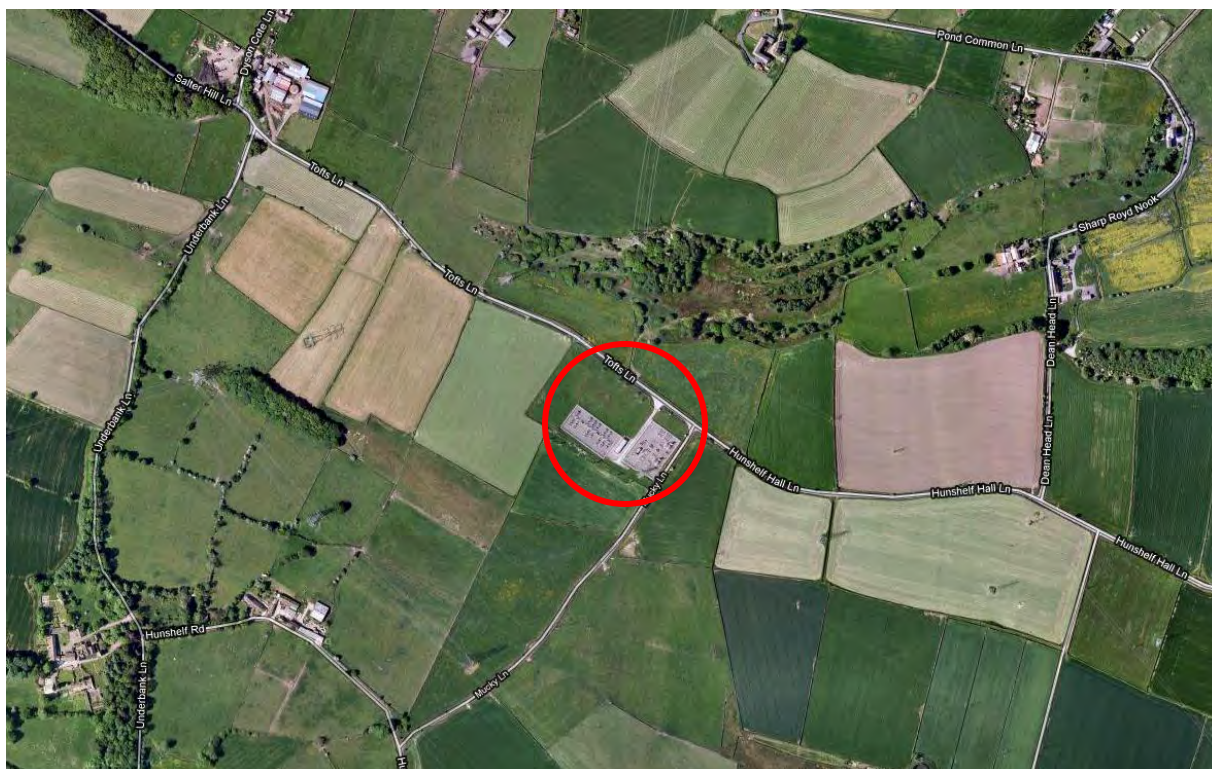
2.4 The site is located in a predominantly rural area consisting of farms and farm land. The closest farm buildings are 700m from the existing site entrance at the junction of Tofts Lane

and Underbank Lane. The closest residential settlement is located on Dean Head Lane, which is 900m from the application site (see aerial photograph below)

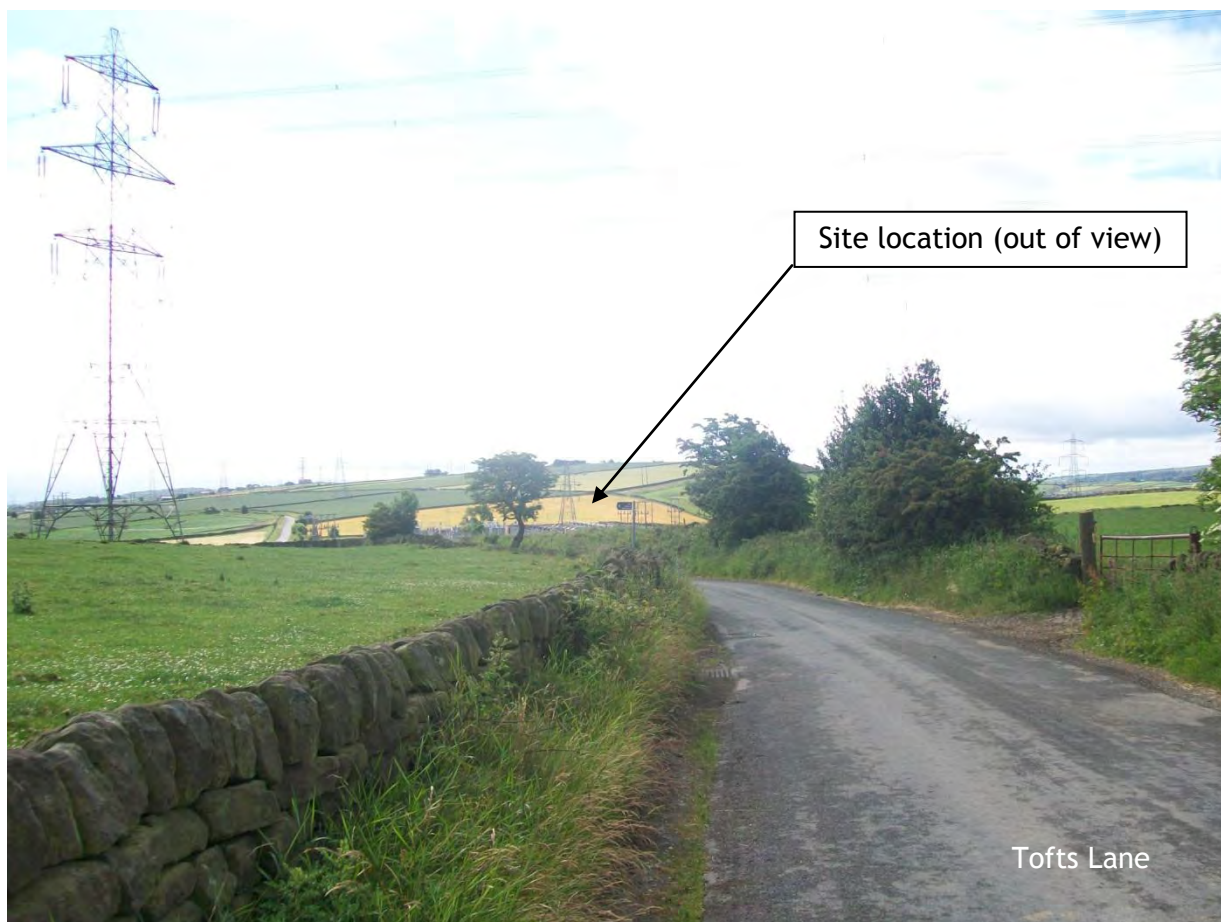
View from Tofts Lane looking east towards the site

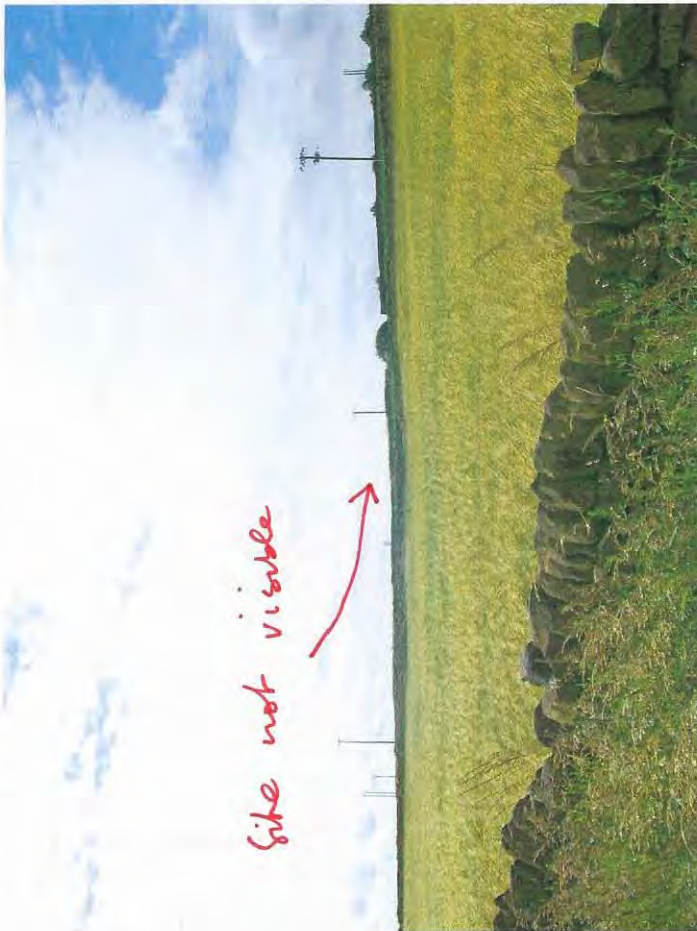
View No: 1 Location: Pond Common Ln Date: 2/7/10 Surveyor: MB

View from Pond common lane which is elevated from the site which is obscured by the topography

Arable fields in good condition

Some built form in the area, but largely rural with limited ability to accommodate change

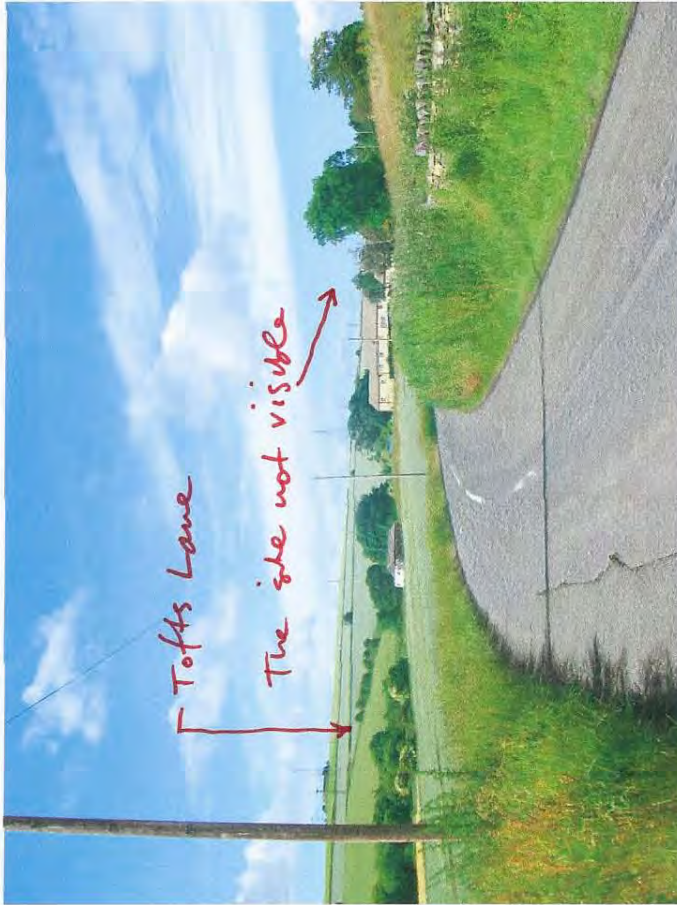
View No: 2 Location: Sharp Royd Nook Date: 2/7/10 Surveyor: MB

*View from Sharp Royd Nook towards Tofts Lane. The site is not visible from here.*

*Well maintained fields and walls*

*Site not visible from here. Built form existing in this area.*

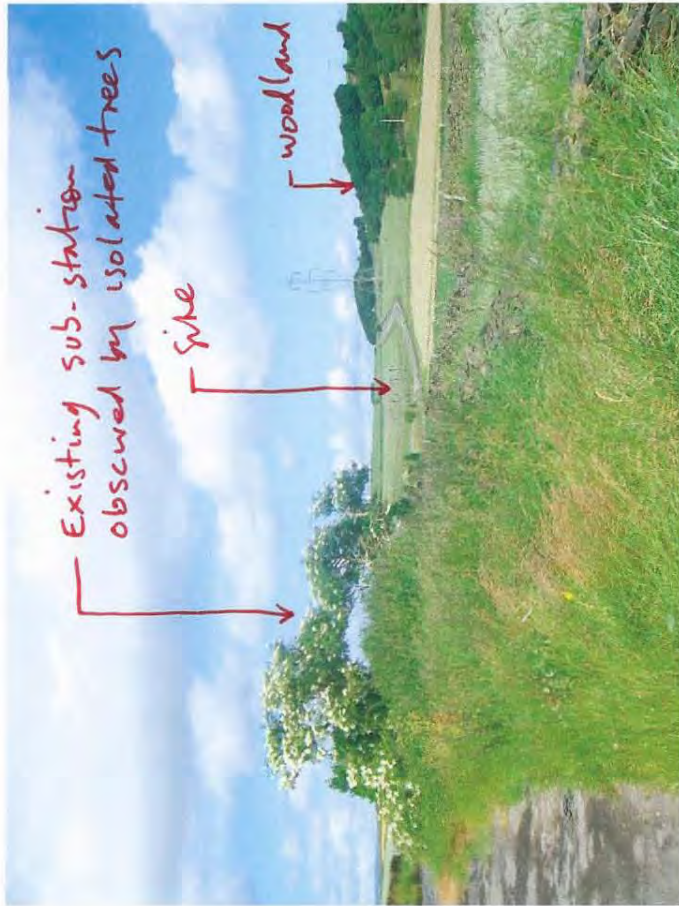
View No: 3 Location: Tofts Lane Date: 2/7/10 Surveyor: MB

View from Tofts Lane showing the site obscured by topography and isolated trees

Well maintained fields and boundary walls

The site is obscured from this location and therefore change could be accommodated if the screening elements are refined/enhanced

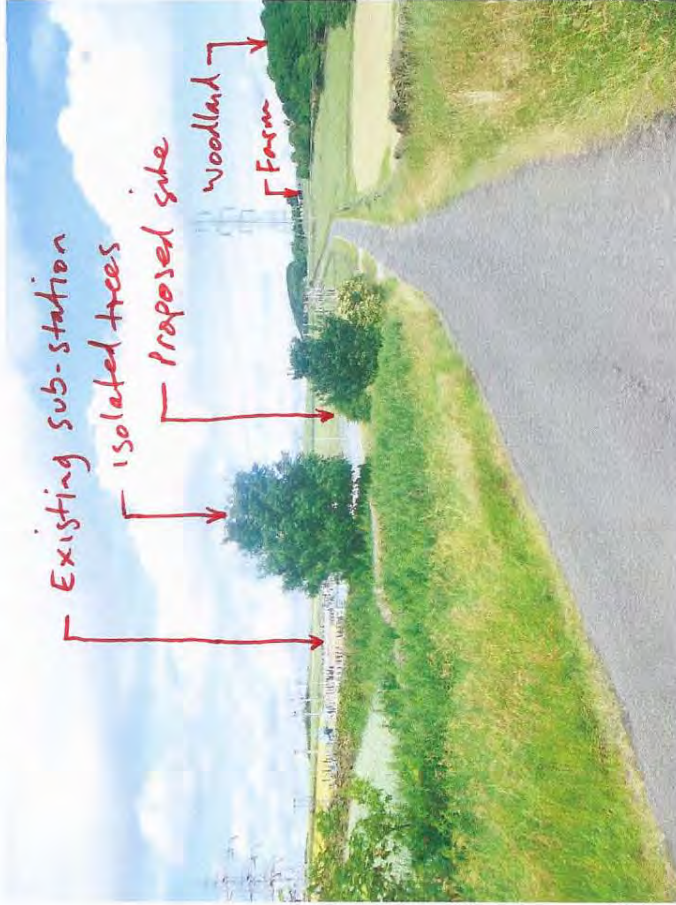
View No: 4 Location: Tofts Lane Date: 2/7/10 Surveyor: MB

*View down Tofts Lane showing isolated trees in the foreground with the site on the left*

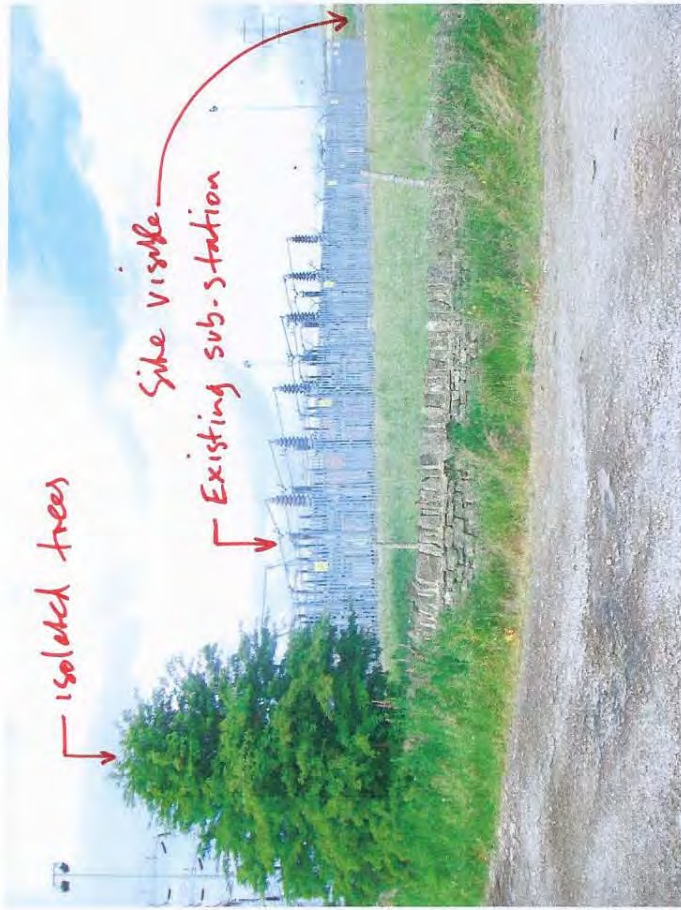
View No: 5 Location: *Muddy Ln* Date: *2/7/10* Surveyor: *MB*

*A view from the junction of Muddy Lane and Tofts Lane showing the existing plant*

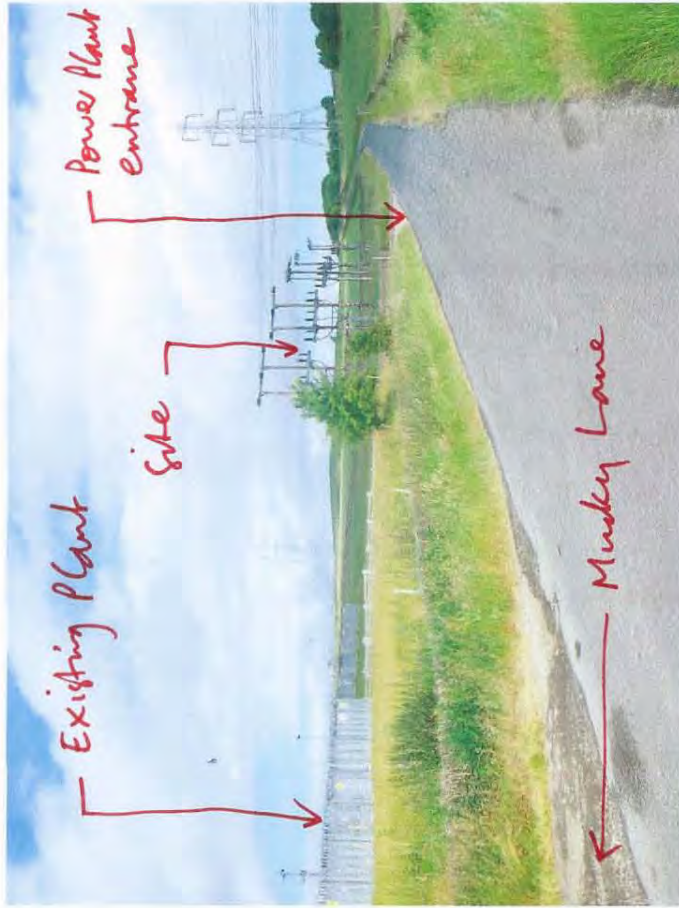
View No: 6 Location: Tofts Lane Date: 2/7/10 Surveyor:

A view up Tofts Lane with the existing plant on the left and the application site

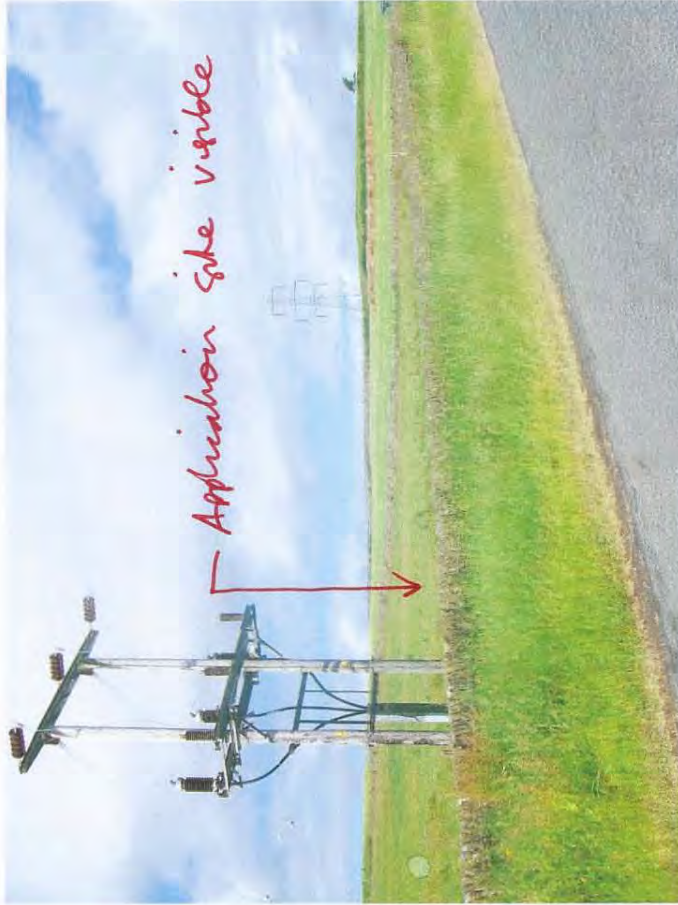
View No: 7 Location: Tofts Ln Date: 2/7/10 Surveyor: MB

*The site is clearly visible from Tofts Lane*

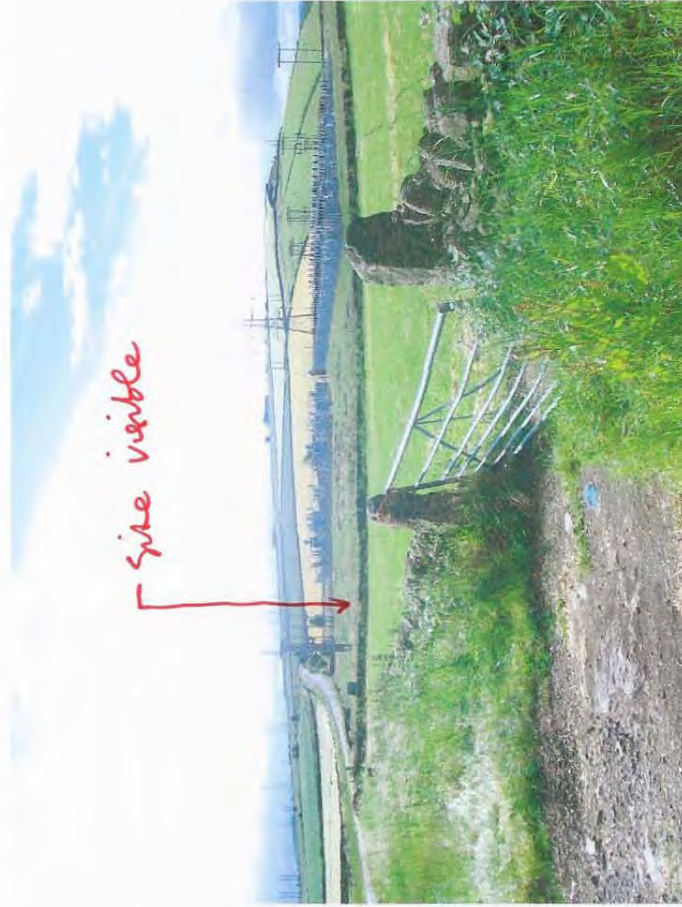
View No: 8 Location: Tofts Lane Date: 2/7/10 Surveyor: MB

*Clear view of the application site in the foreground of the existing plant*

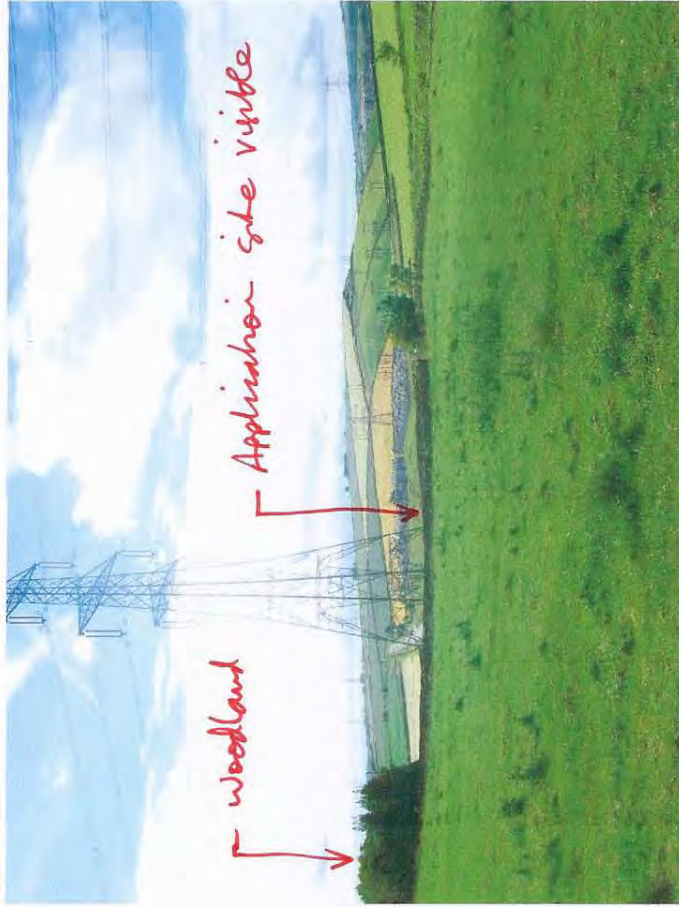
View No: 9 Location: Public footpath (off Totter Ln) Date: 21/10 Surveyor: MB

Applishor site visible adjacent to the existing power station

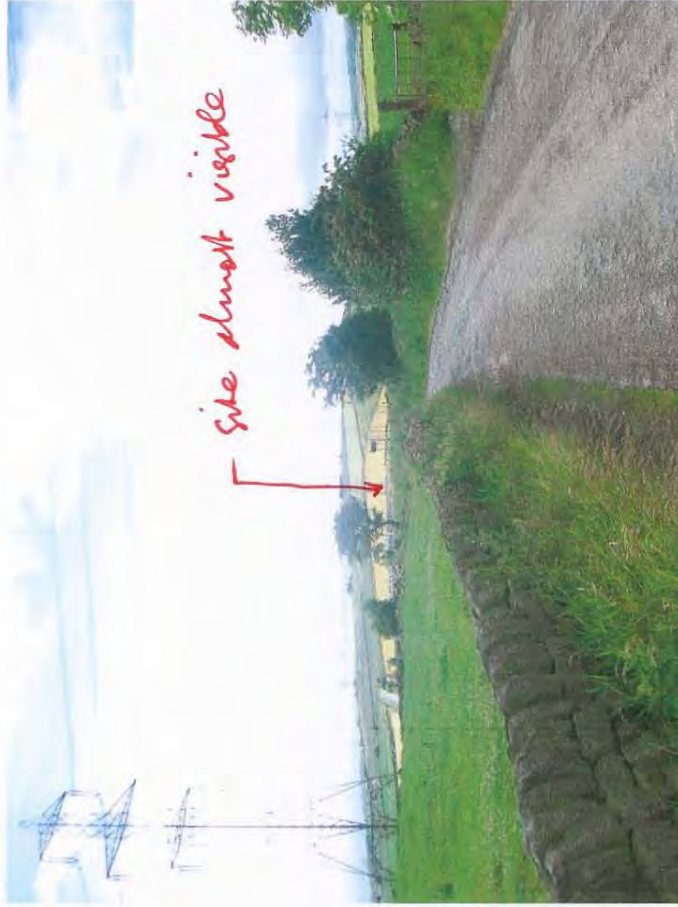
View No: 10 Location: *Tofts Lane* Date: *2/7/10* Surveyor: *MB*

*The site is almost visible as the land falls down the broad valley*

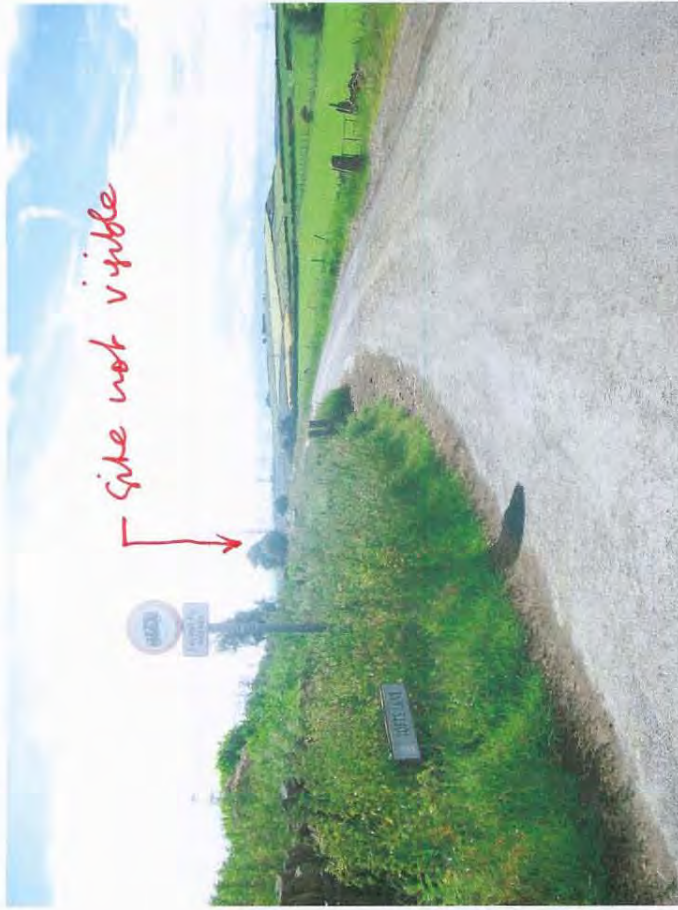
View No: 11 Location: Tofts Lane Date: 2/7/10 Surveyor: NB

*Slightly elevated view looking down the lane and the broad valley*

*Good condition, grass verges overgrown, but in keeping with rural setting*

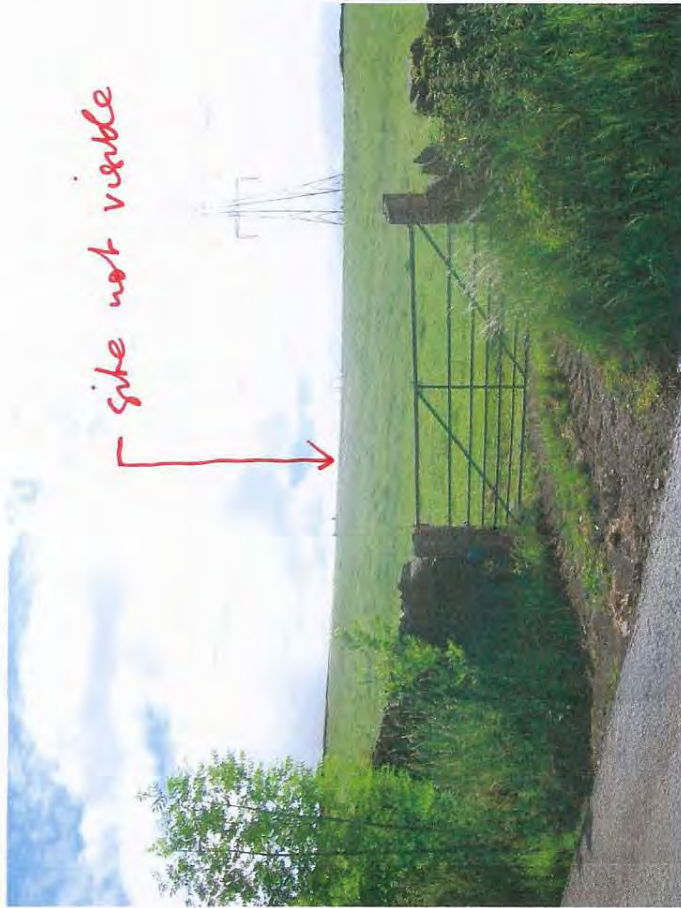
View No: 12 Location: Underbank Ln Date: 2/7/10 Surveyor: MB

Rural farmland with isolated trees on field boundaries

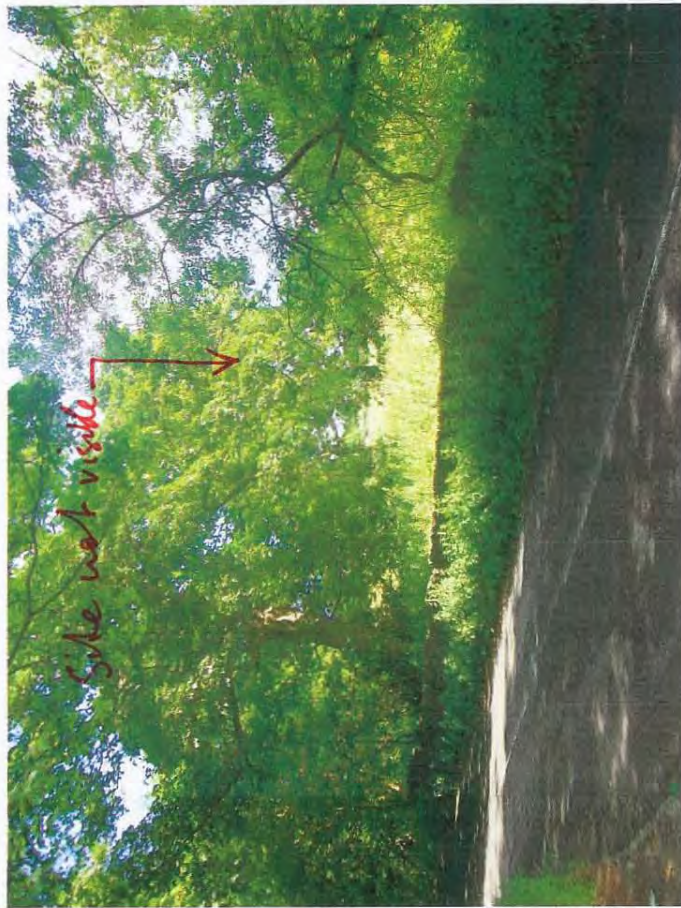
View No: 13 Location: Underbank Ln Date: 2/7/10 Surveyor: MB

*grassy lane with well established trees forming a 'tunnel' effect over the road*

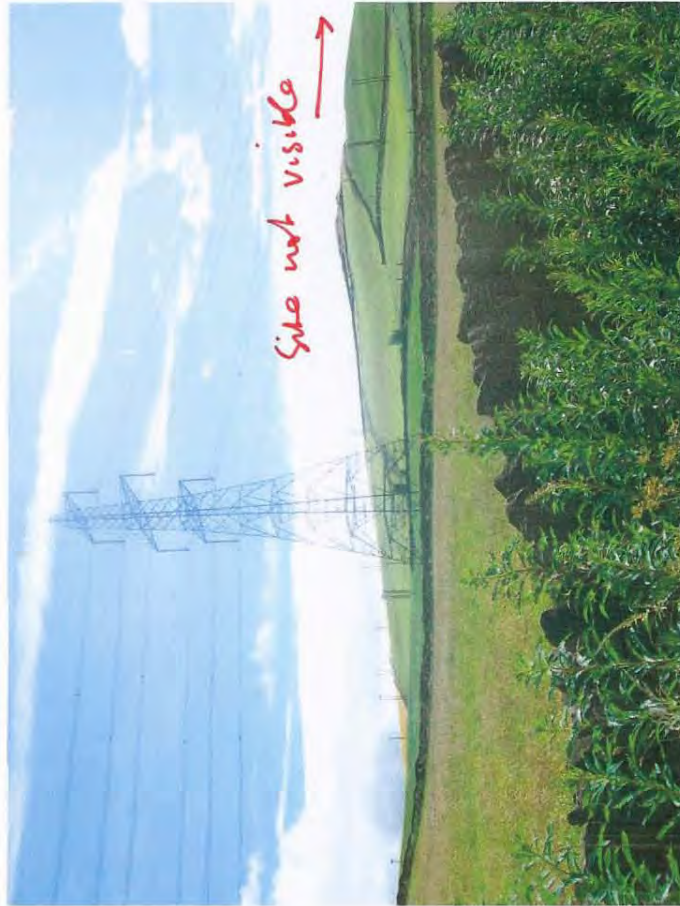
View No: 14 Location: Hunshalf Rd Date: 2/7/10 Surveyor: MB

*Strong field patterns in this view*

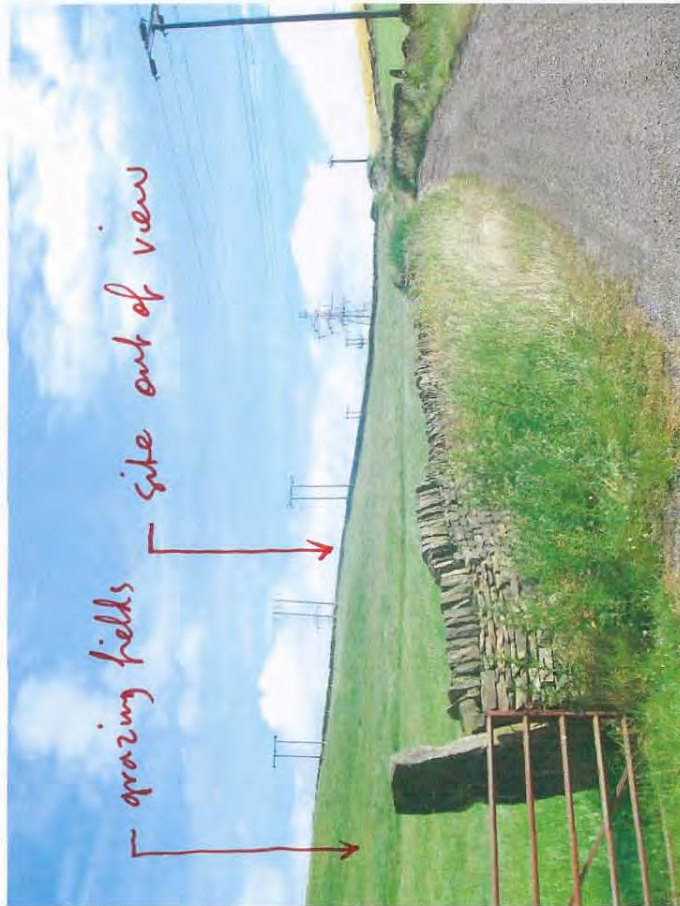
View No: 15 Location: *Mudkey Lane* Date: 2/7/10 Surveyor: *mb*

*Rolling arable/grazing fields dominate the view  
No sign of the power plant other than pylons*
