Taylor Wimpey Yorkshire

Kingstone School, Barnsley

Geo-environmental site assessment

301285

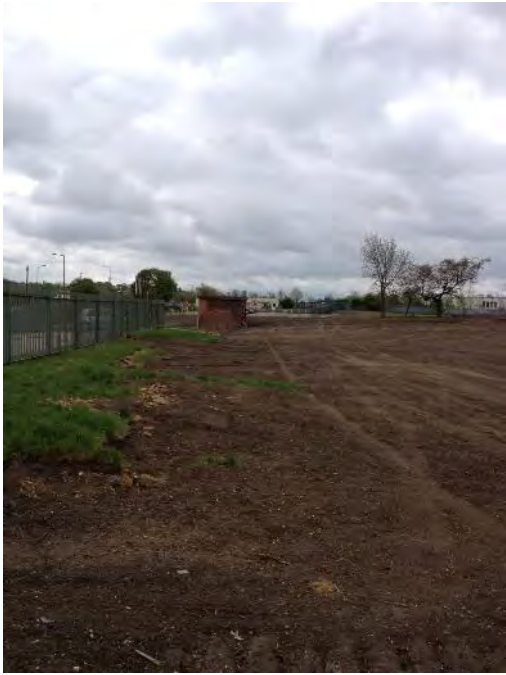
<p>Photo no. 1</p>	<p>Date: 10.05.13</p>

Potentially contaminative activities currently on the site include an electricity substation located in the eastern part of site, probably containing volumes of transformer oil. The historical assessment indicates that the substation was constructed in the 1960's, therefore leaks and spillages may have occurred over time. Historically equipment is likely to have contained oil containing polychlorinated biphenyls (PCB), which even if replaced, residual PCB may remain. Therefore this presents a potential significant source of contamination.

<p>Direction photo taken: South east</p>		
<p>Description: Eastern site boundary looking towards substation building and nursery.</p>

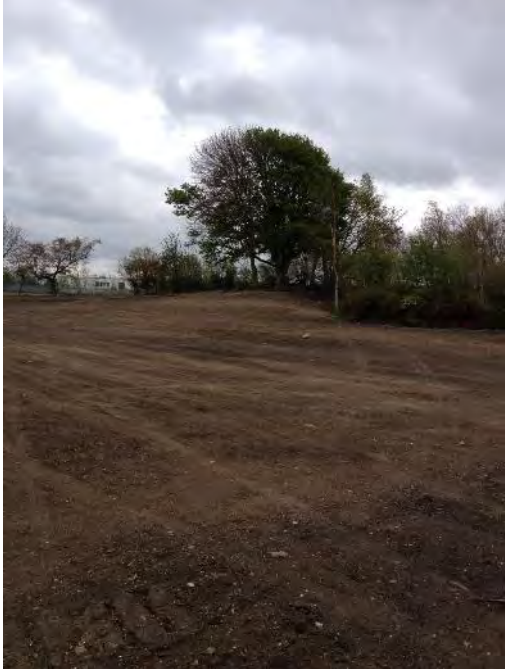
<p>Photo No. 2</p>	<p>Date: 10.05.13</p>

<p>Direction photo taken: South west</p>		
<p>Description: View from entrance towards raised area in ease of site</p>

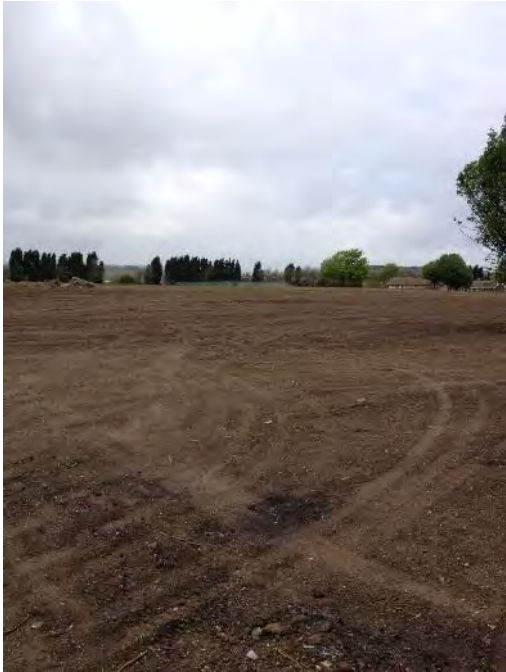
Photo No. 4	Date: 10.05.13

Direction Photo Taken: West		
Description: View across former playing fields towards residential properties adjacent to west of site

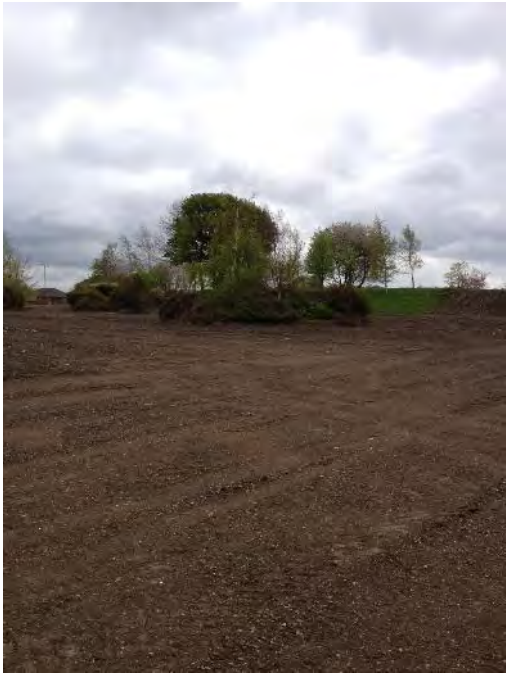
Direction Photo Taken: South		
Description: View towards slope in centre of site

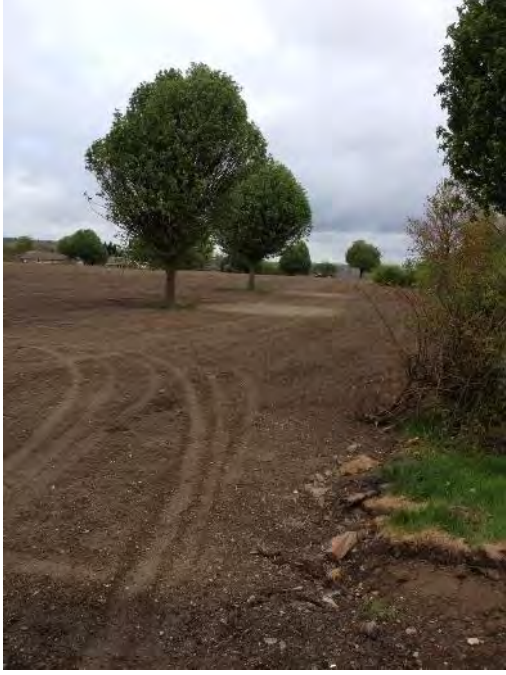
Photo No. 6	Date: 10.05.13

Direction Taken: North west		
Description: View along eastern site boundary

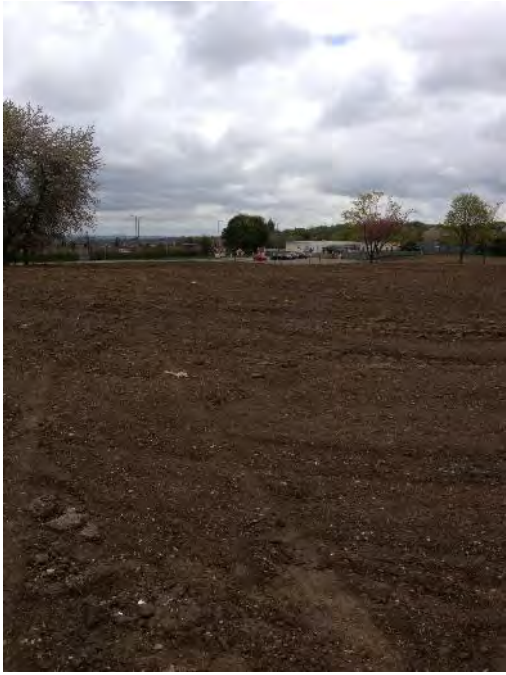
Photo No. 7	Date: 10.05.13

Direction Taken: South east.		
Description: View from slope towards nursery in eastern corner

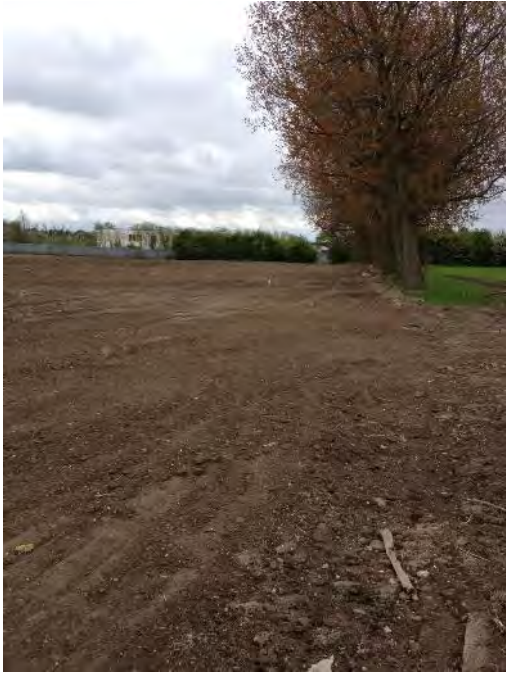
Photo No. 8	Date: 10.05.13

Direction Taken: South east	Photo Taken:	
Description: View looking along western edge of raised area

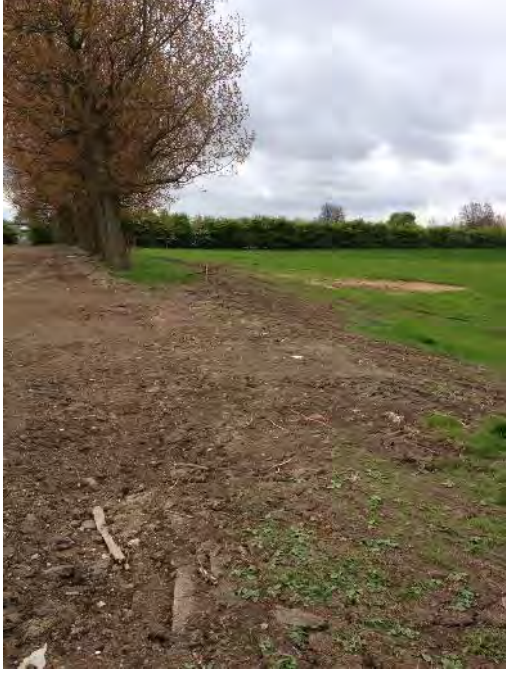
Photo No. 9	Date: 10.05.13	 
Direction Photo Taken: West		
Description: View across former playing fields towards western site boundary

Direction Taken: South	Photo Taken:	
Description: View towards southern corner of site

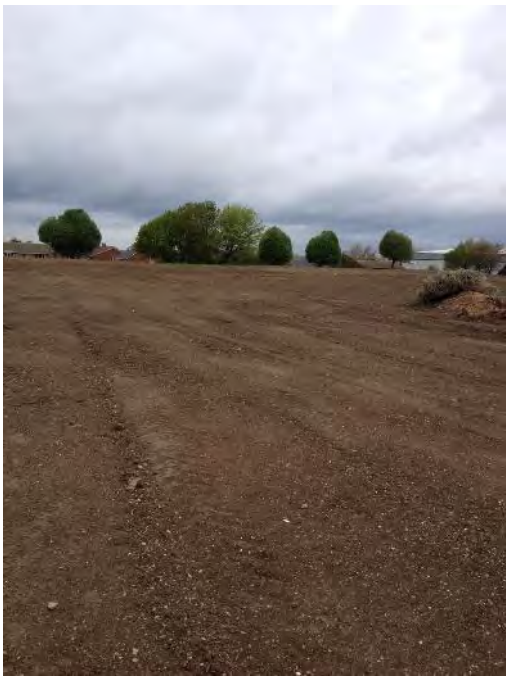
Photo No. 10	Date: 10.05.13

Direction Photo Taken: North west		
Description: View from centre of site towards northern corner showing slope along northern site boundary
