Longfield House Outbuilding

Preliminary Bat Roosting and Bird Nesting Assessment

September 2026

| <b>Reference:</b> | 2026-030 |

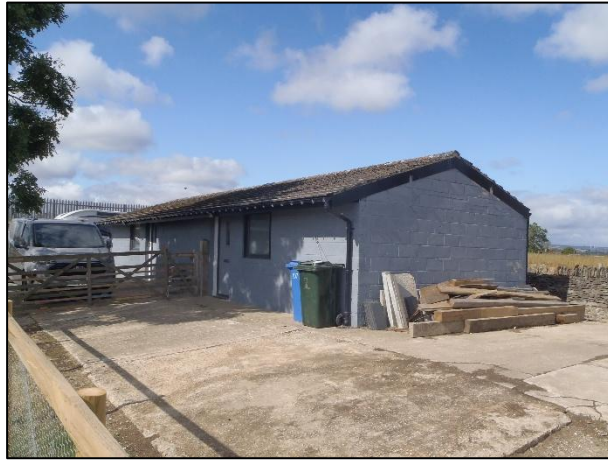
- 3.3 The building (Photographs 1 and 2 in Section 6) is of single storey concrete block construction with a concrete tiled roof pitched to the north west and south east and gabled to the north east and south west. The roof is underlined with bituminous felt and overhangs the south east wall of the building by approximately 0.5m.
- 3.4 Internally the building is used as a workshop, office space and for storage. The interior of the building is open to the roof apex (Photographs 3 and 4).
- 3.5 The findings of the building assessment are set out in Table 1 below.

**Photograph 1: North east and south east elevations**

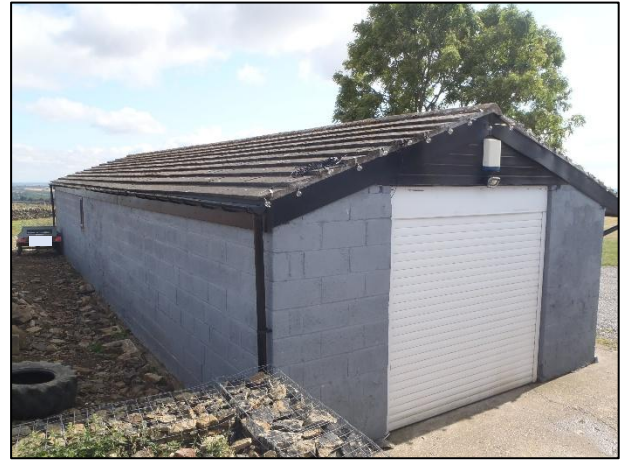
| Area | Description | Photographs |
|---|---|---|
| North west elevation | <ul style="list-style-type: none"> <li>Concrete roof tiles fit tightly together and sit tight against fascia at bottom of roof pitch.</li> <li>No gaps at ridge.</li> <li>No gaps around window.</li> <li>No potential bat roosting features recorded.</li> </ul> | 2 |

**Photograph 2: South west and north west elevations**

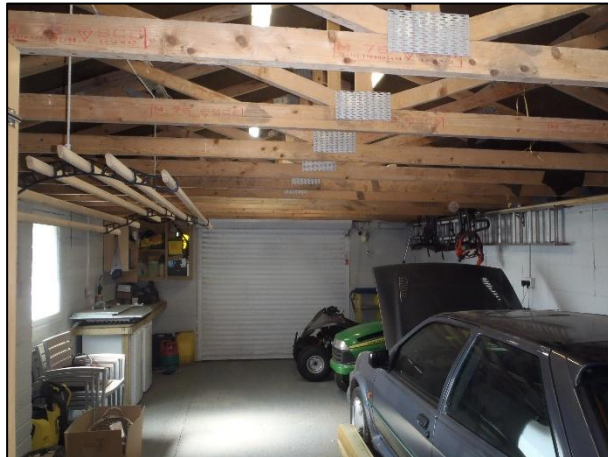
**Photograph 3: Interior of building (south west end)**

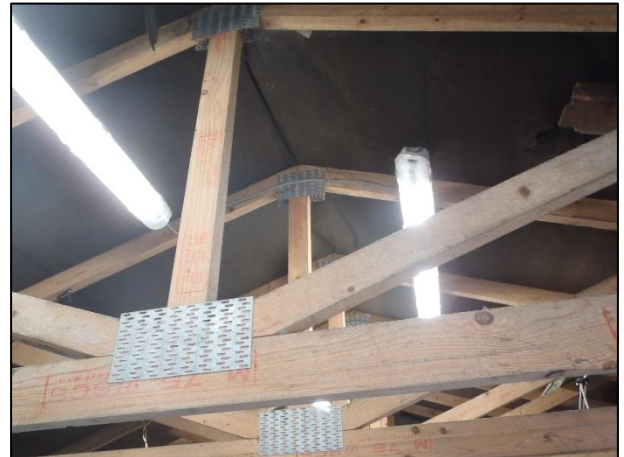
**Photograph 4: Underside of roof of building**

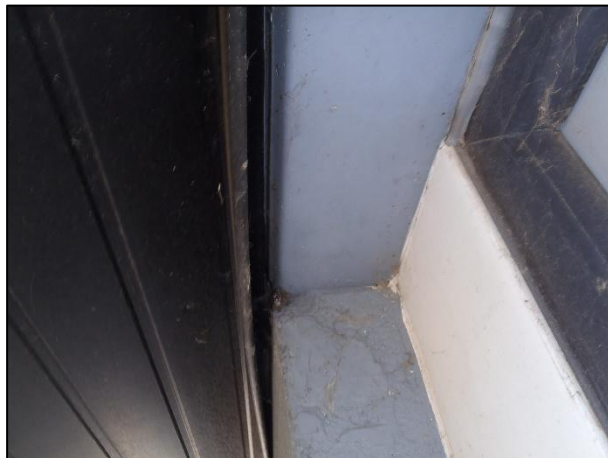
| Area | Description | Photographs |
|---|---|---|
| South east elevation | <ul style="list-style-type: none"> <li>• Concrete roof tiles fit tightly together and sit tight against fascia at bottom of roof pitch.</li> <li>• No gaps at ridge.</li> <li>• No gaps between window or door frames and wall.</li> <li>• Some gaps between trim at wall top and wall behind but do not extend beyond the depth of the trim.</li> <li>• Gap behind trim over window at north east end of elevation with underfelt visible through gap of approx. 8mm at top. Trim overhangs the top of window and potential bird/bat access would be convoluted. Gap behind trim and gap above trim is considered unlikely to be accessible to bats and birds.</li> </ul> | 1, 5 and 6 |

**Photograph 5: Gap behind trim at wall top on south east elevation**

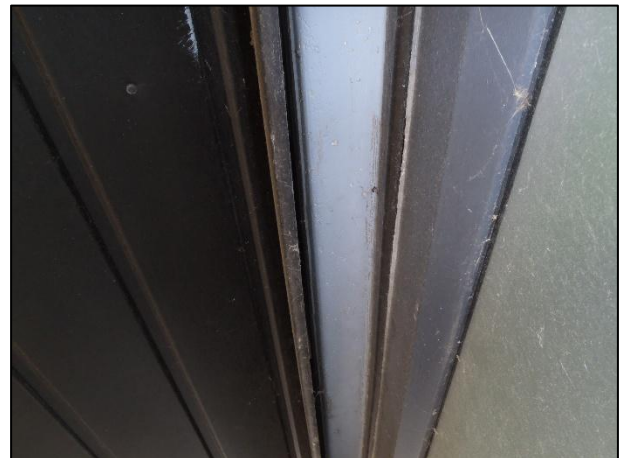
**Photograph 6: Gap behind trim over window on south east elevation**

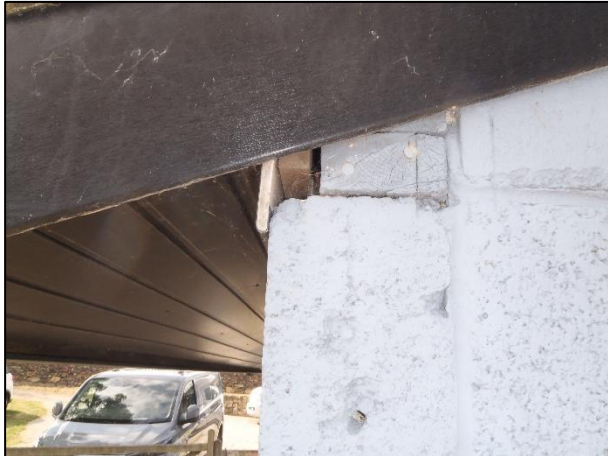
| Area | Description | Photographs |
|---|---|---|
| North east elevation | <ul style="list-style-type: none"> <li>• Gap at east corner leading behind trim at wall top. Densely cobwebbed internally.</li> <li>• Gap in verge mortar. Densely cobwebbed. Narrows down to approx. 8mm.</li> <li>• Gap under trim below gable verge. Densely cobwebbed.</li> </ul> | 1, 7 to 9 |

3.9 The gaps behind trims at the corners of the building may have some potential to be accessed by smaller bird species but these do not lead to a chamber/cavity that would typically be suitable for nesting.

**Photograph 7: Gap at east corner of north east elevation**

- An inspection by a suitably qualified ecologist immediately prior to the commencement of work to the features identified.
- A tool-box talk from a suitably qualified ecologist for those undertaking work to the features identified.
- The removal of the features identified carefully by hand under ecologist supervision.
- Work stopping if any bats are found and an assessment being made by a suitably qualified ecologist with respect to the need for a Natural England Licence to be sought.
- The incorporation of suitable bat roosting features within the new exterior walls to be constructed as outlined in Table 2 below.

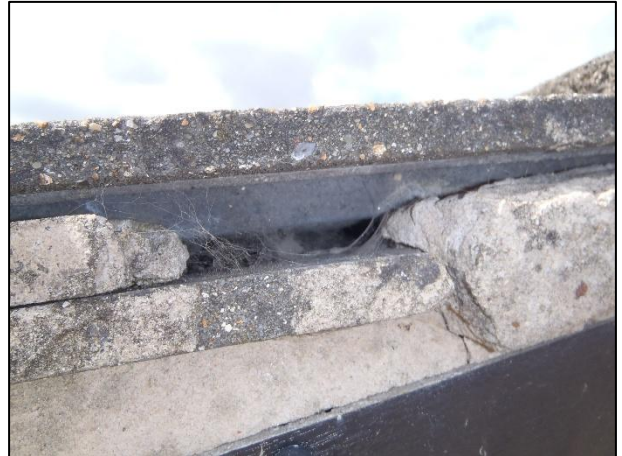
3.10 The gap in the verge mortar on the north east elevation narrows to approx. 8mm and is considered likely to be inaccessible to even the smallest bird species such as blue tit *Cyanistes caeruleus*<sup>1</sup>.

**Photograph 8: Gap in mortar of gable verge of north east elevation**

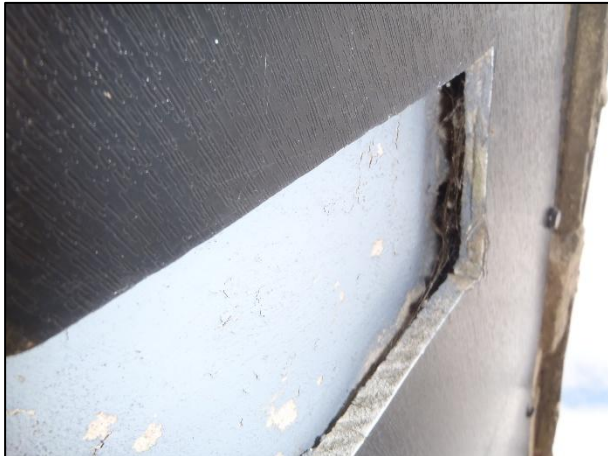
3.8 The gaps under the trims at wall tops and below gable verges are vertical and without a ledge suitable for nest building. As such these features are considered unlikely to be suitable to be used by nesting birds.

**Photograph 9: Gap under trim below gable verge on north east elevation**

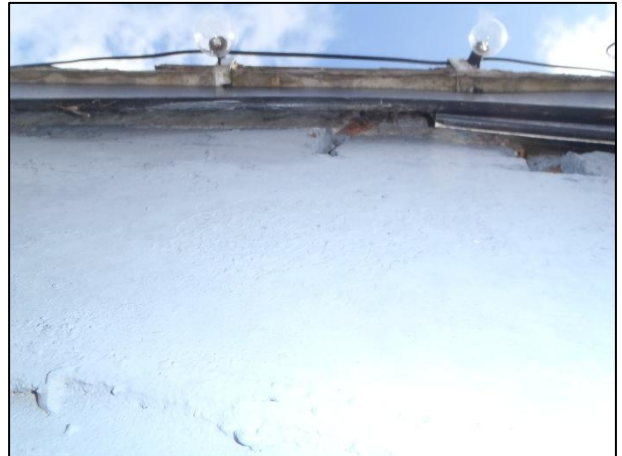
| Area | Description | Photographs |
|---|---|---|
| South west elevation | <ul style="list-style-type: none"> <li>Gap present behind trim below gable verge.</li> <li>Gap of approx. 6mm above this trim at gable verge considered unlikely to be accessible to bats and birds.</li> <li>Gap at south and west corners leading behind trim at wall top. Densely cobwebbed internally and does not lead to a larger cavity.</li> </ul> | 2, 10 to 12 |

**Photograph 10: Gap under trim below gable verge on south west elevation**

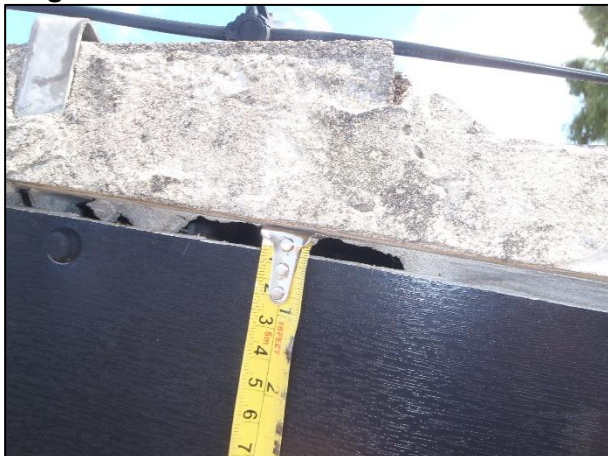
**Photograph 11: Gap above trim at gable verge on south west elevation**

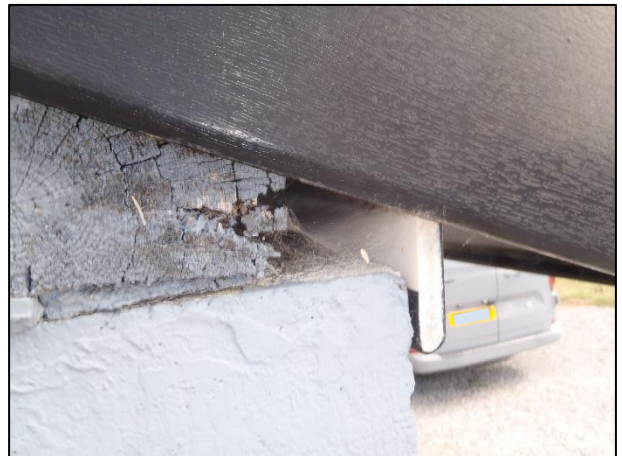
**Photograph 12: Gap at south corner of south west elevation**
