**Menagerie Wood Footbridge  
Repair Specification**

**As agreed with Wakefield Conservation Officer in January 2011  
Under the Upper Lakes Restoration Project which falls within  
the Curtilage of Bretton Hall (Grade II\*)**

**Report R556-002**

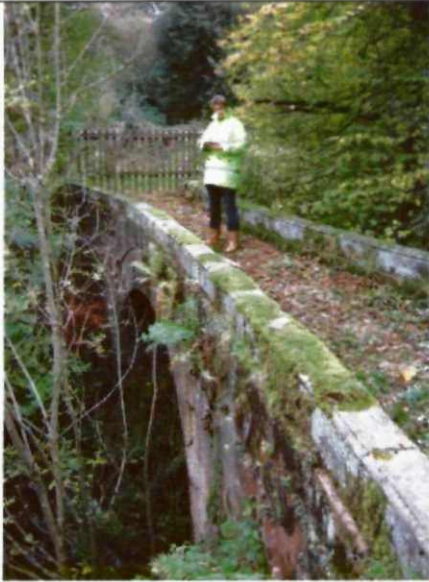
| <b>B5</b><br><b>BRIDGE 5</b><br><b>MENAGERIE WOOD</b> | |

| <i>Brief description:</i> | Narrow single span arch bridge between steep banks. |
| <i>Additional inspections required:</i> | Check for scour beneath abutments. |
| <i>Key defects:</i> | Tree trunks growing above arch barrel and through spandrel walls. |
| <i>Initial estimate load capacity:</i> | Pedestrian use only due to width. |

| SCHEDULE OF WORKS BRIDGE 5 MENAGERIE WOOD | | | | |
|---|---|---|---|---|
| 1 | Take up coping stones approx 3m long in two locations (3m to one side of bridge and 3m to other side). Take down approx 8 sq m loose stonework where displaced by tree roots (4 sq m to each side of bridge), ensuring that each panel is carefully sketched and the stones numbered for re-use in their original locations. Coping stones also to be numbered for rebidding in original locations. Cut out roots within stonework. Take out fill behind stonework (allow at tender stage for 15 cu m) and store on site, and relay behind rebuilt sections in 150mm layers carefully compacted. Relay all stones and copings in 1:3 lime sand (NHL 3.5 lime) and neat flush joints. | | | |
| 2 | Scrape off soil and loose materials from top of bridge. | | | |
| 3 | Brush off all lichen and moss to expose stonework for inspection. | | | |
| 4 | Allow for raking out and repointing 20 sq m of stonework as directed in areas not exceeding 1 sq m. Mortar to be 1:3 lime sand with NHL 3.5 lime. Depth of raking out to be not less than 25mm and joints to be flushed out with a soft brush and clean water. | | | |
