GEOENVIRONMENTAL DESK STUDY REPORT

WENTWORTH PARK ESTATE TANKERSLEY S75 3BG

MT/DS/4776.v2

February 2016

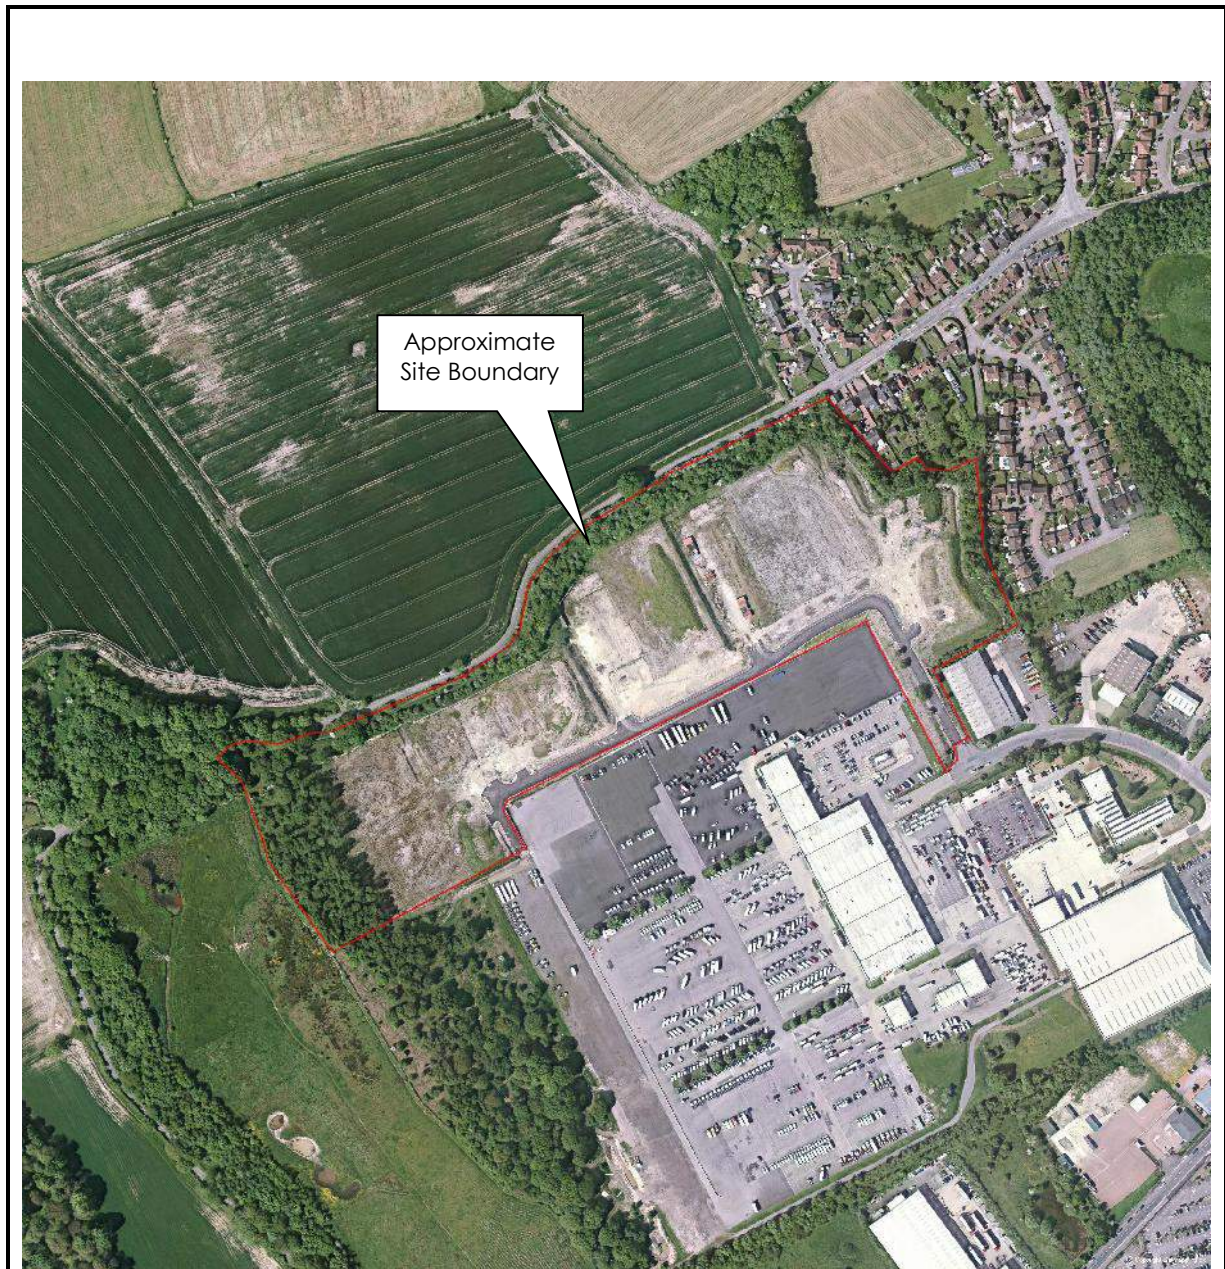
Figure 2 – Aerial Photograph	
Site	Wentworth Park Estate
Client	Barmston Developments Ltd
Job Number	4776
Scale	NTS

An aerial photograph of the site is presented as Figure 2 and selected photographs are contained in Appendix B.
