**PHASE 2 ENGINEERING & ENVIRONMENTAL  
ASSESSMENT  
FOR A RESIDENTIAL DEVELOPMENT AT THE  
FORMER MOUNT VERNON HOSPITAL,  
MOUNT VERNON ROAD, BARNSELY**

**CODA STRUCTURES' TRIAL PIT LOGS**

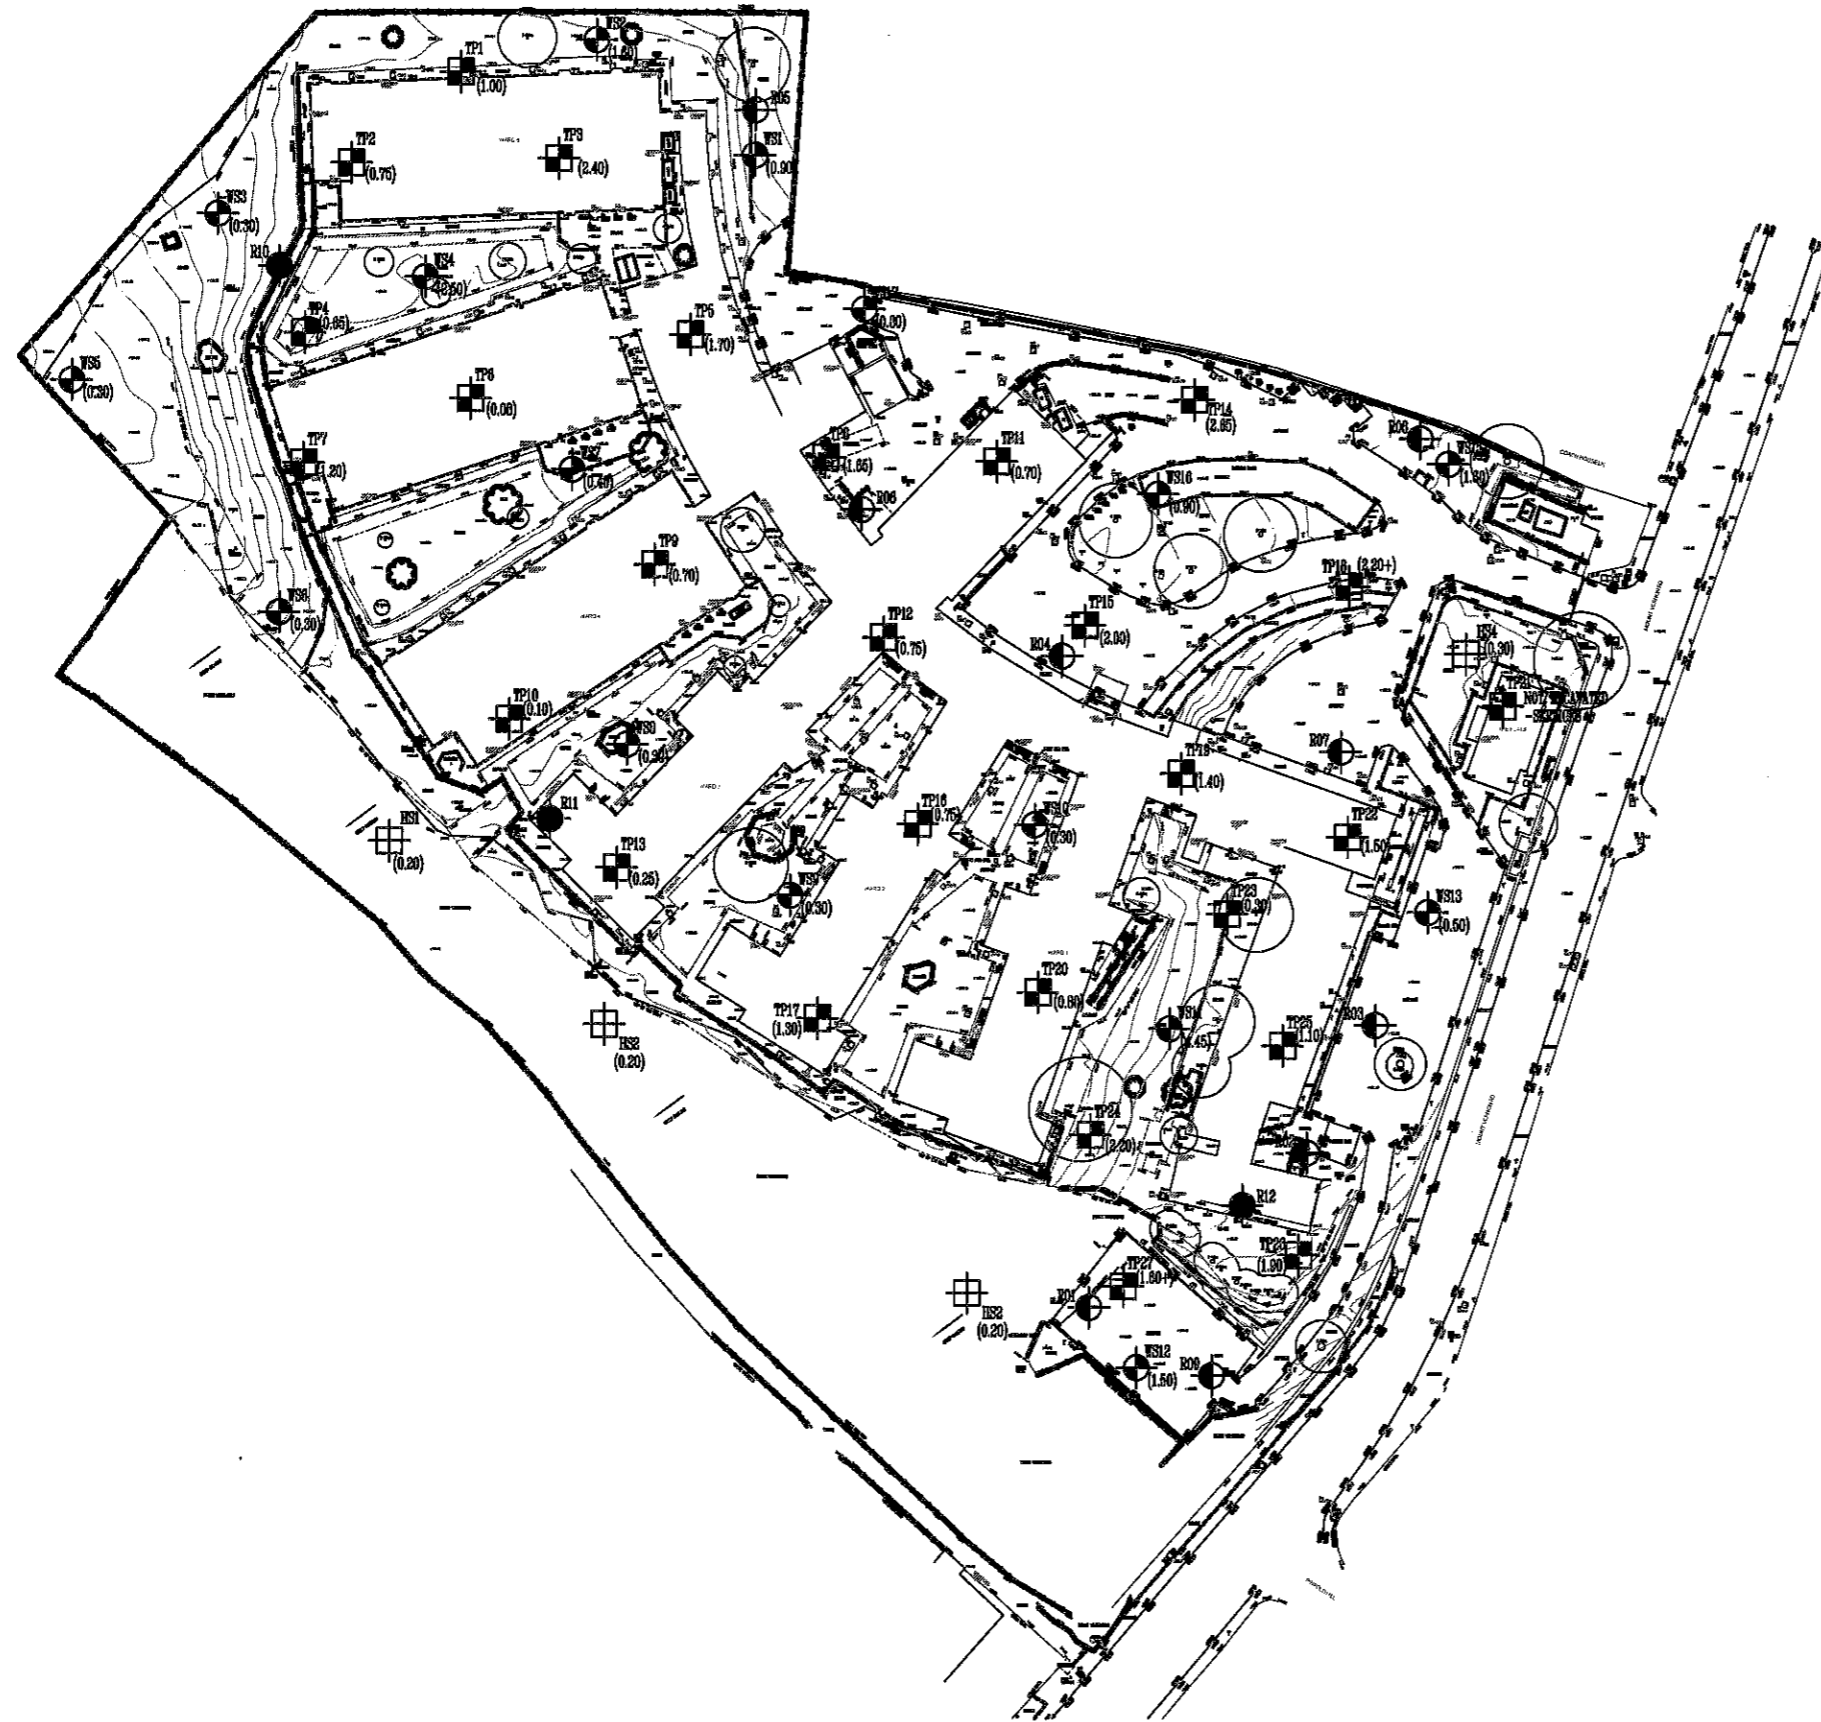
**SITE TOPOGRAPHICAL SURVEY – FIG. 2**

WS1-WS17  
 Window Sampling Borehole sunk by ARP on 15 & 16 Nov. 2017
  -

HS1-HS4  
 Hand dug trial pit by ARP on 15 Nov. 2017
  -

R01-R09  
 Rotary borehole drilled by ARP on 14 and 16 November 2016
  -

TP1-TP27  
 Trial Pit excavated by CODA Structures on 23rd & 24 July 2020
  -

R10-R12  
 Rotary borehole drilled by CoDA Structures on 14 September 2020
- GW Denotes gas/ground water monitoring well  
 (0.50) Made ground thickness including topsoil

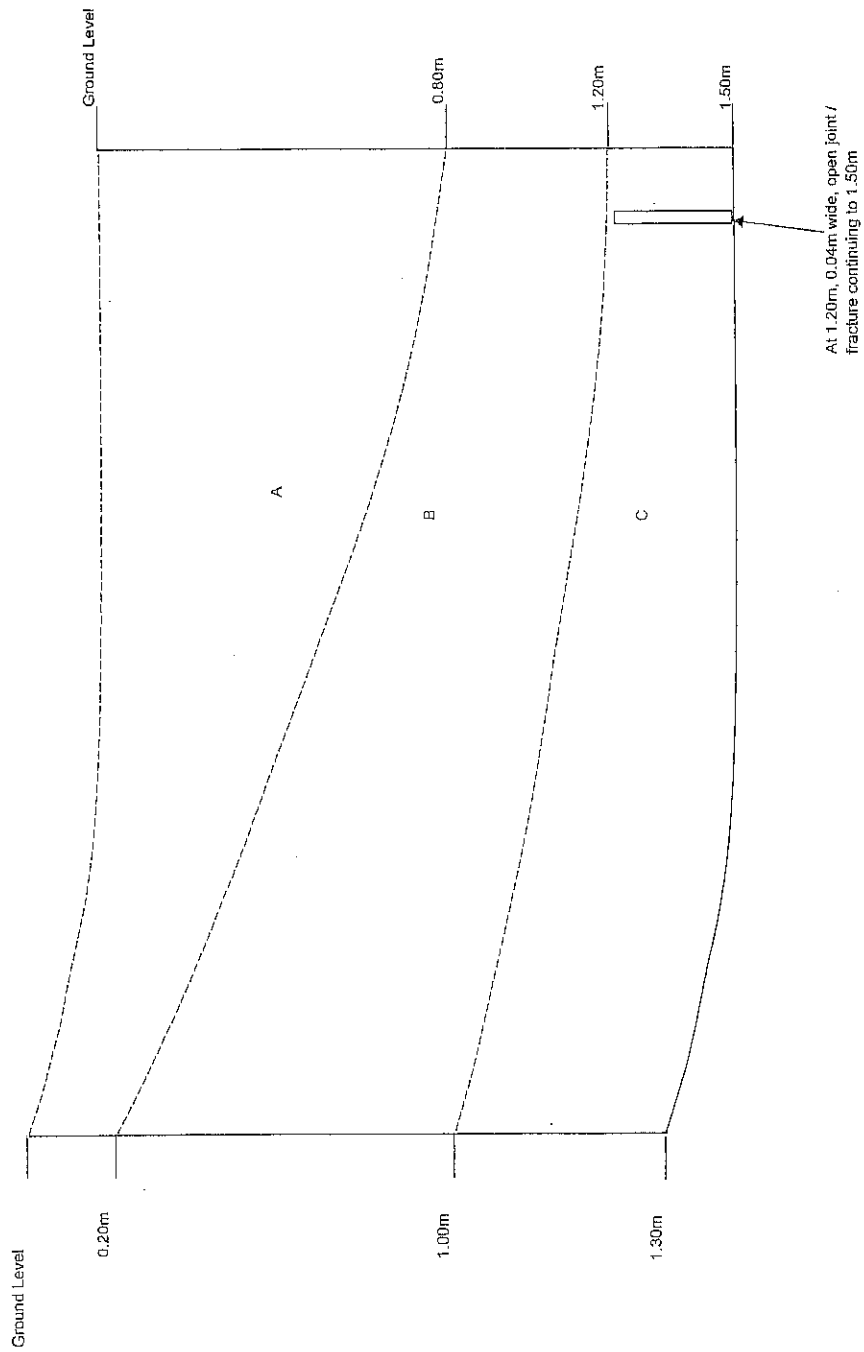
0.10	D				0.02	MADE GROUND: gravelly topsoil. Gravel sized fragments are sandstone (A).

0.60	D				(0.78)	MADE GROUND: brown sandy gravel sized, cobble sized and boulder sized fragments of sandstone (B).

0.90	D				0.80	Strong, thinly to medium bedded, brown, coarse grained moderately weathered SANDSTONE with open fractures. (C).		
			24/07/2020: DRY		(0.70)	... at 1.20m : 0.04m wide open joint/fracture, continuing to 1.50m.

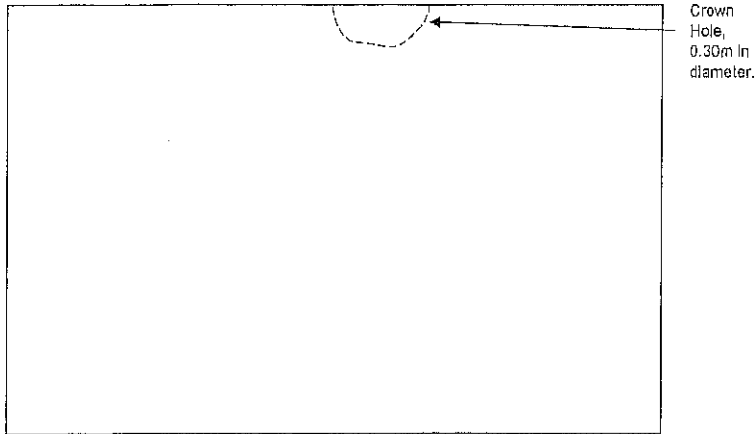
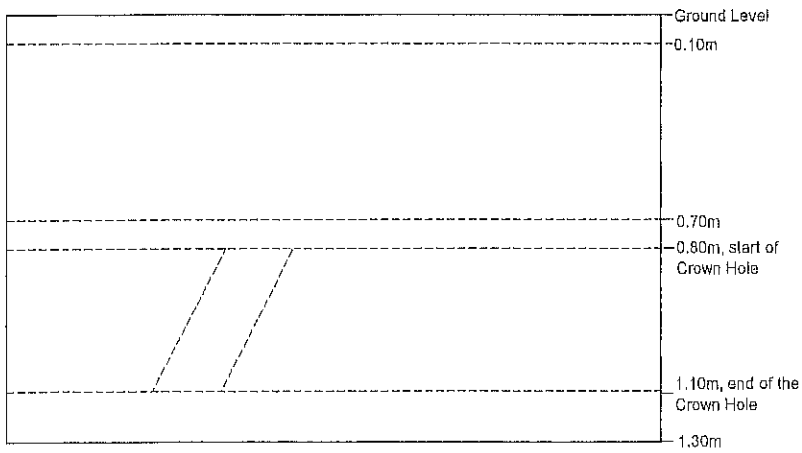
Site: MOUNT VERNON HOSPITAL, MOUNT VERNON ROAD, BARNESLEY, YORKSHIRE	Trial Pit Number: TP09
Excavation Method: MECHANICAL EXCAVATOR	Dimensions:	Ground Level (mOD):	Client: ORION HOMES LIMITED	Job Number:
	Location: AS PLAN	Dates: 23/07/2020- 24/07/2020	Engineer: CODA STRUCTURES LIMITED	Sheet: 2 / 4

0.00	D				(0.10) 0.10	MADE GROUND: brown and grey gravelly coarse sand. Gravel sized fragments are limestone and sandstone.		
0.40	D				(0.60)	MADE GROUND: brown coarse sand with medium cobble sized fragments of sandstone and medium boulder sized fragments of sandstone.

0.85	B				0.70	Medium strong to strong, thinly to medium bedded, brown, coarse grained, moderately weathered SANDSTONE.		
					(0.60)	... at 0.80m : apparent crown hole feature 0.30m in diameter extending approximately 1.10m sub-vertically		
			24/07/2020: DRY		1.30	Complete at 1.30m		
Plan					Remarks Slight collapse of pit sides from 0.00m to 0.70m No groundwater encountered. On completion backfilled with arisings.			
					Scale (approx)		Logged By

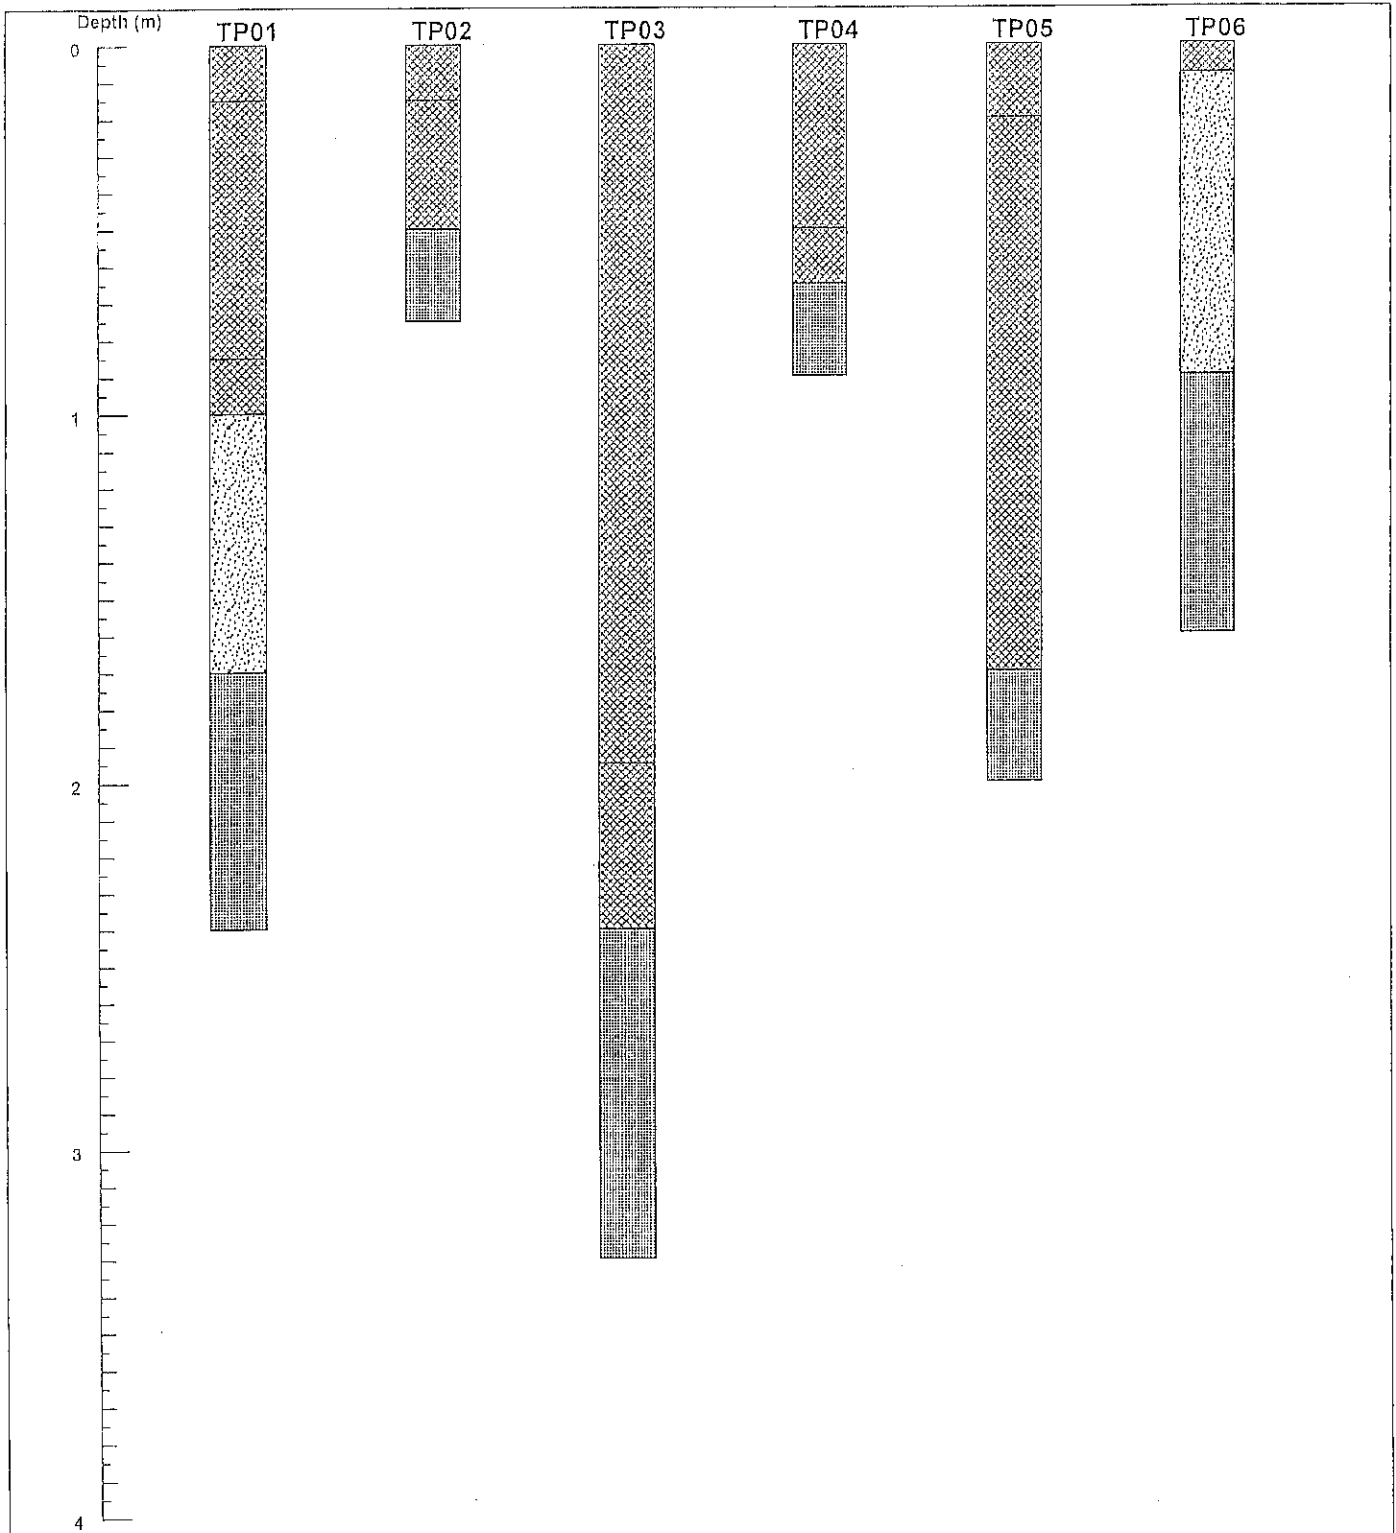
<b>Site</b> MOUNT VERNON HOSPITAL, MOUNT VERNON ROAD, BARNSELY, SOUTH YORKSHIRE	<b>Date Drawn</b> 19/08/2020	<b>Date Checked</b>	<b>Sheet</b> 1/5	<b>Job Number</b>
	<b>Client</b> ORION HOMES LIMITED	<b>Drawn By</b>	<b>Checked By</b>	<b>Scale</b> 1:20[V]
				<b>Figure No.</b>

Key	
	Groundwater Strike
	Strike Rise Level
	MADE GROUND
	SAND
	Cobbly SAND
	Gravelly cobbly SAND
	Gravelly SAND
	SANDSTONE

**Nominal Section**

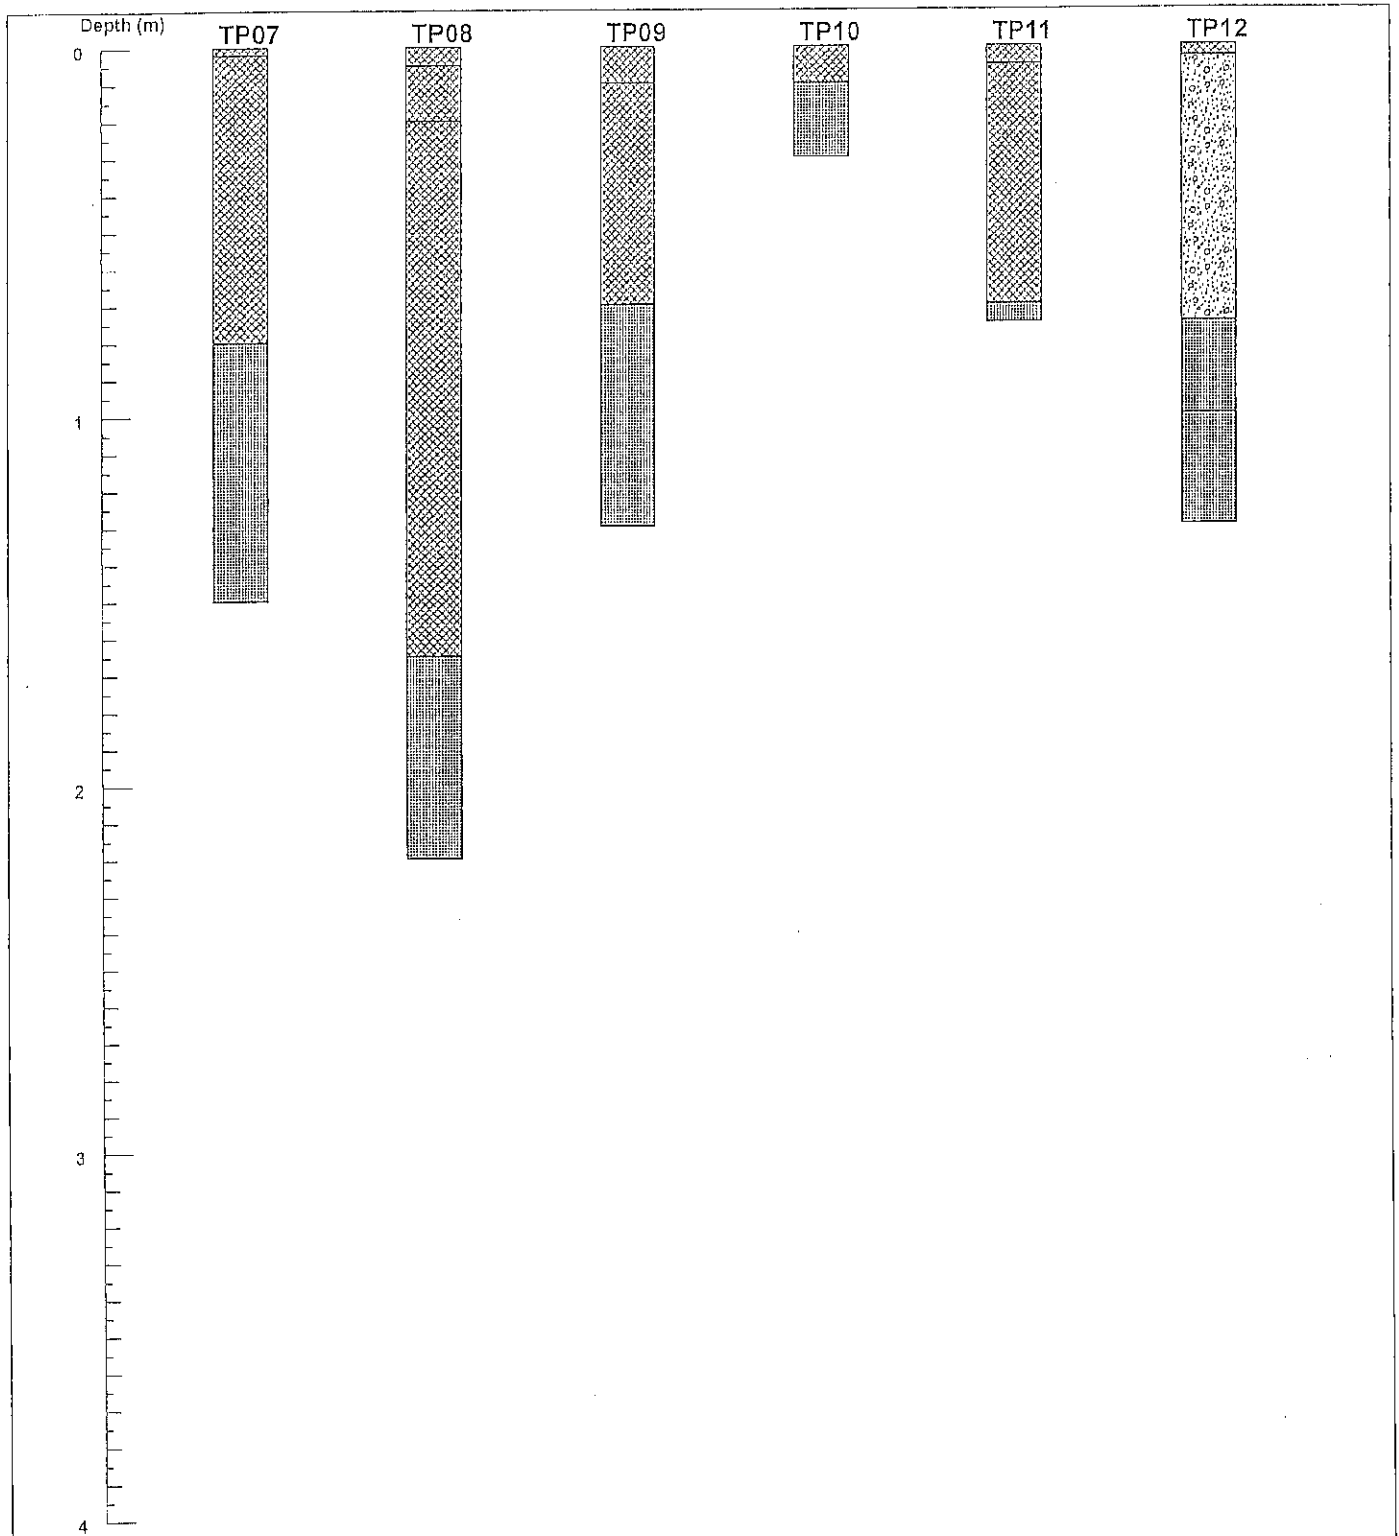
Site MOUNT VERNON HOSPITAL, MOUNT VERNON ROAD, BARNSLEY, SOUTH YORKSHIRE	Date Drawn 19/08/2020	Date Checked	Sheet 2/5	Job Number
	Client ORION HOMES LIMITED	Drawn By	Checked By	Scale 1:20[V]

Groundwater Strike		SAND
	Strike Rise Level		COBBLY SAND
	MADE GROUND		GRAVELLY COBBLY SAND
	GRAVELLY SAND		SANDSTONE

**Nominal Section**

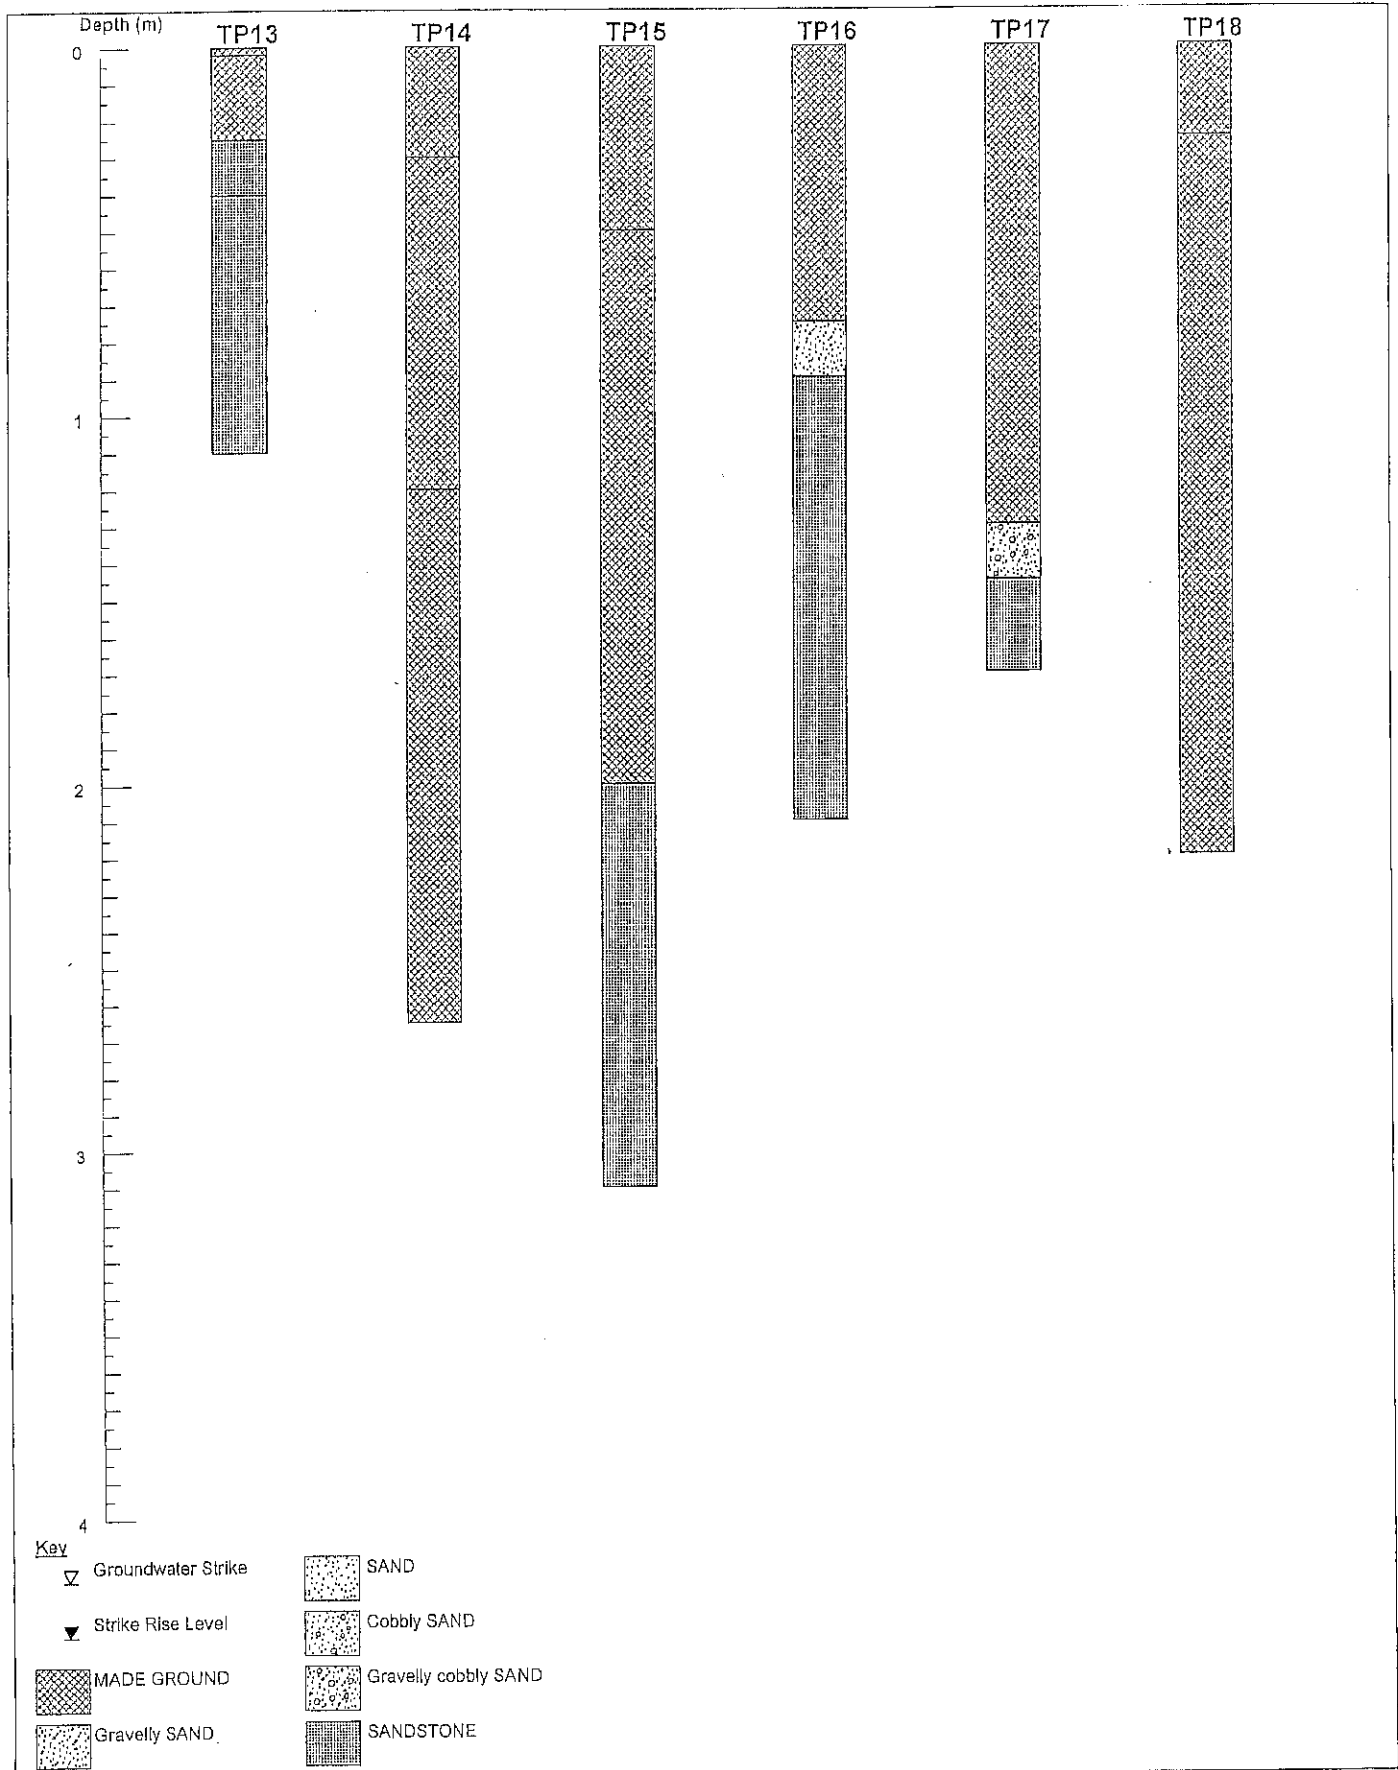
<b>Site</b> MOUNT VERNON HOSPITAL, MOUNT VERNON ROAD, BARNSELY, SOUTH YORKSHIRE	<b>Date Drawn</b> 19/08/2020	<b>Date Checked</b>	<b>Sheet</b> 3/5	<b>Job Number</b>
	<b>Client</b> ORION HOMES LIMITED	<b>Drawn By</b>	<b>Checked By</b>	<b>Scale</b> 1:20[V]

Key	
	Groundwater Strike
	Strike Rise Level
	MADE GROUND
	Gravelly SAND
	SAND
	Cobbly SAND
	Gravelly cobbly SAND
	SANDSTONE

**Nominal Section**

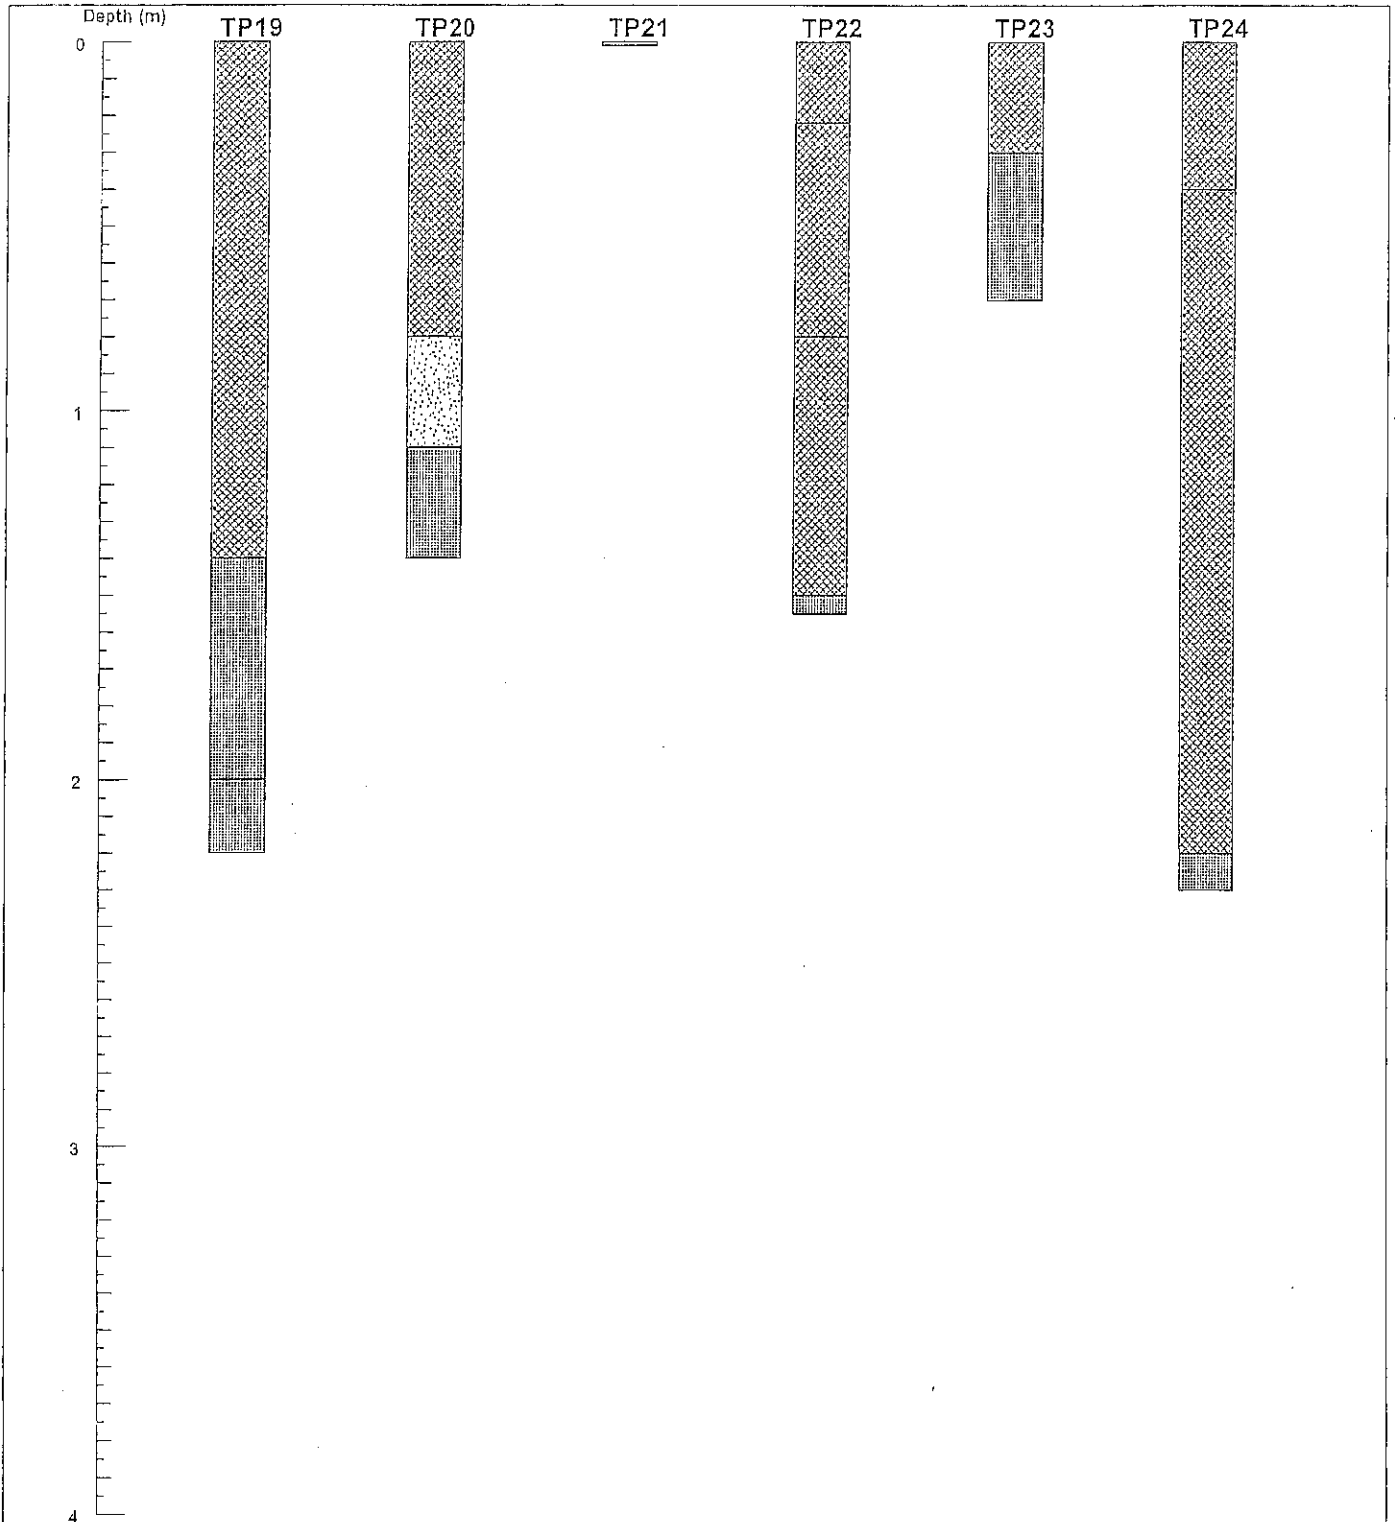
- ▽ Groundwater Strike
- ▼ Strike Rise Level
- MADE GROUND
- Gravelly SAND
- SAND
- Cobbly SAND
- Gravelly cobbly SAND
- SANDSTONE

**Nominal Section**

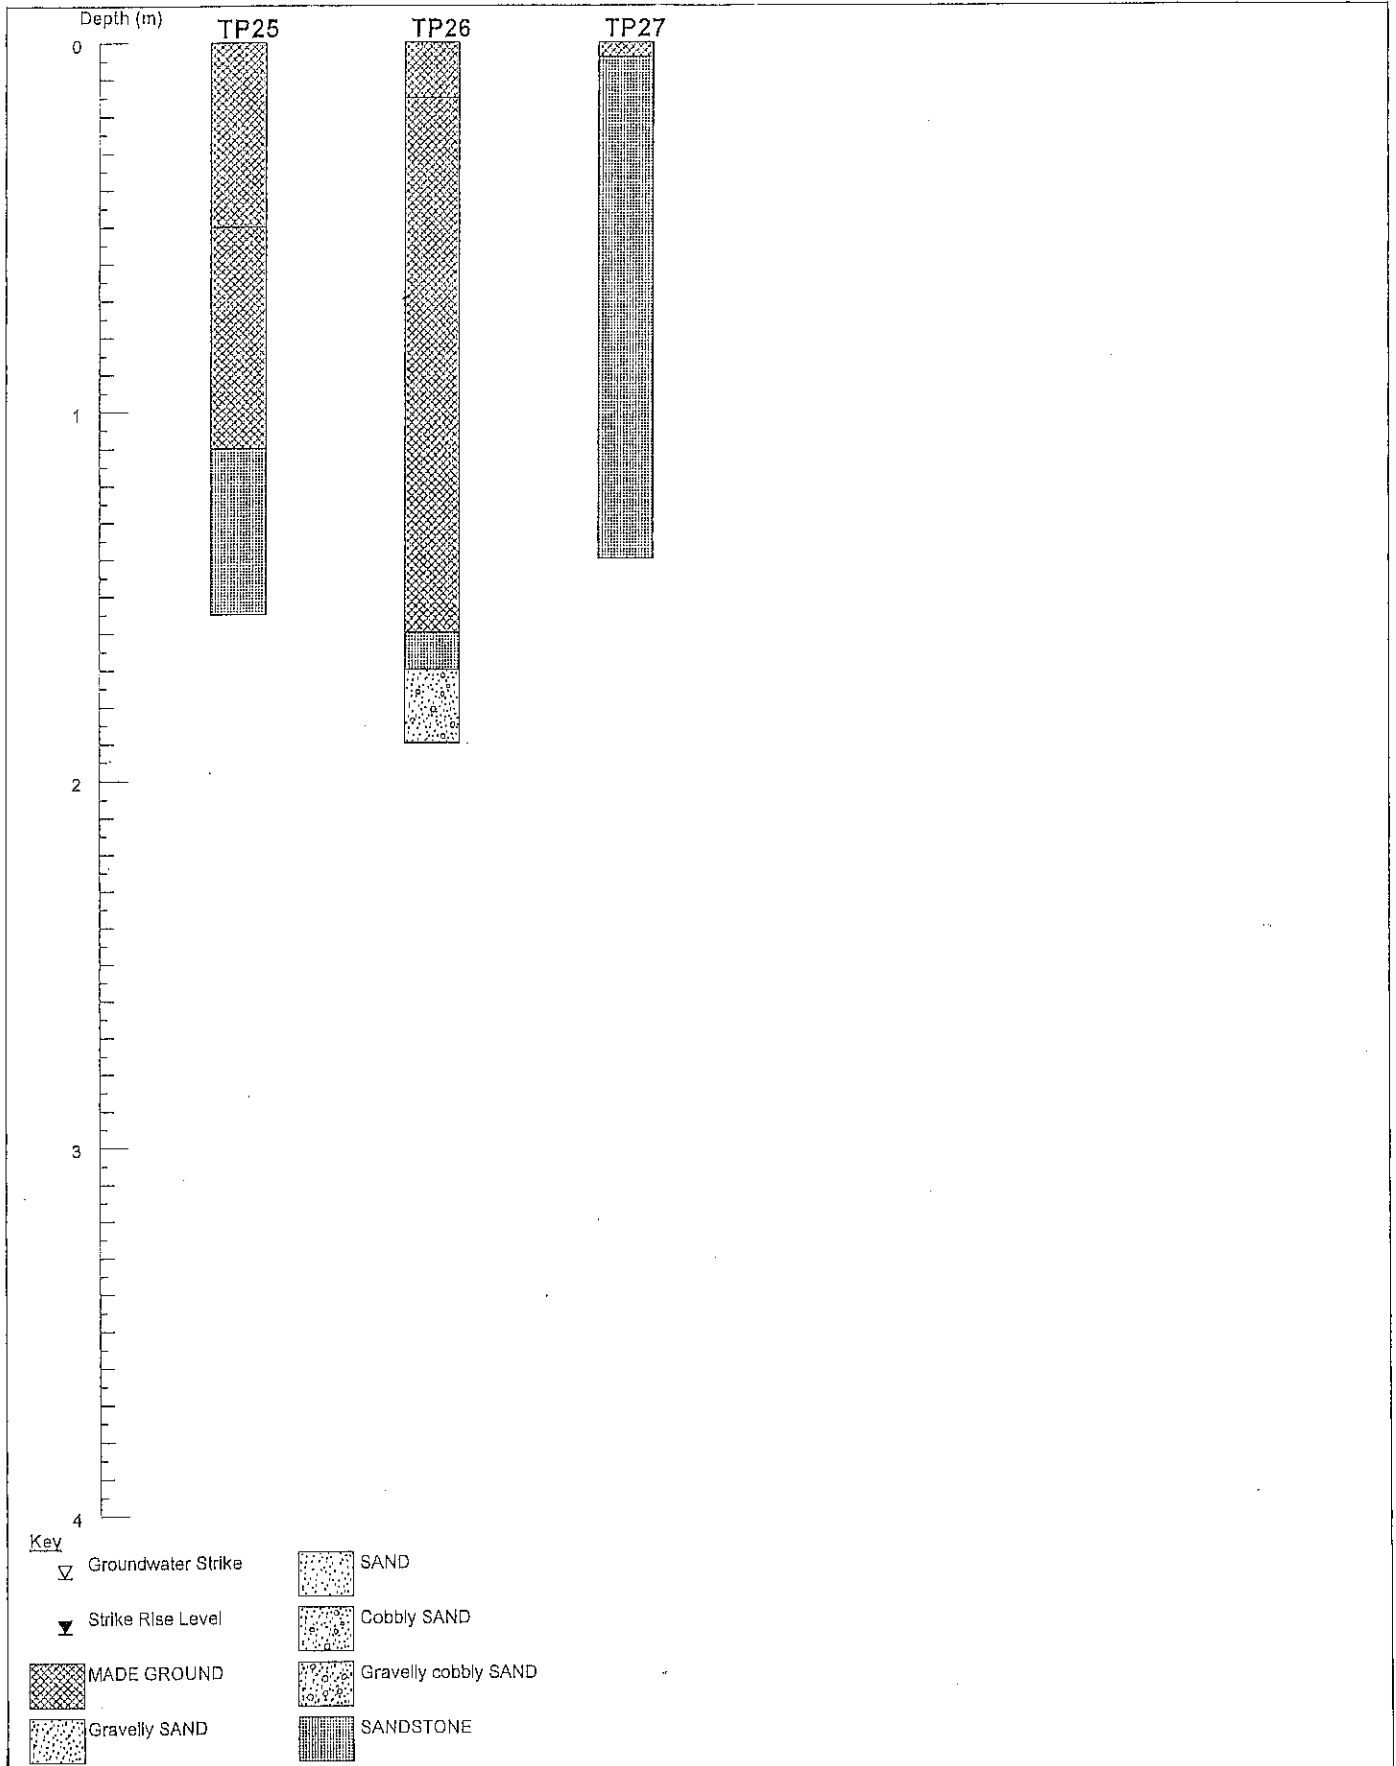
Site MOUNT VERNON HOSPITAL, MOUNT VERNON ROAD, BARNSELY, SOUTH YORKSHIRE	Date Drawn 19/08/2020	Date Checked	Sheet 5/5	Job Number
Client ORION HOMES LIMITED	Drawn By	Checked By	Scale 1:20[V]	Figure No.

Nominal Section
