**Bat Survey Report**  
**The Stable (Blacker Hill Farm), Mapplewell.**  
**28<sup>th</sup> January 2016**

**Middleton Ecological Consultancy, 33 Wilthorpe Road, Barnsley S75 1JA**

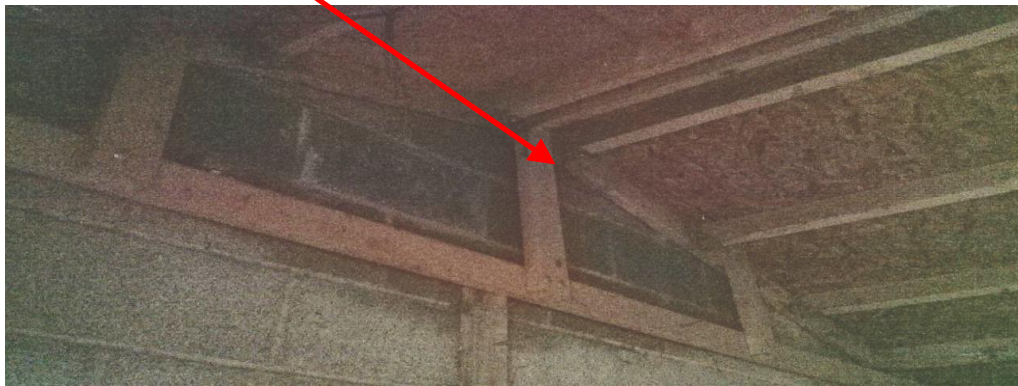
**Plate 2**

- 5.3.1 The internal space of the stable is open to the underside of the roof timbers and boards. The only feature is the roof timbers at the top of the walls at the ends of the building (see plate 2). The gap behind the timbers were inspected with the aid of a high powered lamp and all were found to be very 'cobwebby'. No signs of bats were found.

Timbers against wall with gap behind

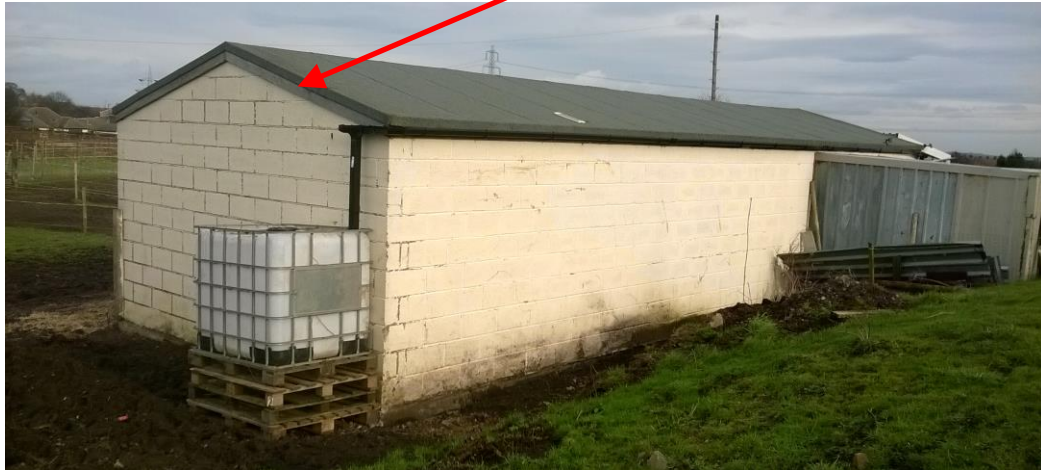
- 5.4.1 The walls have no features and a fascia board that the gutter is fastened too on the south elevation is tight against the wall. However, there are barge boards on the gables that have a small gap behind (see plate 3). The gap was easily checked with the aid of a high powered lamp and the space was found to be full of 'cobwebs' and dust. No signs of bats were found.

**Plate 3** West gable and south elevation. Barge board

- 6.1.1 No bats were found roosting in the building during the preliminary daytime assessment and there were no signs of bat occupation. The stable building has features with a little bat roost potential and consequently it has been assessed as having low bat roost potential. However, the features were easily checked with the aid of a high powered lamp, and for sure, bats have not been using the features identified because of the presence of ‘cobwebs and dust.
