# STUD FARM, CARLTON, BARNSELEY, SOUTH YORKSHIRE: A HERITAGE STATEMENT

**CS Archaeology**  
July 2011

**Project Number:** 85

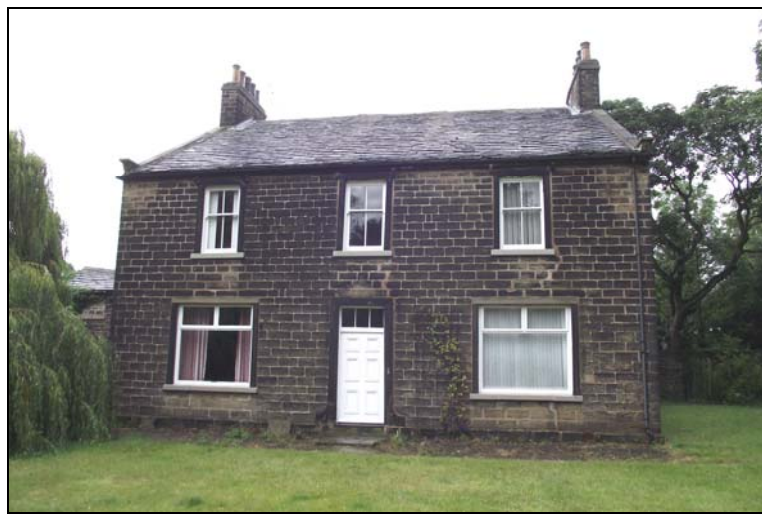
*Frontispiece: view of the front elevation of the farmhouse at Stud Farm, from the west.*

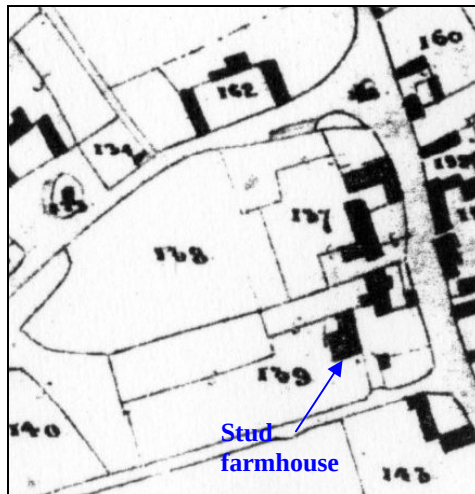
Extract from the 1845 Tithe Map

- 2.4 By the middle of the 19<sup>th</sup> century, Carlton still remained largely untouched by the industrial revolution. Carlton's tithe map depicts 'Stud Farm' with the apportionment number 139. The apportionments from the tithe map confirm that the township of Carlton had two principal landowners: John Francis Carr and the Earl of Wharnccliffe. Wharnccliffe estate owned 348 acres of arable land of which the principal tenant was Joseph Bayldon who tenanted nearly 230 acres and occupied Stud Farm (plot 139), which formed the southern half of the PDA. The northern half was tenanted by John Goody, who farmed 172 acres.

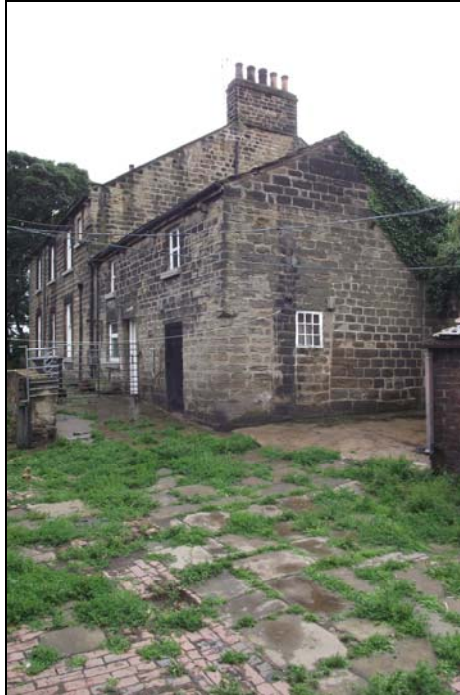
- 3.5 The gabled extension (Building B: Plate 3) at first appears to be a Victorian extension but irregularities in the stone work suggests a possibly earlier date. It most recently served as the Kitchen and had a first floor but the staircase has been removed (pers. comm. Mr Maw). There is a blocked doorway to the front north elevation. Internally the ground floor room has been largely modified, the first floor has more potential for original features but there was no access at the time of the survey.

**Plate 3:** the north and east elevations of the gabled extension (building B)

- 5.2.2 The gabled extension (Building B) has been subject to extensive modifications both internally and externally. The internal staircase has been removed and it was not possible to assess the first floor. The proposed refurbishment will impact possible original 18<sup>th</sup> century fabric, fittings and fixtures.

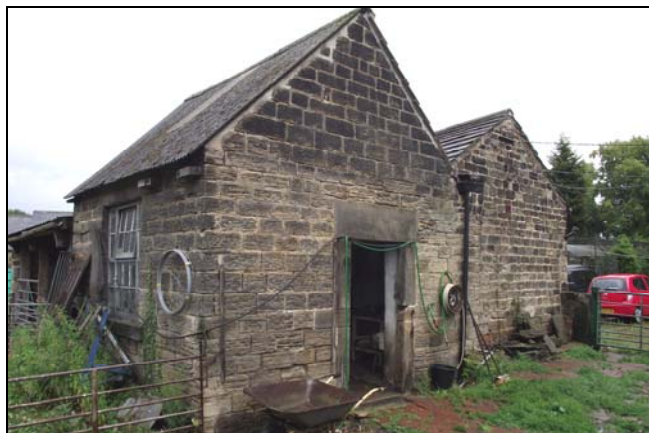
- 3.6 The Wash House/Shop (Building C: Plate 4). The Wash House survives largely intact and the internal boiler scars can still be discerned. The adjacent shop has been renovated and recently served as a farm shop for the local community so any internal features have been obscured. Externally there is an array of blocked doorways. The haphazard appearance of building C and cartographic information suggests that this originally formed part of a larger building, possibly a barn which shared the House's north south alignment.

**Plate 4:** the west elevation of the wash house and butcher's shop (building C)

- 5.2.3 The Wash house and Butcher's Shop (Building C) have been heavily modified. The wash house retains original features and is an important survival relating to the servicing of the house. No internal features are expected to be retained during the renovation.

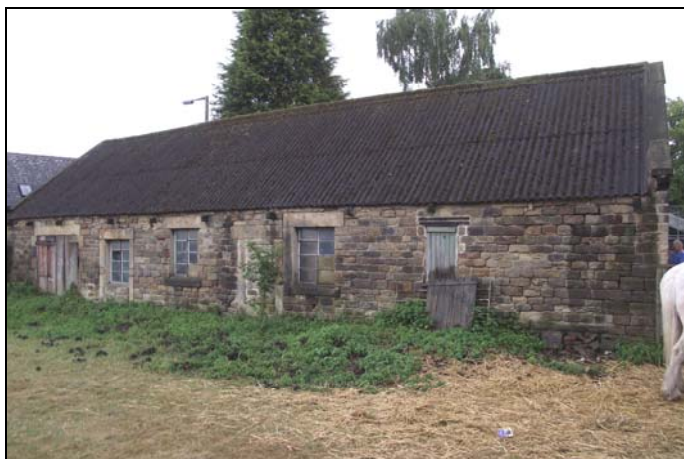
- 3.7 The Stable/Cartshed (Building D: Plate 5) represents the most recent building dating to the late 19<sup>th</sup> century. The north elevation in particular shows evidence for inserted late Victorian fenestration. During the late 20<sup>th</sup> century the internal walls have been largely removed, probably to allow for the storage of machinery.

**Plate 5:** the north elevation of the Stable/Cartshed (building D) largely dates to the late 19<sup>th</sup> century

- 5.2.4 The Stable/Cartshed (Building D) were greatly enlarged during the late C19<sup>th</sup> but may have originally featured a cart shed abutting the high street. Slight internal impacts are anticipated, particularly to the truncated cross walls. The external walls appear to be in good condition and with sympathetic treatment the building's agricultural origins as expressed by the original and inserted accesses and fenestration will endure and contribute to the sense of place.

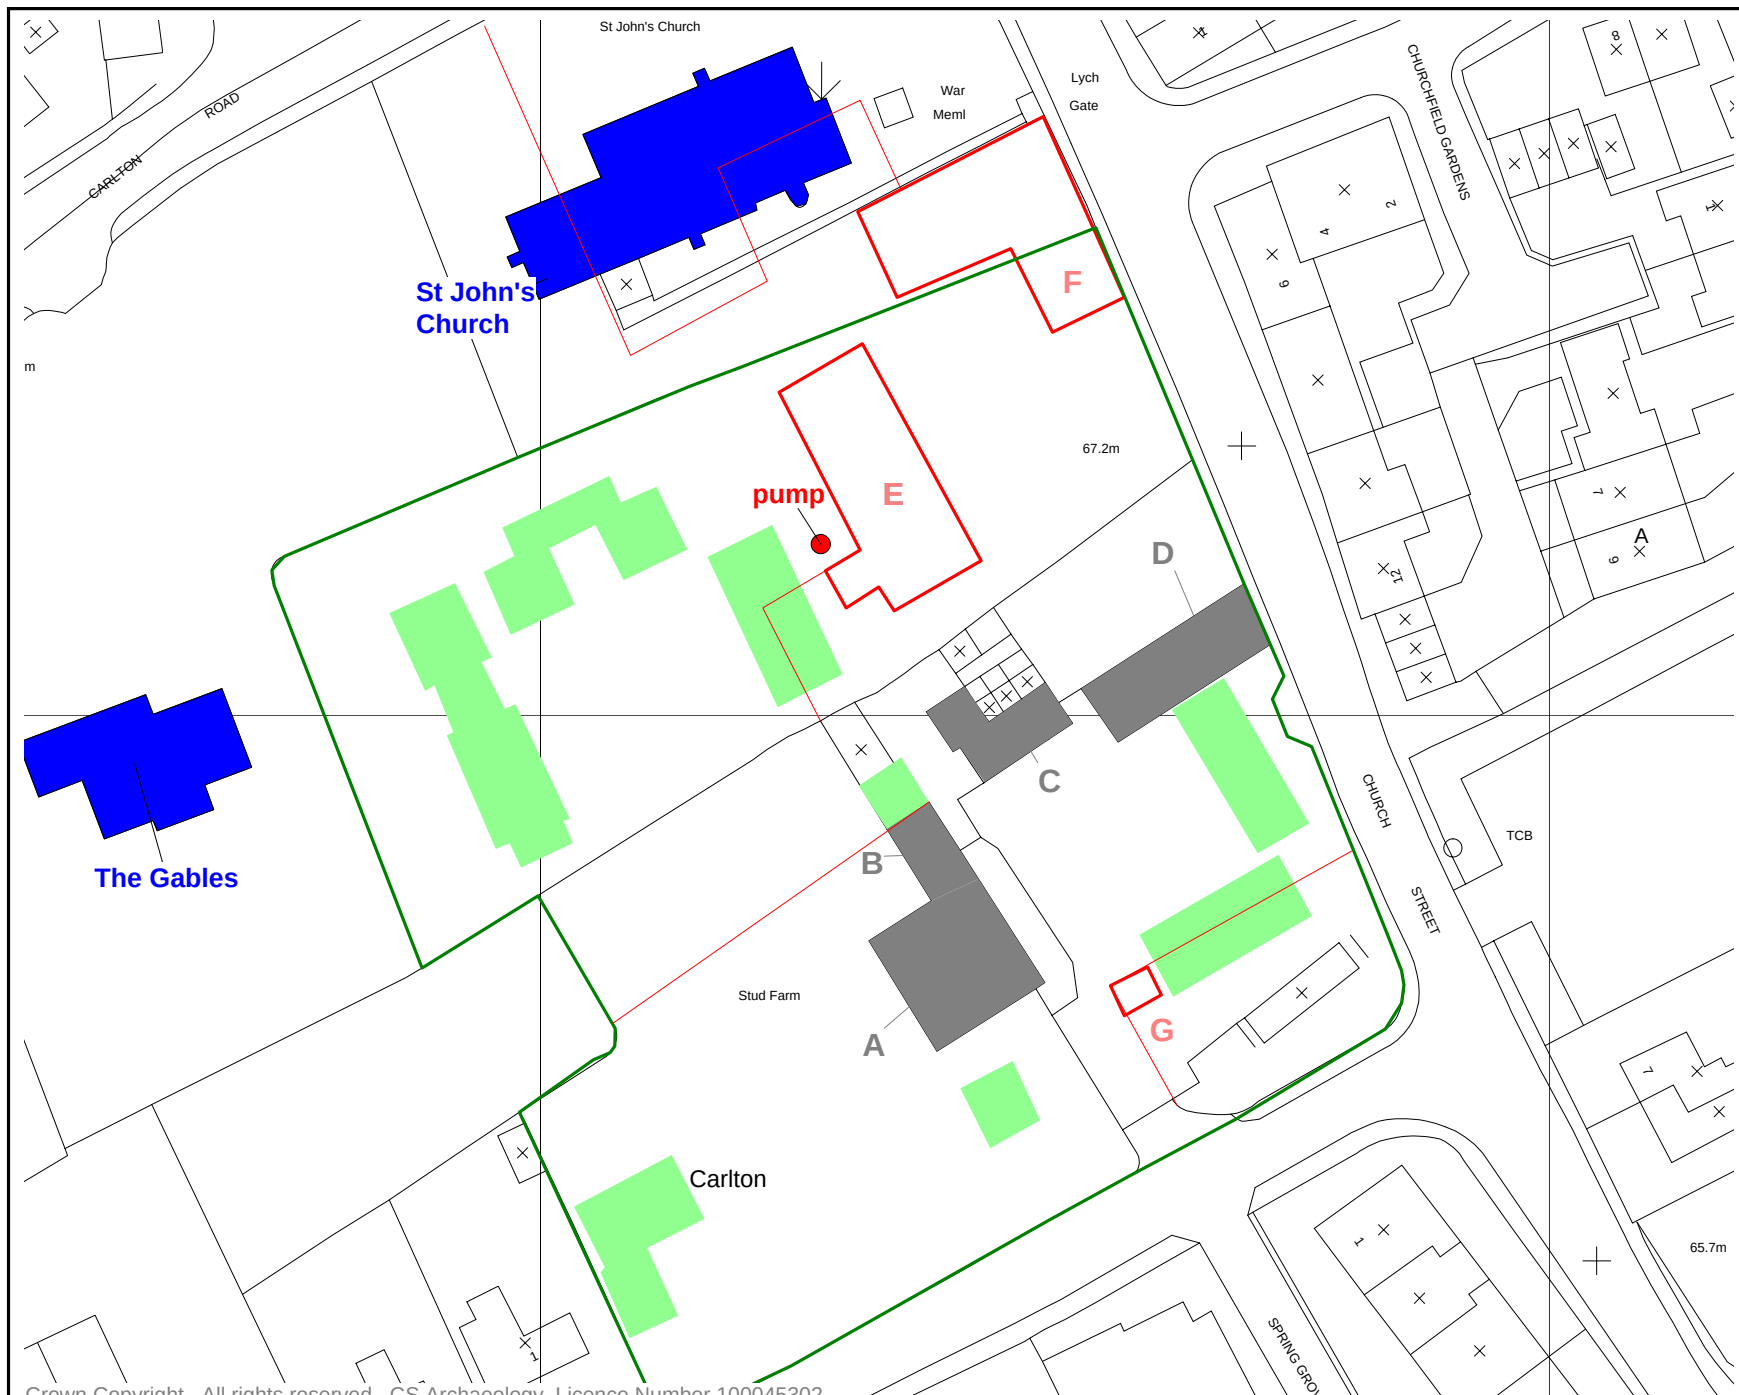
Figure 1: Plan of  
the PDA with constraints

- 3.8 Known heritage assets that are no longer extant include two buildings first depicted on the tithe map of 1845 (apportionment 137). Building E (Figure 1) is a substantial rectangular building and is aligned NNW-SSE. It faced west towards the high street, and probably represented a large agricultural barn. Just to the northwest of Building F, was the 'L' shaped building that probably served as the farmhouse and abutted the high street. The last known historic building G, was situated to the SE of the House, its function is unknown and may have served as a Stable/Cartshed since it was situated at the NW corner of a rectangular enclosure.
