Heritage Statement

Change of use of vacant chapel (Use Class F1) to self-storage (Use Class B8)

Former Wesleyan Church, Hoyland Road, Hoyland Common

January 2026

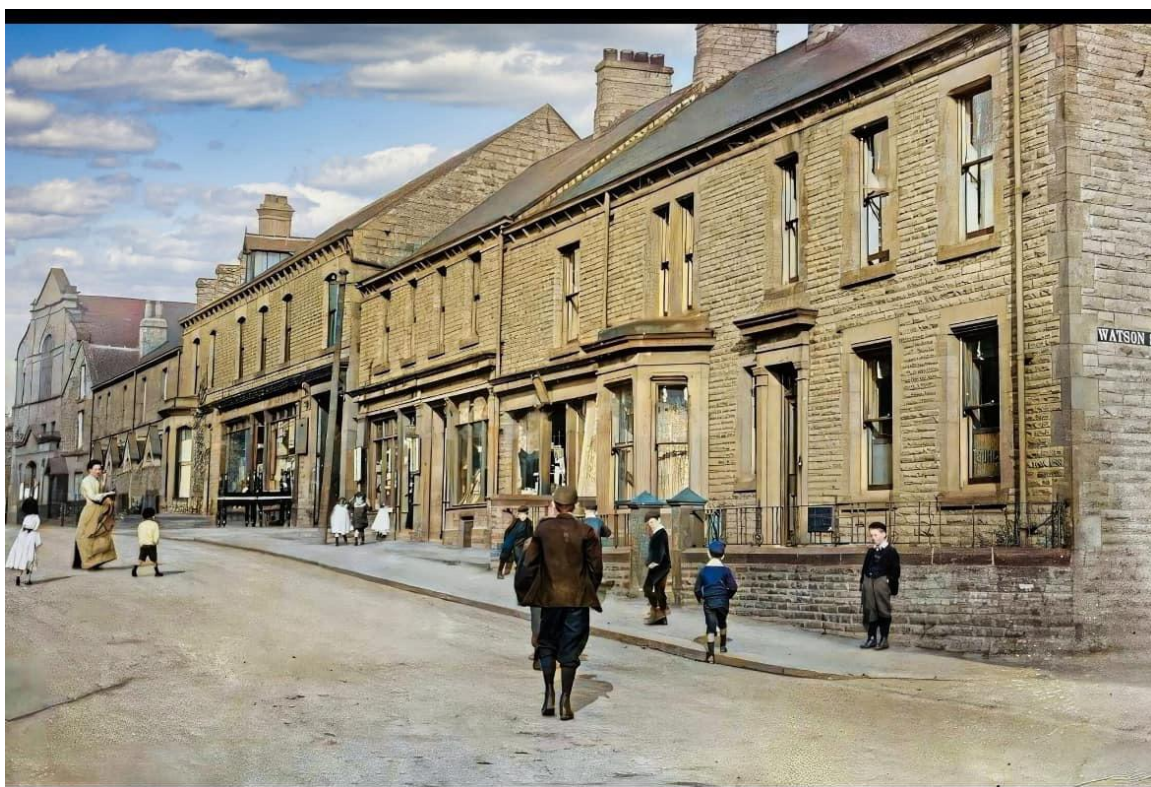
A historic photograph⁴(undated) shows the chapel in the background, which indicates that its façade has remained largely unaltered since it was built.
