# GEO-ENVIRONMENTAL REPORT

site address	The Crescent, Barnsley Road, Cudworth, Barnsley, South Yorkshire, S72 8SY
--------------	--

# Report on a Phase 2 Geo-environmental Investigation

Location:	<b>The Crescent</b> Barnsley Road, Cudworth, Barnsley, South Yorkshire, S72 8SY	
For:	Barnsley Metropolitan Borough Council	
Report No.	C5255/25/E/8168	Report date: August 2025

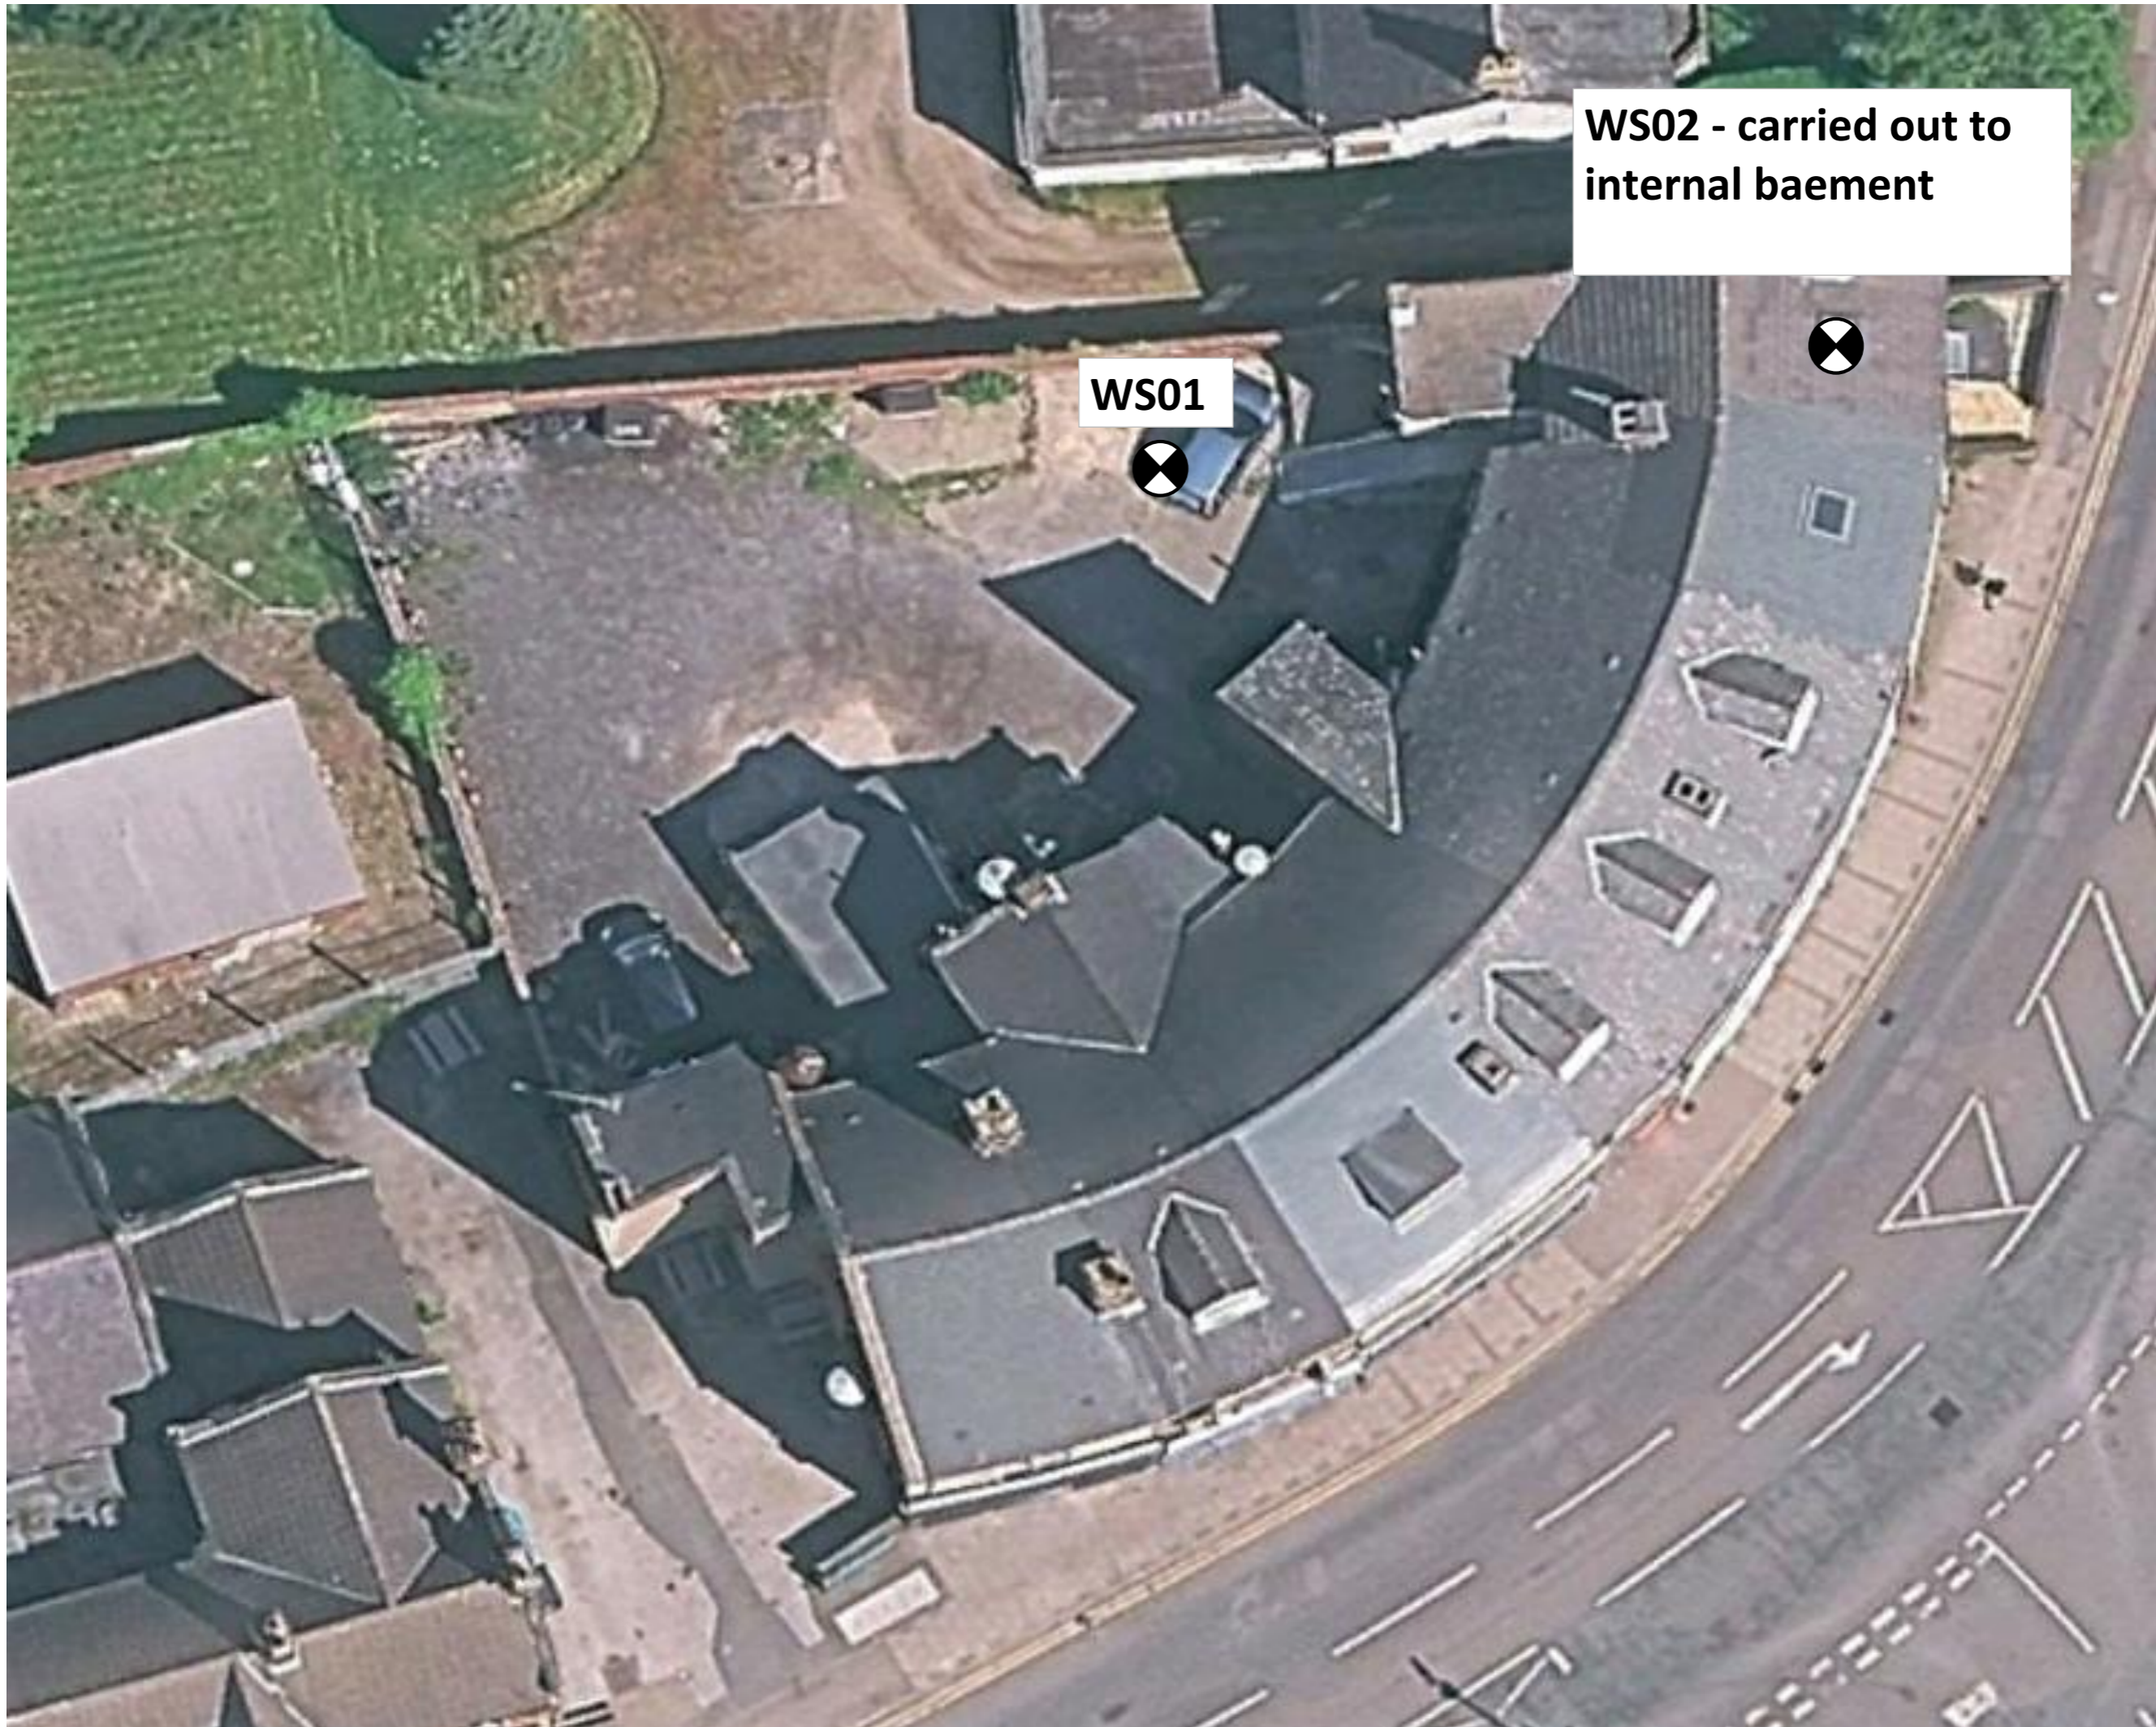
### Site Plan

The investigatory locations are shown on the site plan which is presented in Appendix 1 to this report.

**WS02 - carried out to  
internal baement**

**WS01**

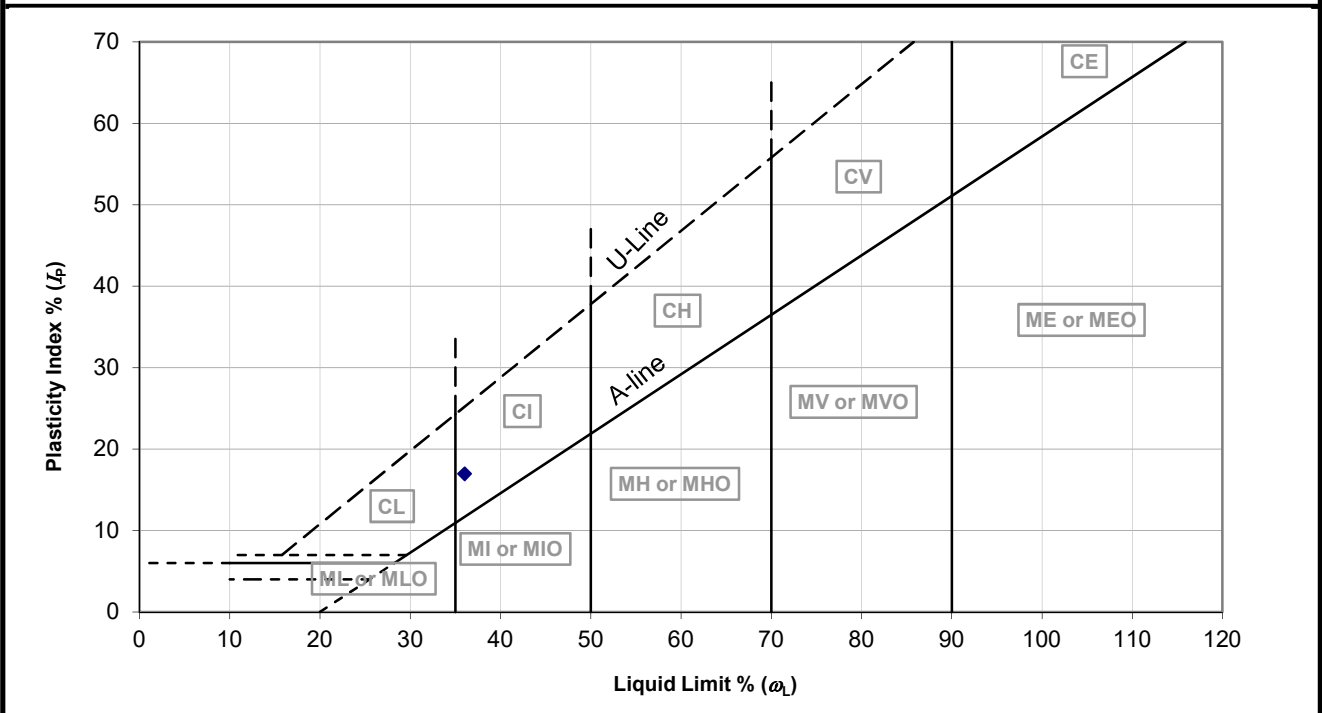
Location	Depth (m)	Water Content ( $\omega$ ) (%)	Liquid Limit ( $\omega_L$ ) (%)	Plastic Limit ( $\omega_P$ ) (%)	Plasticity Index ( $I_P$ ) (%)	Retained by 0.425mm (%)	Modified ( $\omega$ ) ( $\omega'$ ) (%)	Modified ( $I_P$ ) ( $I_P'$ ) (%)	Liquidity/ Consistency		Casagrande Class	N.H.B.C Class (%)
									( $I_L$ ) (%)	( $I_C$ ) (%)		
WS01	1.50	20	36	19	17	50	40	9	0.1	0.9	C I	*

Interpretation graph based on BS EN ISO 14688-2:2018 any interpretations are expressed outside of our UKAS Accreditation.

Test type	Number of tests	Range of results		Comments
Water content determinations	1	20%		Well below the liquid limit.
Index properties (1 Point)	1	LL PL PI	36% 19% 17%	Clay of intermediate plasticity. Consistency index of 0.9.
Soluble sulphate & pH	1	SO <sub>4</sub> pH	28.9mg/l 8.3
