**THE MONKEY, THURGOLAND.**

**BAT SURVEY REPORT.**

**Ref No: 210625/1.**

**Date: 16<sup>th</sup> August 2021.**

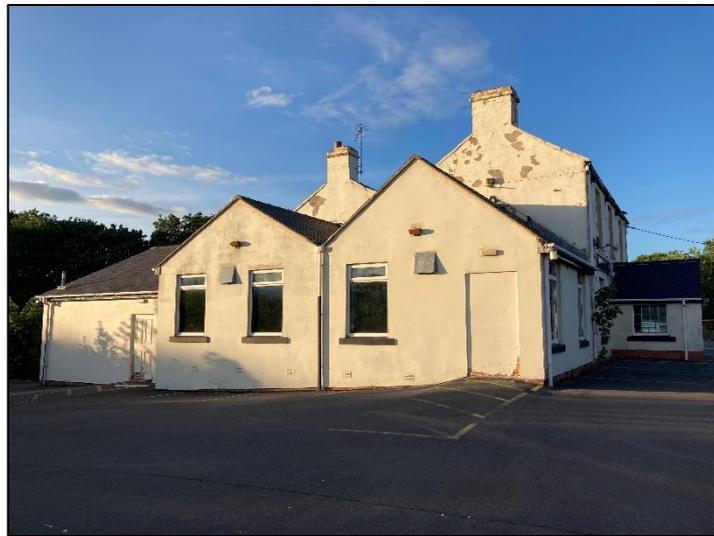
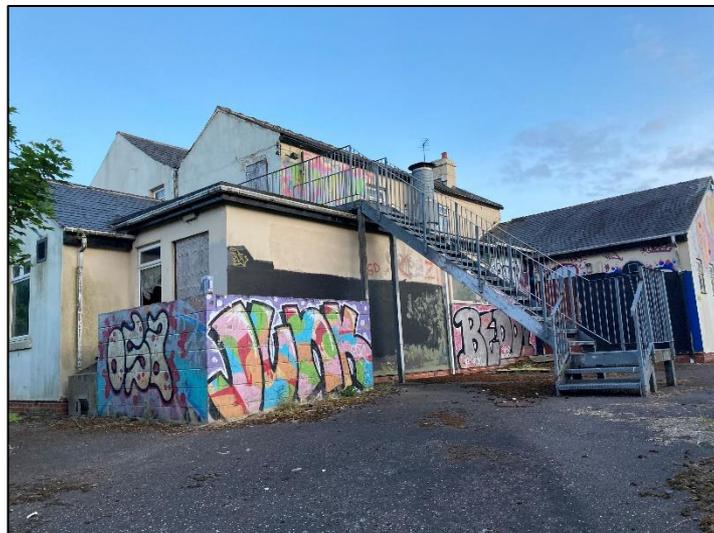
3.2.1. The surveyed buildings comprised a two-storey section with multiple single-storey extensions on all elevations. A single-storey garage building and plant room was identified to the west of the main building. The buildings were set in a large, overgrown garden.

3.2.2. The photographs below show a general view of the buildings.

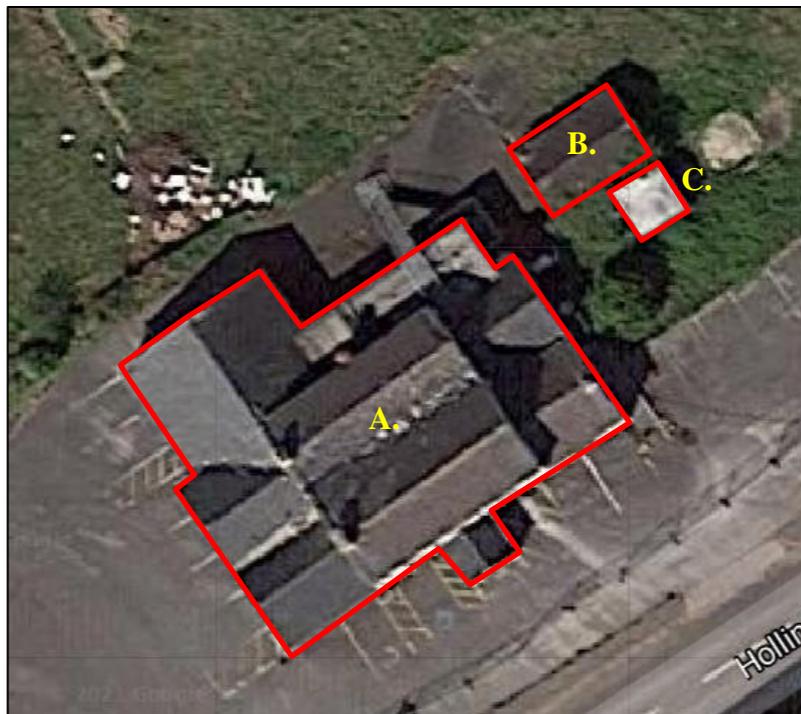
3.3.1. For the purposes of this survey the surveyed buildings have been separated and allocated a letter. The aerial photograph below shows the location of each of the buildings.

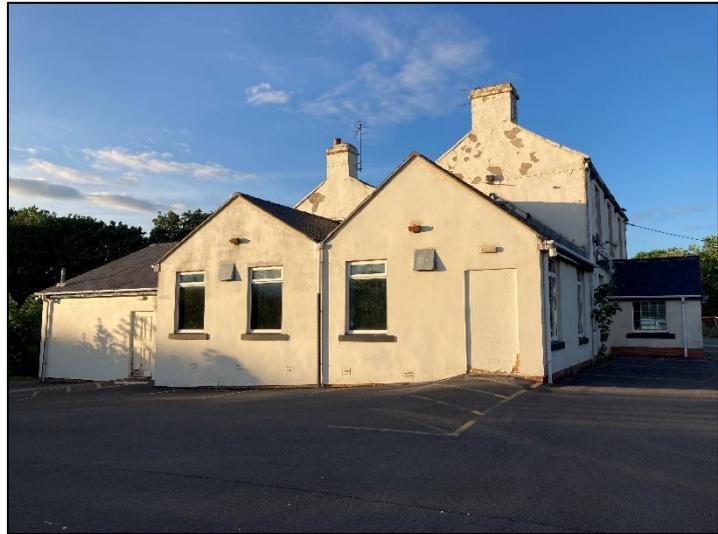
3.3.2.1. Building A comprised a main two-storey building with multiple extensions. The main building comprised rendered brick cavity walls, which were generally in a good condition with no access for roosting bats. However, there was a broken window on the northern elevation of the building providing access inside the building.

3.3.2.3. The roof of the building had two pitched sections with a valley between and four gable ends, which were well pointed with no gaps or crevices suitable for roosting bats. The roof comprised a rafter and purlin design wooden frame covered with blue slate with no lining. There had been fire damage in the second-storey kitchen that had extended into the loft space, which made some of the building inaccessible for health and safety reasons.

3.3.2.6. The roofs of the extensions comprised both pitched and flat roof sections with six gable ends, which were well pointed with no gaps or crevices suitable for roosting bats. The roof comprised a rafter and purlin design wooden frames covered with blue slate, some of which had a tight-fitting lining, other sections it was absent. The flat roofed sections were covered with tight fitting bitumen. Lead flashings had been

removed from the majority of the valleys and tie ins on the single-storey sections leaving access into the building for bats.

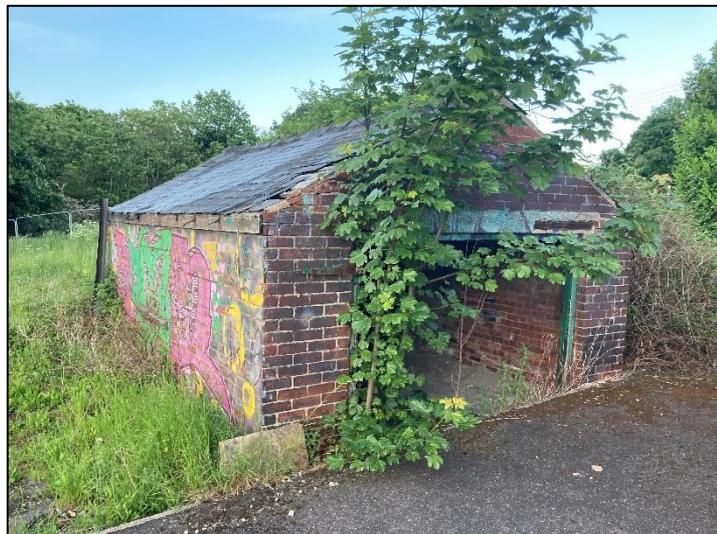
3.3.3.1. The building comprised a single-storey garage with solid brick walls, which were tight fitting with no gaps or crevices suitable for roosting bats. However, the doors were missing providing access into the building.

3.3.3.2. The pitched roof comprised a king post wooden structure. The roof was covered with blue slate with no lining. The roof was generally in a good condition. However, there was an area of missing slate. There was a wooden fascia board on both the eaves, which was tight fitting with no gaps or crevices suitable for roosting bats.

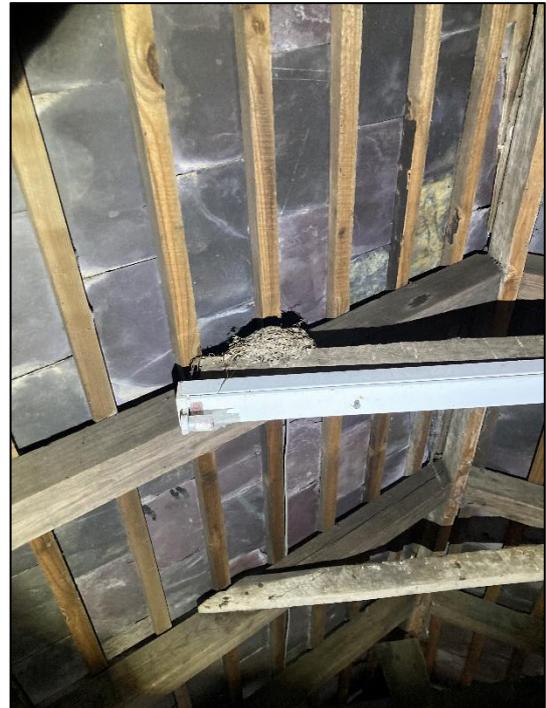
3.3.3.5. Two swallow cups were identified inside the building. However, they were disused during this survey. The photograph adjacent shows one of the swallow cups.

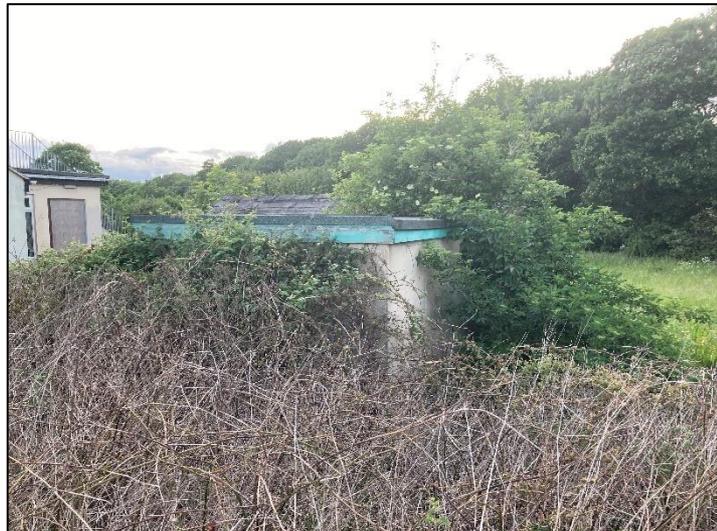
3.3.4.1. The building comprised a single-storey-plant room constructed from tight fitting breeze block with no gaps or crevices suitable for roosting bats. However, the doors were open providing access into the building.

3.3.4.2. The flat roof comprised wooden purlins covered with bitumen felt. The roof was generally in a good condition. There was a wooden fascia board on all aspects of the building, which was tight fitting with no gaps or crevices suitable for roosting bats.

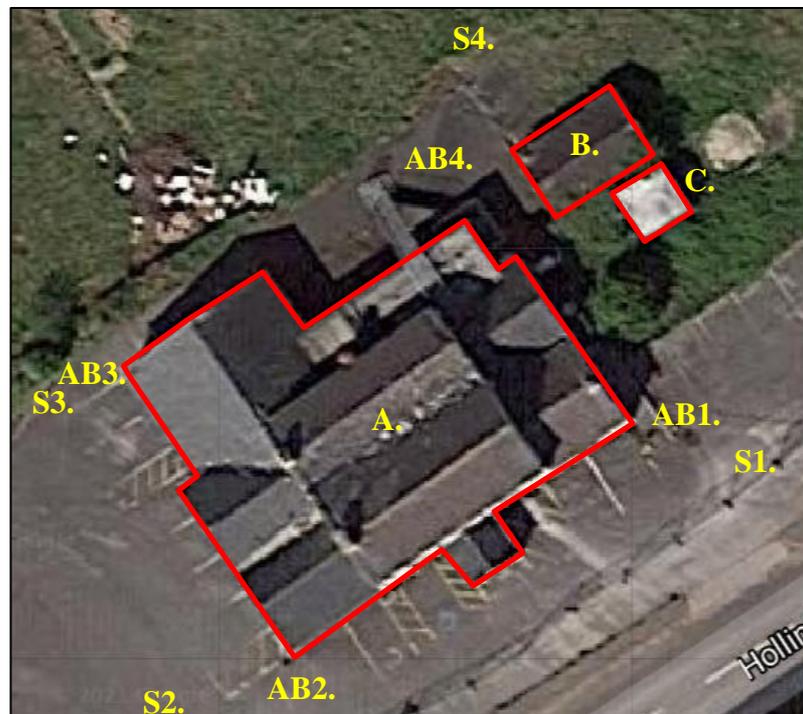
3.4.3. The aerial photograph below shows the building letters, where the Surveyors (S) and Anabats (AB) were positioned.

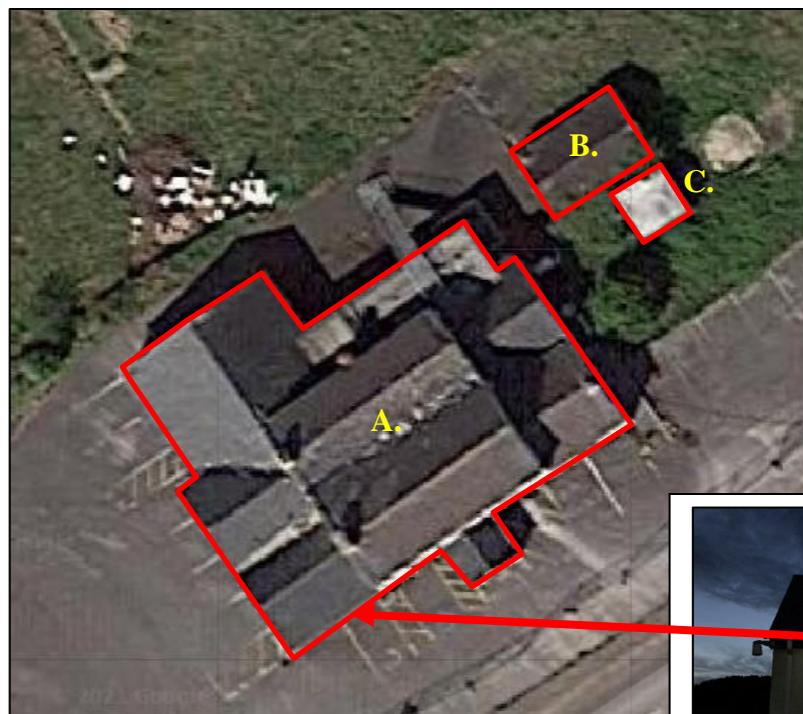
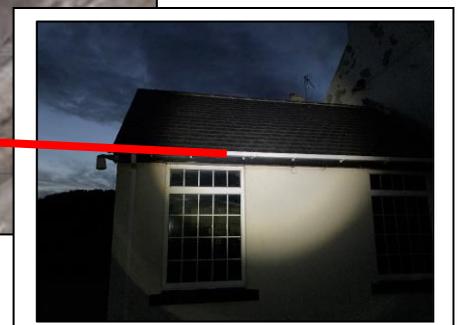
**22:39. Common Pipistrelle emerged from the eaves in a single-storey section to the south of the building.**

The aerial photograph below shows the location of the eaves to the south of the building where the bat emerged.

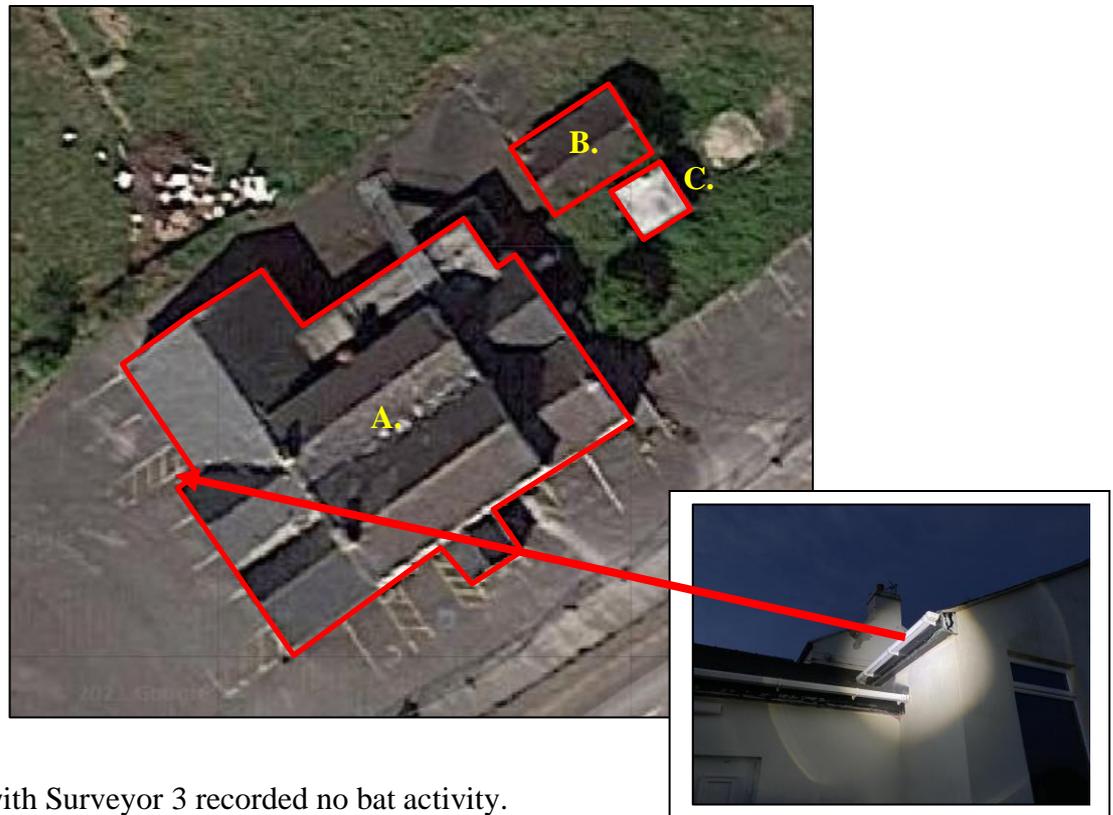
**22:28. Common Pipistrelle emerged from the eaves in a single-storey section to the west of the building.**

The aerial photograph below shows the location of the eaves to the west of the building where the bat emerged.

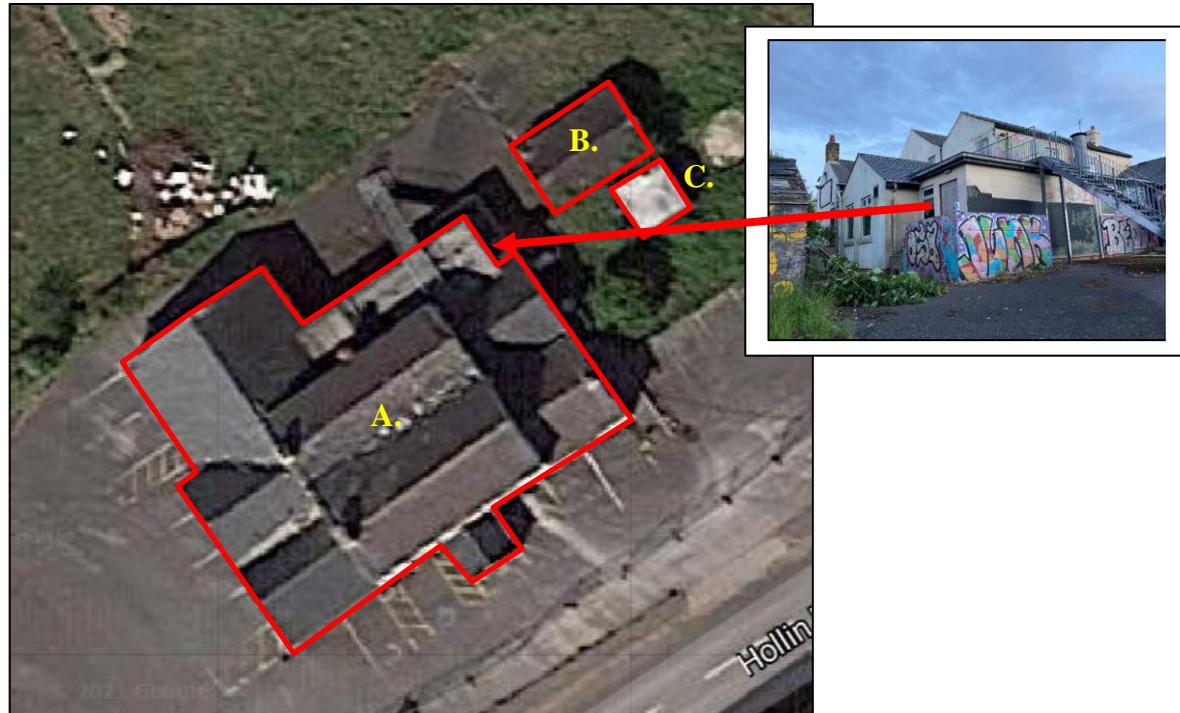
**22:19. Quiet bat (Brown Long eared) emerged from the broken window to the north of Building A and left site to the east.**

**22:34. Quiet bat (Brown Long eared) entered through the broken window, foraged inside the building and re-emerged through the broken window.**

The aerial photograph below shows the location of the broken window where the bat emerged.

3.5.2. Since the dusk emergence survey was carried out the broken window on the north of Building A has been boarded up for insurance purposes and to prevent vandals accessing the building.

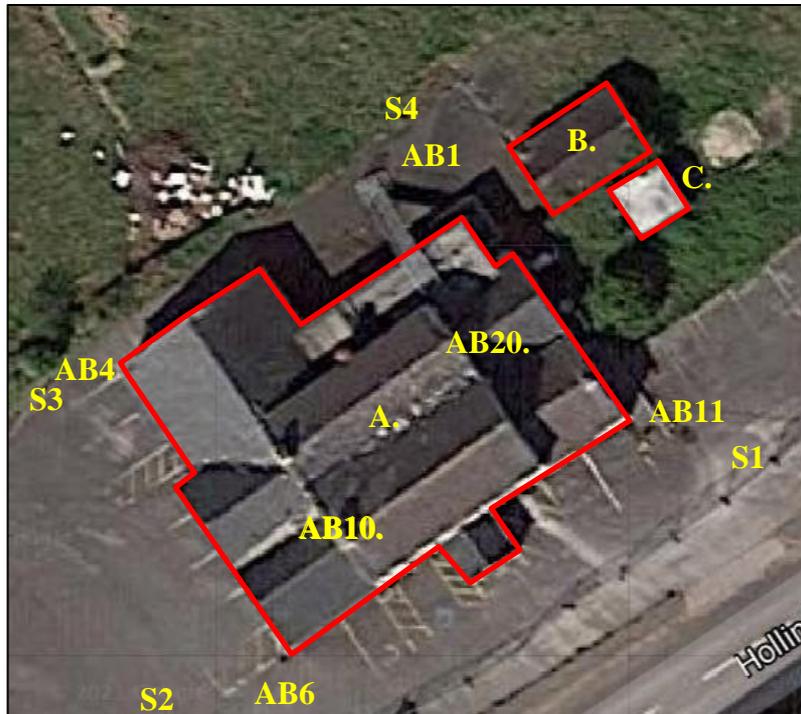
3.6.3. The aerial photograph below shows the building letters, where the Surveyors (S) and Anabats (AB) were positioned.

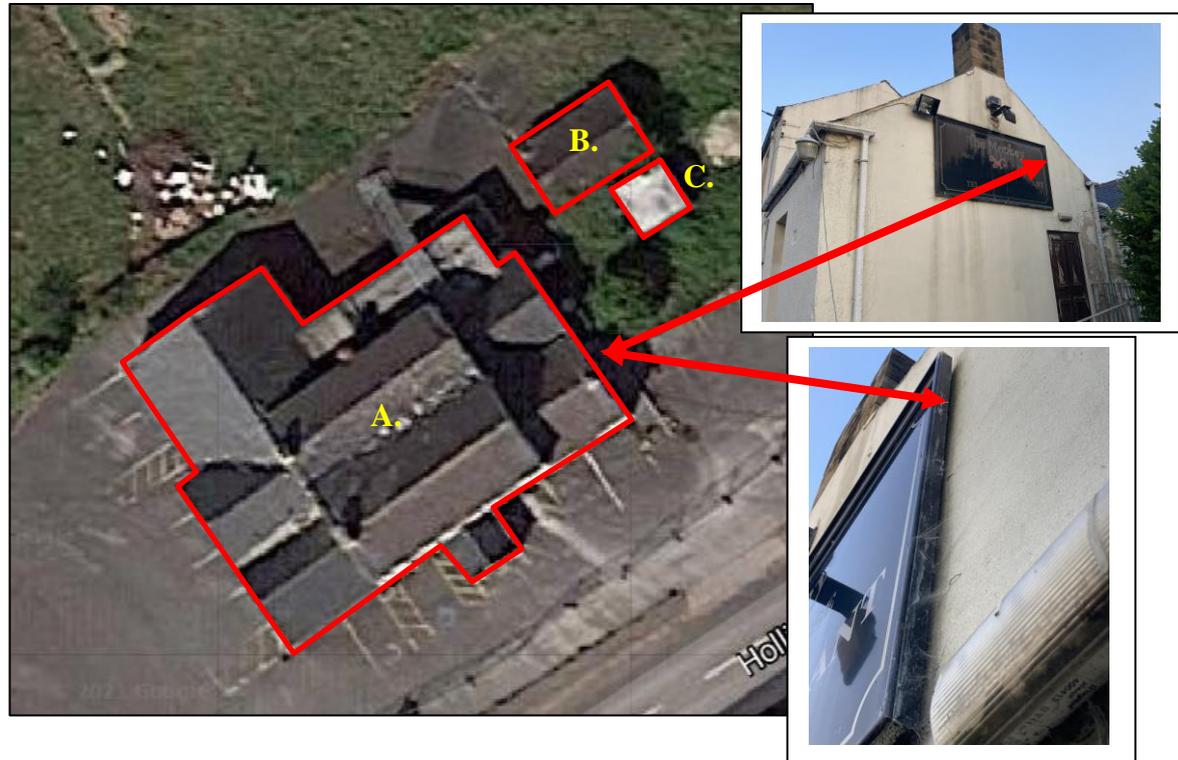
- **04:28. Common Pipistrelle entered a roost behind the sign on the east end of the building.**
- **04:31. Common Pipistrelle entered a roost behind the sign on the east end of the building.**

The aerial photograph below shows the location of the sign on the building and the location behind the sign where the two bats entered.

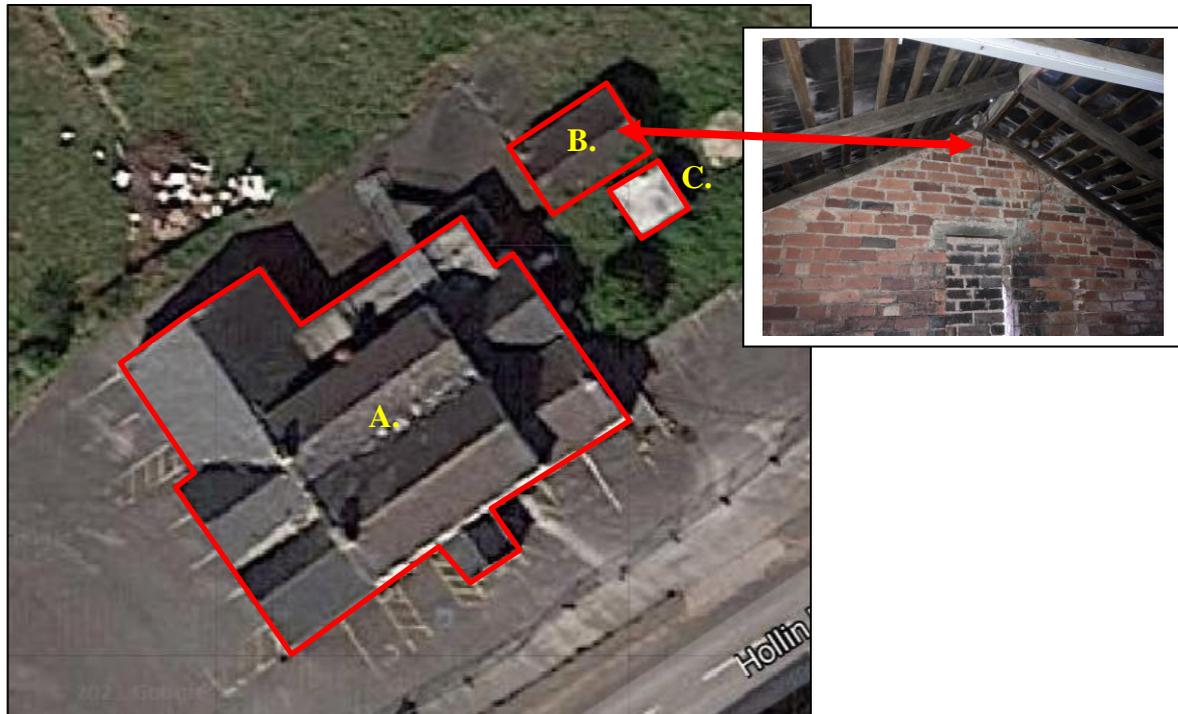
- **04:37. Bat seen to enter the open door on the west end of Building B, not echolocating. The bat was seen swarming inside the building. This bat continued to swarm inside the building, touching up to the rear wall of the building until 04:53. The bat was no longer flying inside and was not seen to exit the building. Therefore, the bat entered a roost inside Building B on the rear wall where it was seen to be touching up to the wall. This bat was not echolocating**

The aerial photograph below shows the location inside Building B where the bat was touching up and swarming.

3.7.3. Inside Building B, a group of bat droppings was found beneath the ridge and at the end of the floor pit. The size and shape of the droppings were indicative of Brown Long-eared bats. A sample of these droppings was collected for subsequent analysis.

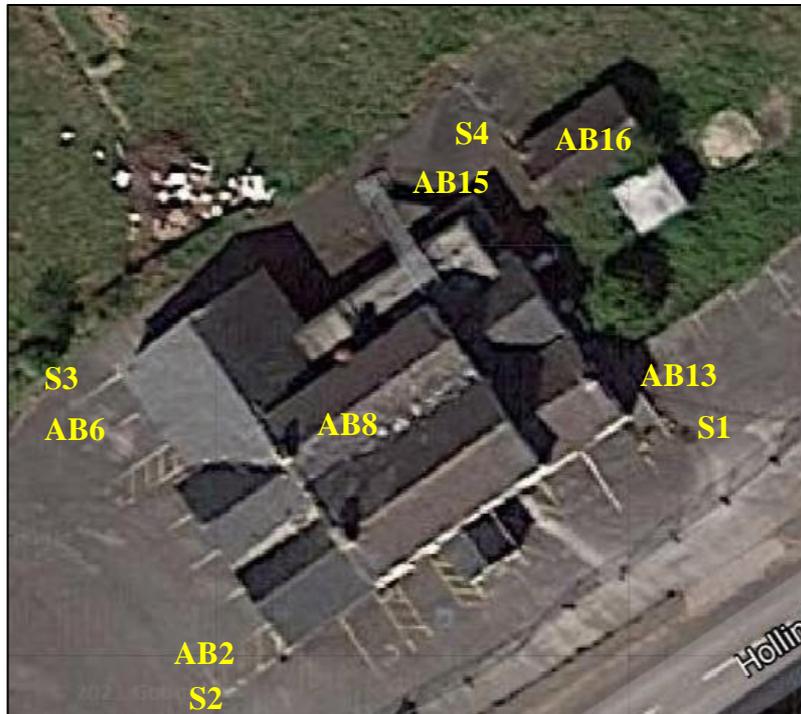
3.8.3. The aerial photograph below shows the building letters, where the Surveyors (S) and Anabats (AB) were positioned.
