# **Trinity Academy, Barnsley**

## **Geo-Environmental Assessment**

**Appendix B****Groundtech Consulting Draft Factual Report**

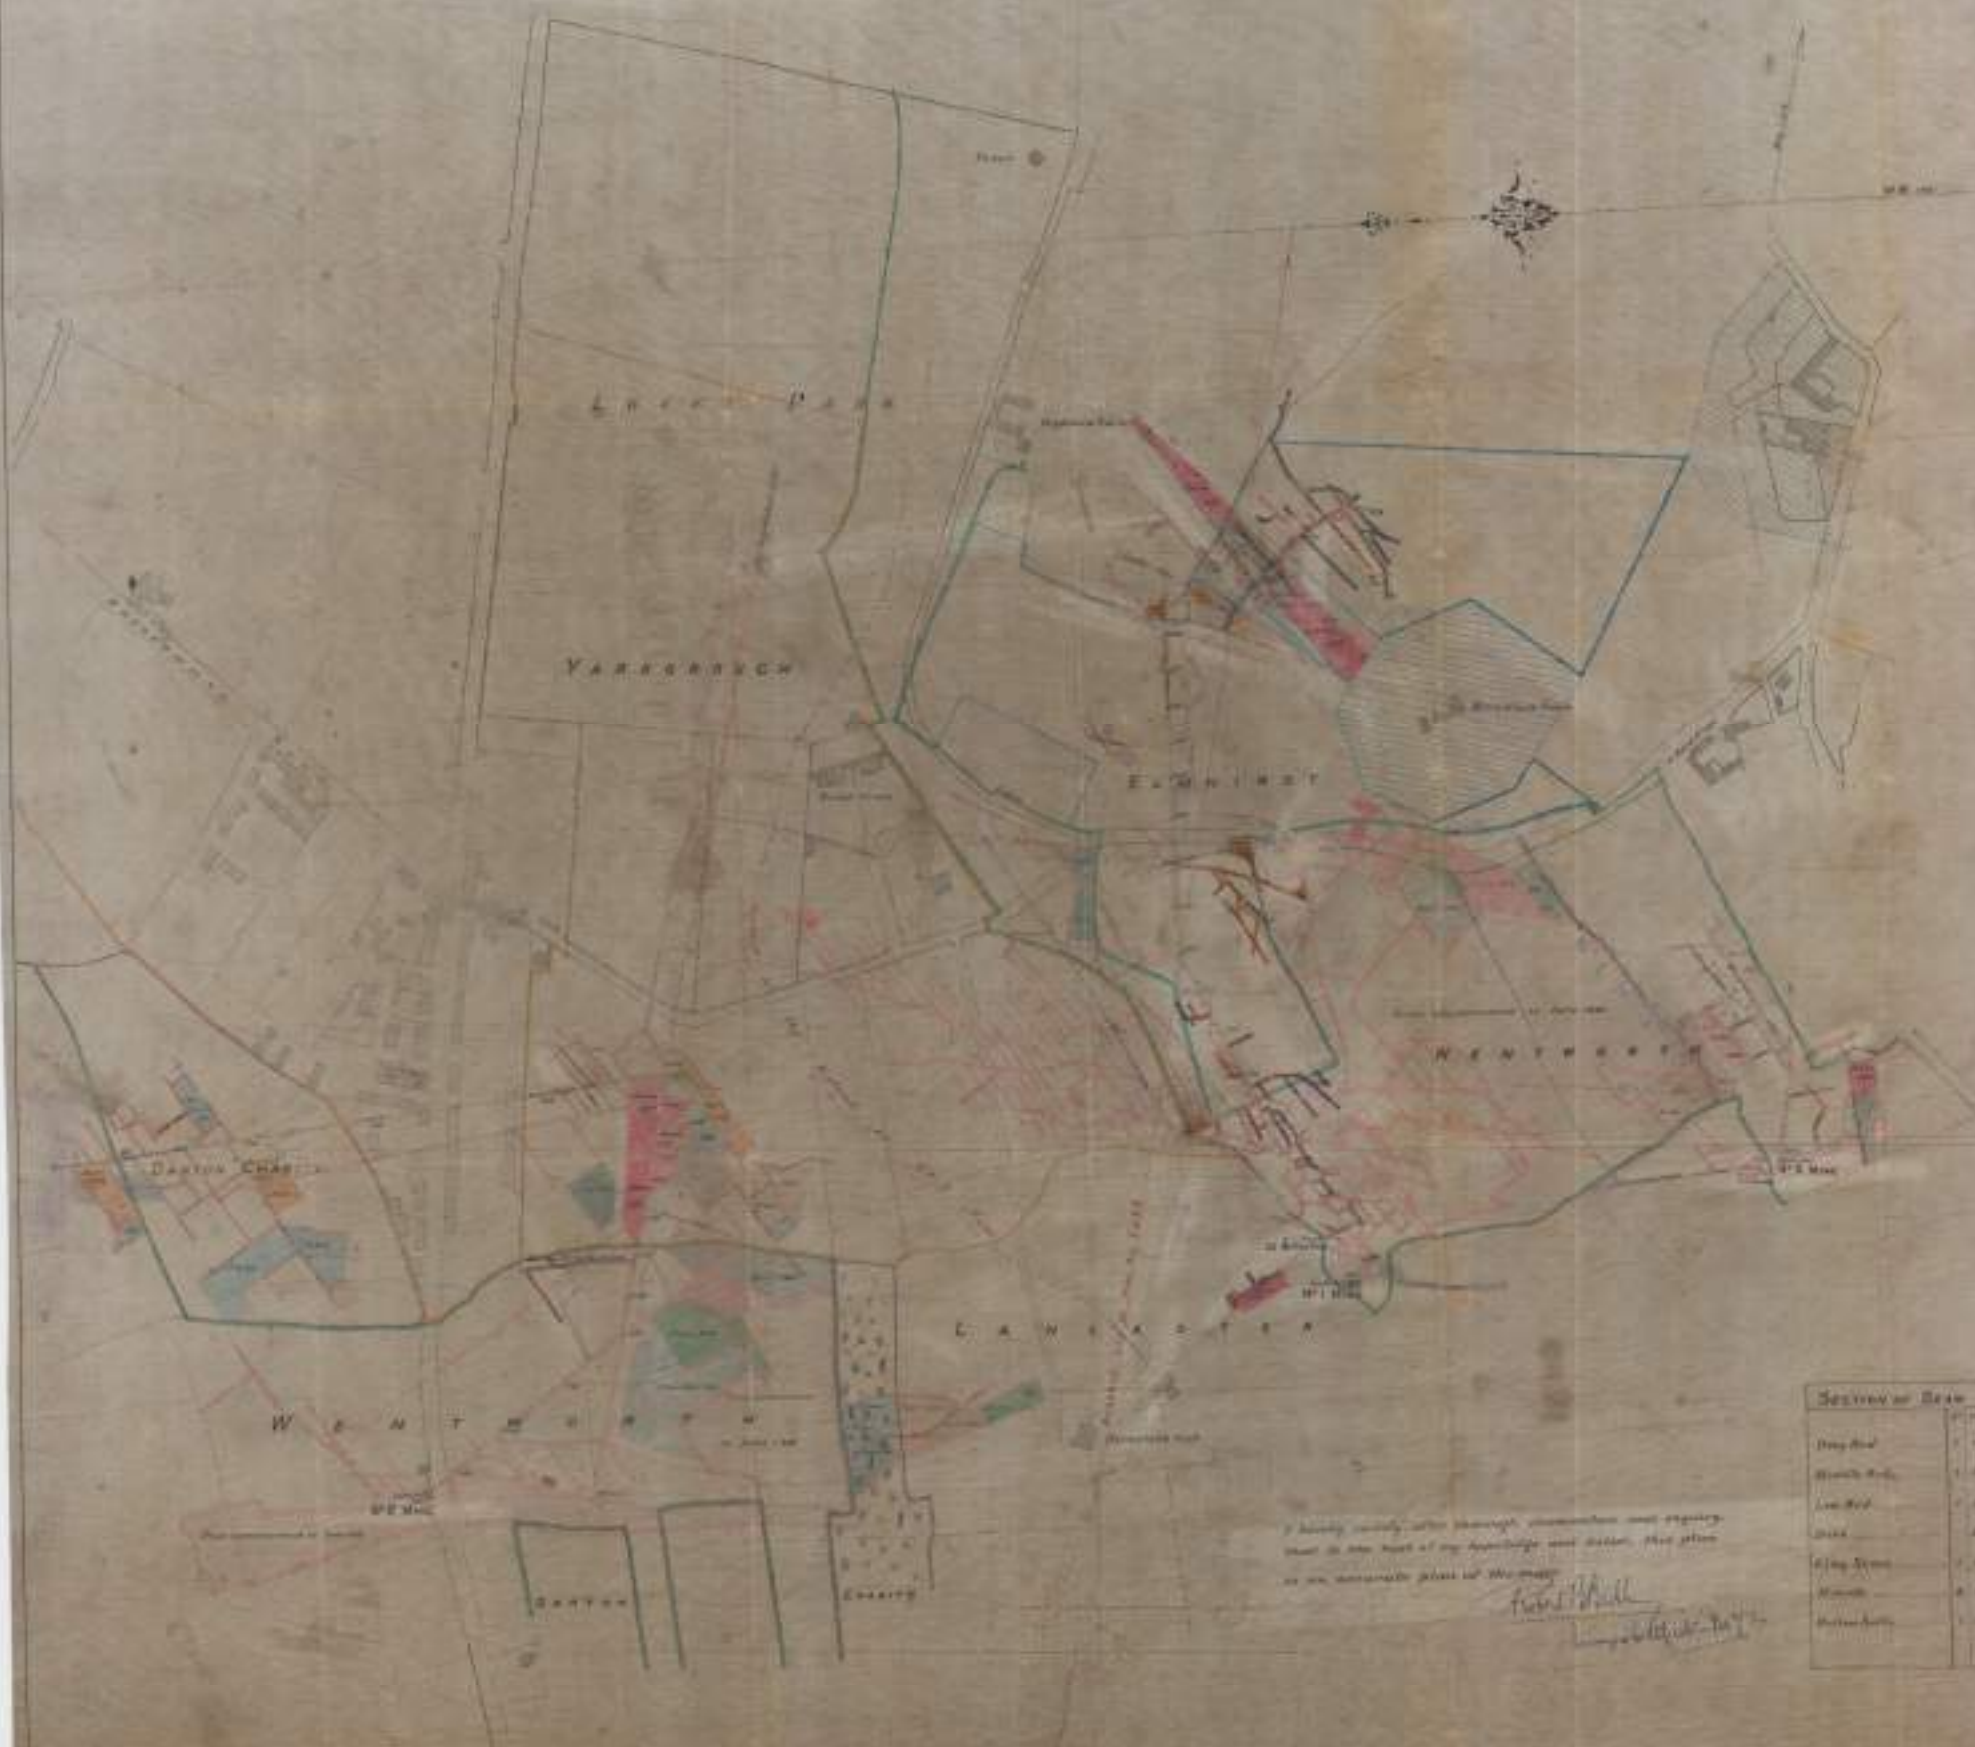
## BARNSLEY BED PILLARS

SKETCH PLAN OF MINE  
ORANGE SHEET N5745E  
Longitude 1° 38' 26" W  
Latitude 53° 32' 10" N

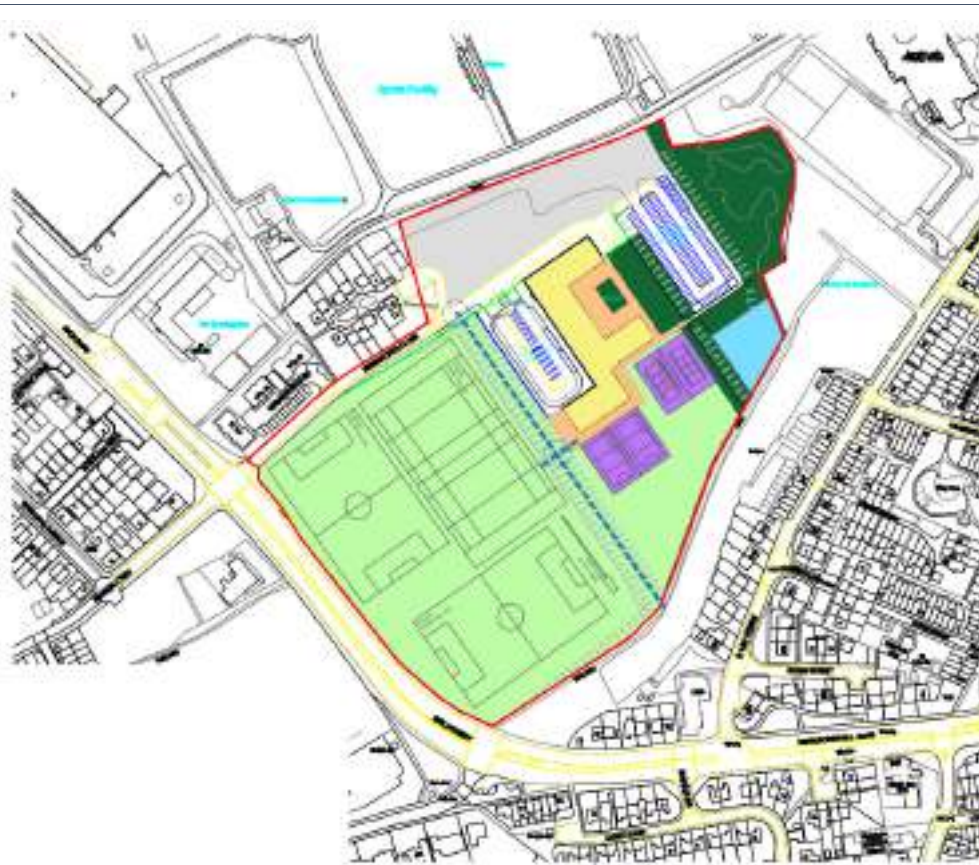
*Proposed Development*

The proposed development is commercial end use comprising a new college with associated car parks, infrastructure and sports pitches.

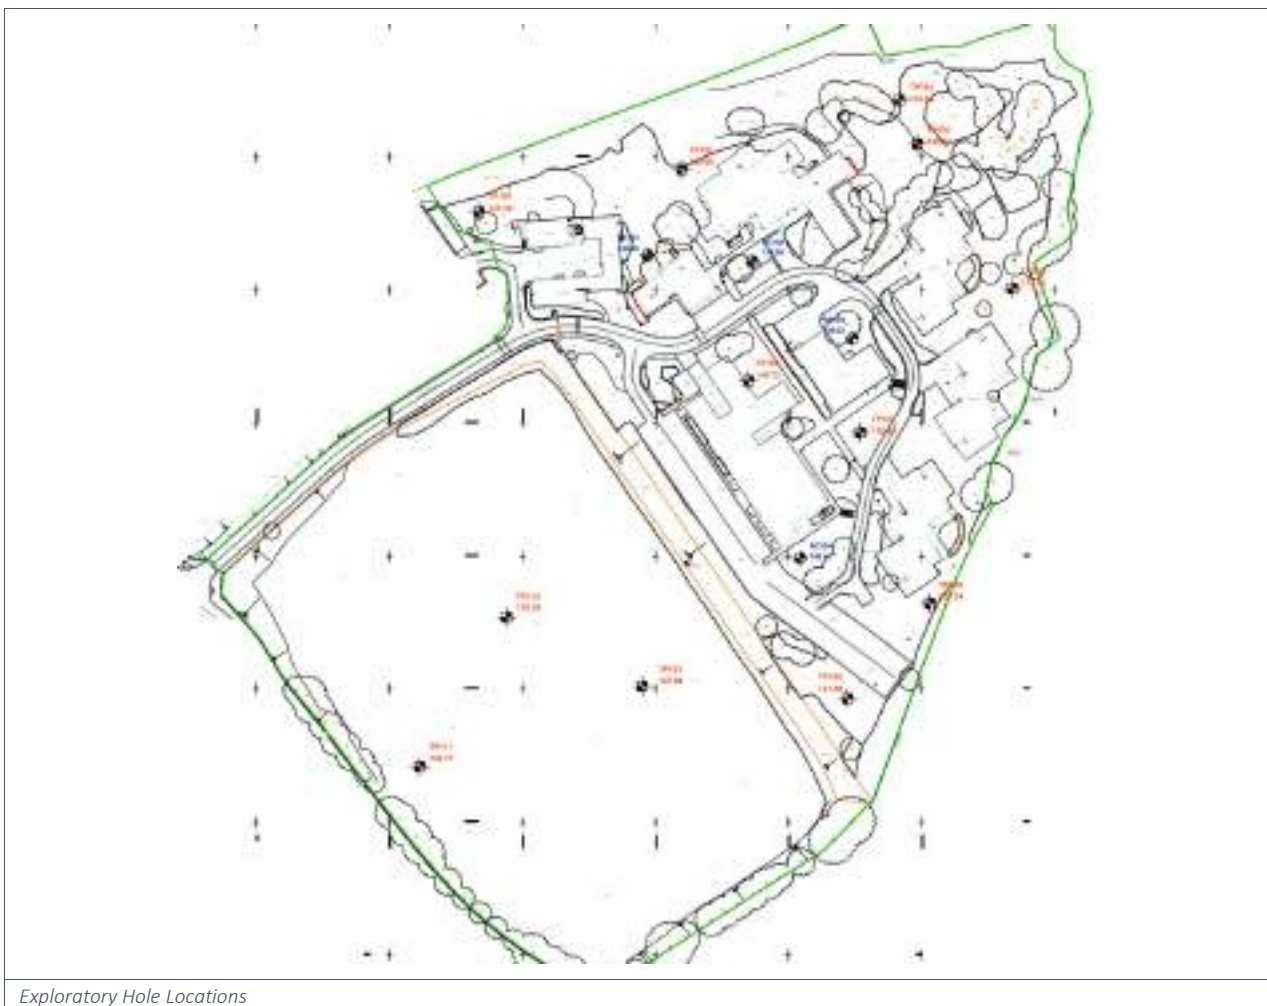
Exploratory Hole Locations

In TP110 in the south west of the site, a suspected mine shaft was encountered with the Made Ground consisting of dark grey to black sandy gravelly friable clay with a low cobble content of sandstone and gravel of coal, ironstone, sandstone and ceramic between depths of 0.33m and 3.1m bgl. The lateral extent of the shaft was observed with natural ground either side of the infilled material which measured c.2.5m wide. Photographs of the ground conditions are presented in *Appendix 2 - Photos 36 to 39*.

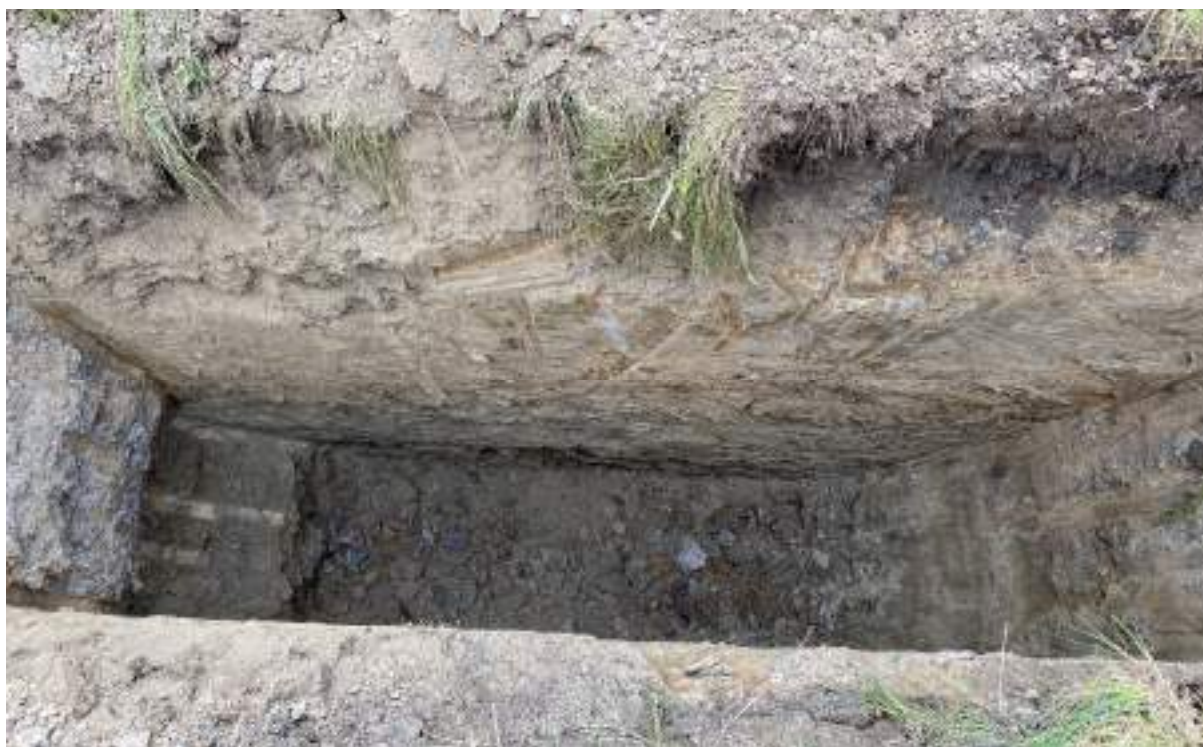
Photograph 33 – TP109

Extremely weak grey to brown residually weathered Mudstone was observed underlying the natural soils in TP109 and RC103 in the east and north east of the site from depths of 1.4m and 1.5m bgl respectively.

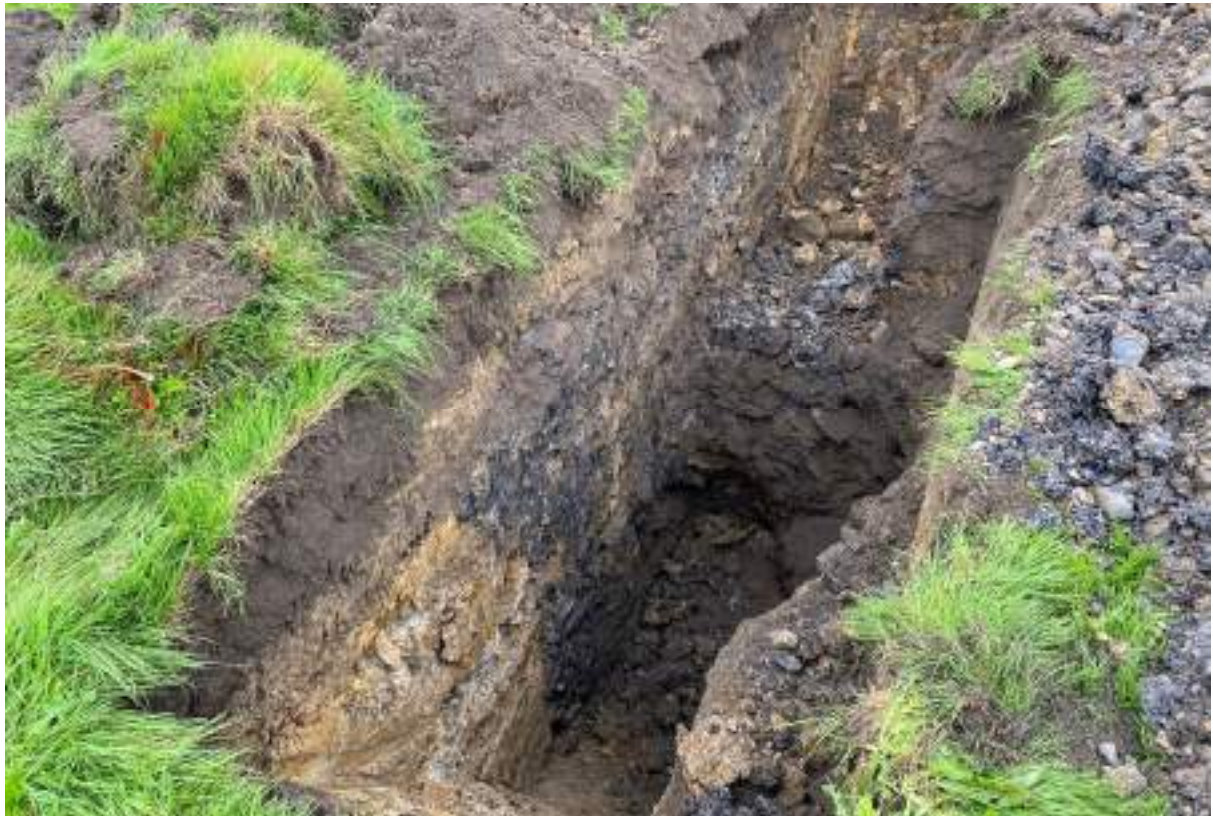
Photograph 36 – TP110 Showing change between natural and infilled shaft.

A mine shaft has been identified in trial pit TP110, in the playing fields in the west of the Site. The shaft was found to be uncapped and to have a diameter of approximately 2.5m. The shaft backfill was present from approximately 0.5m below ground level and comprised of Colliery Spoil.

The mine shaft should be fully investigated and appropriately treated, most likely by construction of a reinforced concrete cap. It is recommended that the design of the proposed sports pitches in this area of the Site includes mitigation for the risk of ground collapse associated with unidentified coal mining features.

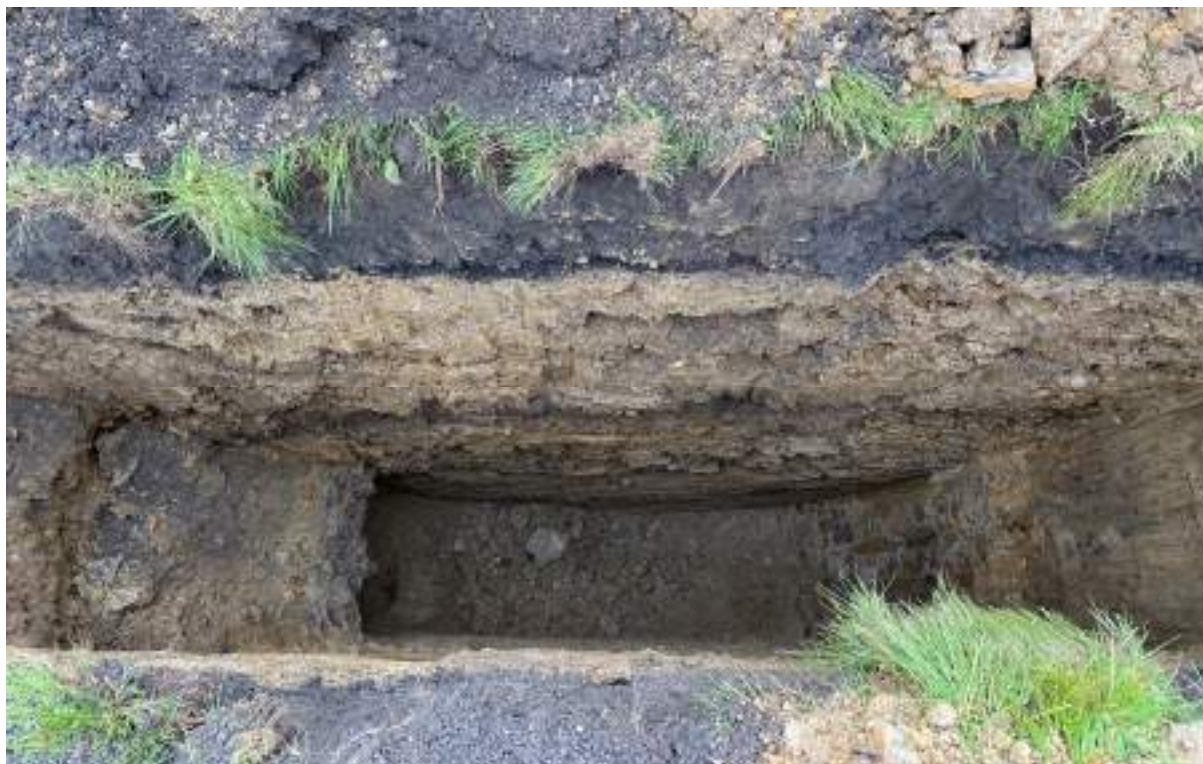
Photograph 43 – TP112

Made Ground was generally shallow across the site consisting predominantly of topsoil. Visual evidence of potential contamination was observed within the topsoil at TP110 and TP112, in the south west of the site, where ash was observed. Furthermore, a band of black ash and clinker was observed in TP112 between 0.42m and 0.53m bgl.

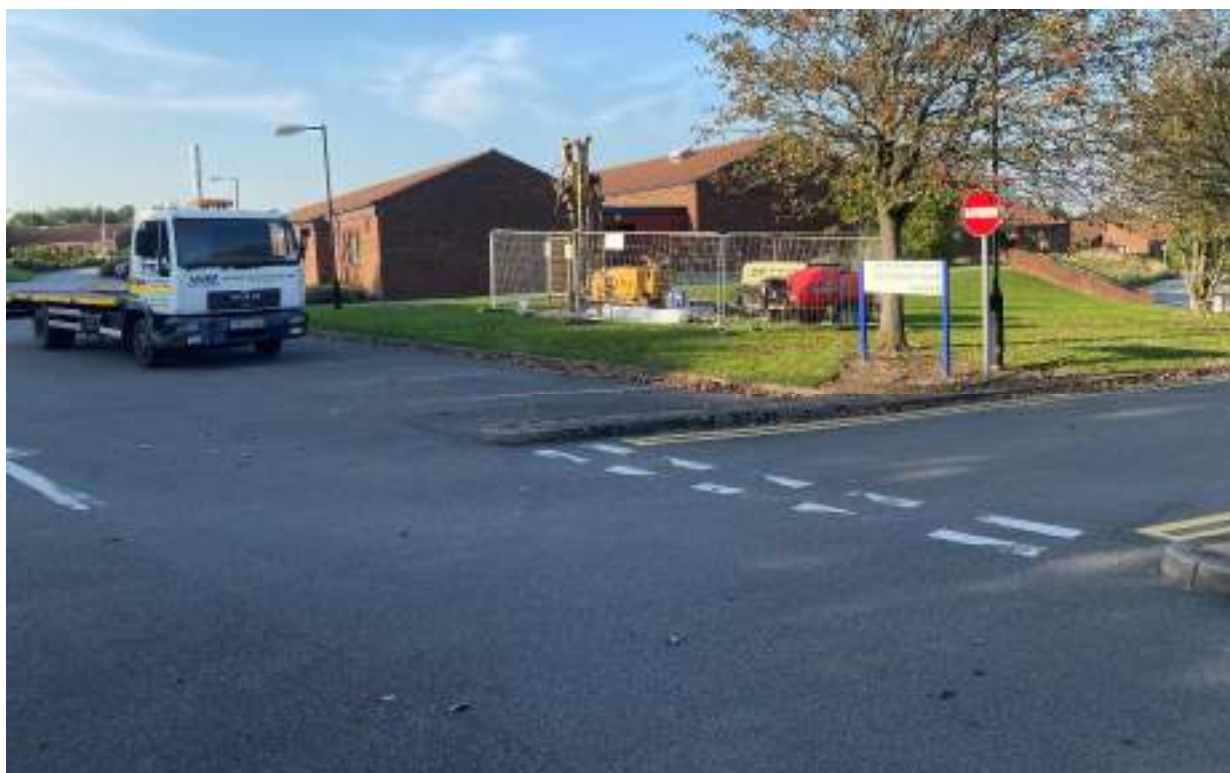
Photograph 46 – RC104 Location

- *TP110 – Suspected mine shaft encountered measuring c.2.5m wide and present to the base of trial pit which was terminated at 3.1m bgl due to instability within the backfilled material.*
- *RC101 – Broken ground was encountered between 8.0m and 10.5m bgl and water flush lost.*
- *RC102 – Broken ground was encountered between 8.0m and 9.5m bgl and water flush lost. Void encountered between 9.5m and 10.5m bgl.*
- *RC104 – Void encountered between 15.4m and 16.8m bgl.*
