## **Written Scheme of Investigation**

### **Archaeological Evaluation**

**Bolton Hall, Carr Head Lane, Rotherham,  
South Yorkshire**

## **Archaeological Watching Brief: Geotechnical Pits**

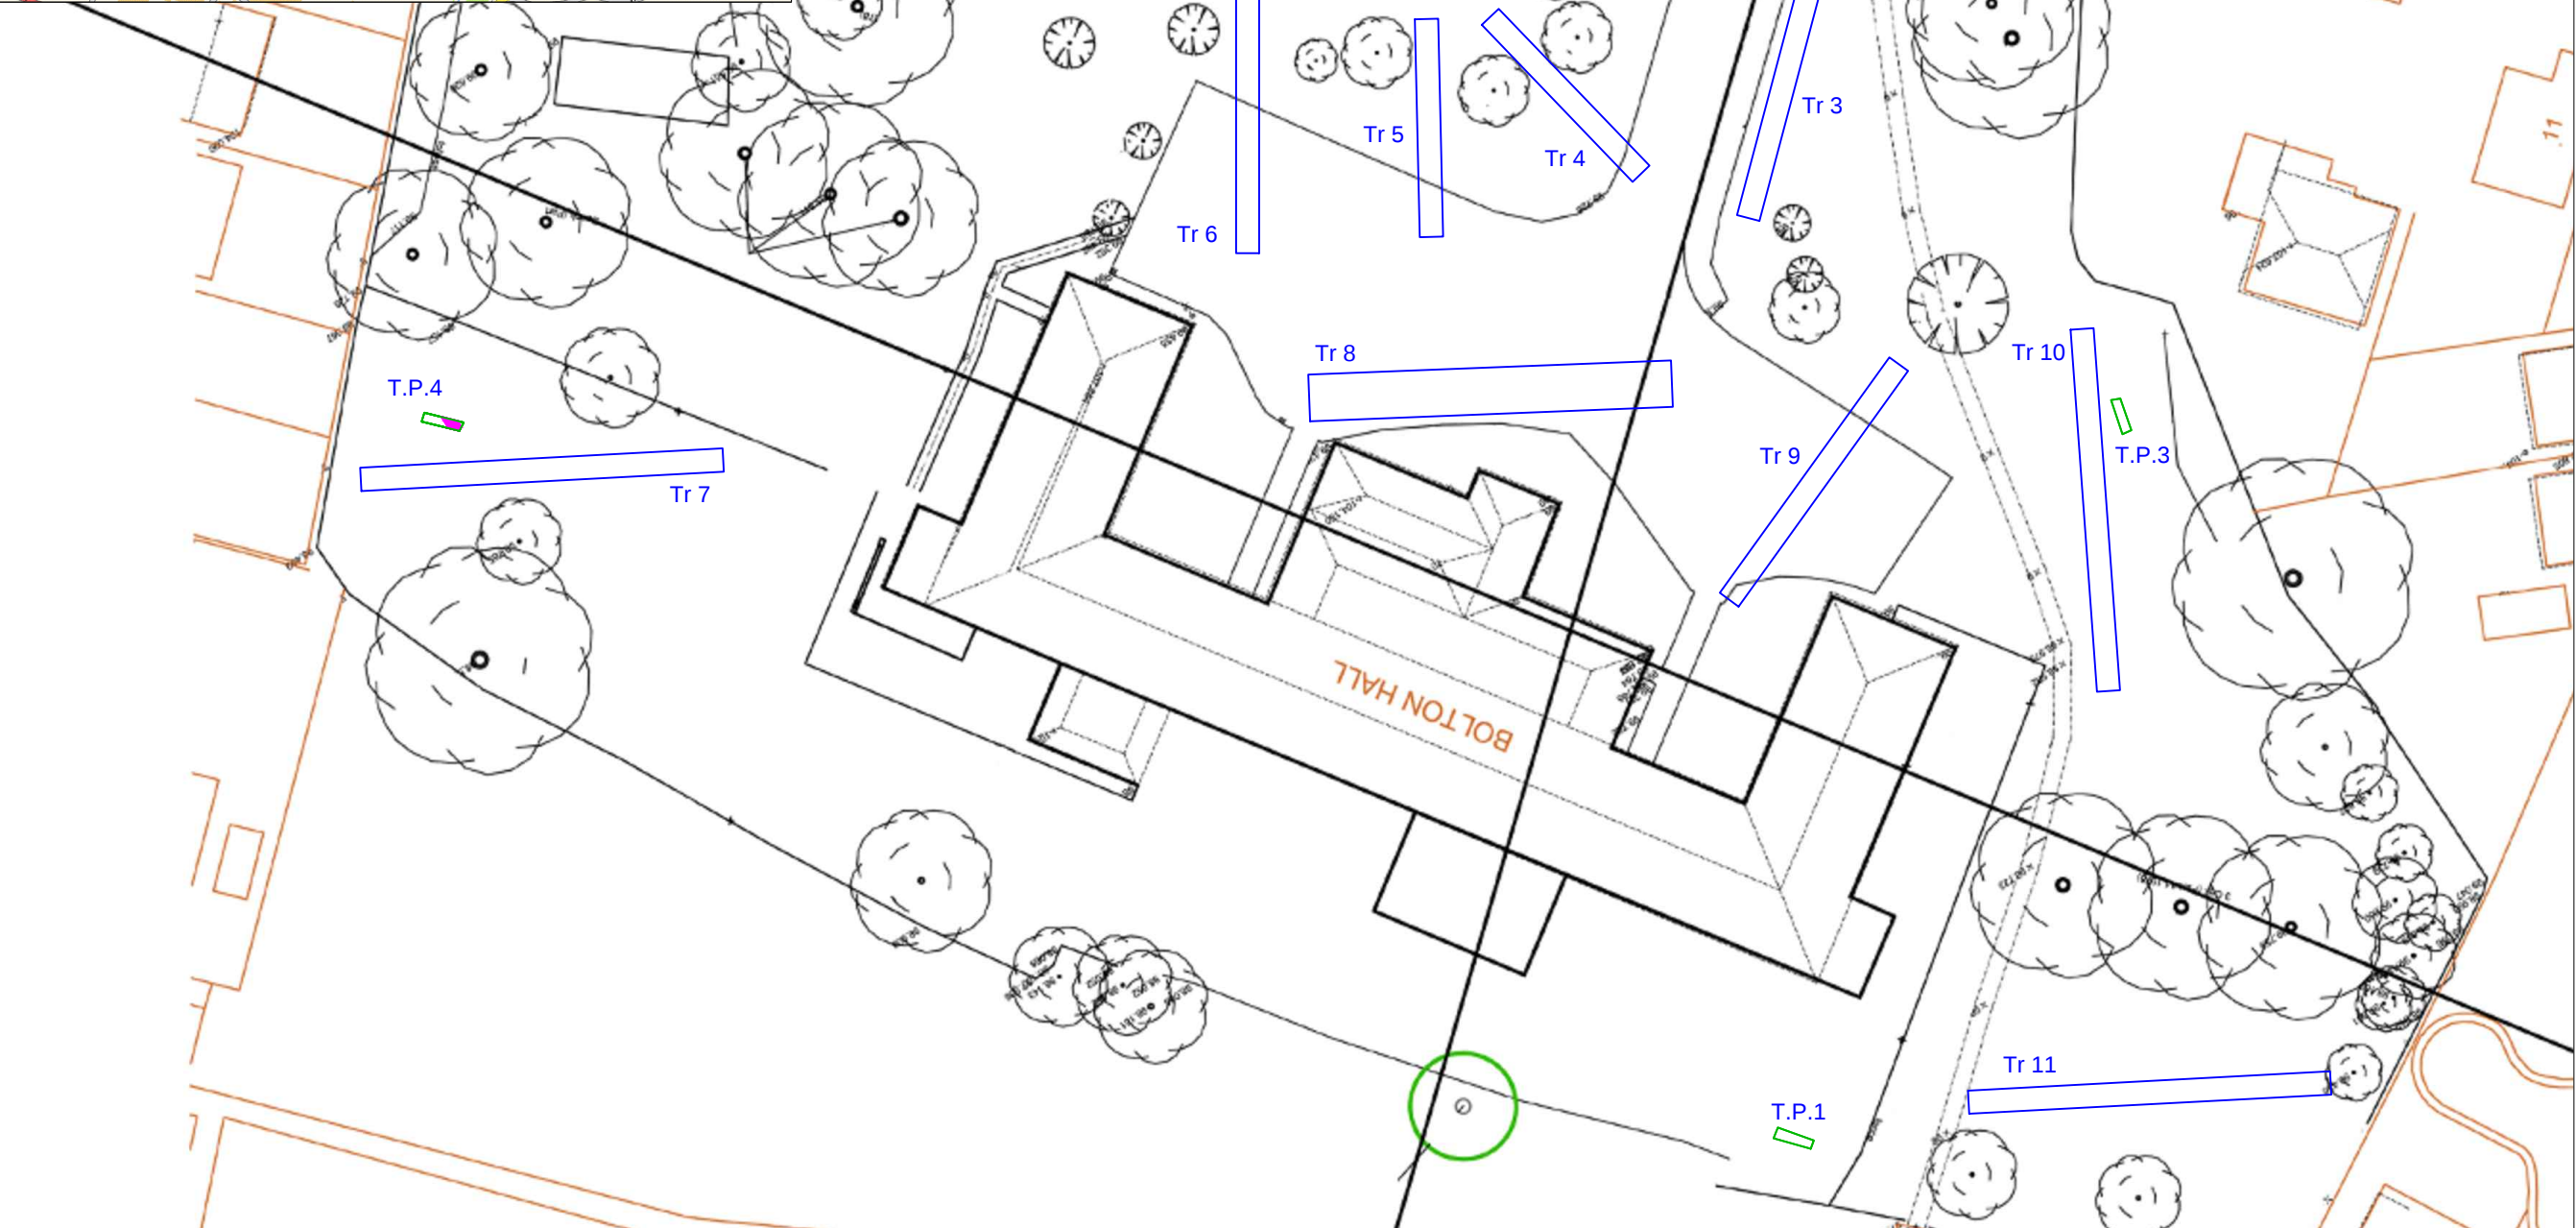
**FIGURE 1**

deep stratigraphy was noted in the watching brief or are located where the remains of Bolton Hall might include basements/cellars. Trenches target features identified from map regression, the results of the geotechnical pit watching brief, and also target blank areas; some of the blank areas have been chosen to try to capture any surviving human remains. Trenches will be laid out according to Figure 1, and are described in Table 1 (above).

| Title:<br>Trench Location plan | | |

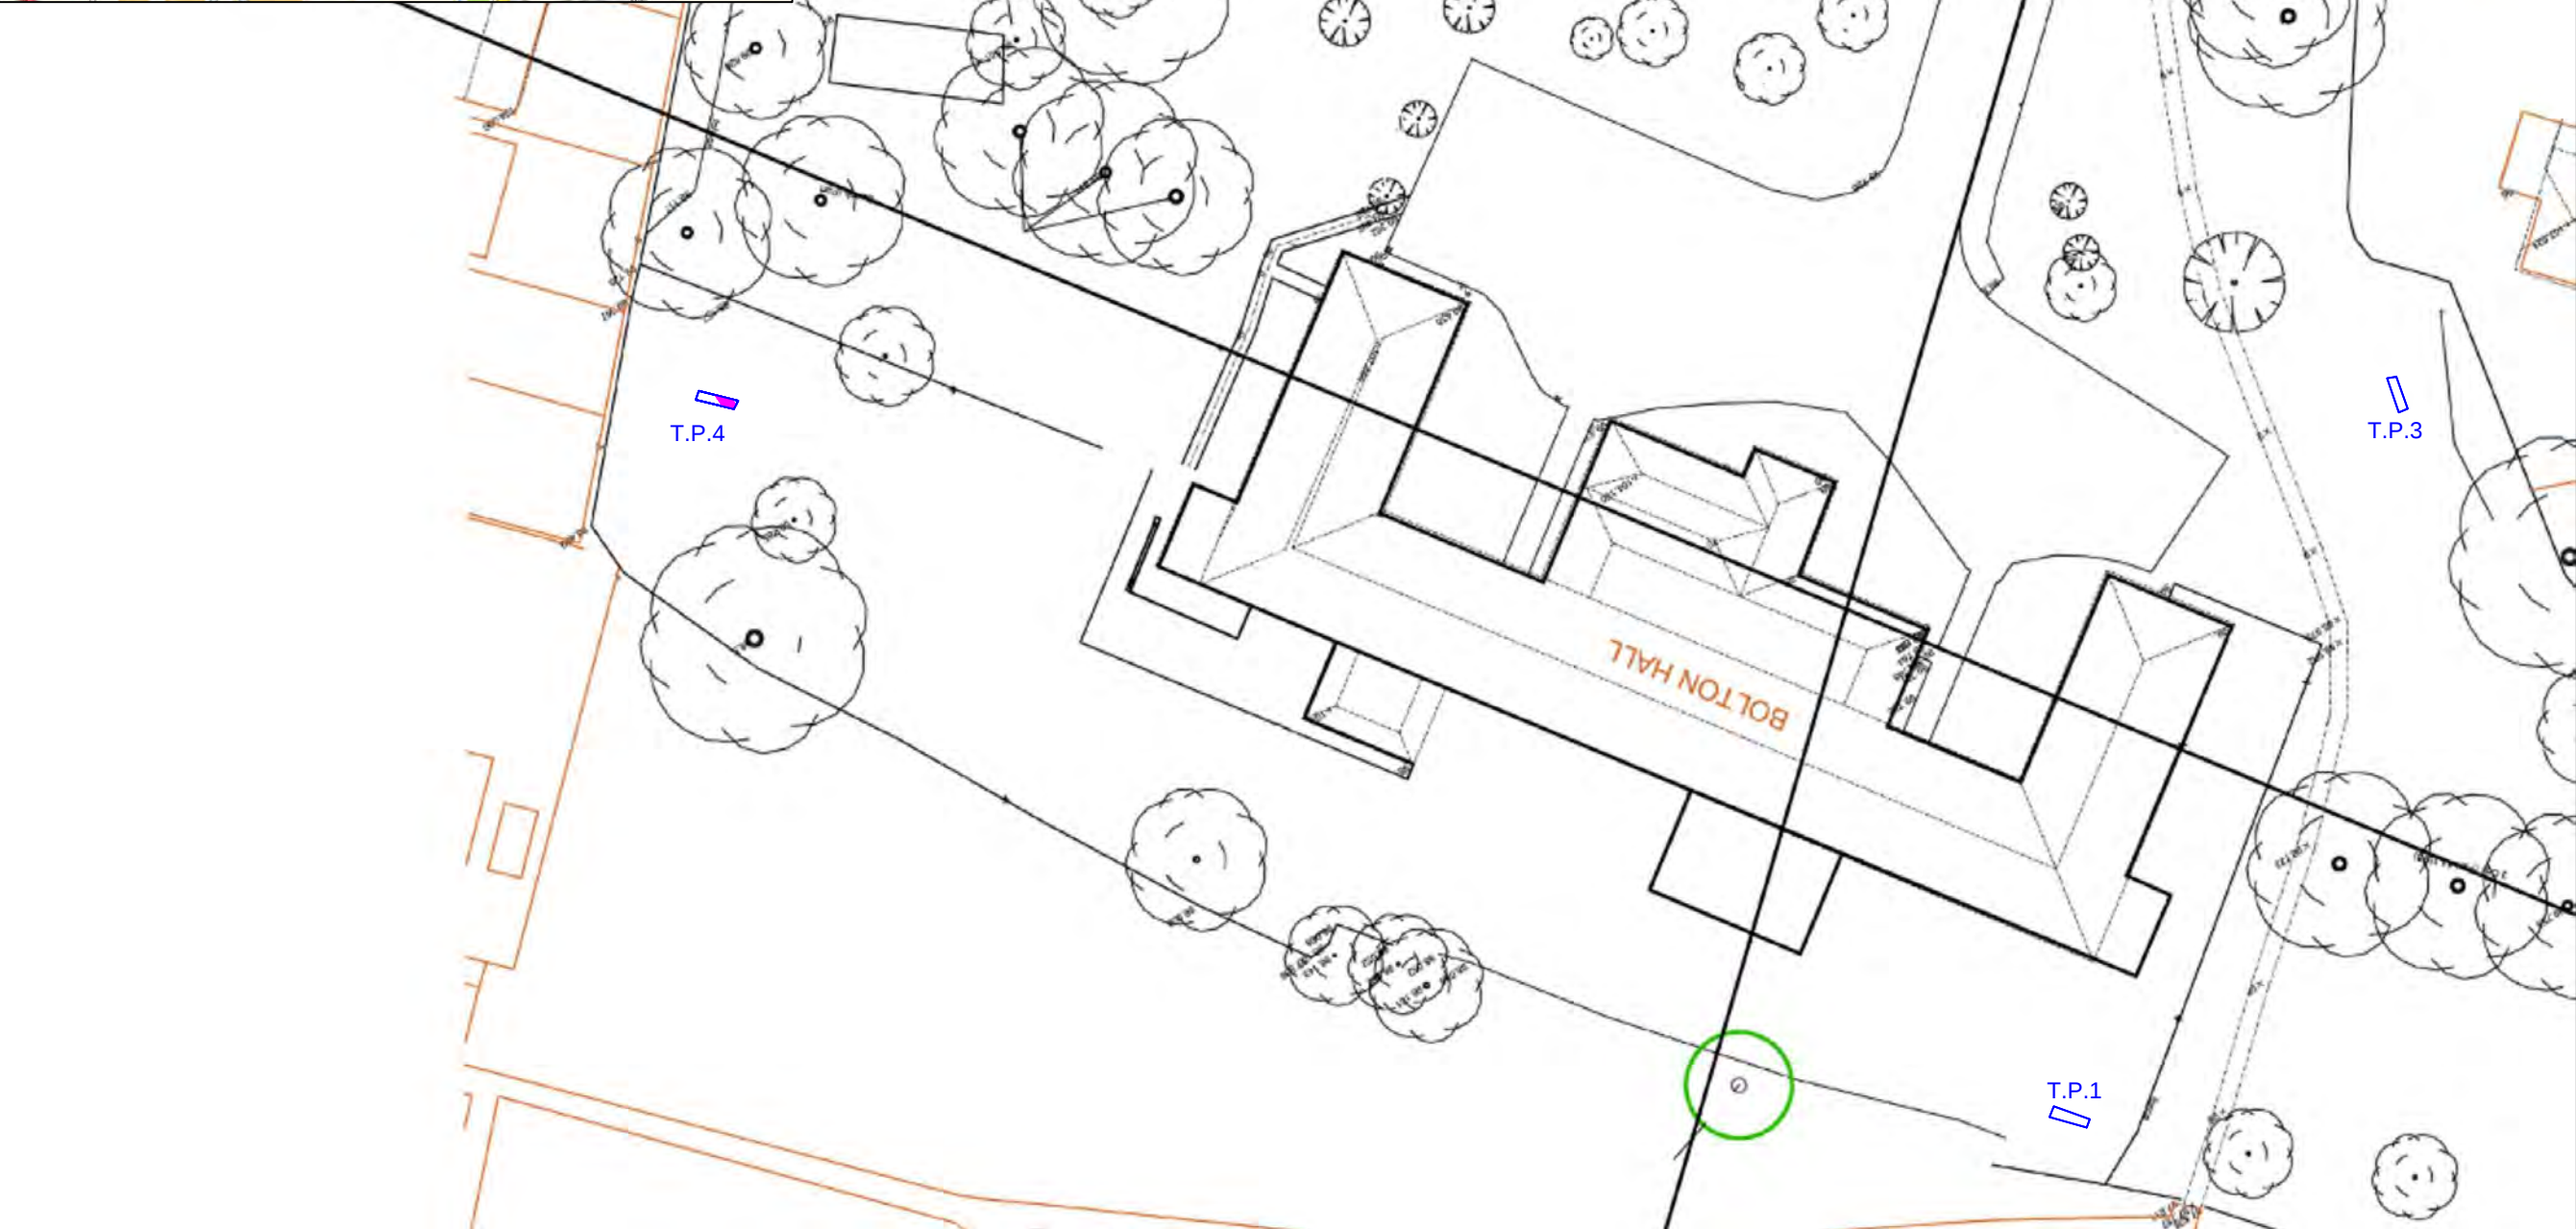
## **FIGURES 1-3**

Figure 1: Site and Geotechnical Pit Location

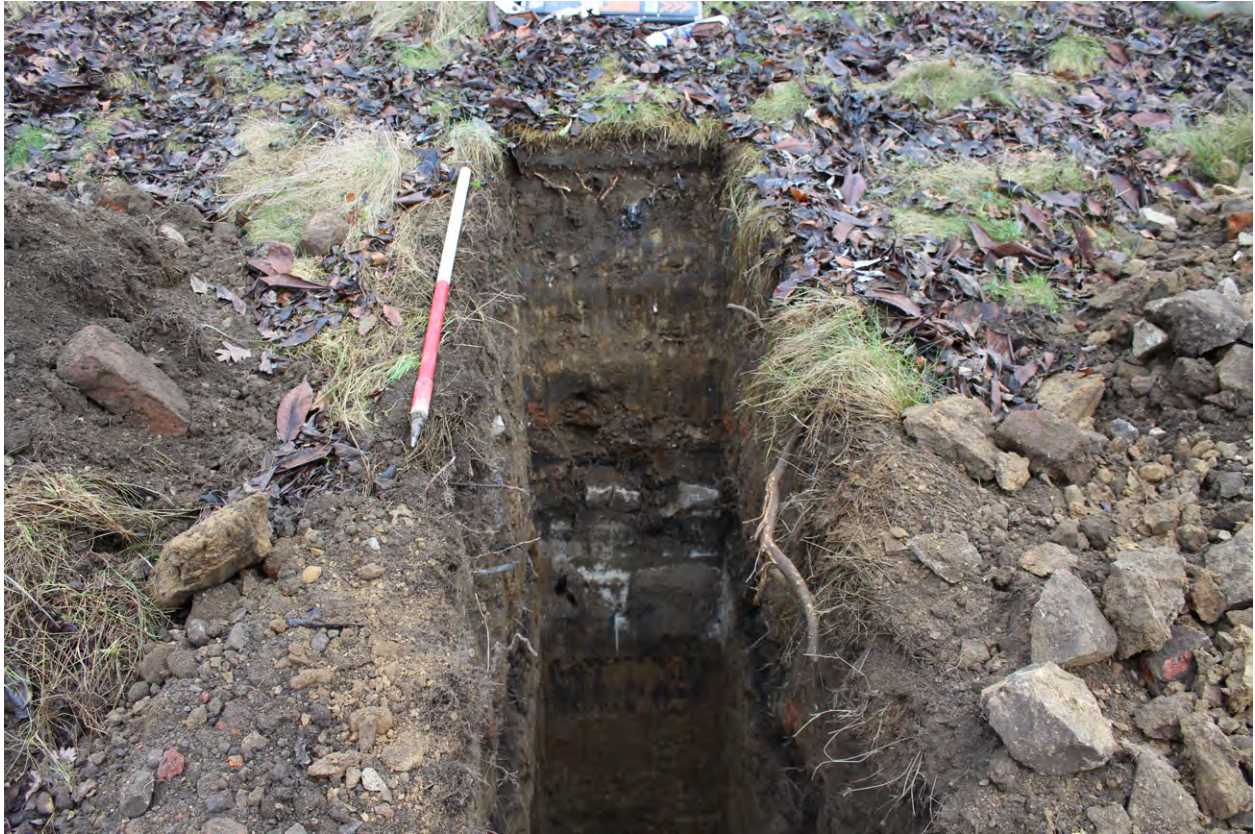
Test Pit 5 revealed the remains of a possible foundation course of grey stone, underlying a demolition layer (Fig. 2). This is possible evidence for the mid-twentieth century extension of Bolton Hall's outbuildings that used to exist on the site. Over the top of this is a layer of made ground from landscaping work for the grounds of Bolton Hall Nursing and Care Home.

Fig. 2 Possible remains of the extension of Bolton Hall's outbuildings as seen in Test Pit 5

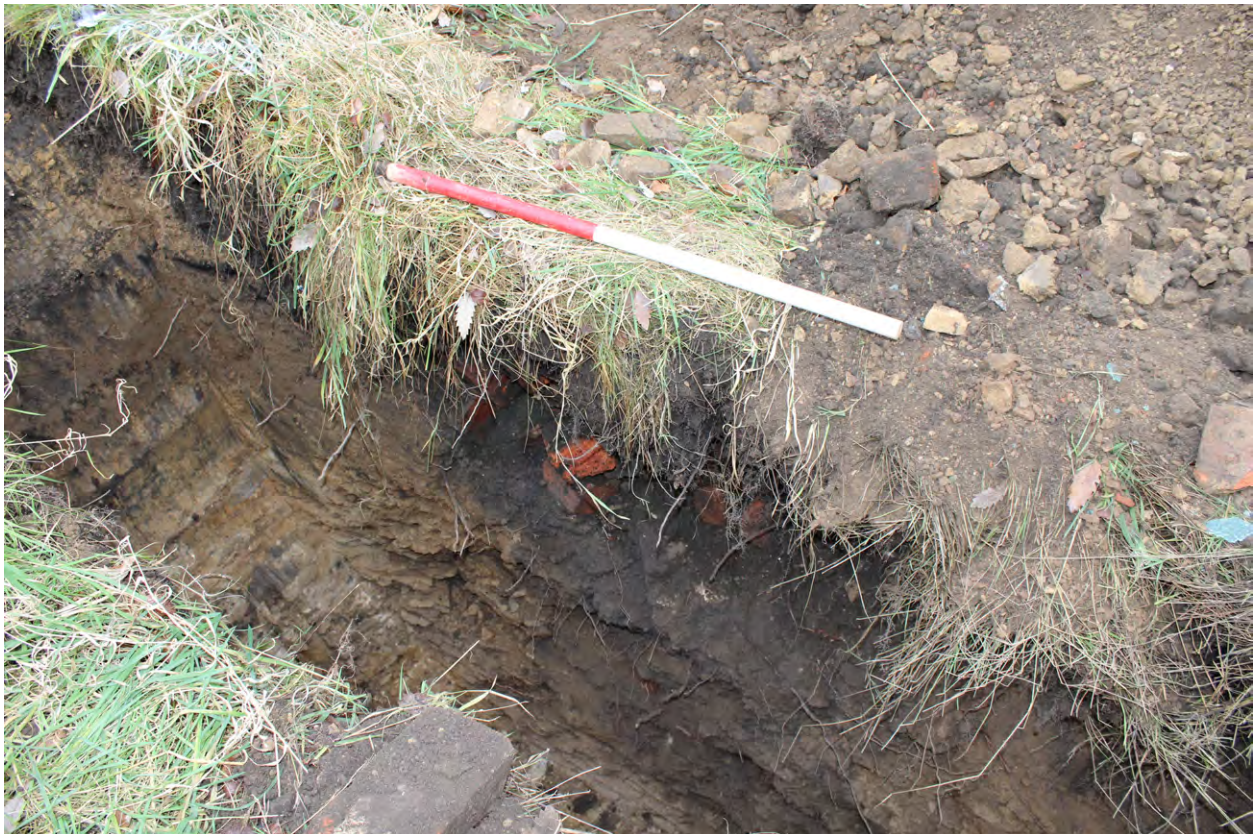
Fig. 3 Feature identified in Test Pit 4
