## Millhouse Green Intrusive Coal Mining Assessment September 2021

**Project:** Millhouse Green Intrusive Coal Mining Assessment

**Job Number:** RBG250

## Intrusive Coal Mining Assessment

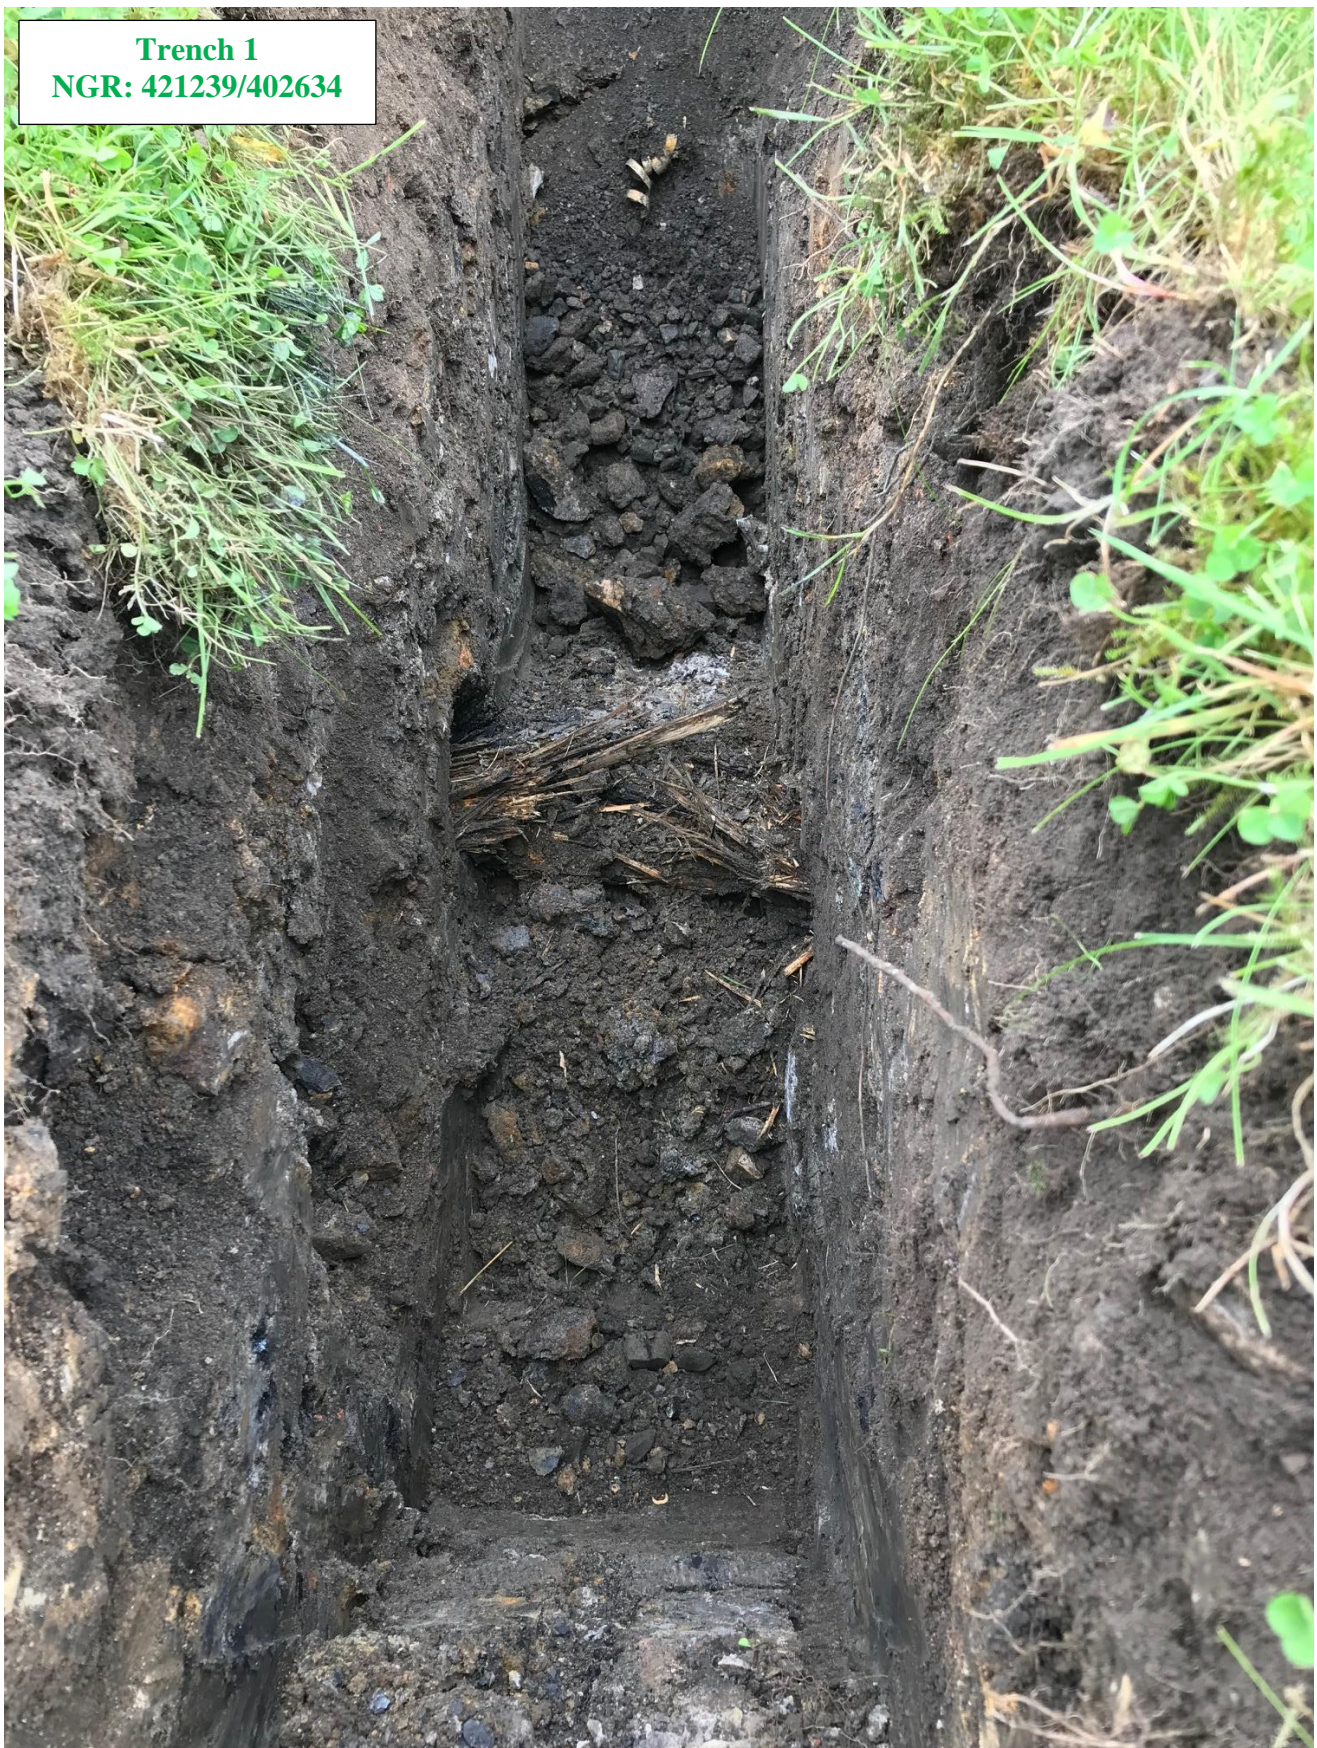
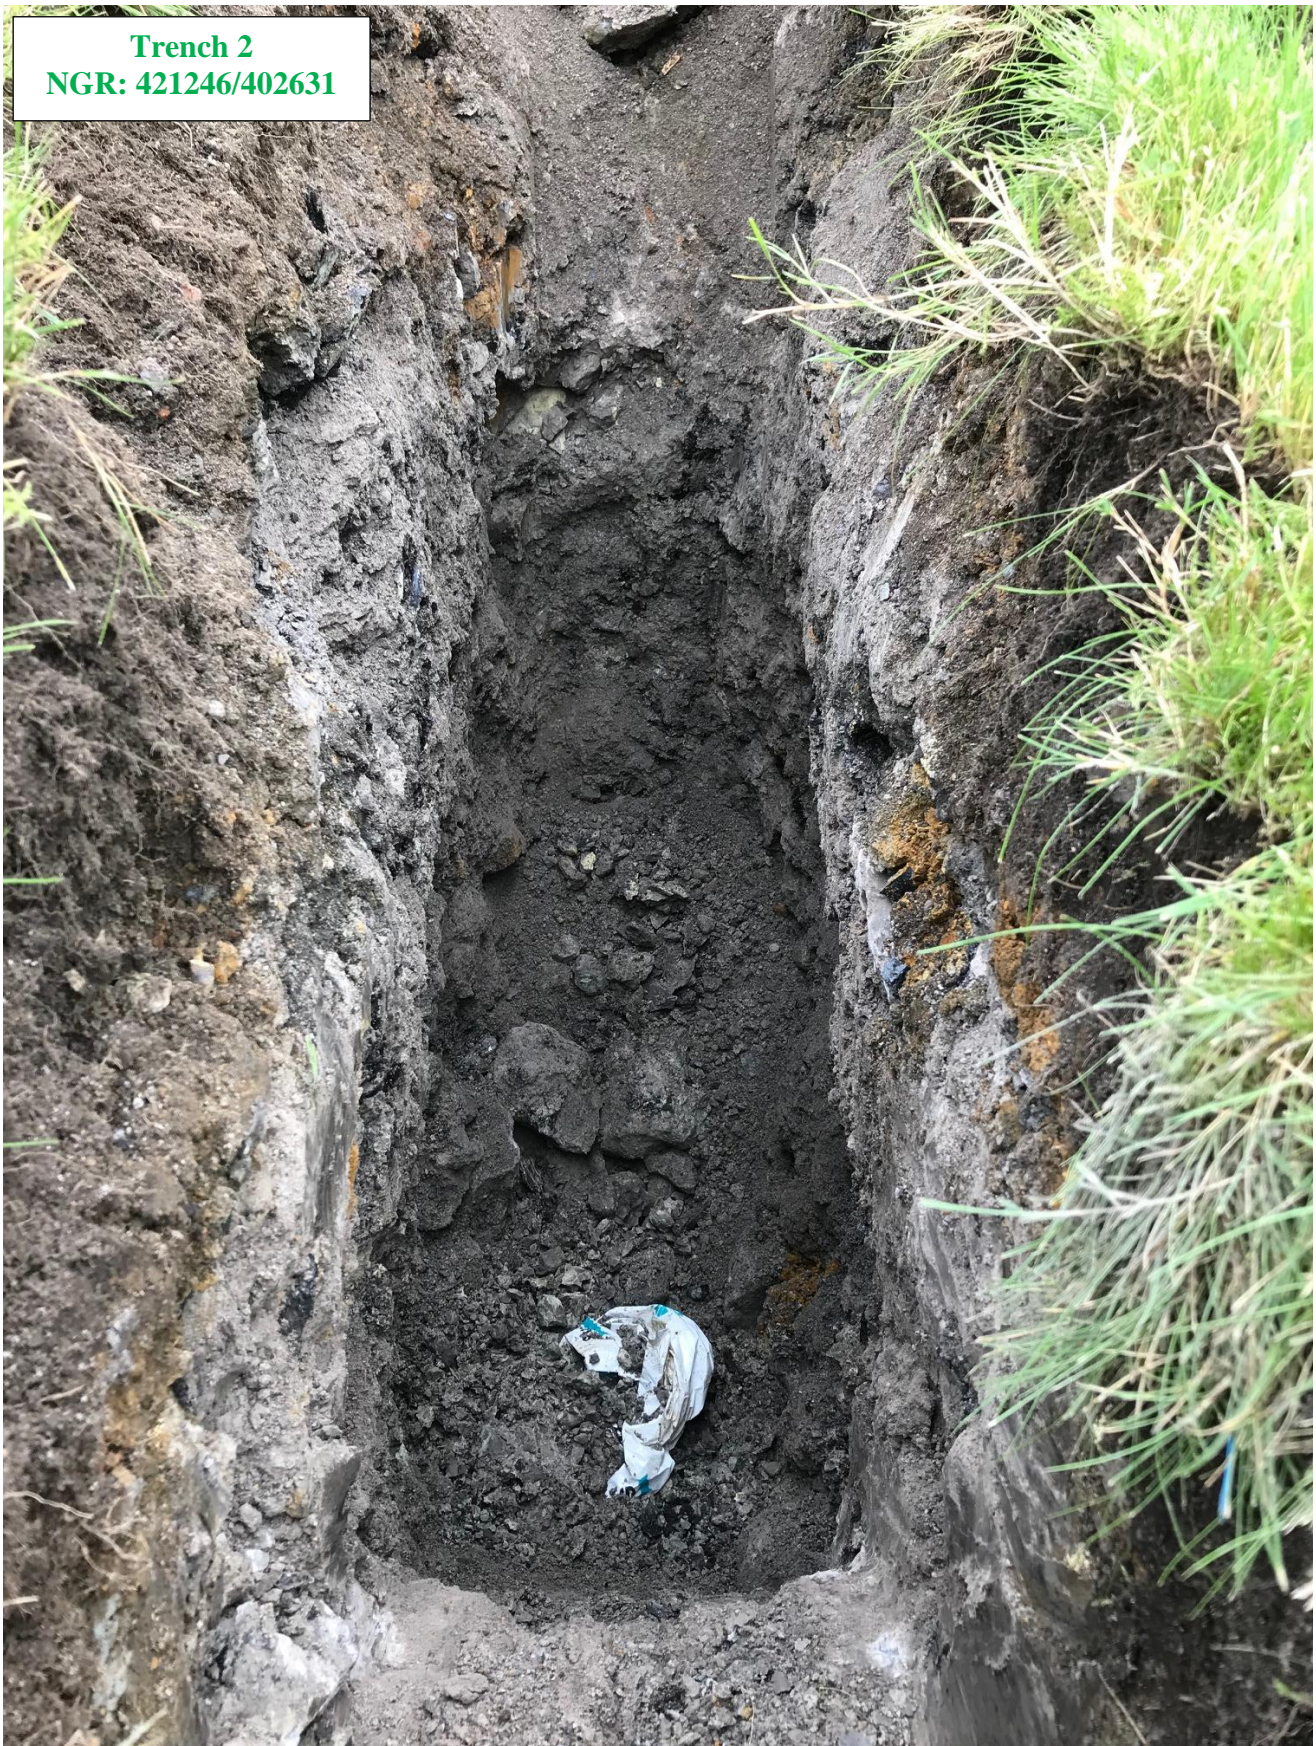
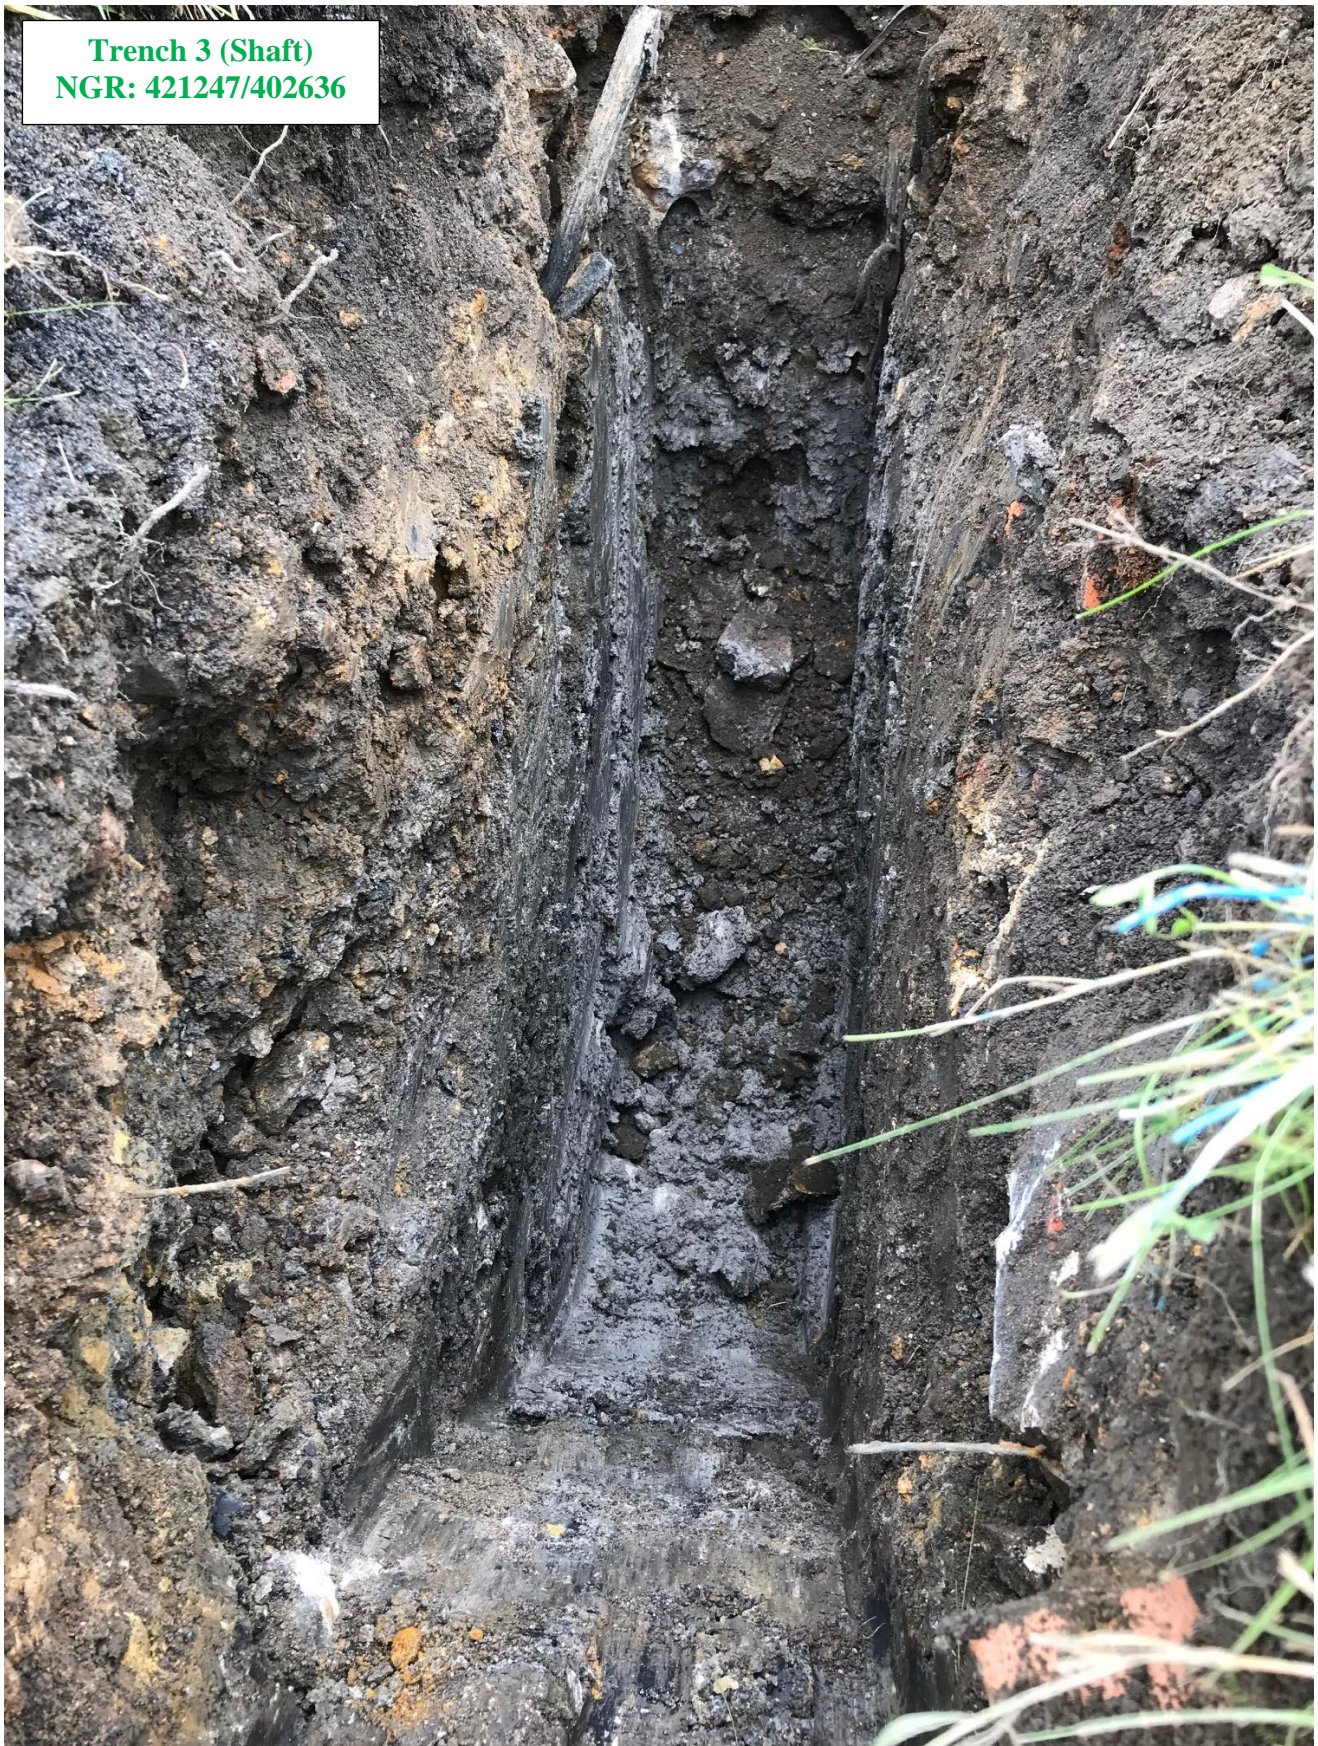
Appendix B – Trench Photographs

Details of the trenching exercise are summarised in the following table; photograph images can be seen in appendix B.

Trench No.	NGR	Details
1	421239/402634	Colliery waste/fill to 1.8m – old single railway sleeper obstruction at base; natural ground/bedrock not determined; no sign of mine entry.
2	421246/402631	Colliery waste/fill to 2.3m; natural ground/bedrock not determined; no sign of mine entry.
3 (Shaft Plan Position)	421247/402636	Colliery waste/fill to 2.3m; natural ground/bedrock not determined; no sign of mine entry.
4	421252/402635	Colliery waste/fill to 1.4m; natural ground (orange clay) determined; no sign of mine entry.

- No signs of the known mine entry were observed during the investigation. The shaft cap (if present) is expected to lie beneath the fill material at depth. Further investigation involving larger equipment to reach greater depths could be undertaken, otherwise it would be advisable to stand the proposed dwellings outside of the 20m radius zone from the plan position of the shaft. Certain development inside this zone, such as hard standings/driveways are likely to require an element of geo-grid matting for safe construction designs, depending on the Coal Authorities requirements. Watching briefs would be prudent during future ground works for any associated signs of other unrecorded mine entries. The Coal Authority should be notified where any such feature is suspected.
