## BS 5837:2012 Arboricultural Survey

Kirkgate Lane Solar- Cable Route  
for:

**Ethical Power Development (EPD)**

3073.001.ENZ.XX.00.RP.AR.45.101

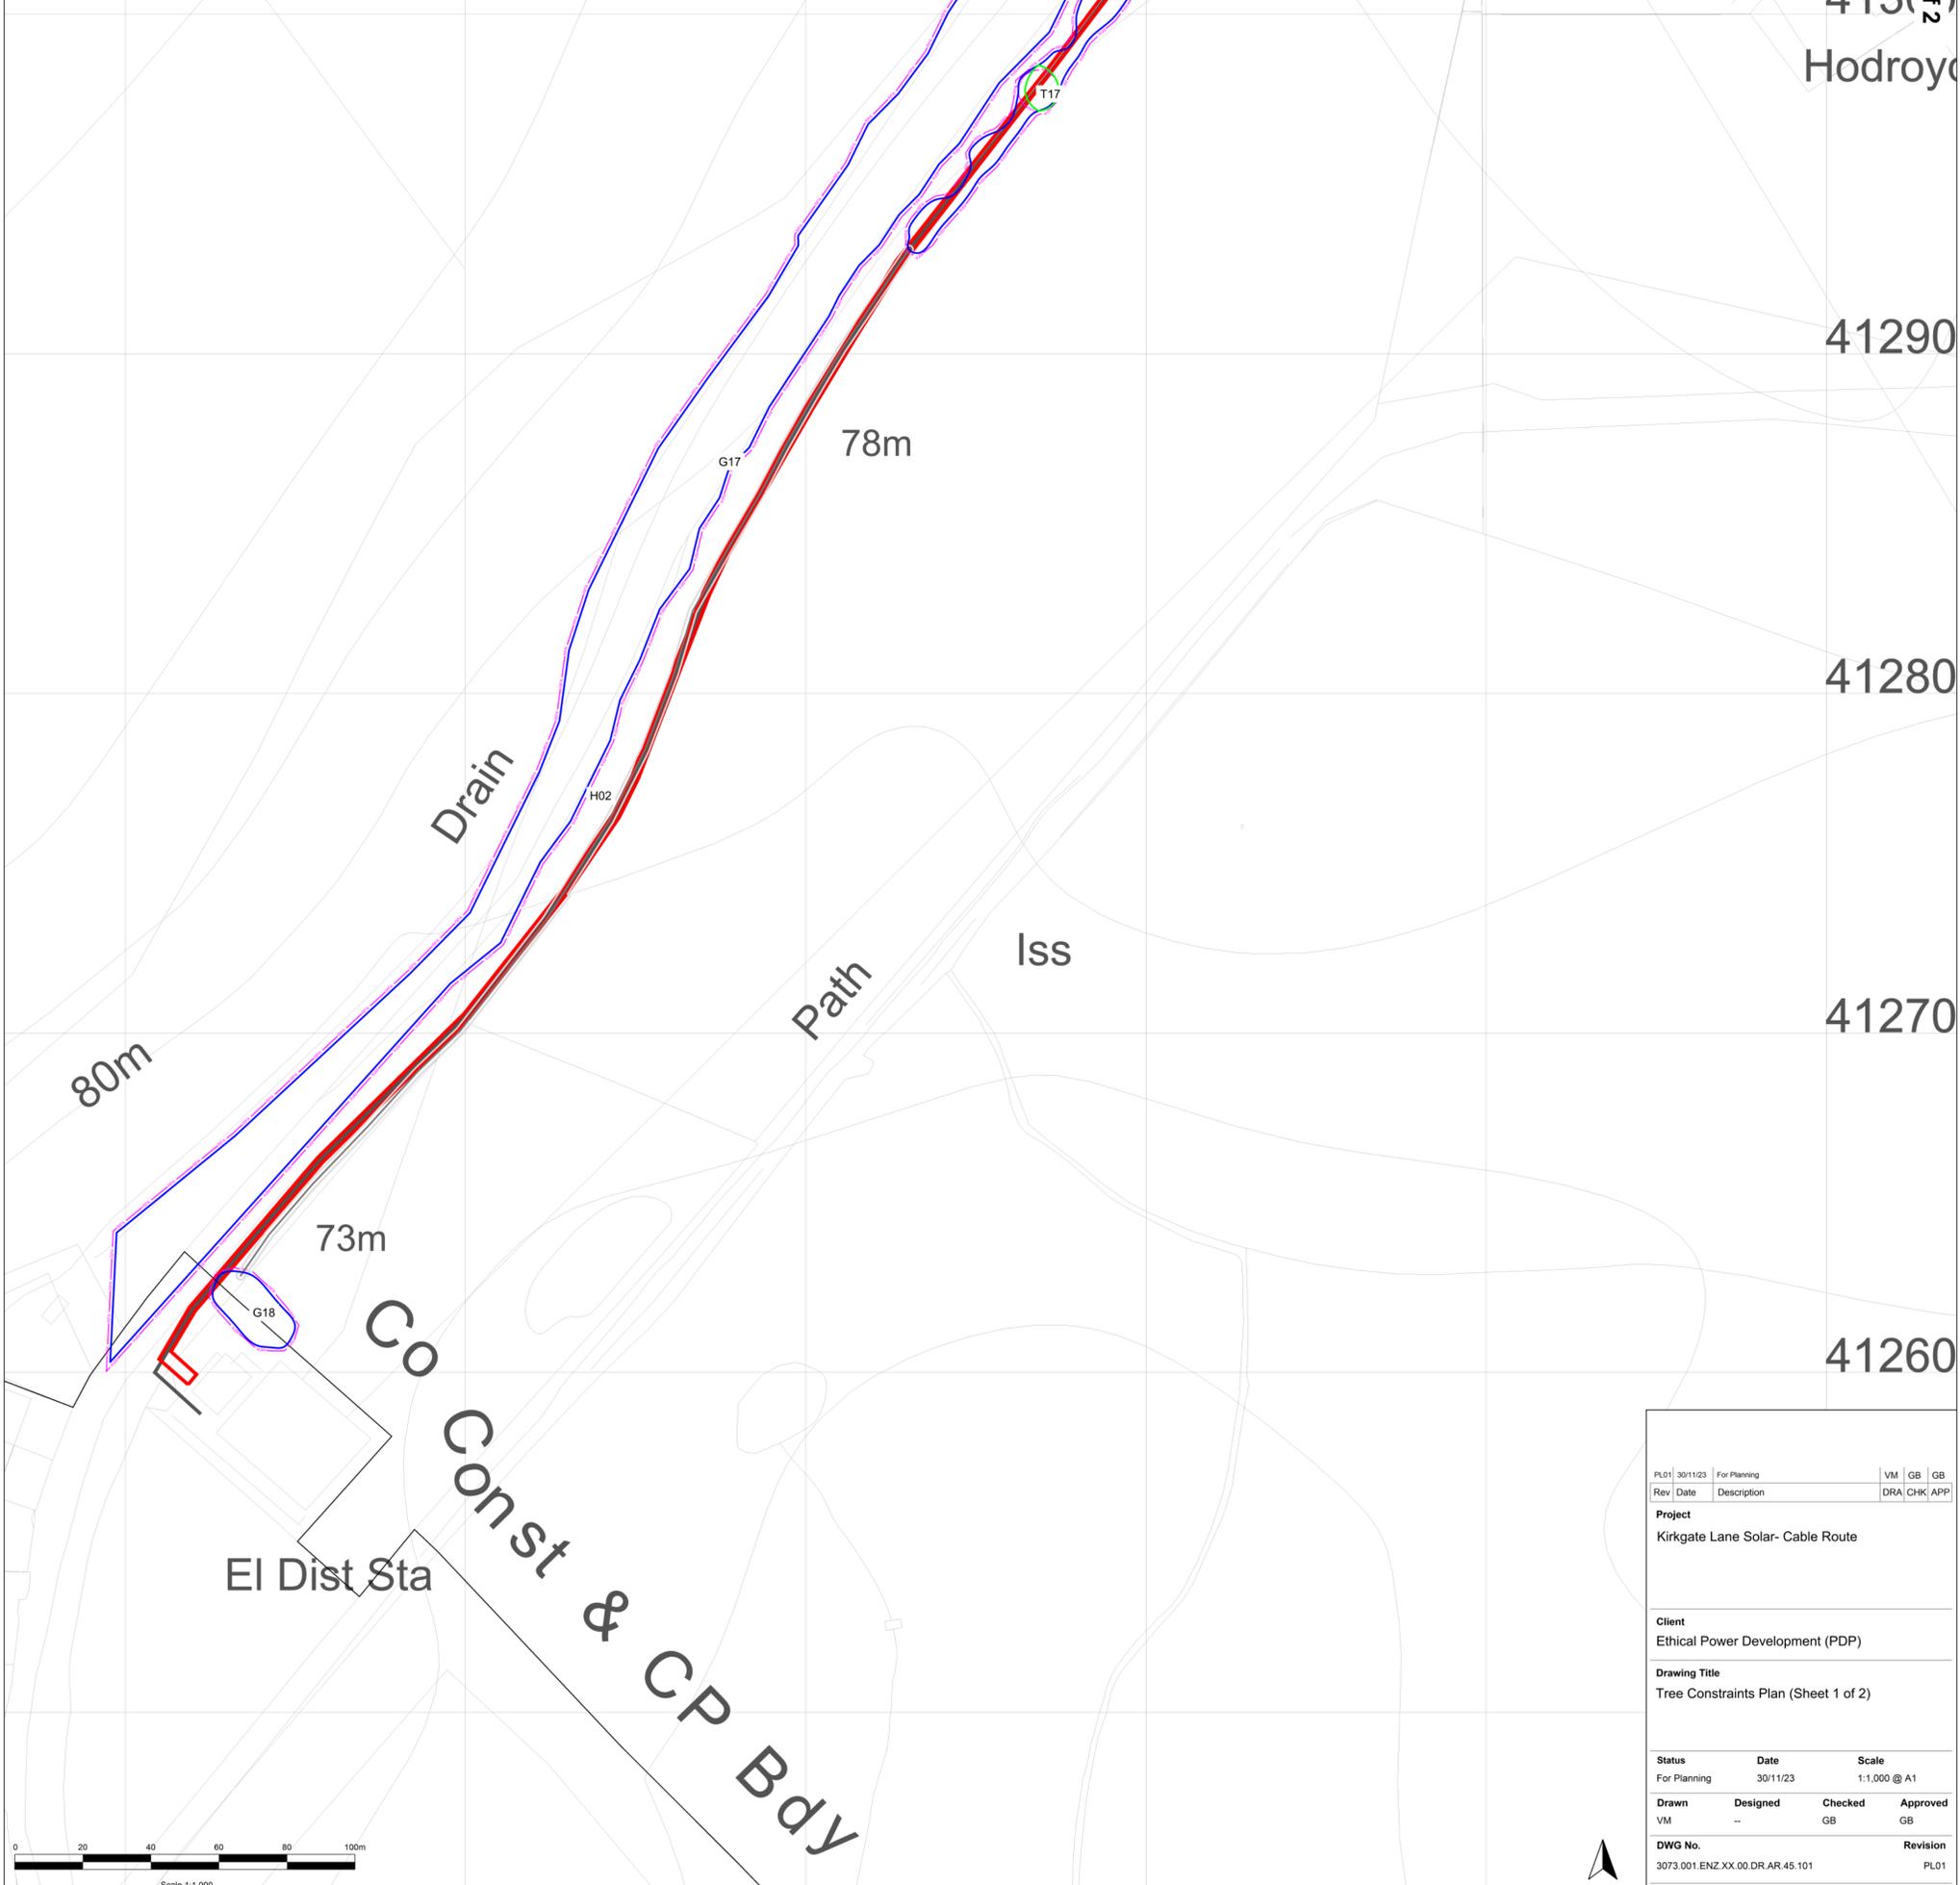
## 7.0 Appendix 2 – Tree Survey and Constraints Plan

**KEY - Tree Survey and Tree Constraints Plan**

10.2.3 The findings of the tree survey are recorded in an Arboricultural Survey Schedule supported by a Tree Survey and Tree Constraints Plan, both appended to the report.

4.5.1 The Root Protection Areas for each Category A to C tree and tree group has been calculated based on measured stem diameters. Both the radius and the area of each RPA are listed in Appendix 1 – Arboricultural Survey Schedule and shown on the plan included in Appendix 2 – Tree Survey and Constraints Plan Appendix 5 – .

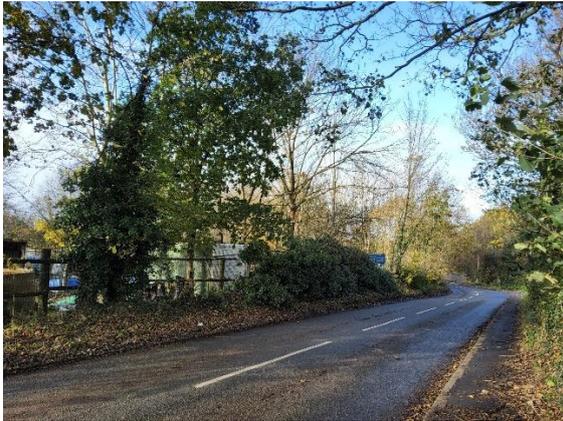
**Plate 1: Group G01**

Ref	Species	Ht (m)	Stem dia (cm)	Canopy spread (m)				Clear crown	Life stage	RULE	Cond.	Notes (Including preliminary management recommendations)	BS Cat.	RPA (m)	RPA (m <sup>2</sup> )
				N	E	S	W								
G01	Mixed species	12	200					1.5	Semi Mature	40+	Good	Linear group along Kirkgate Lane. Comprising oak, ash and sycamore. Retention category based on group value for screening, individual trees predominantly of low value.	B2		
G02	Sycamore ( <i>Acer pseudoplatanus</i> )	20	300					2	Mature	40+	Good	Linear tree group along road, comprising predominantly early mature to mature sycamore, on top of retaining wall between 0.5m and 0.8m above road level. RPA unlikely extending south.	B2		
G03	Mixed species	12	250					1.5	Mature	40+	Good	Small woodland group around road bridge with trees at bottom of slope not influenced by proposed cable route. Trees on top of embankment sit on approximately 0.5m high mound. Group includes oak, sycamore, ash and hawthorn.	B2

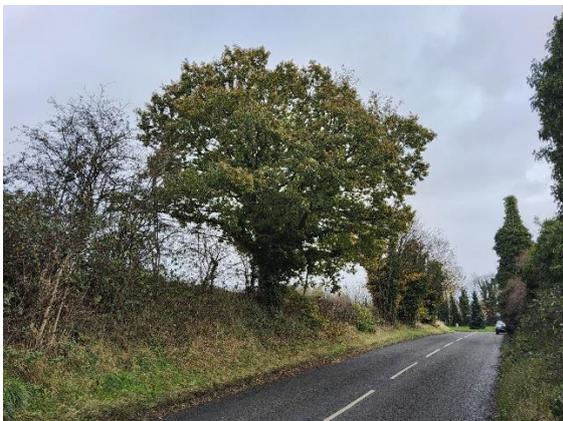
**Plate 3: Trees T08, T06 and T05**

Ref	Species	Ht (m)	Stem dia (cm)	Canopy spread (m)				Clear crown	Life stage	RULE	Cond.	Notes (Including preliminary management recommendations)	BS Cat.	RPA (m)	RPA (m <sup>2</sup> )
				N	E	S	W								
T08	Pedunculate Oak ( <i>Quercus robur</i> )	25	500	7.0	7.0	7.0	7.0	3	Mature	40+	Good	Significant boundary tree with wide open canopy. On steep slope with stem base 1.5m above road level. Twin-stemmed with dense ivy up to 8m into canopy.	A2,3	6	113
T10	English yew ( <i>taxus baccata</i> )	8	400	2.0	2.0	2.0	2.0	0	Mature	50+	Good	Significant tree associated with churchyard and visible from road. Behind stone wall and possibly higher than road level.	A2,3	4.8	72
T11	Pedunculate Oak ( <i>Quercus robur</i> )	12	500	4.0	7.0	7.0	8.0	4	Mature	40+	Good	Historic boundary tree with open canopy, northern crown reduced either by pruning or accidentally by larger vehicles. Ivy on stem. At bottom of steep slope down towards field.	A2,3	6	113

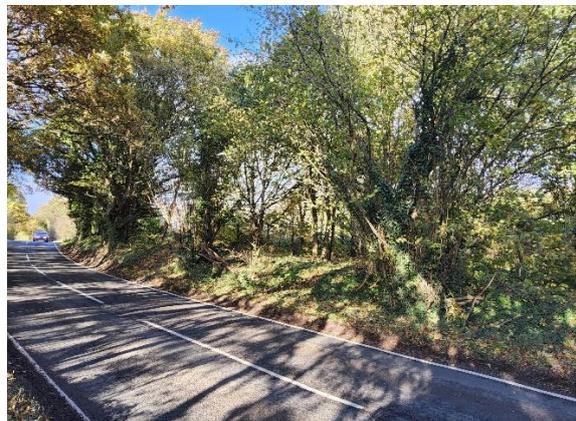
**Plate 4: Woodland W01**

Ref	Species	Ht (m)	Stem dia (cm)	Canopy spread (m)				Clear crown	Life stage	RULE	Cond.	Notes (Including preliminary management recommendations)	BS Cat.	RPA (m)	RPA (m <sup>2</sup> )
				N	E	S	W								
T17	Pedunculate Oak ( <i>Quercus robur</i> )	12	500	7.5	6.0	6.0	4.0	4	Mature	40+	Good	Significant oak tree within overgrown hedgerow group. Historic boundary tree with open canopy.	A2,3	6	113
W01	Mixed species	20	400					0	Early Mature	40+	Good	Oak woodland with scattered hazel understorey. Hazel coppiced along road.	A2,3		
W02	Pedunculate Oak ( <i>Quercus robur</i> )	15	400					4	Mature	40+	Good	Oak woodland with bramble understorey.	A2,3		
W03	Mixed species	20	500					4	Mature	20+	Fair	Mixed deciduous woodland, mainly ash with Ash Dieback having impact on canopy cover. Dense scrubby understorey. Row of oak along northwestern edge.	B2		
W04	Mixed species	25	400					3	Mature	40+	Good	Attractive oak woodland with dense understorey incl. blackthorn	A2

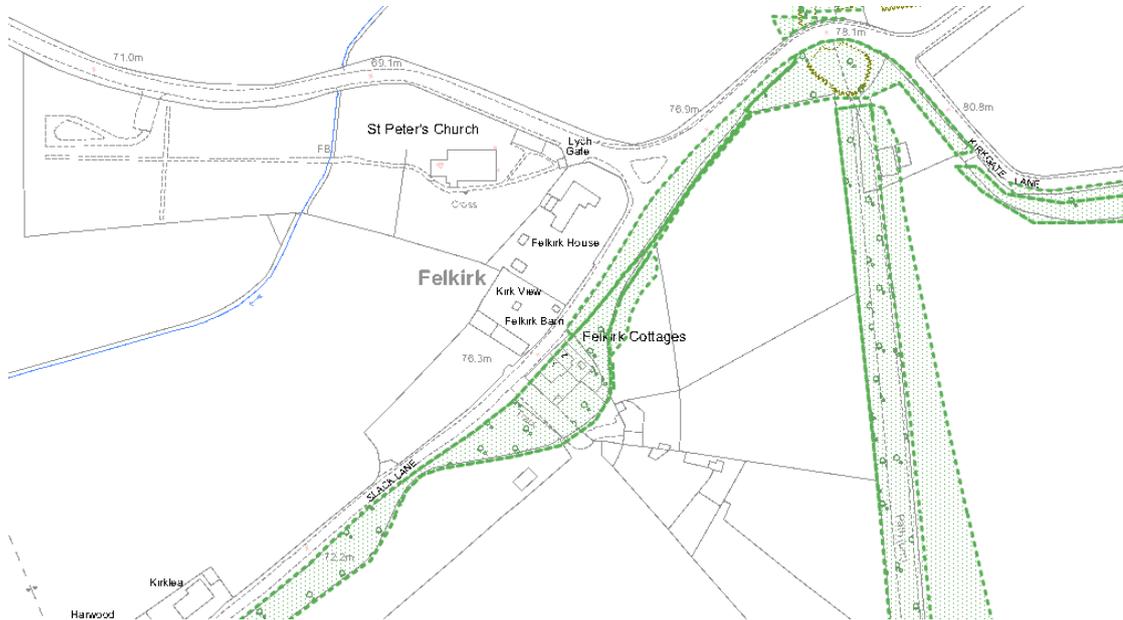
### 9.1.2 Wakefield Council Tree Preservation Order ref. TPO/19/00134/W “Woodland at Felkirk and South Hiendley, Kirkgate Lane/Slack Lane South Hiendley Barnsley”

4.6.3 The Tree Preservation Order covers T001 and T002 as well as groups G001, G003 and G004.

- 9.1.4 Written permission needs to be sought from the Local Planning Authority before any works are carried out which may directly or indirectly affect protected trees, including any works included in the preliminary management recommendations in Appendix 1 – Arboricultural Survey Schedule. Consent for the proposed works can further be assumed if they are included in an Arboricultural Impact Assessment and/ or Tree Protection Plan and where these documents are listed as approved documents under the relevant planning permission.
