# Heritage Statement

Bank House Farm consists of the main 250 year old Grade II listed farm house facing and set back from Barnsley Road along with two large two storey barns, barn A approximately 150 years old and barn B 200 years old. The barns form a courtyard behind the farm house. The three main buildings are stone built with stone roofs, each in varying states of repair. The main building, Bank House Farm, caught on fire in November 2014. The building suffered severe damage internally and is currently not habitable. The windows and doors are boarded up but it appears that that stonework and the roof have remained intact thanks to the prompt response of the fire brigade. Barn B has been renovated using local stone to compliment Bank House Farm. Barn A is subject to this current application.

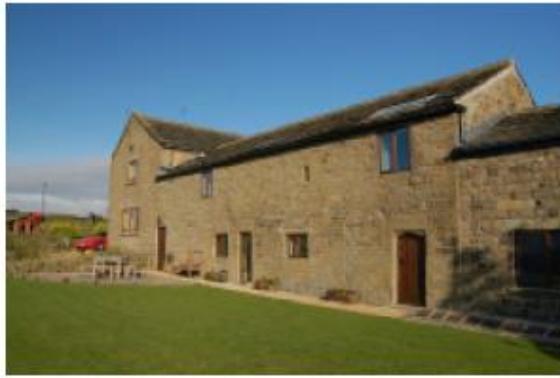
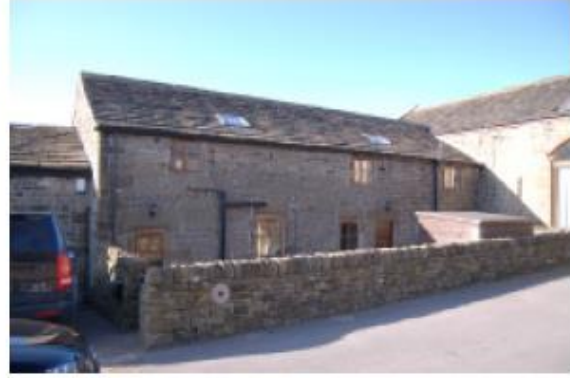
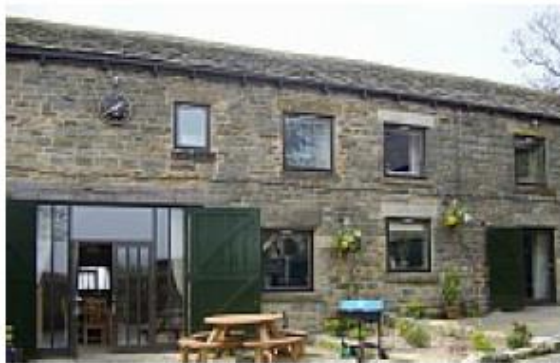
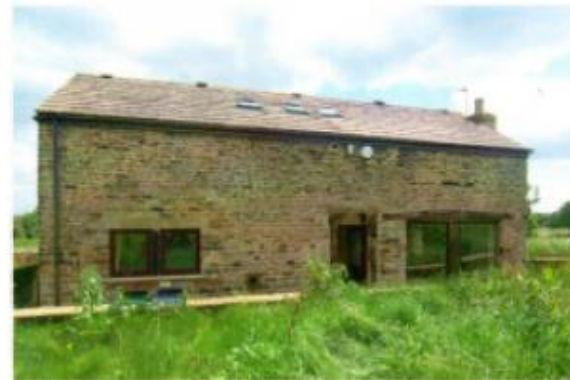
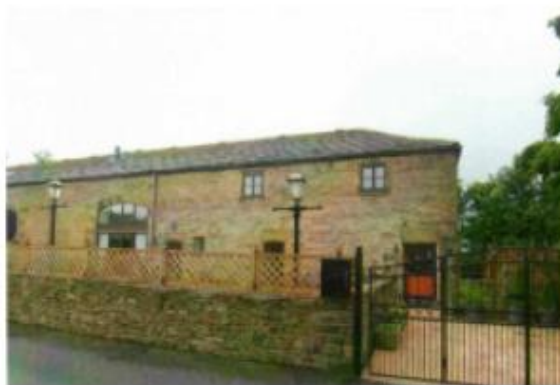
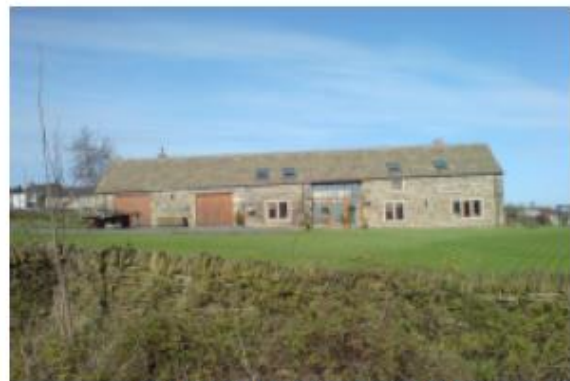
Barn conversions around the area

The photos show several sensitive barn conversions around the area.
