Stables off Royd Moor Road, Thurlstone

Bat and Bird Survey Report

31st March 2025

Document ref: MBE/BAT/2025/032/01				
Purpose and Description	Originated	Checked	Reviewed	Date
For Planning	R Bell MCIEEM <i>R Bell</i>	P Middleton MCIEEM <i>P Middleton</i>	R Bell MCIEEM <i>R Bell</i>	31/03/2025

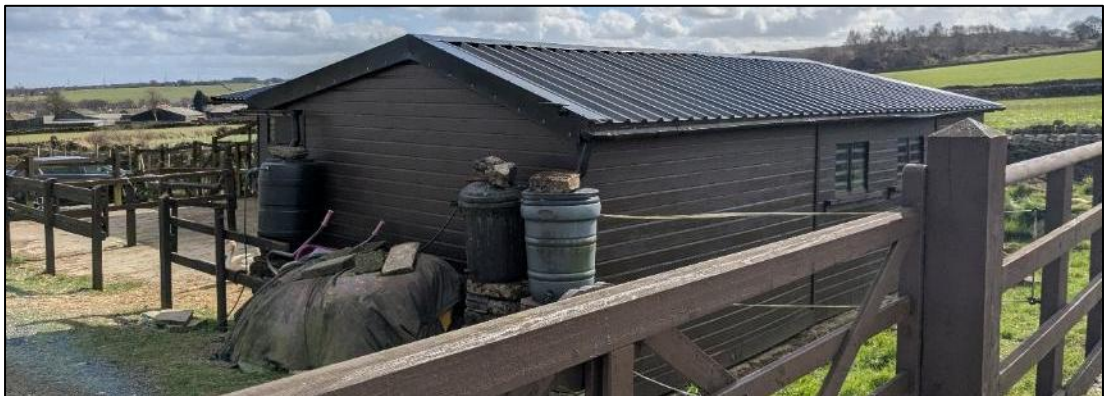
Plate 1. North corner of stables

- 5.2.2 The surveyed stable building was constructed between 2003 and 2009. It comprised a single-storey L-shaped timber framed and wood clad structure, with a pitched corrugated metal sheet covered roof, with metal ridge and verge capping (Plates 1-4). Single paned windows and wooden stable doors were present. Guttering was uPVC and ran into water butts.

- 5.2.3 The exterior of the stables was in a good state of repair and lacked any suitable bat access points or features offering more than negligible bat roost potential.

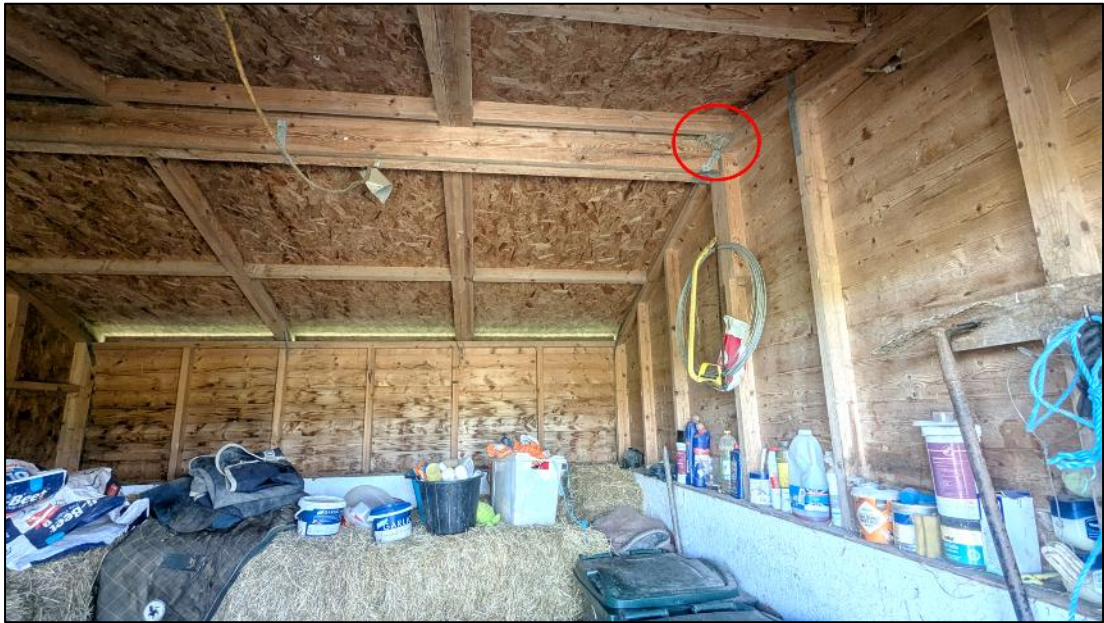
Plate 5. Interior of roof, with old swallow nest visible

- 5.2.4 The roof was lined with chipboard and suspended on a simple timber framework. The external walls were single skin from 1 m up, with a double skin below this height. There were however no potential bat access points into the double skin section of the wall.
- 5.2.5 Approximately three former swallow nests were recorded from various compartments of the stables (Plate 5).

- 6.3.5 Demolition of the stables should either be undertaken outside the bird nesting period (March to September inclusive), or the works would need to be preceded by a nesting bird check, to be undertaken by an experienced ecologist.
- 6.3.6 It is also recommended that mitigation for nesting swallows be incorporated within the development. Suitable mitigation may include the provision of two swallow nest cups within a newly constructed open sided structure (i.e. car port, stables or log store).

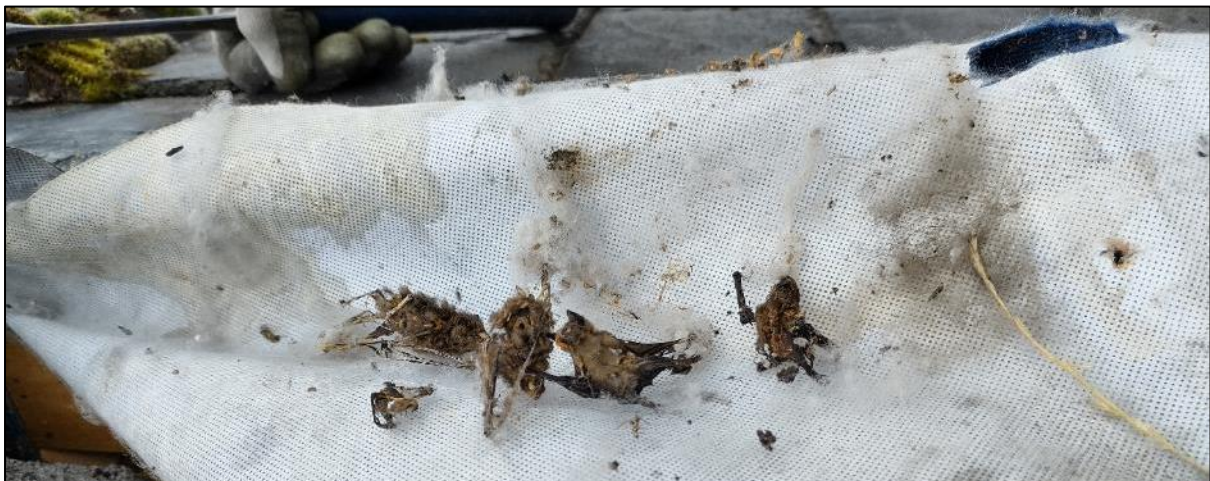
Plate A1.1. Four dead pipistrelles tangled in breathable roofing membrane

Standard non-bitumen coated membranes (including almost all breathable membranes) used below roof slates and tiles present a significant problem for bats. Over time, strands are pulled away from the surface of these materials as bats crawl over them. These fuzzy strands are very strong and can tangle and trap bats, sometimes causing the death of bats over multiple years¹.

One example we have encountered comprised a pipistrelle roost which formed in a building extension constructed in 2009. Over the course of just 13 years the roofing felt degraded to the extent that it trapped and killed more than 10 bats. Fortunately, the problem in this roost was identified and remedial work was undertaken to replace the roofing membrane in 2022.

From a bat perspective, the best membrane option for areas where roosts are expected comprises traditional hessian-backed Type 1F bituminous felt. This product has been widely and safely used as a secondary weather barrier since approximately the 1950s/1960s. Wooden sarking has also been used for many decades and if appropriately treated, is safe for

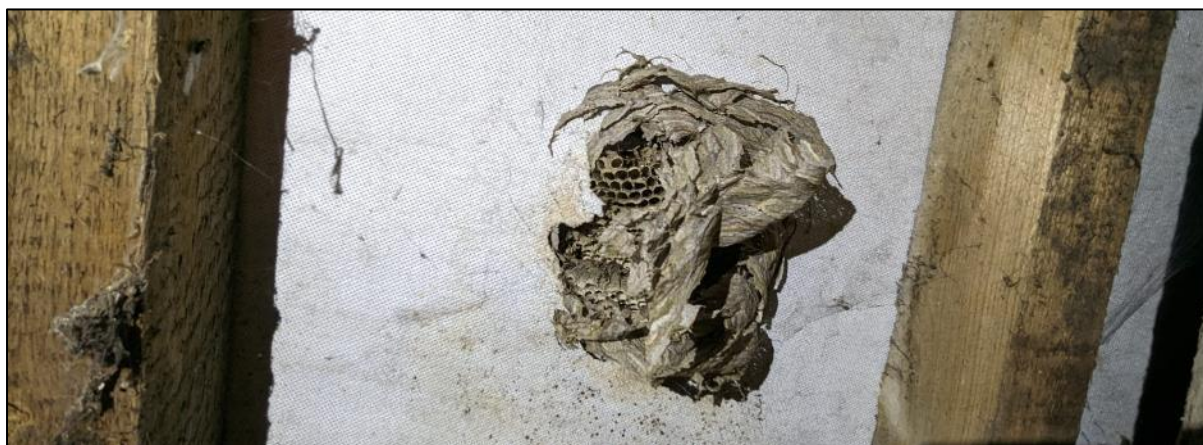
Plate A1.2. Damage to a breathable roofing membrane adjacent to a wasp nest

In recent years a fairly substantial proportion of the lofts we have surveyed which had existing breathable felt, were found to have been damaged by wasps (Plate A3.2). The wasps appear to have chewed holes in the felt and formed nests. This doesn’t appear to be a problem associated with traditional bitumen coated roofing felt. Any holes within roofing felt are likely to significantly reduce its functionality as a secondary weather barrier. Where bats or birds come into contact with breathable roofing membranes, they can also damage it causing it to leak, they can also significantly reduce the breathability of the felt in that location.
