## Bat Survey

Cliffe Farm

Cubley

March 2011

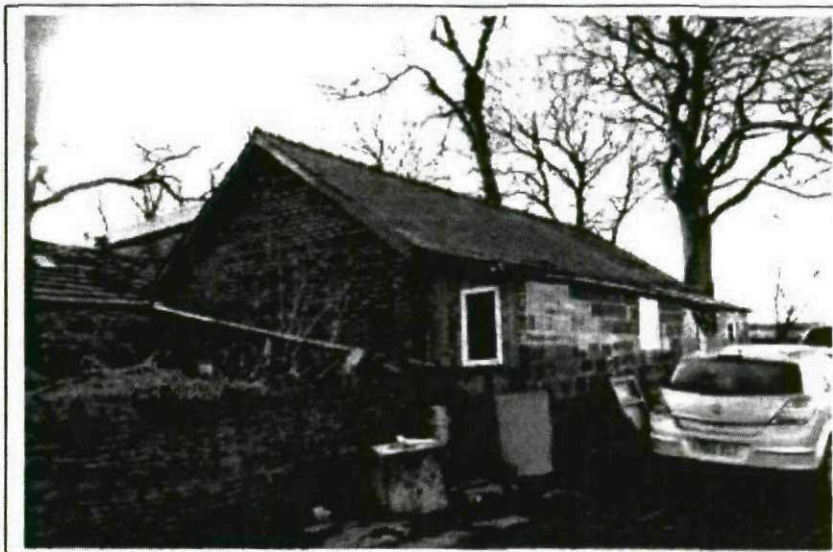
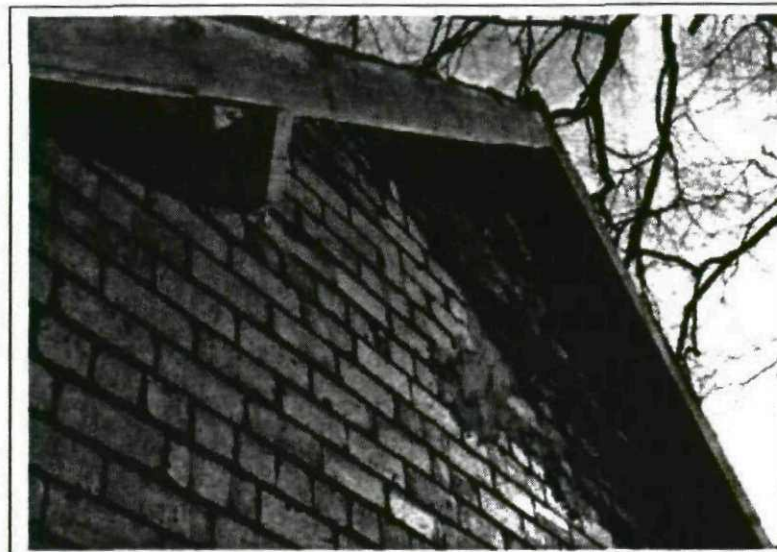
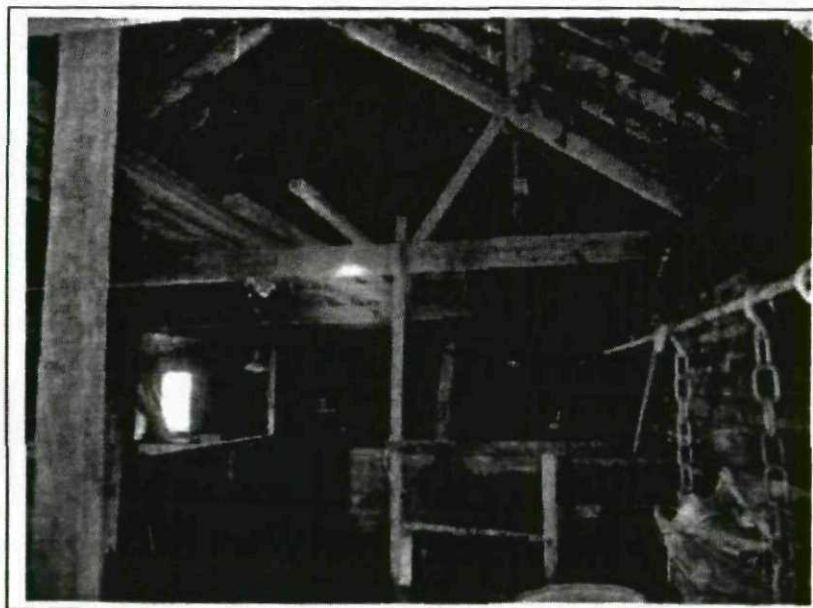
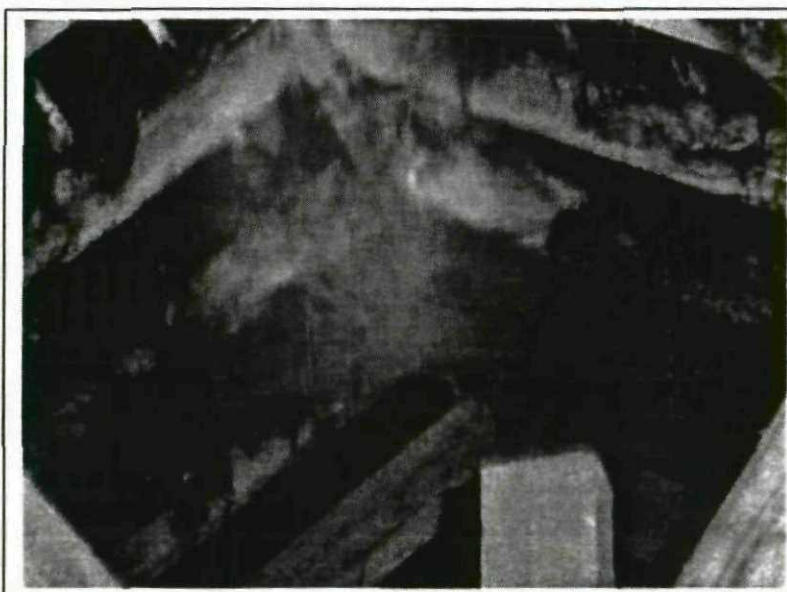
**FIG 6**

| Ref | Description |
|---|---|
| F | Single-storey brick barn with a blue slate roof. A lean-to on the front wall had brick walls with profile steel roof sheets. The gables had timber fascias with large gaps behind, potentially allowing access to crevices under the roof although no signs were found.<br><br>Internally the building was open to the underside of the roof with no underfelt. The ridge and inside gables were exceptionally cobwebby indicating that bats were very unlikely. (Fig 6) |

**Barn F**

| F- Brick Barn | Roost unlikely- gable verge gaps probably too large for bats. Internal roof very cobwebby. |
