# COCKLE EDGE FARM, INGBIRCHWORTH

## Results of Preliminary Bat Survey (including initial dusk and dawn bat detector survey)

SLR Consulting Ltd was commissioned by WHp Residential Limited to undertake a daytime building inspection and dusk/ dawn bat detector survey of Cockle Edge Farm, Huddersfield Road, Ingbirchworth, South Yorkshire, S36 7GQ (OS grid reference SE 22918 05559).

It is understood that planning permission is being sought to convert the buildings, most of which are derelict and not in use, into a team room and cafe.

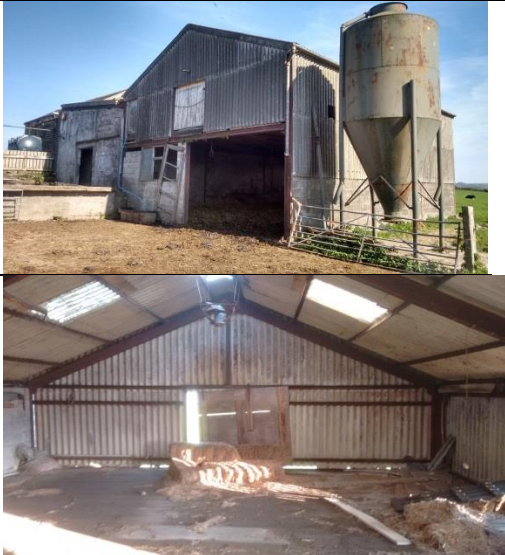
No.	Description of Building	Plate	Bat Potential
A	<p>'Cow shed' in active use. The walls are a mixture of breeze block and corrugated asbestos cement sheeting supported by a simple metal structure. A wooden floor divides the building into two levels. Internal light levels are relatively high.</p>

Low
B	<p>Former milking parlour, or 'mistle', which has been disused for circa 20 years. Mainly breezeblock walls, with stone wall on eastern side (where meets Buildings C and D). The corrugated asbestos cement roof, which contains 8 'open' skylights, is supported by a simple metal frame. A small corrugated metal lean-to occurs at the rear (see Plate 3). A small 'window' in the breeze block wall separating it from the upper floor of Building A has hollow sections of potential value to roosting bats. Number of gaps potentially suitable for roosting bats, between breeze blocks, and above wooden beam above doorway, on northern side. A single common pipistrelle emerged from a roost at the top of a wall on the northern side (see bottom left plate), during the evening survey.</p>

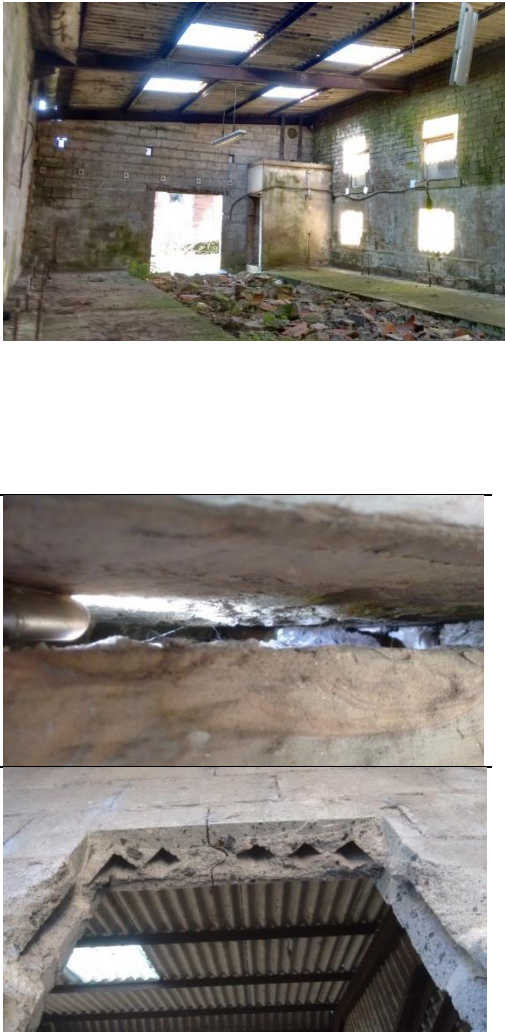
Confirmed Bat Roost

Building B (disused milking parlour) at Cockle Edge Farm was found to support a single roosting common pipistrelle bat, which was occupying a gap at the top of a breeze block wall, on the southern aspect of this building, in May 2016.

As such, it is recommended that a further survey is undertaken during June 2016, to establish whether additional and perhaps larger, roosts are present at that time.

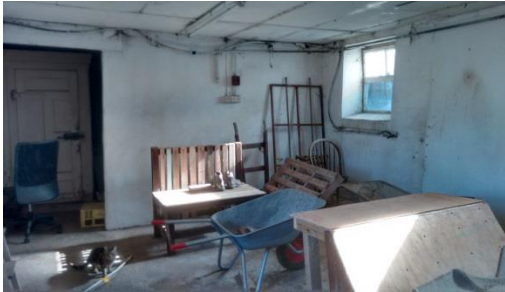
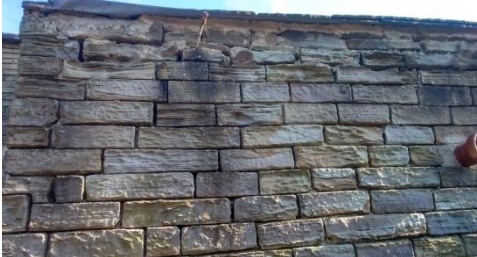
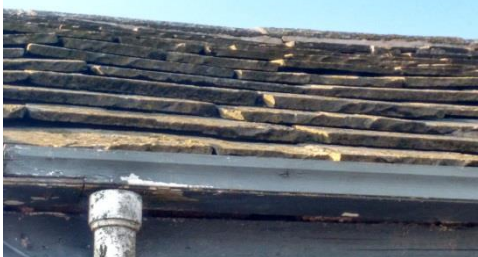
No.	Description of Building	Plate	Bat Potential
C	<p>Stone building with stone tiled roof supported by traditional wooden 'kingpost' beams, and multiple purlins. The roof has bitumen under-felt, which is in sound condition. The building consists of two levels, separated by a wooden ceiling; the lower level has rendered white-washed walls and is being used to store wheelbarrows, carpets, and other belongings. The upper floor is being used to store old windows and window frames, a child's swing, and chairs. The lower floor has three windows, and high internal light levels; the upper floor has a single open window (i.e. not containing glass) on its western side, which was being used as an access point for swallows. There are many gaps within the external and internal mortar, creating potential bat access points.</p>

Moderate

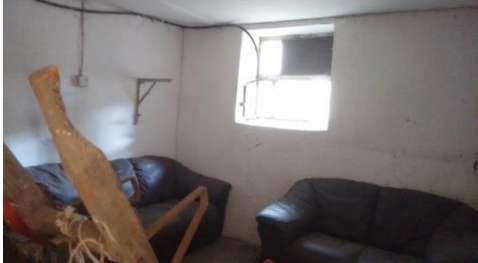
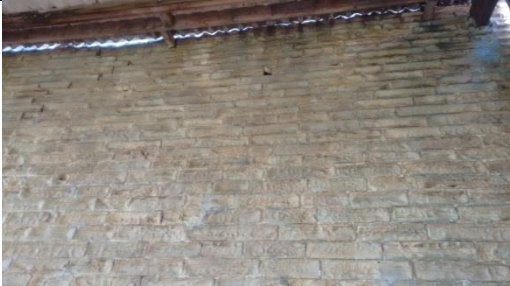
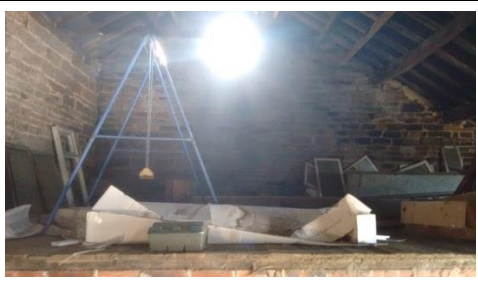
D	<p>Small white-washed room being used to store sofas (downstairs) with a window and high internal light levels; shares the same roof space as that which lies above building C (i.e. also split-level). The southern stone wall (pictured below) contains multiple gaps in masonry, within potential for roosting bats.</p>

Moderate

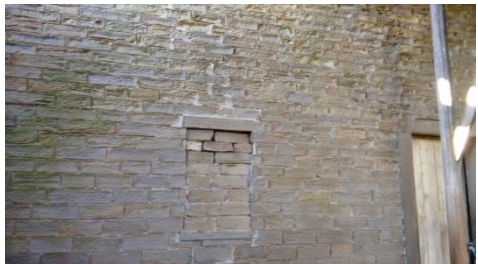
Moderate
E	<p>Fairly large walk-in cupboard/ pantry beside Building D, with white-washed walls. To the south, the stone wall (forming the boundary between it and Building I) contains a window which has some un-mortared blocks in it (see right), creating crevices of potential value to roosting bats.</p>

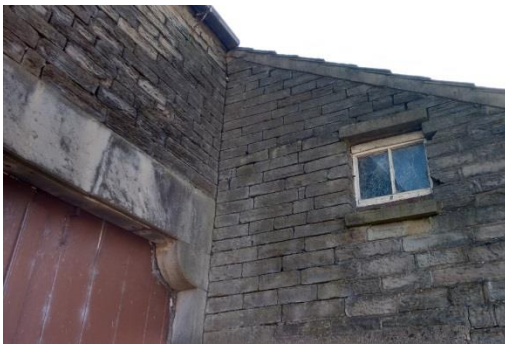
No.	Description of Building	Plate	Bat Potential
F	<p>Building F is accessed via two large wooden doors on its northern side. It is of stone construction, and is open to the roof – it does not have a second floor (unlike Buildings C, D, E and G). As with the other buildings, the roof supports stone tiles, with kingpost beams and purlins; there is bitumen underfelt, creating a potential roosting cavity between the outer tiles, and the inner felt. There are gaps in the masonry between the stones, both internally and externally, including where Buildings C and F join (see right).</p>

Moderate
G	<p>This stone building is on two levels and is attached to the residential property (which lies immediately to the east). The ground floor consists of a 'blackened' white-washed room containing a large wood-burning stove, and a more modern boiler. The upper floor shares the same roof space as Buildings C, D, E and F, with traditional stone tiles supported by wooden kingpost beams. A window on the north-facing aspect creates relatively high internal light levels. A large sheet of black polythene separates the upper part of this building from the residential property, to the east (see below).</p>

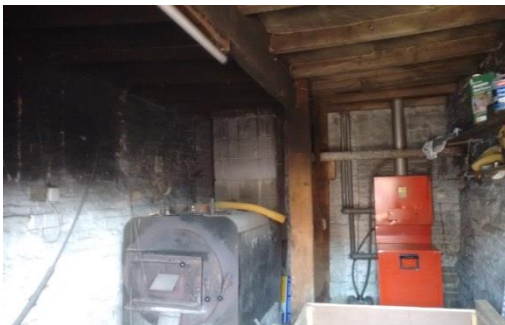
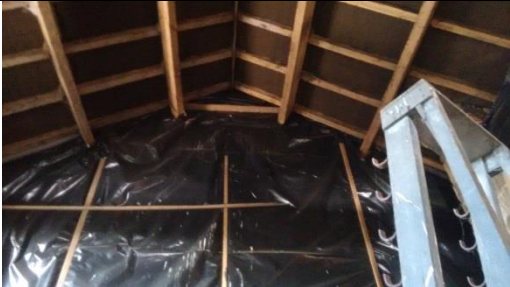
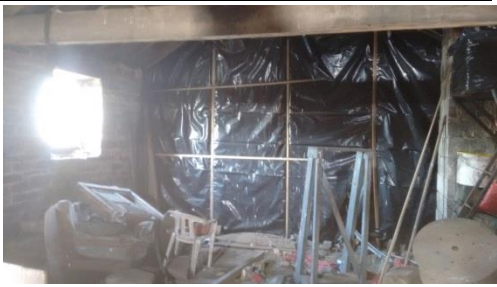
Moderate

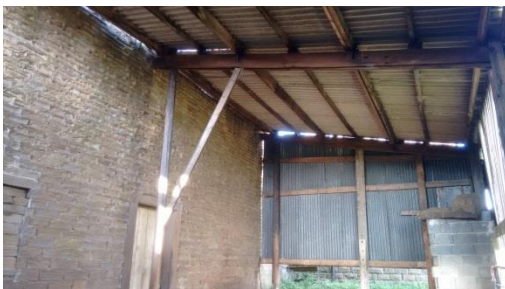
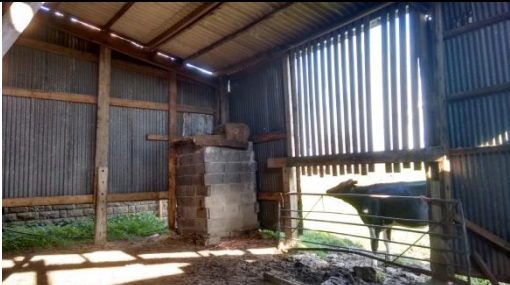
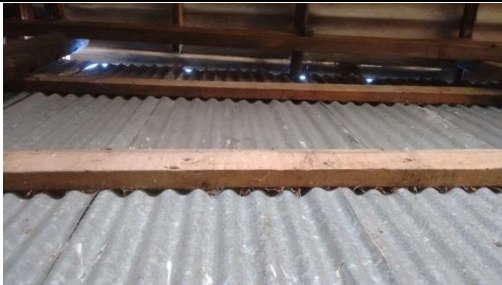
H	<p>Large two-storey residential property which lies outside of the proposed development footprint. This building is of stone construction with a stone tiled roof.</p>	N/A	N/A
I	<p>Corrugated metal lean-to attached to the back (i.e. southern side) of Buildings D, E, F and G. It has a simple wooden structure. It appears to be used as a shelter for cattle. As previously described, the stone wall contains missing mortar and is of potential value to roosting bats, whereas the southern, eastern and western metal sides, and the metal roof, are less suitable. There are some gaps between the timber sides and the corrugated sheets they support, which potentially create niche roosting features for bats (see overleaf) but those that could be accessed were not found to contain bat droppings, or bats themselves.</p>

Moderate

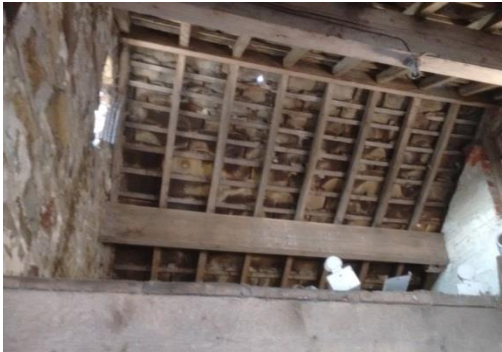
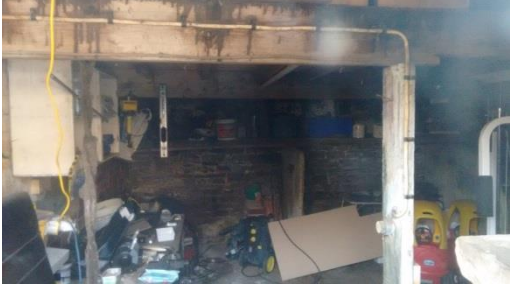
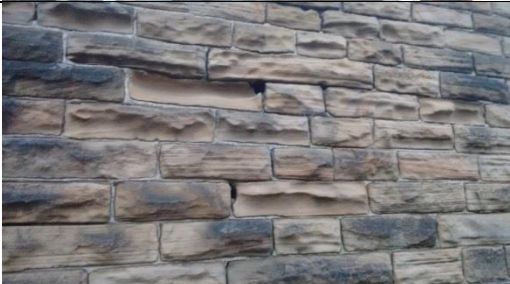
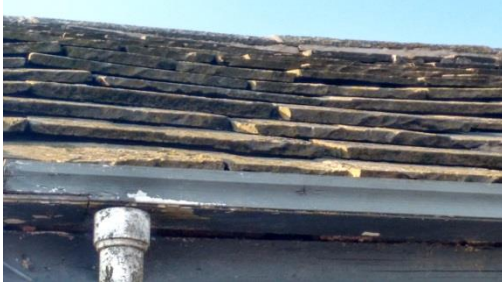
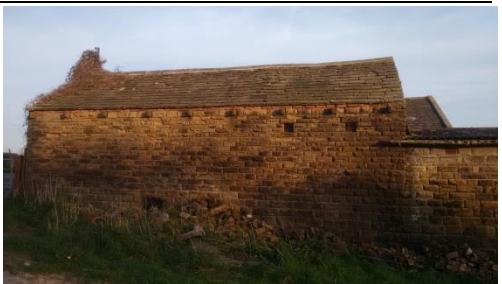
<p>J</p>	<p>Constructed mainly of stone, but with some breeze block and brick, and with a pitched stone tiled roof containing many gaps but without any underfelt (see right, and bottom right). This building is divided into two sections, the most easterly is a locked garage (used by the resident of the occupied dwelling (Building H)); it seems to be being used as a workshop and place to store childrens' toys. It could not be entered, but was viewed from a window (see below). The western half of Building J is divided into two levels by a wooden floor; the lower floor is cobbled, and is used to store a bicycle; the upper floor is being used to store old fluorescent lights, and a blue toilet. There are many gaps in the stonework of this building, particular on the rear (i.e. north facing side); one crevice was being used by nesting blue tits.</p>

<p>Moderate</p>

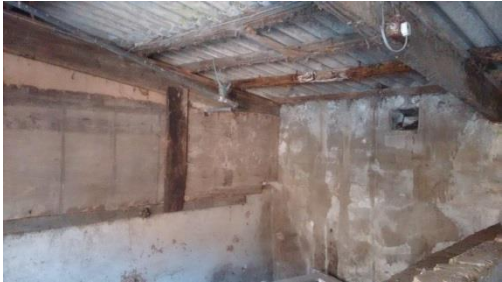
<p>K</p>	<p>Former single floor piggery building, of stone, breeze block, and brick construction and a single pitched corrugated asbestos cement roof. It is divided into a number of rooms, the largest of which is being old to store furniture. There are some sizeable gaps, where mortar is missing between breeze blocks, at the western end of this building, on the southern aspect, of potential value to roosting bats.</p>

<p>Moderate</p>

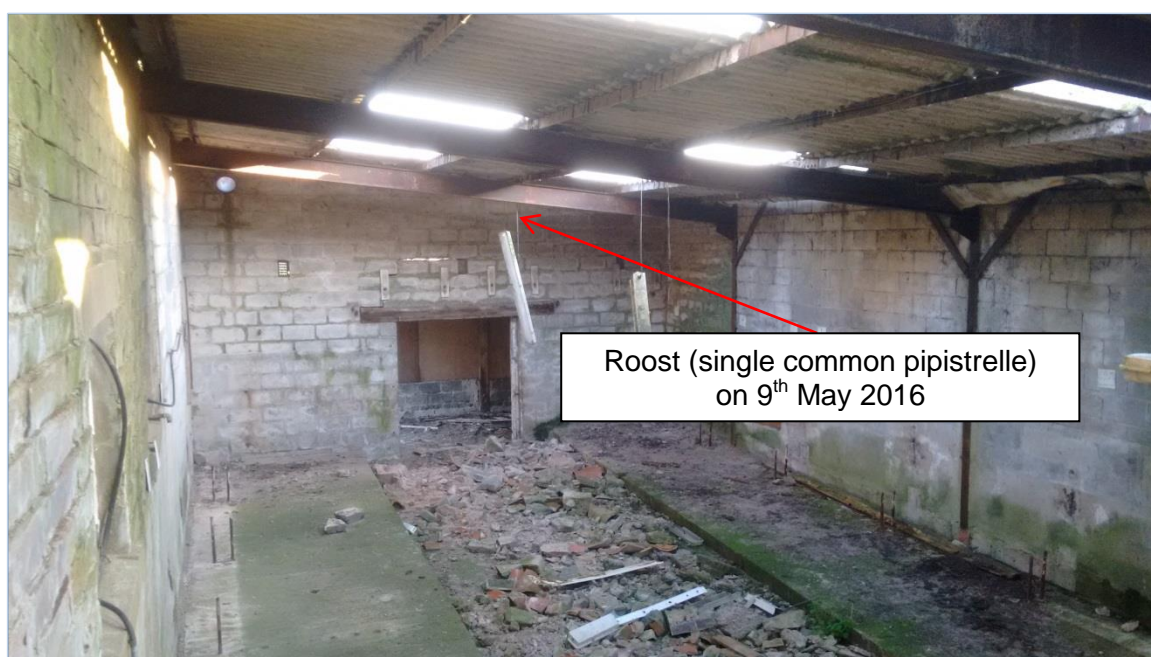
During the dusk emergence survey of the 9<sup>th</sup> May 2016, a common pipistrelle *Pipistrellus pipistrellus* bat emerged from the top of the breeze block wall, on the southern aspect of Building B (see Drawing 1 for location, and Plate 4 below). The bat emerged at 21.17 hours, and circled around inside Building B for approximately a minute, before returning to the same roost.

The surveyor then entered Building B again, and the same pipistrelle which had emerged at 21.17 hours, then returned to its roost, emerged once again (at 21.41 hours), before circling around inside the building, then exiting it through the roof, via one of the missing skylights.

**Plate 4:** Location of common pipistrelle roost (single bat), on southern breezeblock wall of Building B. This bat emerged at 21.17 hours, and circled before re-entering the roost; it emerged again at 21.41 hours, before exiting the building by an open skylight.
