**Doncaster Road, Darfield, Barnsley**

**Road Safety Audit Stage 1**

Doncaster Road, Darfield, Barnsley – Road Safety Audit Stage 1

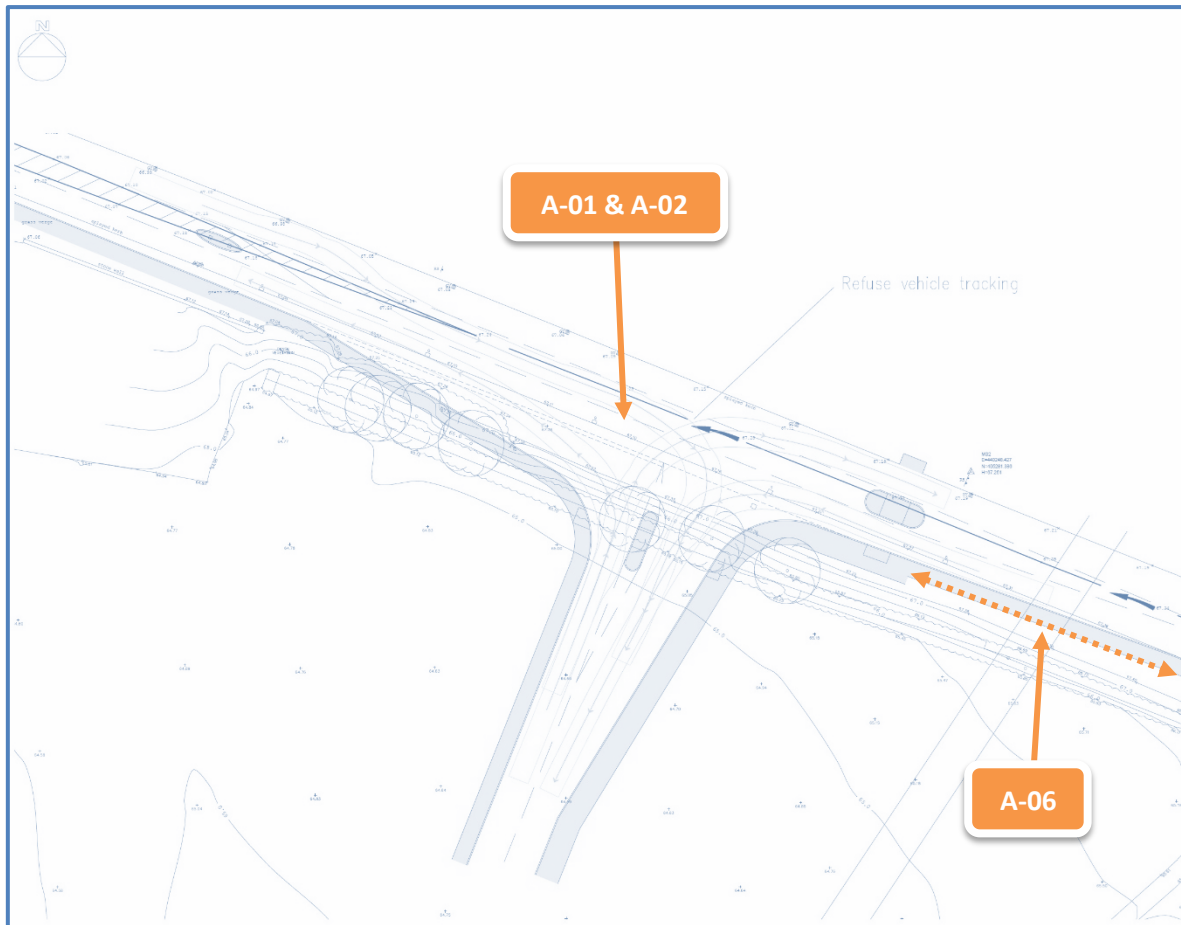
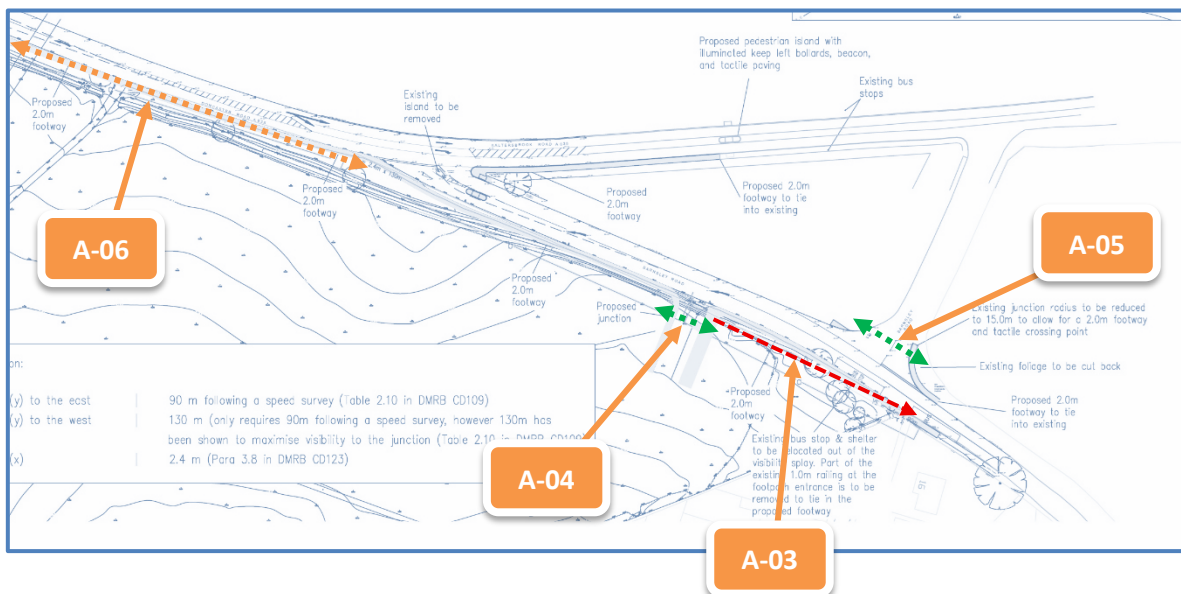
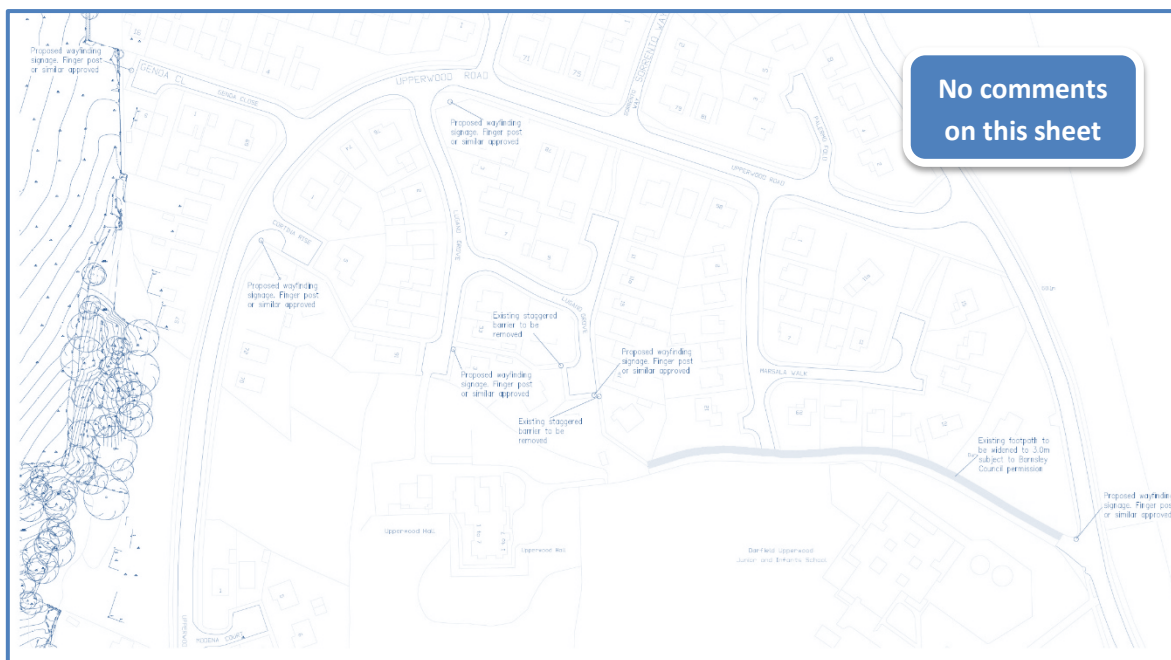
# Problem Location Plan

Each of the auditors' responses is classified as a 'Problem' that is likely to result in a significant road safety hazard. All comments and recommendations are referenced to the detailed design drawings and the locations have been indicated on the plan at the end of the report.
