## **The Brownie Hut, Cawthorne Barnsley**

### **Bat Survey**

July 2008.

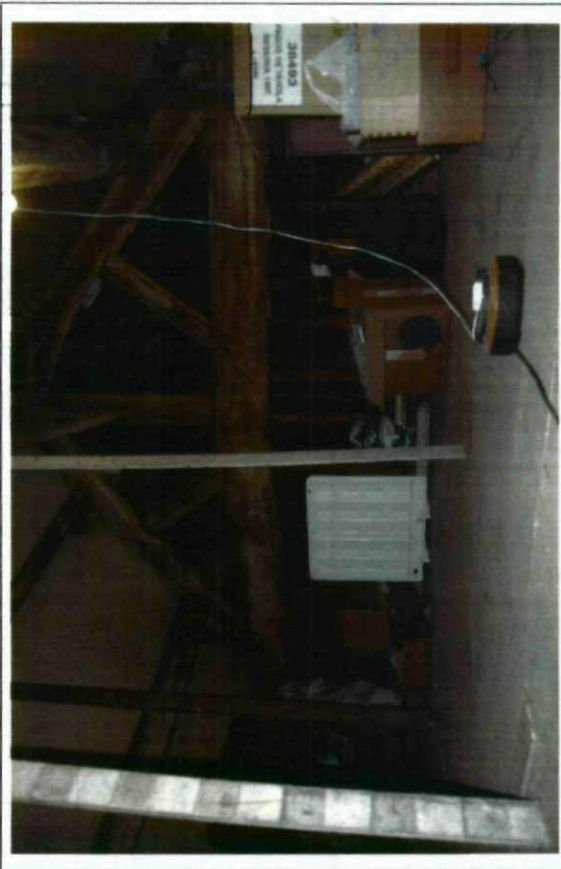
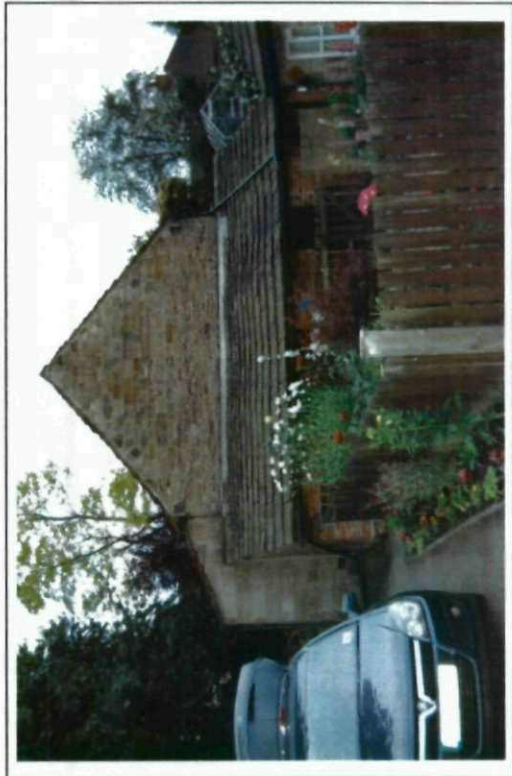
FIG 1

- 7.1 The survey was carried out on 12 July 2008.
- 7.2 The building was a simple rectangular stone structure with a stone slate roof. A small stone porch type extension was attached to the east wall and low coal bunkers attached to the north wall. The walls contained numerous crevices to the point that they appeared to be dry-stone construction. Gaps were also noted at wall top level under the edge of the roof slates. The gables were well pointed with no openings at all except between the stone slates. The porch was built from finely dressed stone with no suitable openings and the brick coal bunkers were too low to be attractive to bats. No signs of bat droppings etc were found externally but signs of nesting birds were found on the eastern eaves.

- 7.3 Internally, the upper floor was open to the underside of the roof. The roof was supported on two timber trusses. Some socket holes were noted in purlins but none in the trusses. Part of the roof was dry lined with plasterboard with a polythene lining behind. The remainder was lined with traditional under-felt. The roof timbers were covered by cobwebs. No signs of bat droppings, urine spotting or discarded insect remains were found.
