**Whitcher Wildlife.
Wildlife Consultants.**

**GREEN ROAD, DODWORTH.
PROTECTED FAUNA SURVEY.**

Ref No:- 081138.

Date:- 13th November 2008.

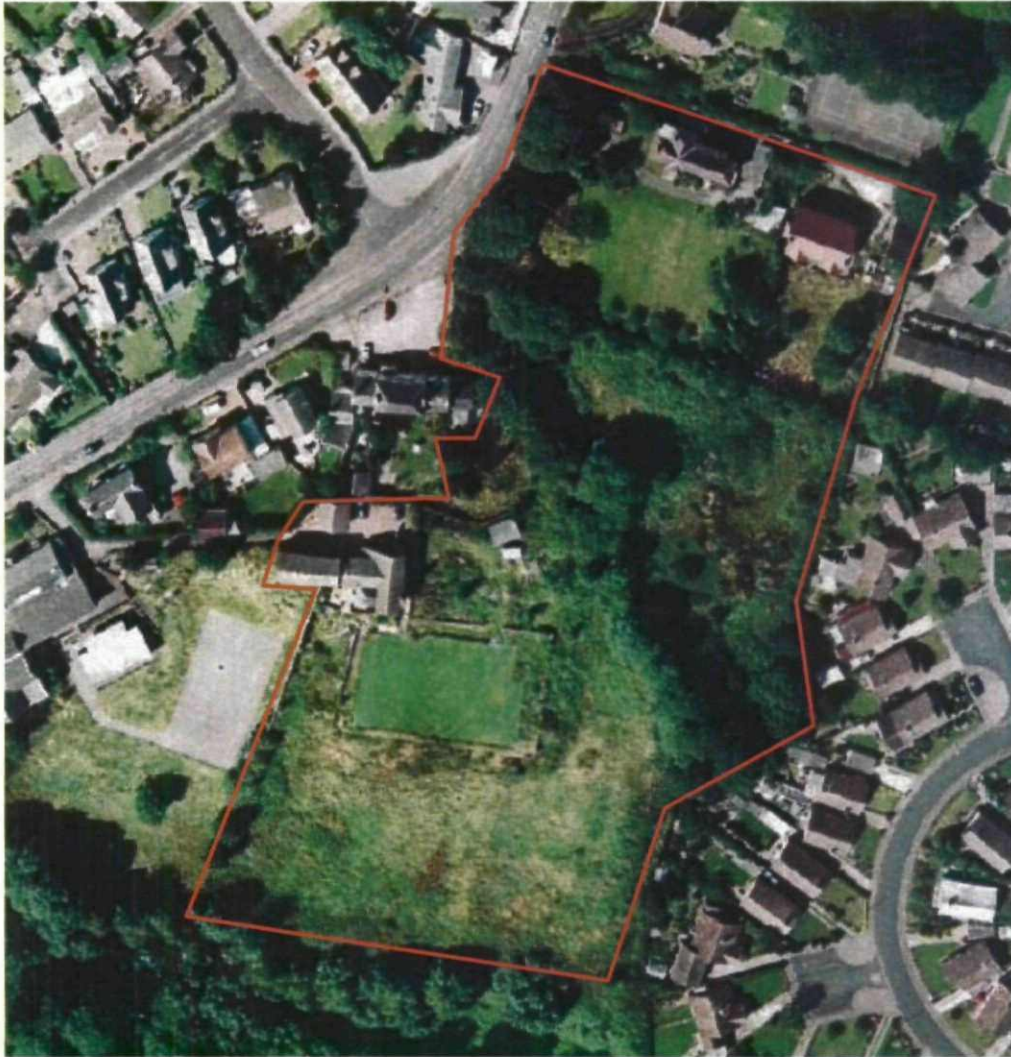
3.1.1. The site lies at the edge of the residential village of Dodworth, Barnsley and is as shown on the old aerial photograph below outlined in red.

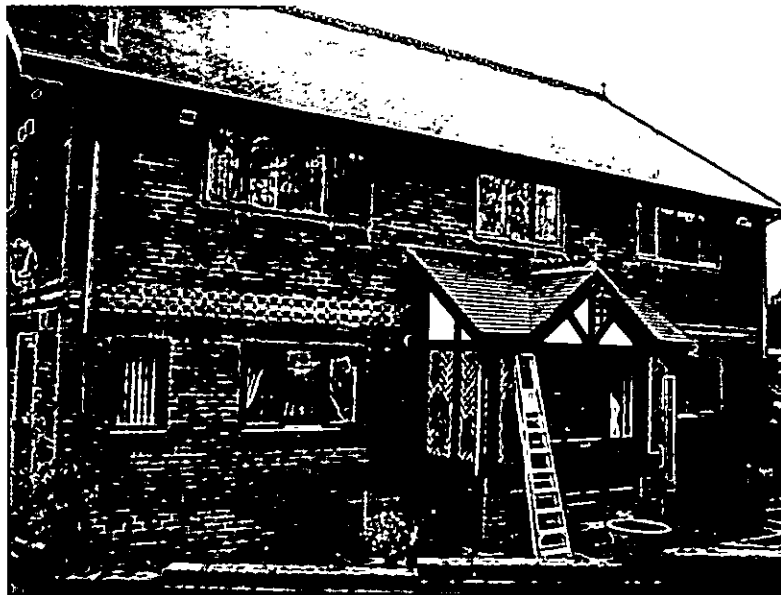
3.4.1. Fieldhouse.

3.4.1.1. This is a detached brick house with a pitched tiled roof, located at the north east corner of the site.

3.4.1.2. The house is fairly new with no open joints, cracks or crevices in the well pointed brick walls.

3.4.1.3. The eaves are well sealed with timber soffit boards and no visible opportunity for bats to roost.

3.4.1.4. The roof tiles are all closely fitting and the ridge tiles are all well pointed with no opportunities for roosting bats.

3.4.1.5. The loft comprises a modern trussed roof design. The loft is well sealed throughout with felt sarking beneath the tiles. The loft insulation is very clean with no materials stored within the loft space.

3.4.1.6. No bat droppings or other field signs were identified anywhere inside or outside of this property.

5.1. No evidence of bat roosts was identified in any of the buildings on the site and there is therefore no requirement for a European Protected Species Licence.

5.2. However, individual bats can seek temporary shelter almost anywhere and it is therefore recommended that all demolition is carried out with care and in the unlikely event that a bat is found, the bat is covered and protected, work in that area must cease and further advice must be sought.

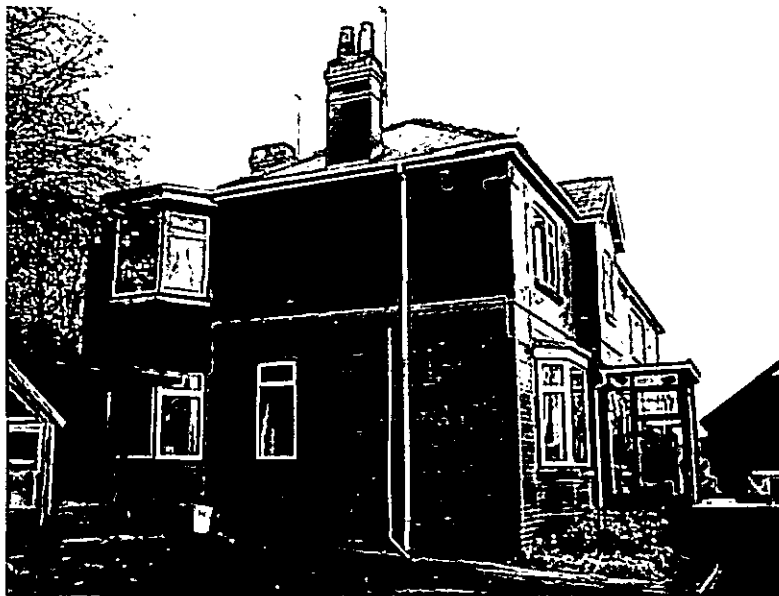
3.4.2. Hillside.

3.4.2.1. This is a detached brick house with a pitched slate roof, located at the north west corner of the site.

3.4.2.2. No open joints, cracks or crevices in the well pointed brick walls and the eaves are well sealed with timber soffit boards and no visible opportunity for bats to roost.

3.4.2.3. The roof slates are all closely fitting and the ridge tiles are all well pointed with no opportunities for roosting bats.

3.4.2.4. The loft comprises a trussed roof design supported by timber purlins. The second floor rooms all have a sloping edge to the ceilings resulting in a narrow and low roof space above. There is no felt sarking beneath the tiles leaving the underside of the slates exposed. The ridge board is well sealed with no access beneath the ridge tiles.

3.4.2.5. No bat droppings or other field signs were identified anywhere inside or outside of this property.

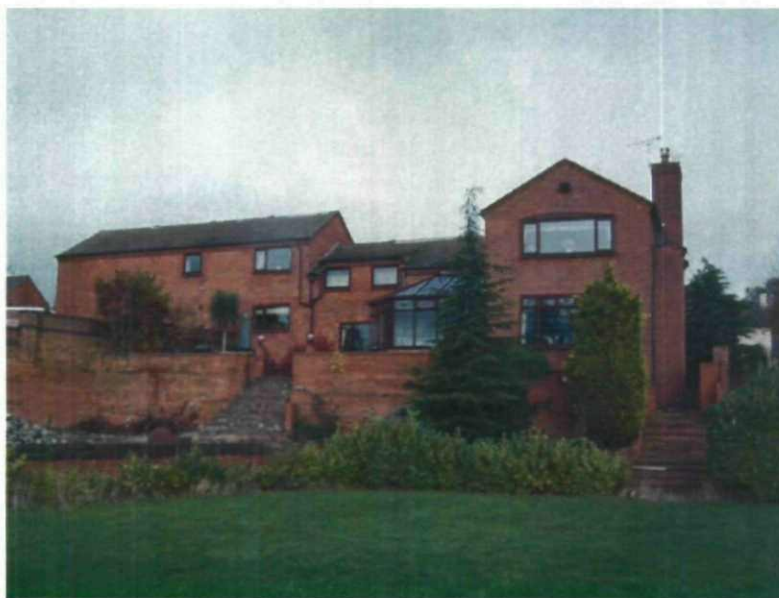
3.4.3. The Old Stables.

3.4.3.1. This is a detached brick house with a pitched tiled roof, located at the western side of the site.

3.4.3.2. The house is fairly new with no opening joints, cracks or crevices in the well pointed brick walls.

3.4.3.3. The eaves are well sealed with stepped brickwork providing no visible opportunity for bats to roost.

3.4.3.4. The roof tiles are all closely fitting and the ridge tiles are all well pointed with no opportunities for roosting bats.

3.4.3.5. There are two lofts in the building with a central separating section with no loft space. The first of these comprises a modern trussed roof design. The loft is well sealed throughout with felt sarking beneath the tiles. The loft insulation is very clean with no materials stored within the loft space.

3.4.3.6. The second loft is over the converted farm buildings and comprises a heavy timber support frame and purlins. The loft is well sealed with felt sarking beneath the tiles that is continuous over the ridge of the building.

3.4.3.7. No bat droppings or other field signs were identified anywhere inside or outside of this property.

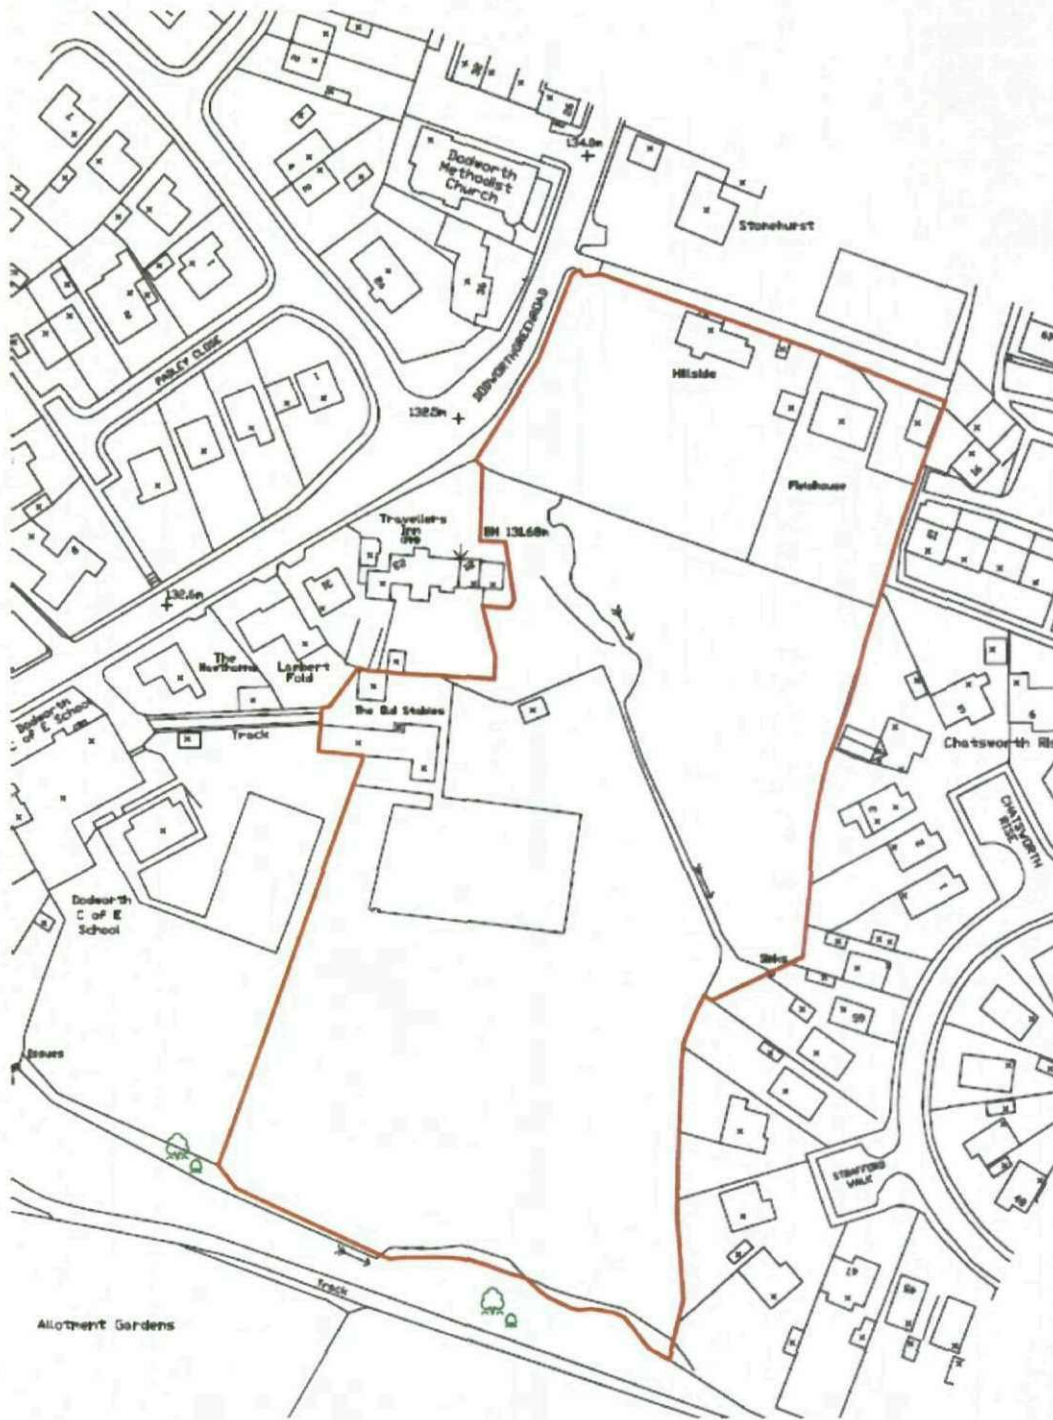
Appendix V. SITE PLAN.

1.1. There are plans to develop a site off Green Road, Dodworth, Barnsley. The site is as shown on the plan in Appendix V of this report. The Local Planning Authority has requested a protected species survey and report in support of that planning application.
