project: Far Westhorpe Farm

client: Mr + Mrs Pearson
drawing: Historic Barns #7+#8
Work to historic fabric

drawing number: **24-39-304**

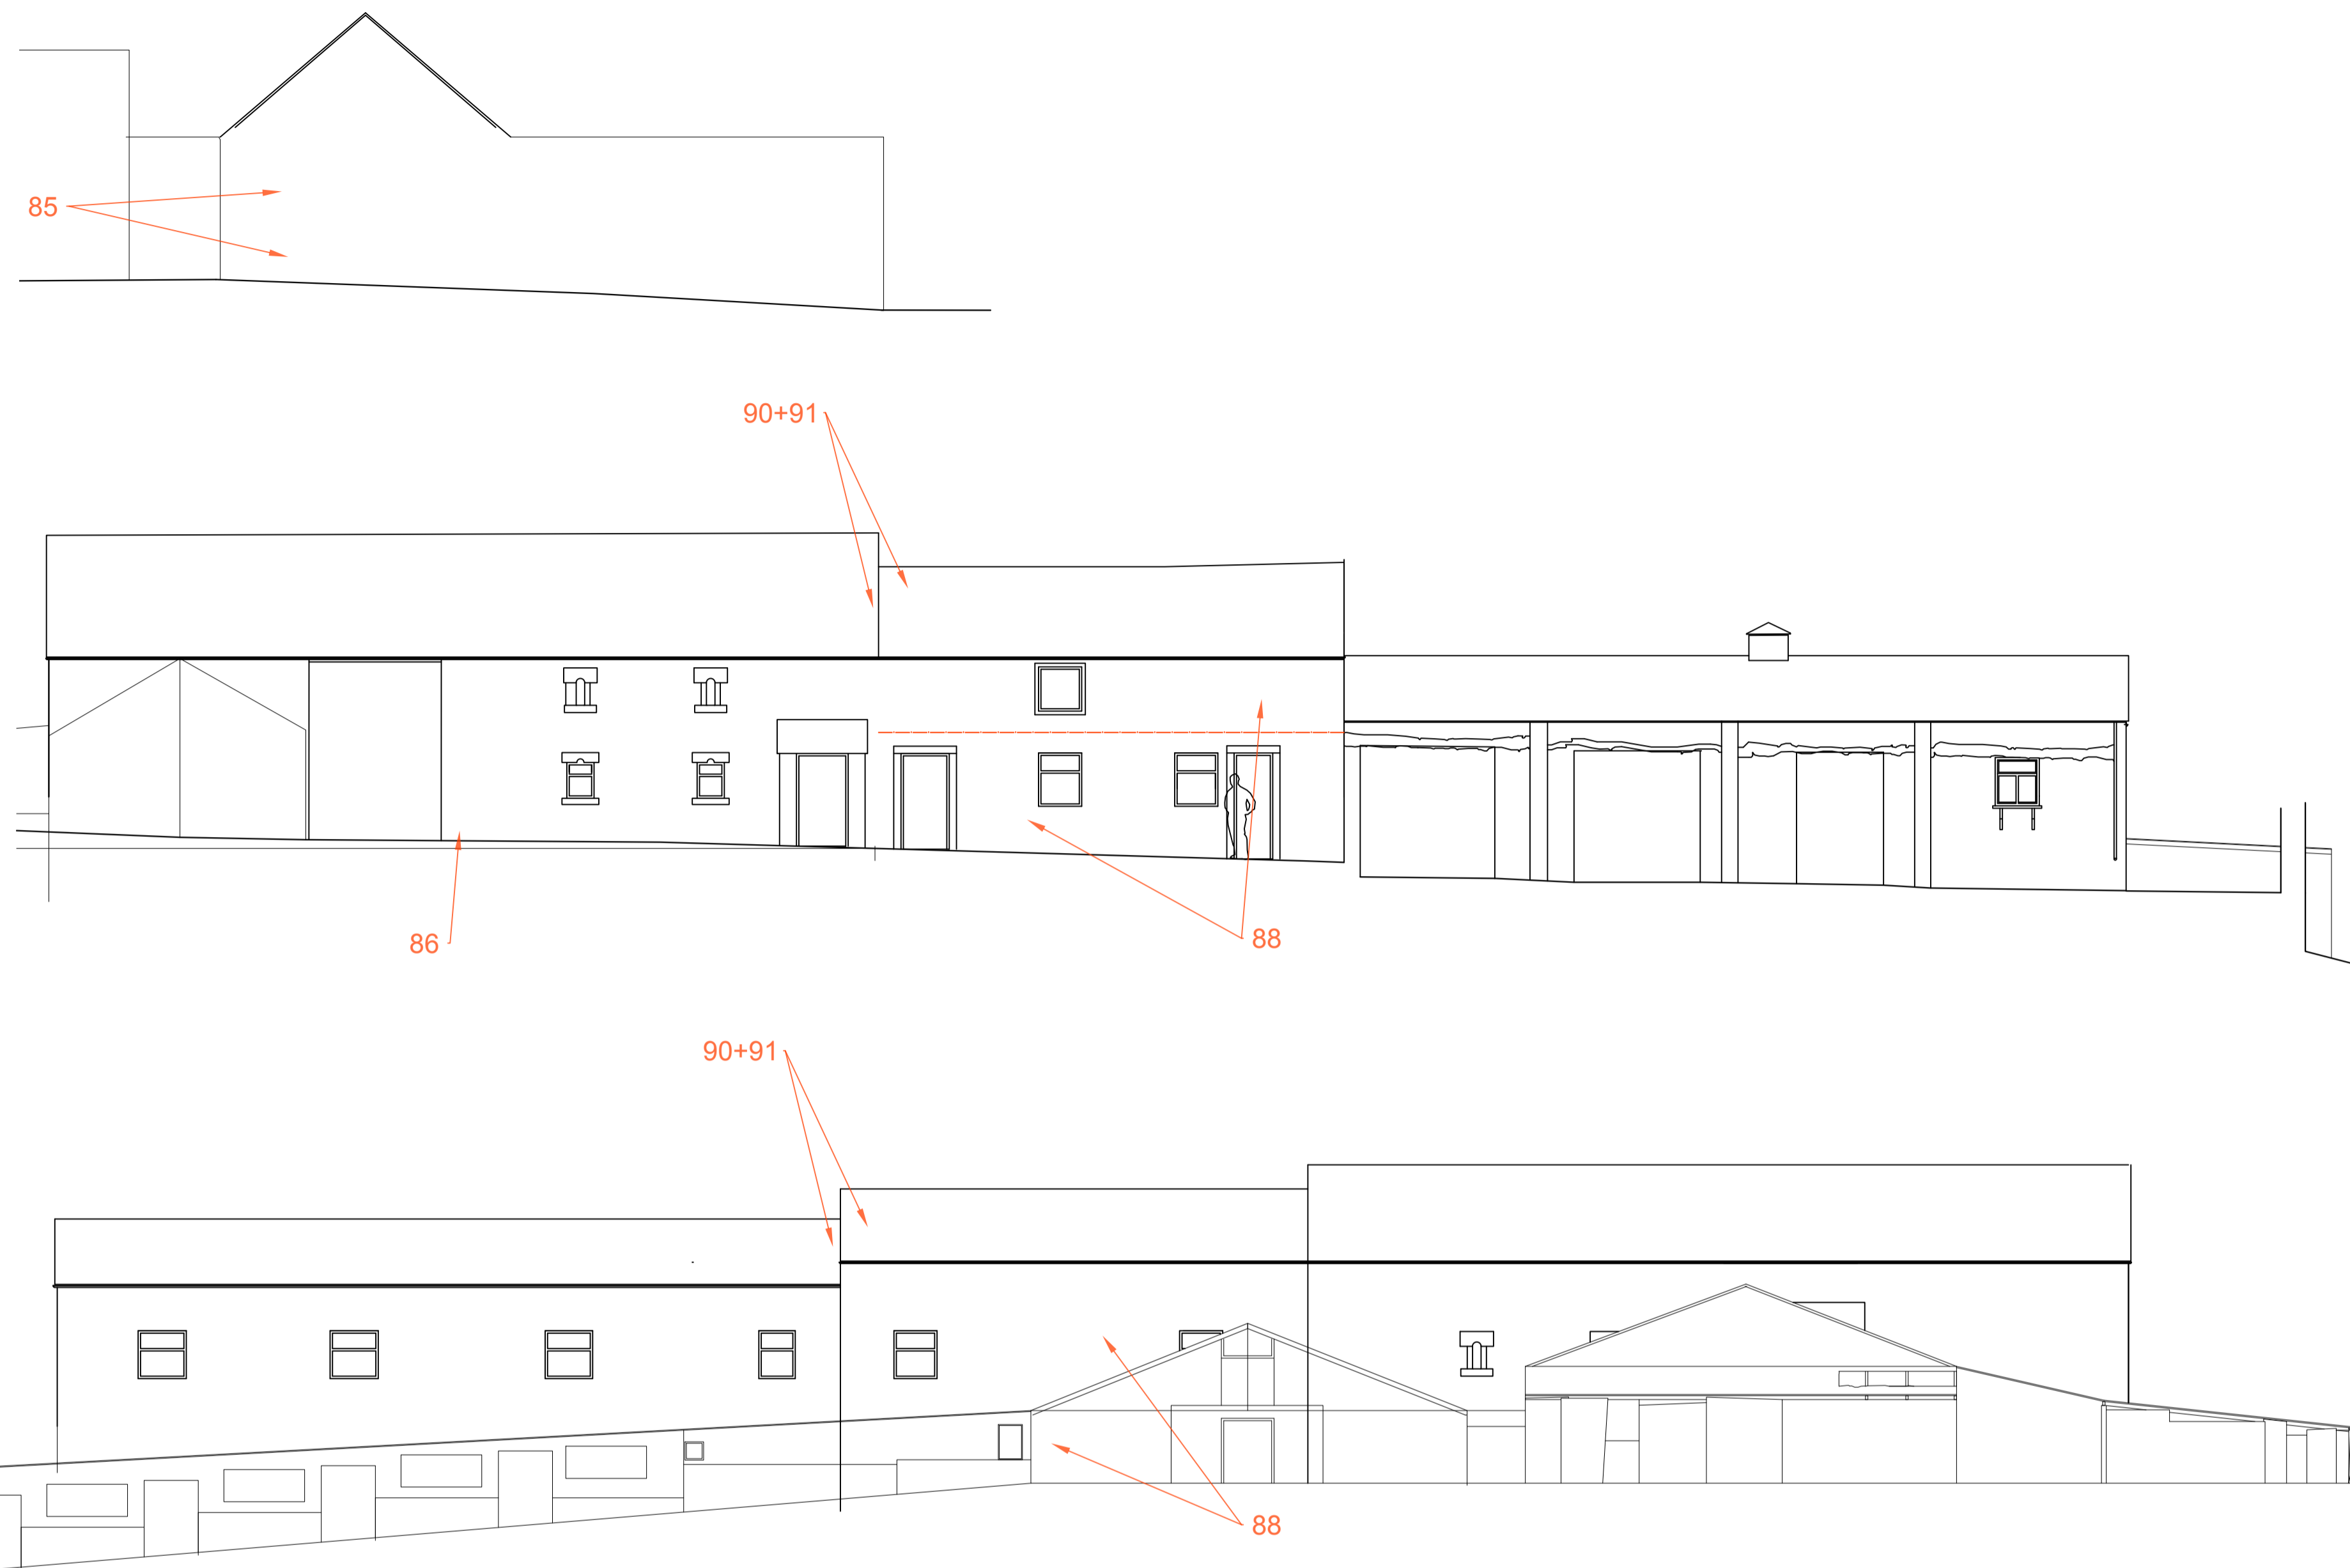
- Refer also to structural engineer's report.
85. Bulging external wall wall in Barn #7 carefully removed and rebuilt using the salvaged stone externally and cavity blockwork internally, with a new footing if required.

86. Local underpinning to the jamb of the main door opening.
 87. Part of internal gable wall in Barn #7 carefully removed and rebuilt using the salvaged stone.

88. External walls of Barn #8 carefully removed and rebuilt using the salvaged stone externally and cavity blockwork internally, with a new footing if required.

89. Local repair to the head of the archway in the intermediate wall in Barn #8.
 90. Specialist inspection of roof timbers to be carried out for beetle and fungal attack and check calculations. Timbers replaced as required for structural safety.

91. For both barns, corrugated cementitious roofing sheet carefully removed for disposal according to the material type. New roof covering provided of natural slate, on softwood battens, on permeable underlay supported by the new carcassing, retaining as much of the timber primary structure as possible.
