**Land North of Keresforth Road, Dodworth,  
Barnsley**

**Section 278 Highway Works**

**Road Safety Audit Combined Stage 1 & 2**

**on behalf of Barnsley MBC**

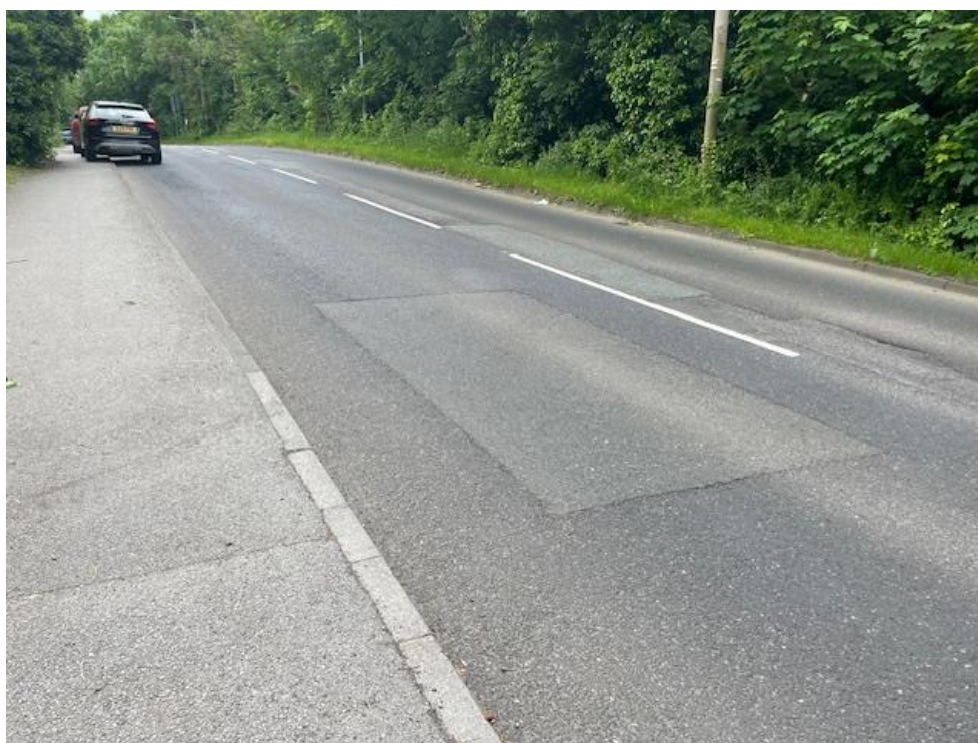
Location: Keresforth Road j/w site access road

Summary: Poor carriageway condition may increase the risk of braking, skid and loss of control type vehicle collisions

The existing carriageway condition on Keresforth Road at the proposed site access junction is poor, with patches from previous works and some surface cracks. This may result in differential skid resistance across the junction. The development will introduce a significant number of braking and turning manoeuvres into the site and as such the poor carriageway condition may increase the risk of braking, skid and loss of control type vehicle collisions.

Keresforth Road should be resurfaced for the extent of the new junction.

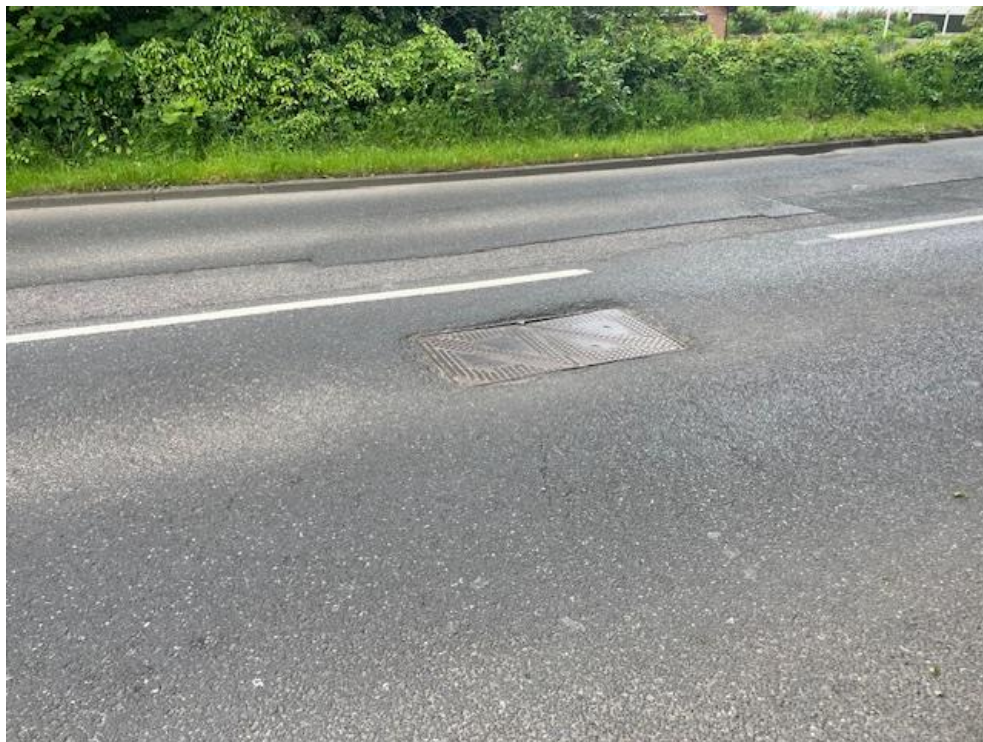
Location: Keresforth Road j/w site access road

Summary: Sunken utility may be a loss of control hazard to turning vehicles

There is a sunken utility cover within the southbound running lane on Keresforth Road at the site access junction. The manhole cover may be a potential loss of control hazard to vehicles making turning manoeuvres to and from the site access. This may be a particular issue for two wheeled vehicles.

In addition, the polished nature of the utility cover may present a potential skid hazard to vehicles, exacerbated during wet or icy conditions.

The utility cover should be reset flush with the carriageway and treated with a suitable non-slip surface with similar skid resistance to the surrounding carriageway.

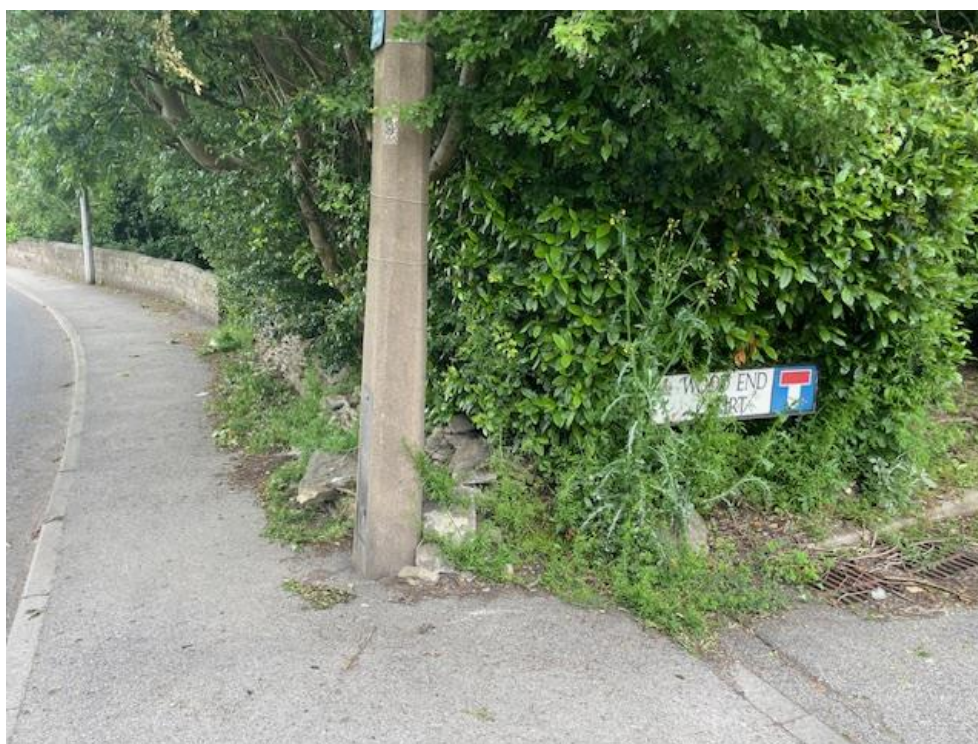
Location: Keresforth Road j/w site access road

Summary: Poor illumination of the junction may increase the risk of darkness related vehicle collisions

There is an existing lighting column that will be within the extents of the widened access junction and will therefore require removal. No details have been provided to show if and where the lighting column will be relocated. A lack of illumination at the junction may increase the risk of darkness related vehicle collisions.

The junction of Keresforth Road and the site access road should be appropriately illuminated.

A suitable system of street lighting should also be provided along the site access road.
