Land off Work Bank Lane, Thurlstone

Bat Survey Report

17th June 2022

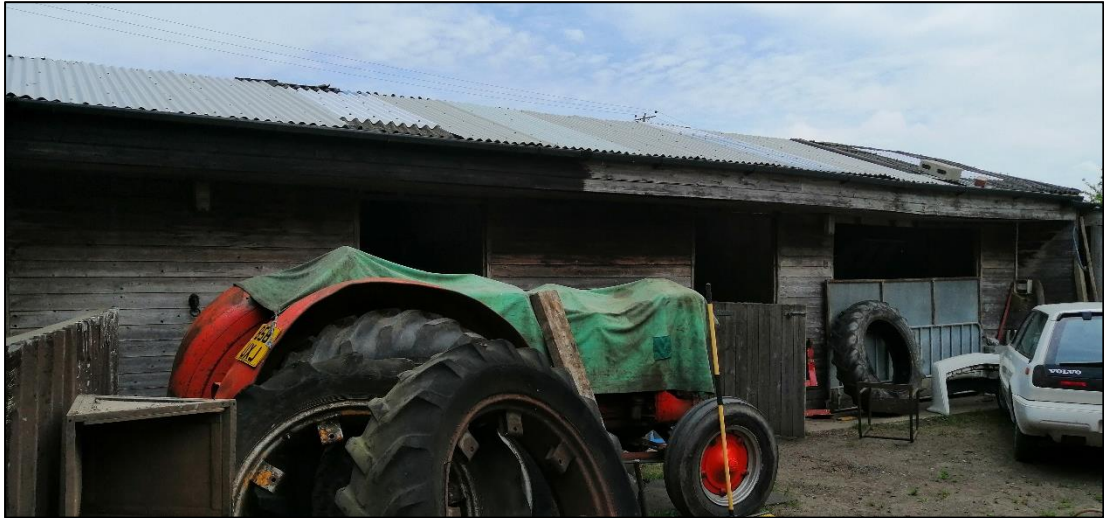
5.2.2 The site consists of a 'L' shaped stable with six compartments including one which is open fronted. The building is timber framed and wood clad beneath a pitched roof covered largely in corrugated metal sheets. At one end is an open fronted lean-to with a mono pitched corrugated sheet metal roof, which is supported at the front with telegraph poles. The rear and sides of the lean-to have single skin concrete block walls to 1.2m (Plates 1-3).

Plate 1. Front (south-southwest elevation)

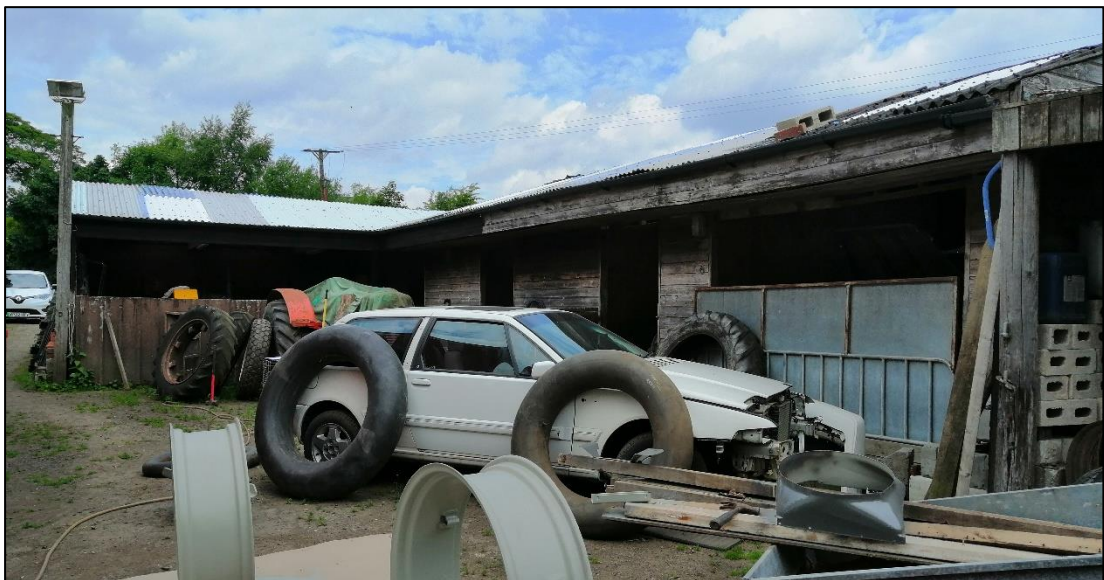
Plate 2. Looking west with open fronted section on left

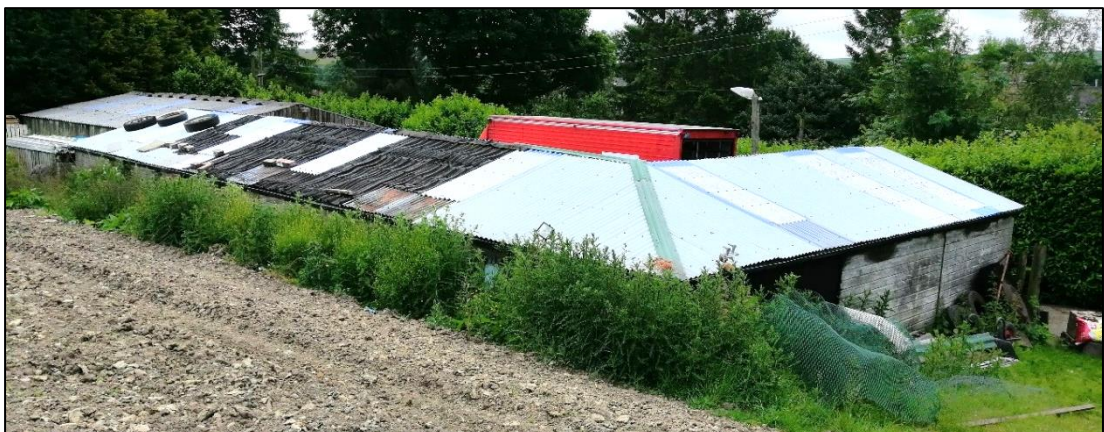
Plate 3. Rear elevations

- 5.2.3 The external cladding is intact and the buildings, including the attached lean-to, lack features with potential to support roosting bats.

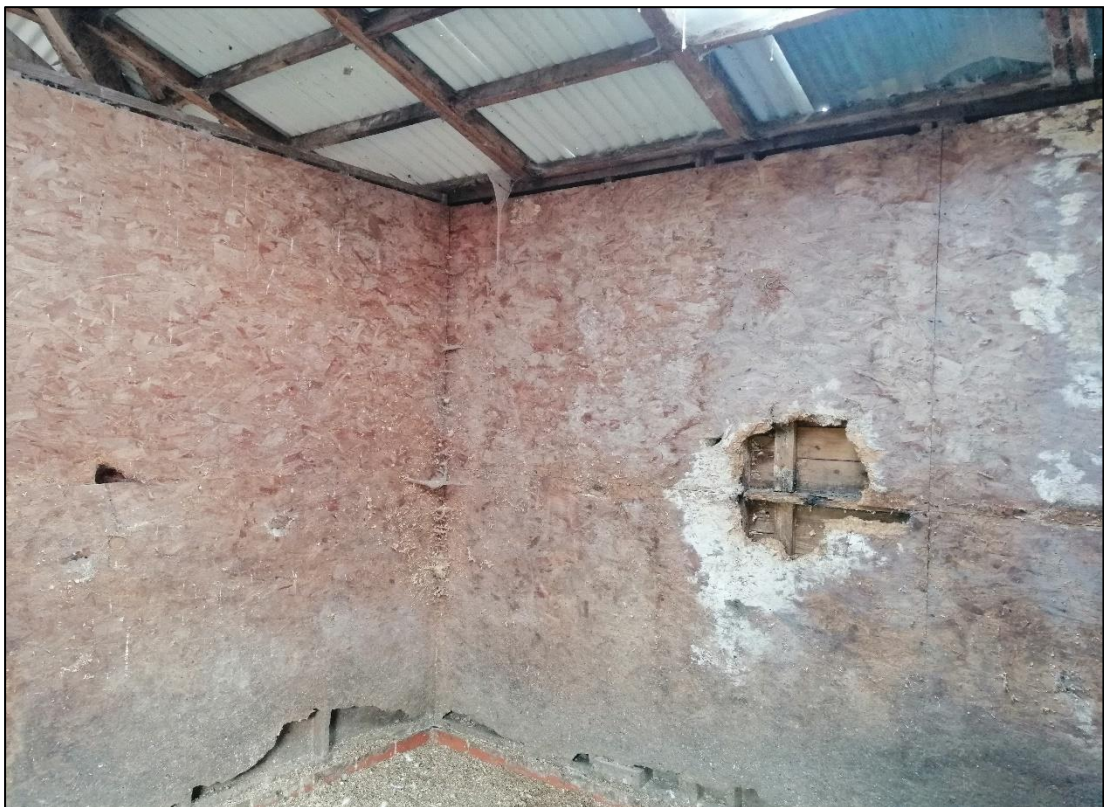
- 5.2.4 The inside is open to the underside of the roof covering which is supported by timber roof trusses, joists and battens. There is strand boarding attached to the inside of stables which have resulted in a void between the external cladding and the boards. There are several damaged boards which potentially allow bats access to the void (see Plate 4). However, these were thoroughly inspected, and found to be very 'cobwebby' and probably too wide for use by crevice dwelling bats. All the roof timbers were found to be heavily cobwebbed, and no signs of bats were found. One active swallow *Hirundo rustica* nest was noted.

Plate 4. Inside of a stable compartment showing damaged strand board
