**Schedule of Repair Works
6 and 7 Hall Close
Worsbrough Hall
Worsbrough Barnsley**

Ref 12.42
Date Oct 2012
Version 02

The following Schedule of Works and drawings ref S1 Survey and P10 Proposals has been prepared to describe and illustrate essential repairs and alterations to the fabric of part of the existing Grade II Listed Building at Worsbrough Hall.

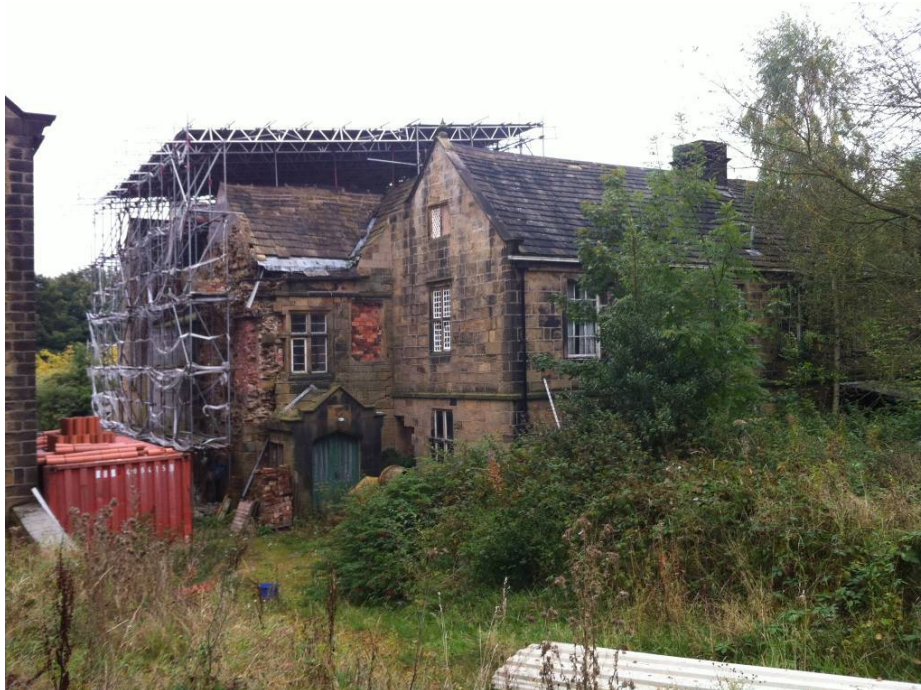
View of north elevation of Worsbrough Hall (October 2012) with protective scaffolding.

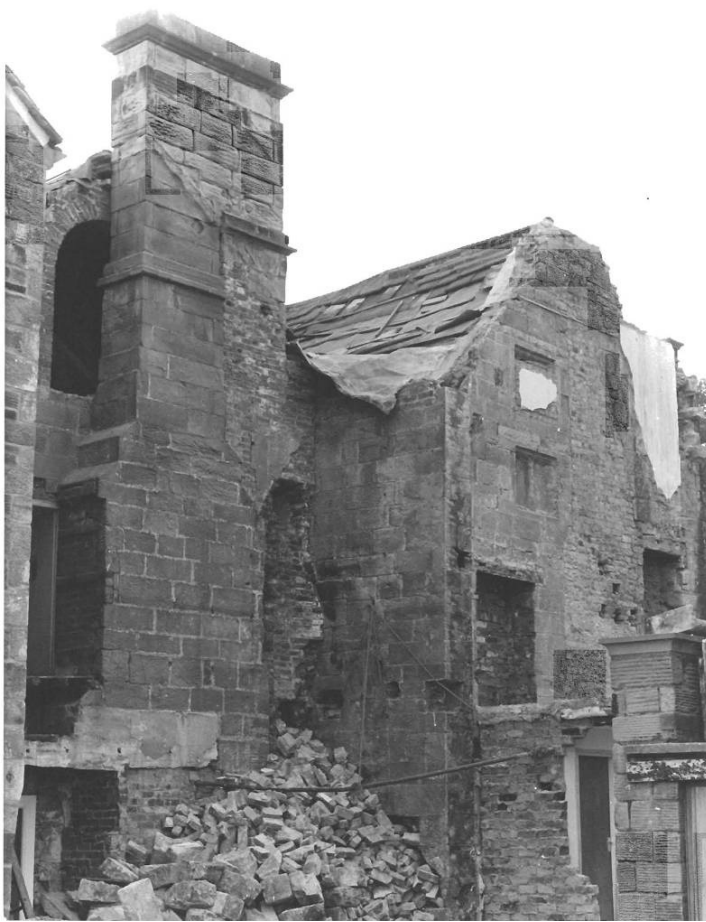
Photo of north elevation immediately following demolition indicating extent of repair works necessary.

- 1.0 Walling
- 1.2 Rebuild north elevation of No 6 in reclaimed stone with outer leaf of 200-300mm deep coursed dressed stonework with tight joints bed in lime mortar.
- 1.3 Form openings for doors and windows as shown and build in reclaimed stone surrounds to ground floor door opening D1 and first floor window openings W12 and W13. Note: stone surrounds available from site.
- 1.4 Reconstruct chimney stack to north elevation to match original design in reclaimed stonework with dressed stonework to outer as before described.
- 1.5 Form internal fireplace openings within chimney stack and build in reclaimed arched head moulded stone surround and stone hearth at ground floor level and reclaimed stone surround with purpose made stone lintel to match original at first floor level. Form flues within chimney breast.

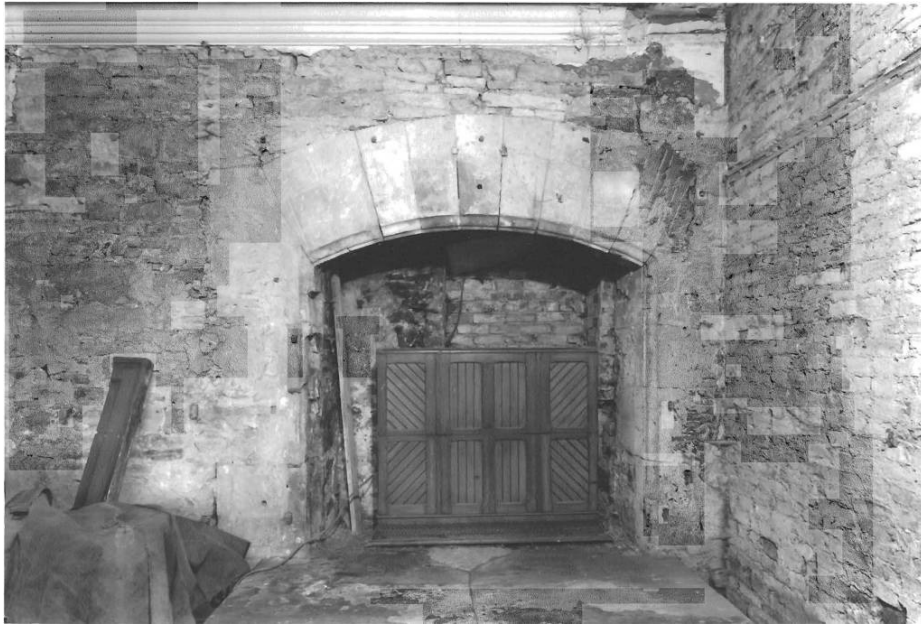
View of original ground floor fireplace to be reinstated.

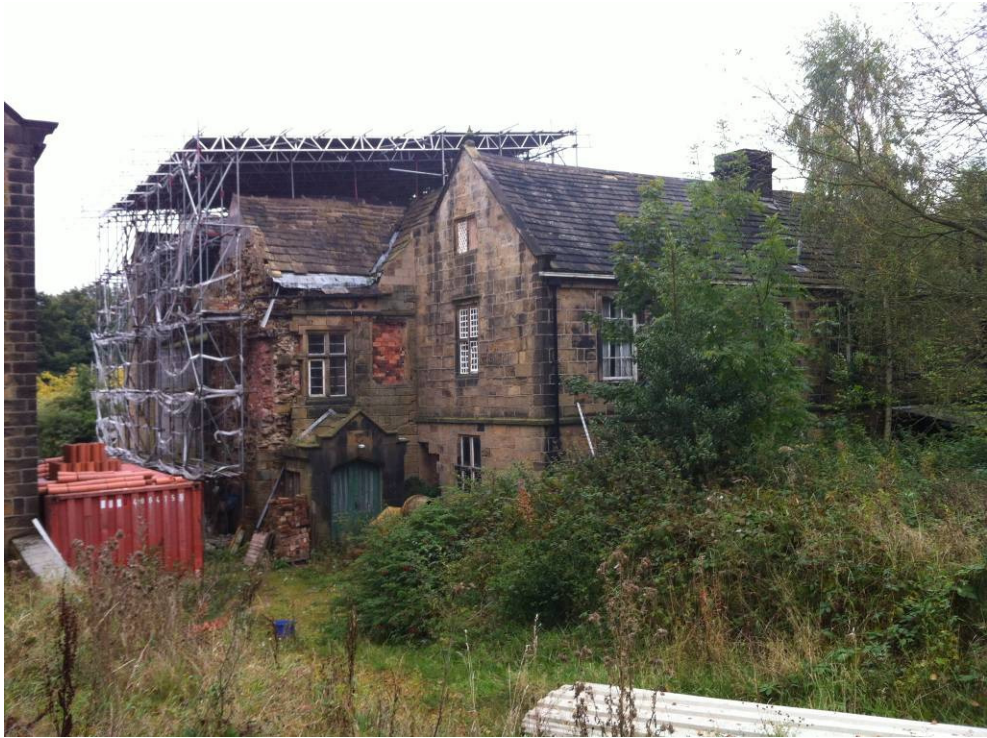
1. North elevation with West Wing on right hand side.

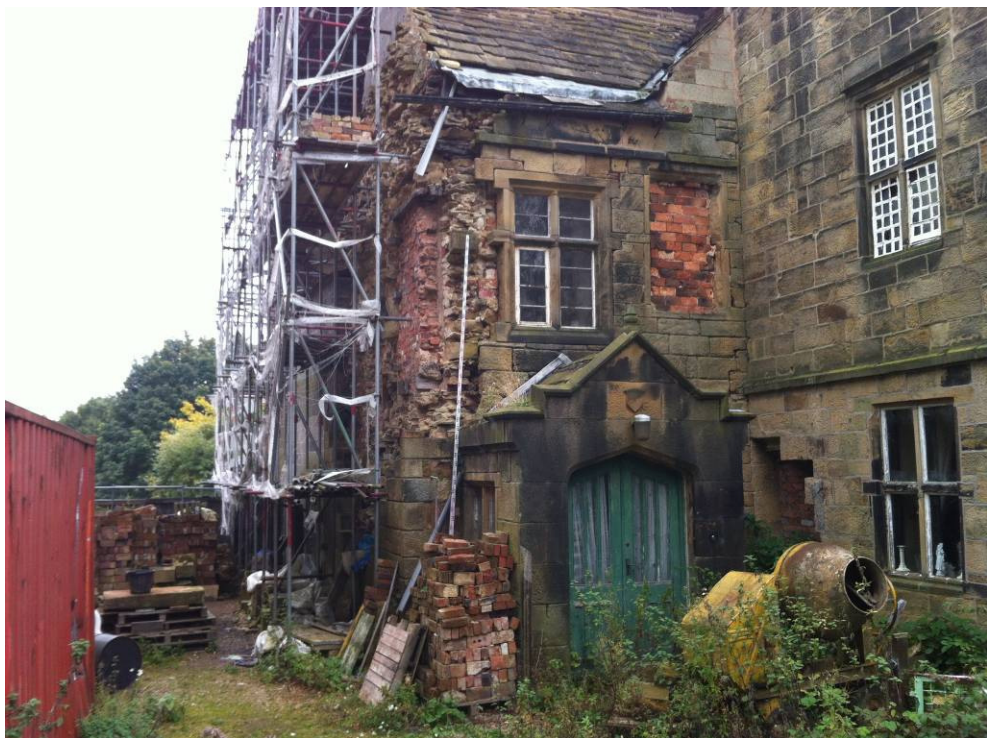
2. North east corner of rear offshot.

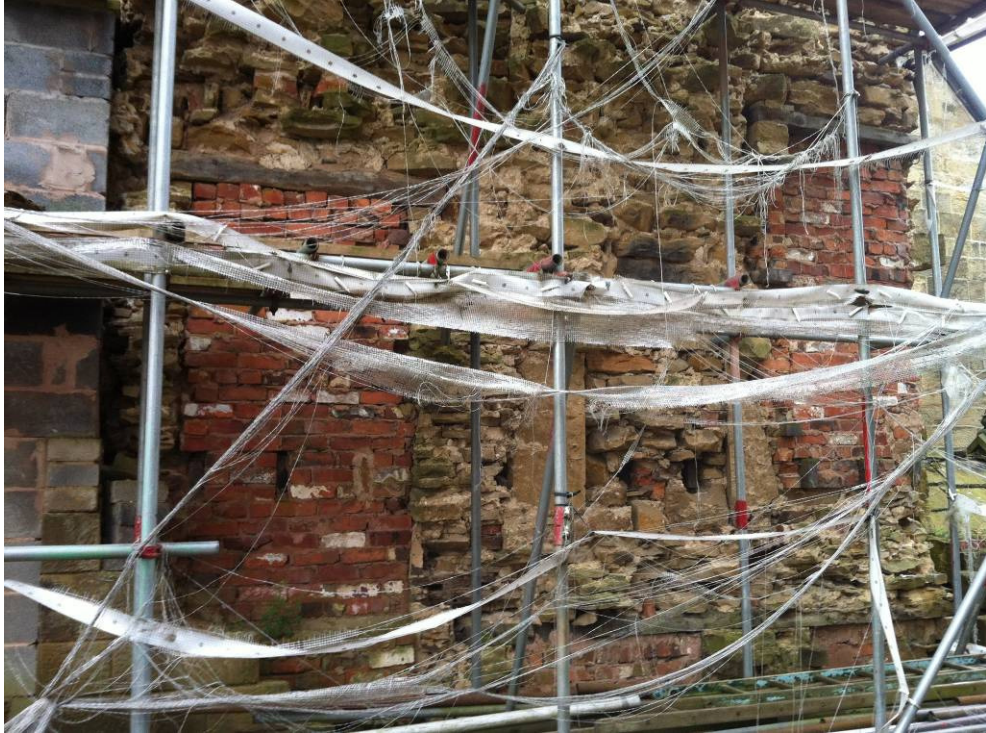
3. North elevation of rear offshot (through scaffolding).

- 1.6 Reconstruct outer skin of external wall to rear offshot on north elevation between porch window W4 and corner window W5 full height as shown on drawing No P10. Walling to be 200-300mm deep coursed dressed stonework to match existing with tight joints bed in lime mortar. Extend existing stone string course at eaves to match remaining string course above head of W9 on west elevation and reclaimed stone kneelers and verge copings and finial to gable.

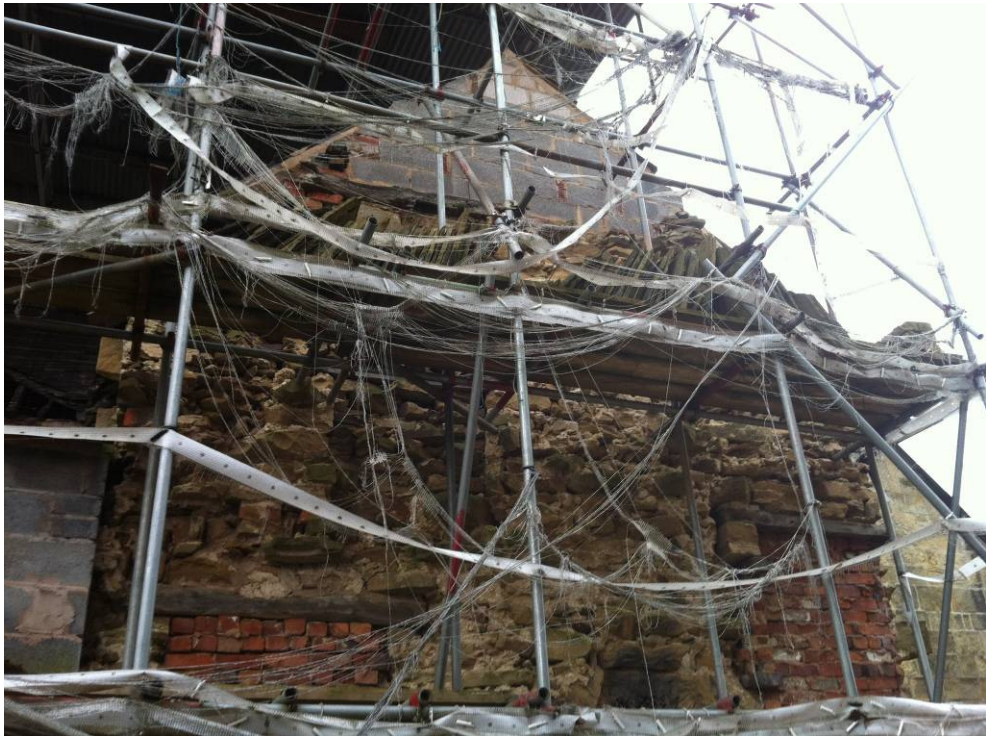
4. Upper gable wall of rear offshot.

- 1.7 Form openings for window Nos W10, W11 and W14 in north gable of rear offshot and build in reclaimed stone surrounds available on site as shown on drawing No P10.

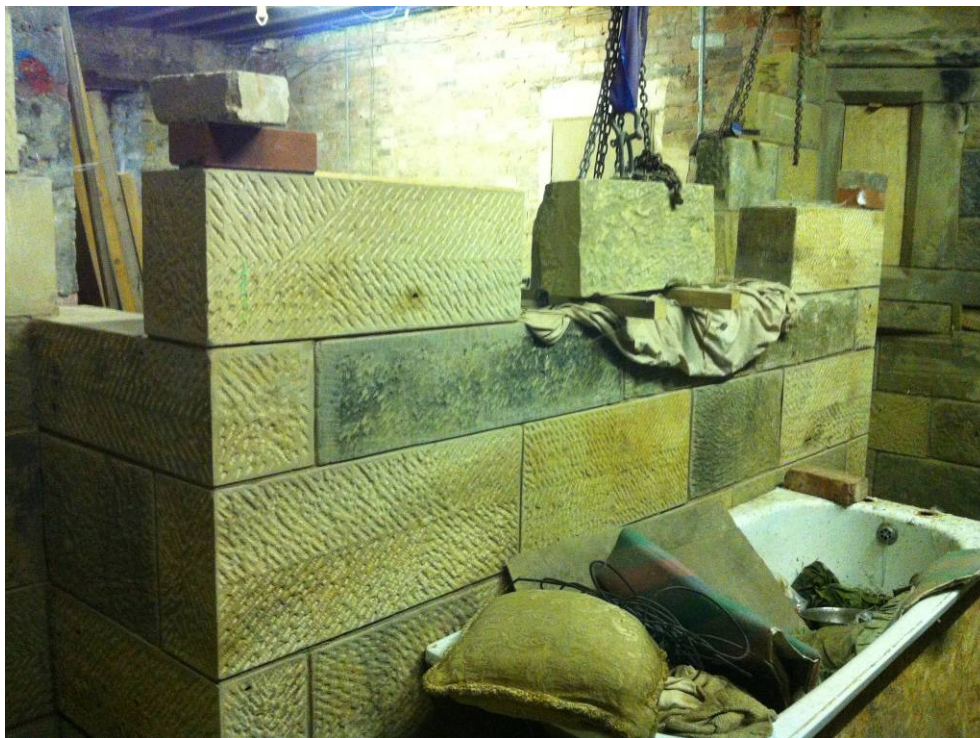
6. External view of chimney stack under construction.

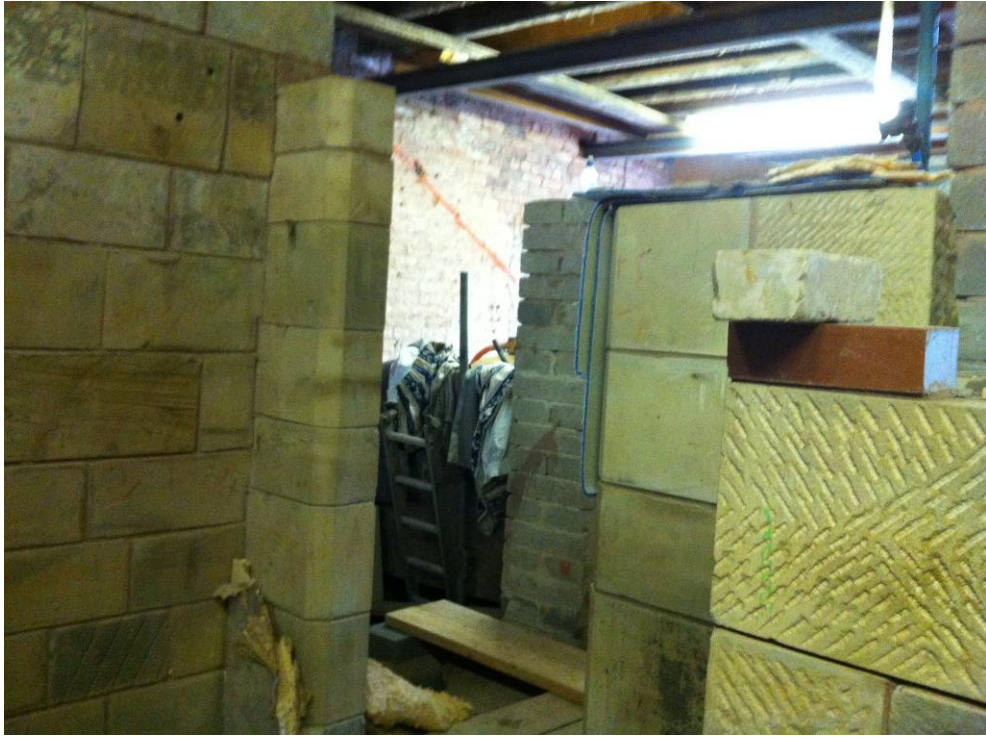
7. External view of new door opening D1 with corner of chimney stack in foreground.

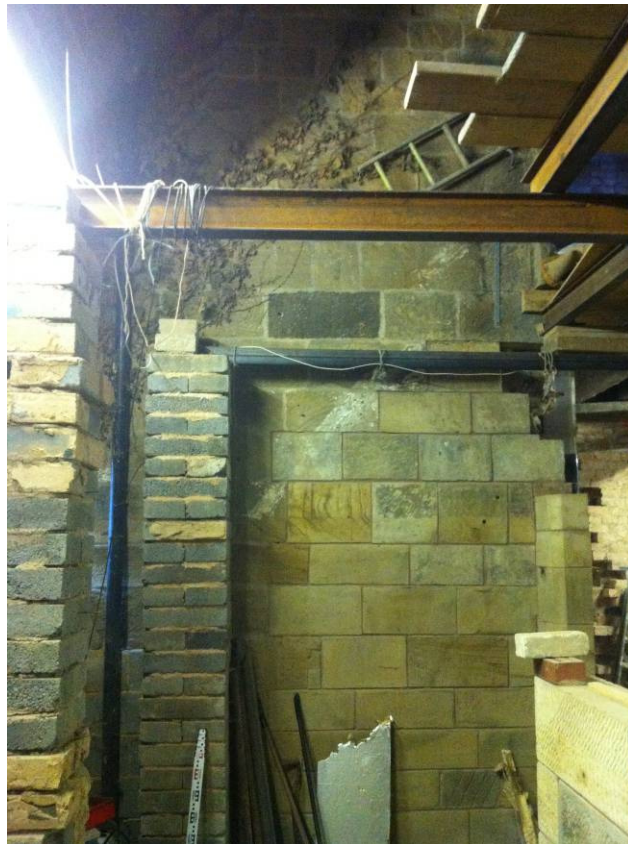
8. West elevation of external wall adjacent D1.

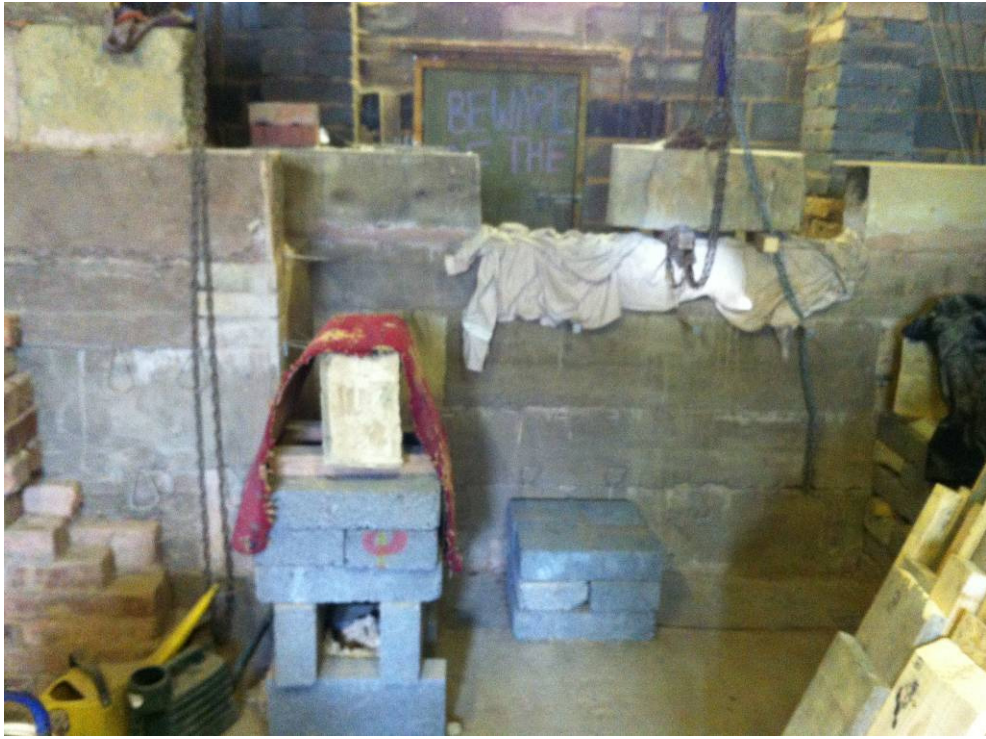
9. Internal view of ground floor fireplace

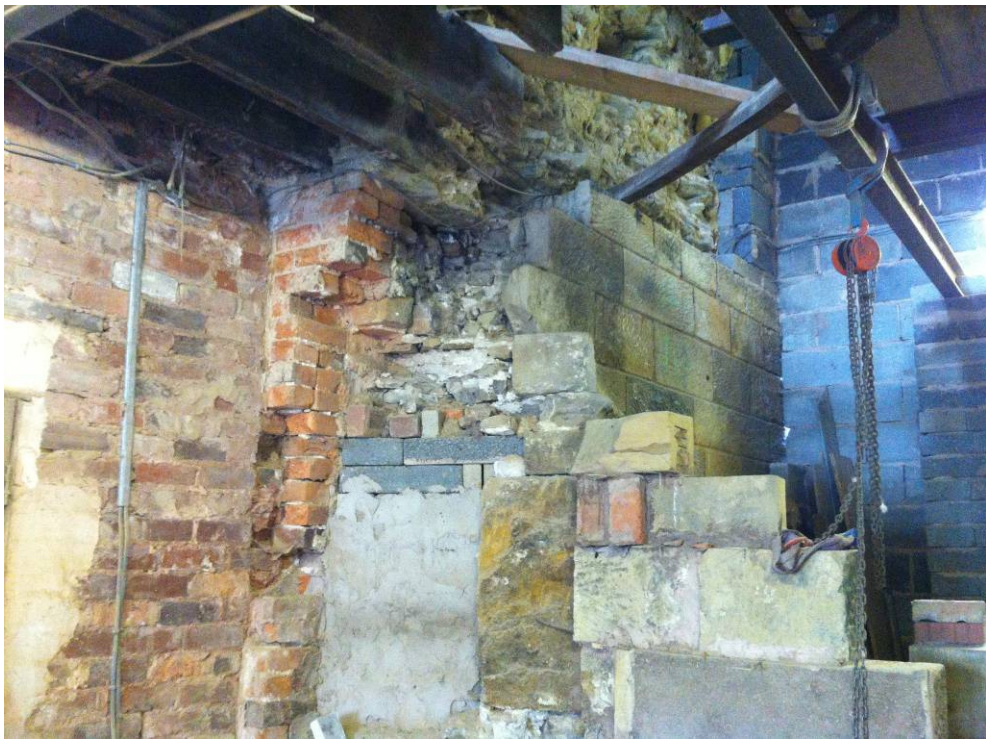
10. Internal view of north wall and junction with rear offshot- ground floor level.

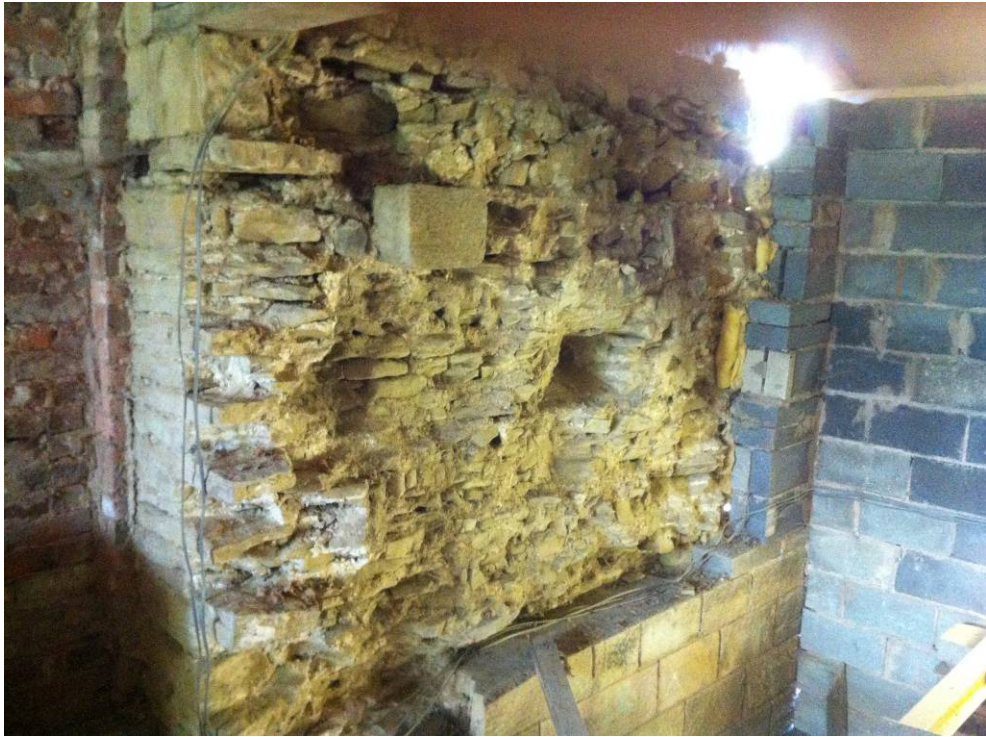
11. Internal view of north wall and junction with rear offshot- first floor level.

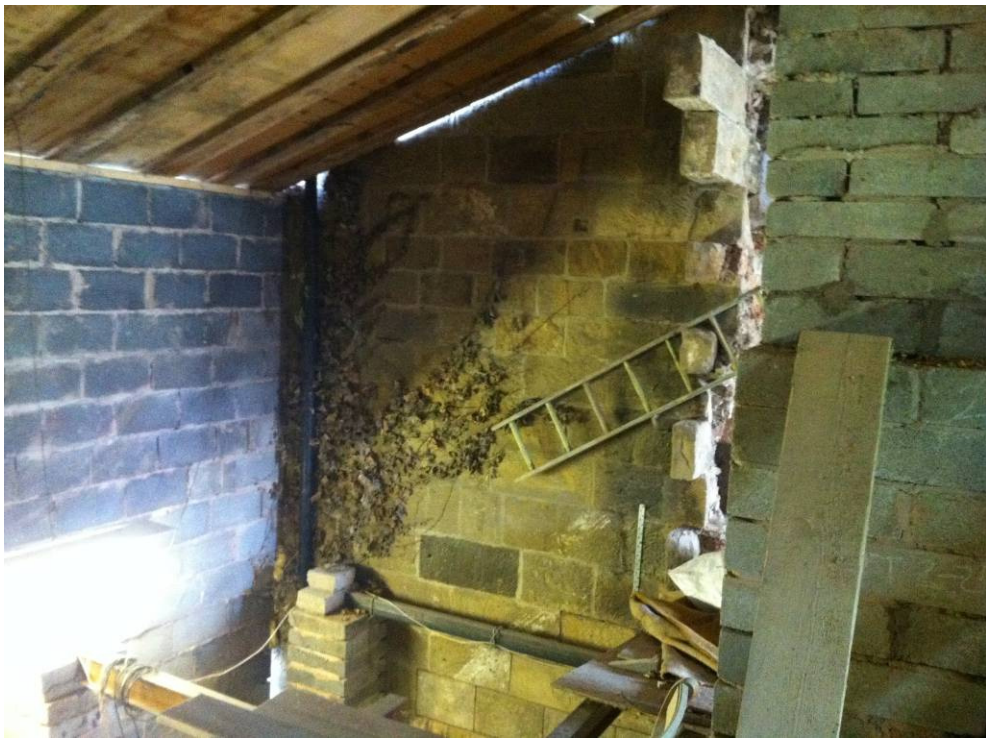
12. West elevation of external wall adjacent D1 – first floor level
