ROYSTON WORKING MEN'S CLUB.

BAT SURVEY.

Ref No: 240457/1.

Date: 28th November 2024.

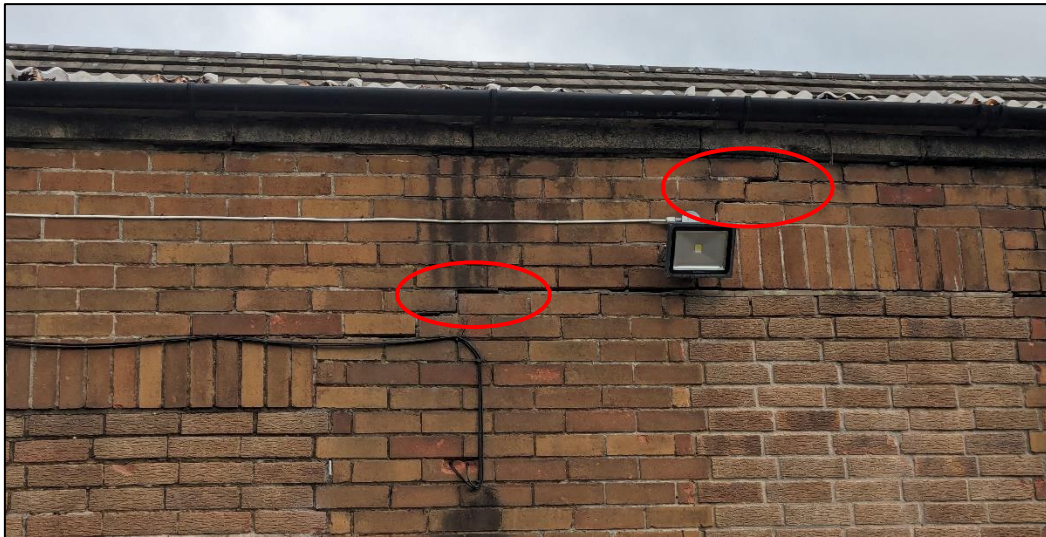
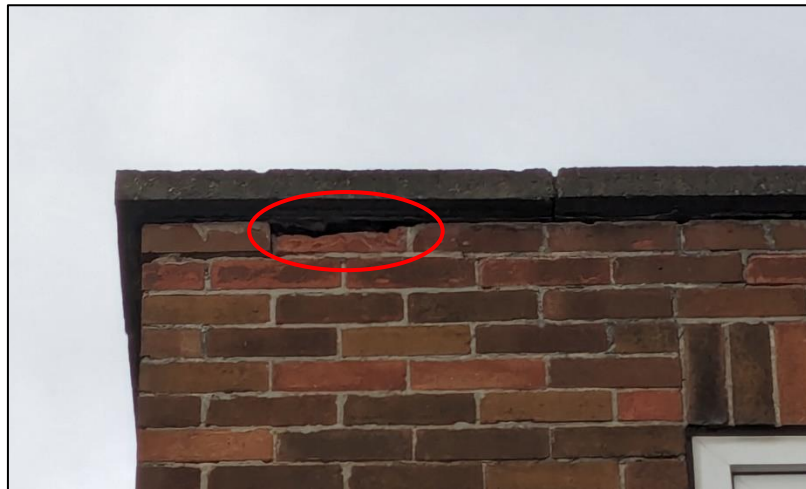
3.3.2. Externally, the building is in a moderate condition, but small defects can be seen throughout. The walls themselves are in fair condition, but areas of missing mortar and fractures were identified, as shown in the photographs below.

3.3.13. The building provides some small features which could be used by nesting birds, including the flat roofs and defects in the brickwork identified in this report.

4.4. The flat roofs of the building and defects within the walls provide potential nesting opportunities for birds. The nesting bird season extends from March to August each year. Therefore, demolition of the house within this timeframe could have a negative impact on nesting birds if they are present.

5.3. It is recommended that where possible the demolition and any external works are carried out outside of the nesting bird season. Where this is not possible, it is recommended that they are immediately preceded by a nesting bird survey to identify if there are any nesting birds present. If any active nests are found, a buffer zone around them should be left and no works should be carried out that will disturb the nest or prevent the birds from accessing to and from the nest, until the young have fledged.

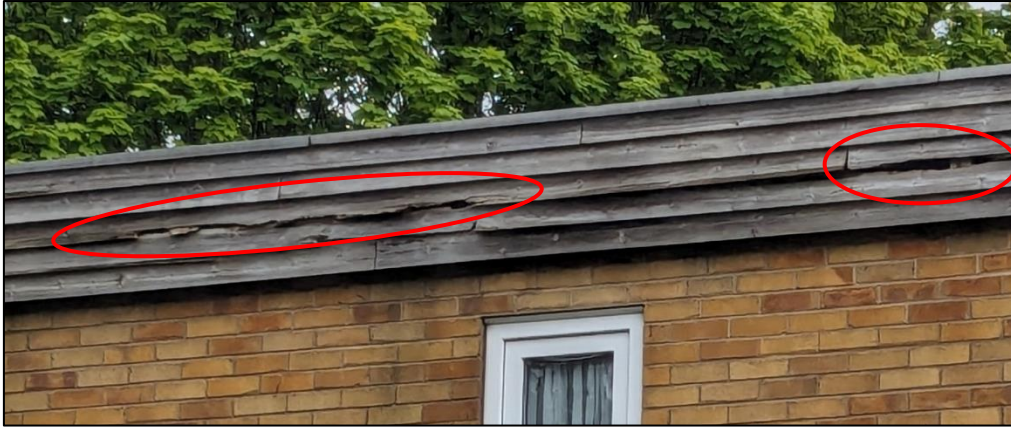
3.3.3. Wooden panels were present on the external walls of a two-storey extension to the north of the building, shown in the photograph below. Several of the panels were damaged or deteriorated, providing access to the space between the external wall and panelling. This could not be inspected closely due to the height of the feature.

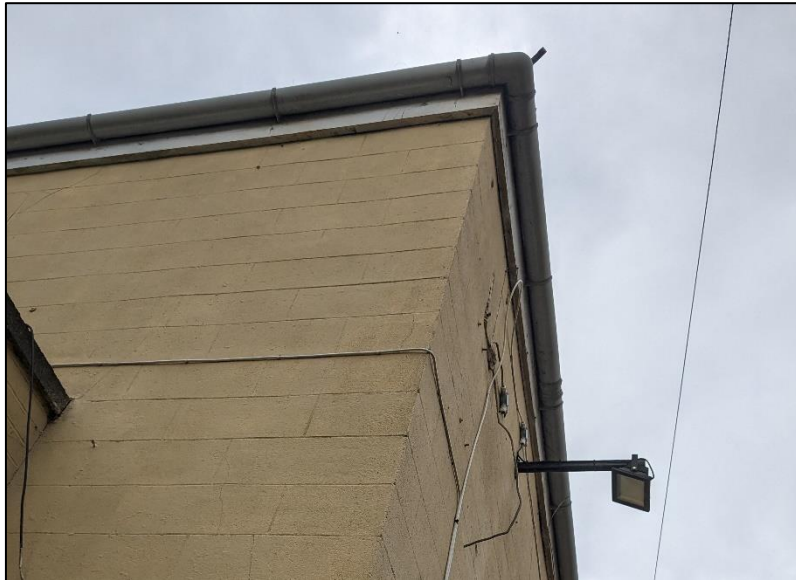
3.3.4. The fascias and guttering around the remaining parts of the building were in good condition with no visible gaps which could provide potential roost features for bats, shown in the photograph below.

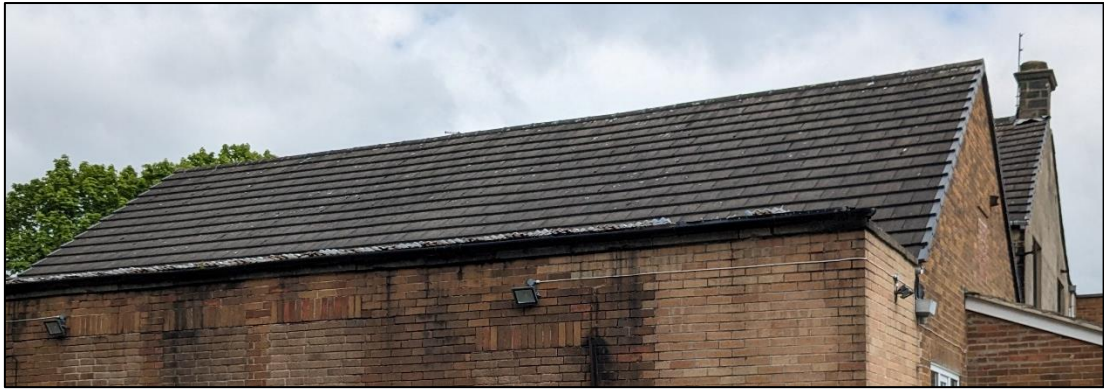
3.3.5. The parts of the buildings with pitched roofs are in a moderate condition with all visible tiles sitting flush. Some of these are chipped or showing general signs of aging, but none are in such a condition as to allow bats to roost beneath. Examples of these are shown below.

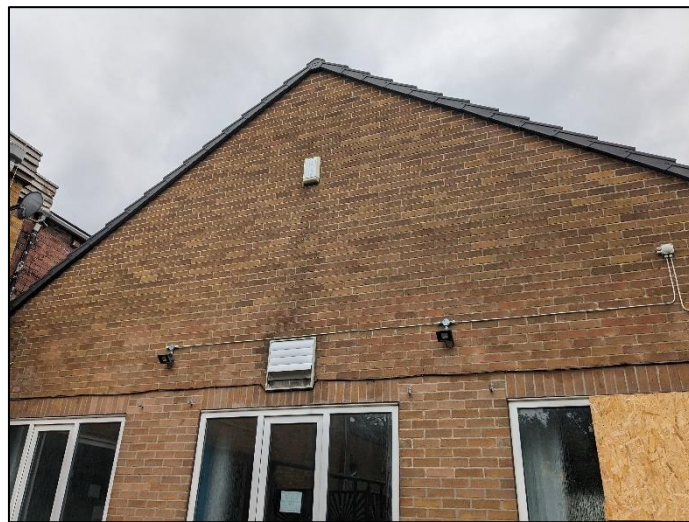
3.3.6. The gable ends were in good condition with no visible access points for bats.

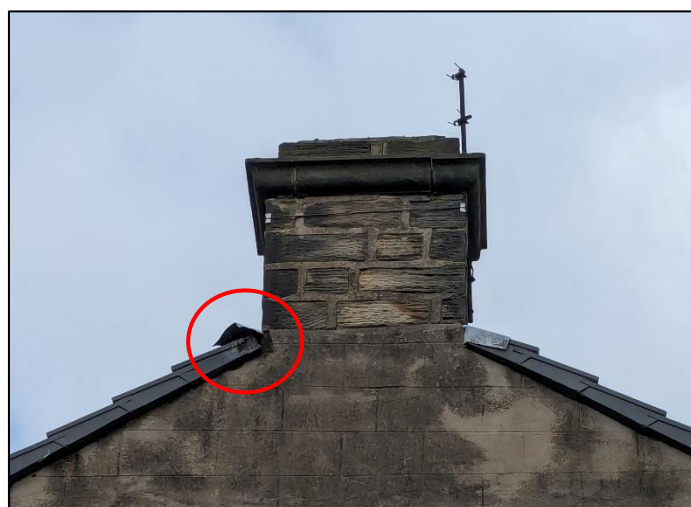
3.3.7. Any flashing seen from ground level was generally in good condition. However, one area of lifted flashing was identified at the base of a chimney stack on the southeastern aspect of the building, as shown the photograph below.

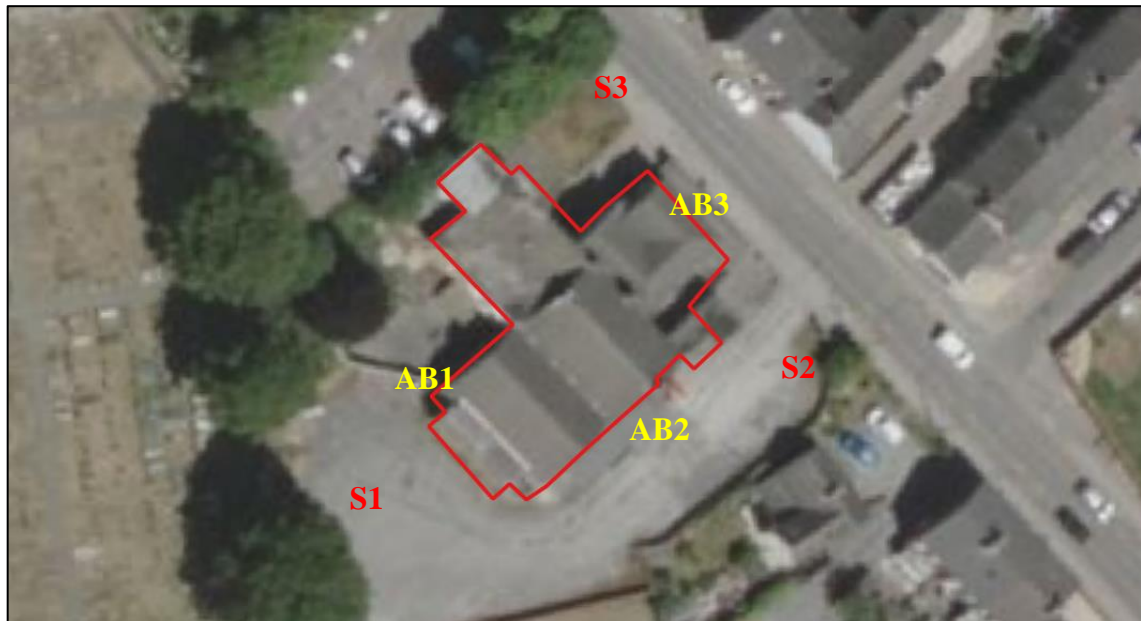
3.4.5. The aerial photograph below shows where the Surveyors (S) and Anabats (AB) were located throughout the survey.

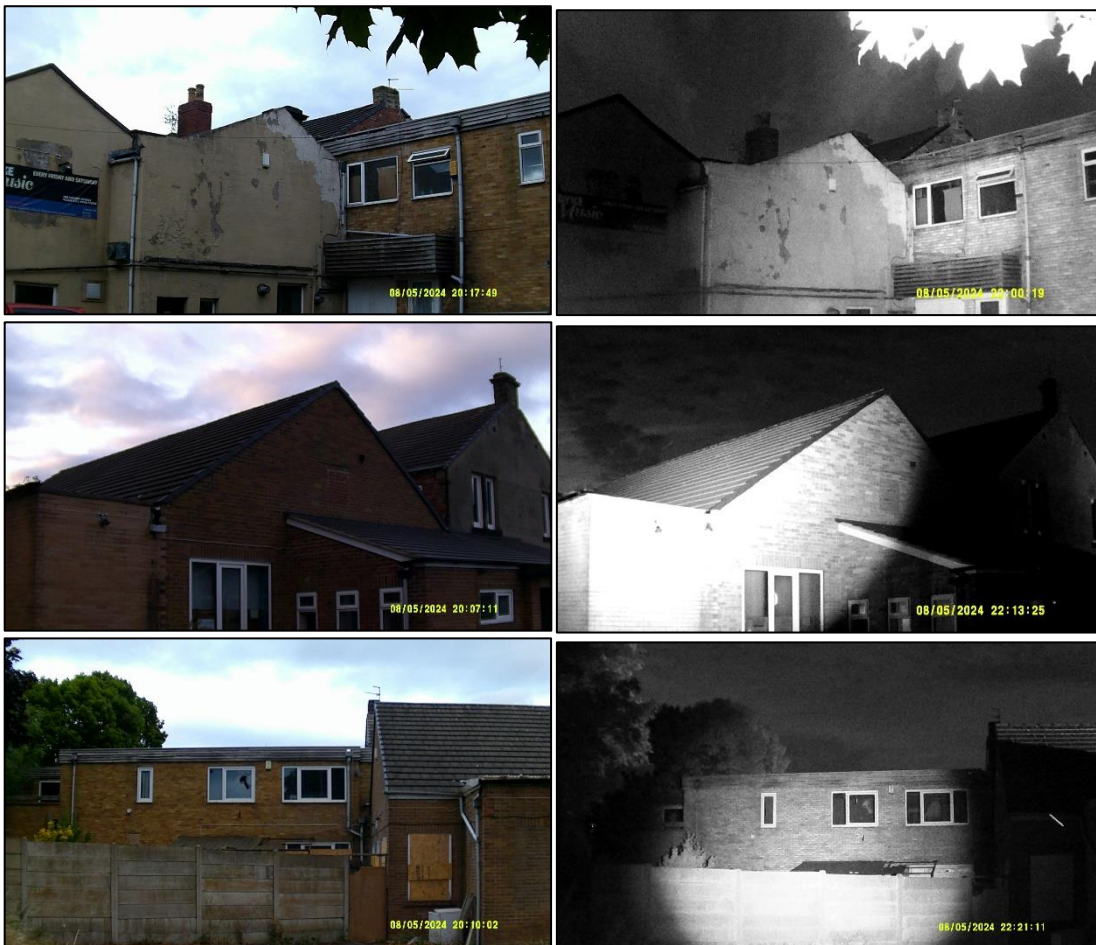
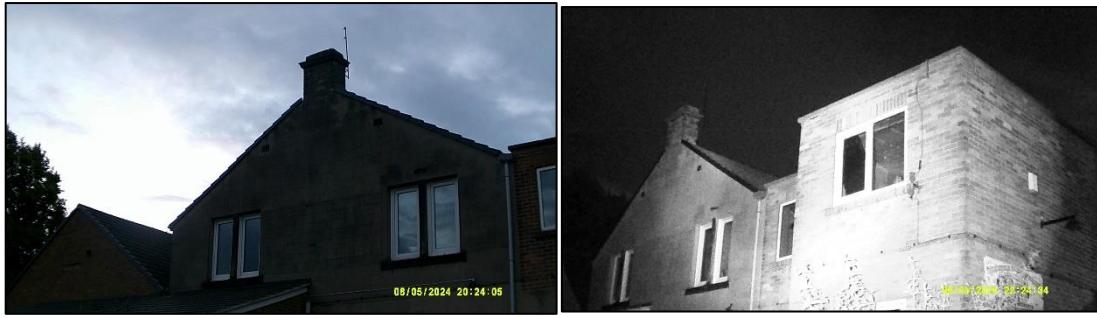
3.4.7. The below shows start and end still photographs which show the views of the cameras both at the beginning of the survey as well as at the end of the survey.

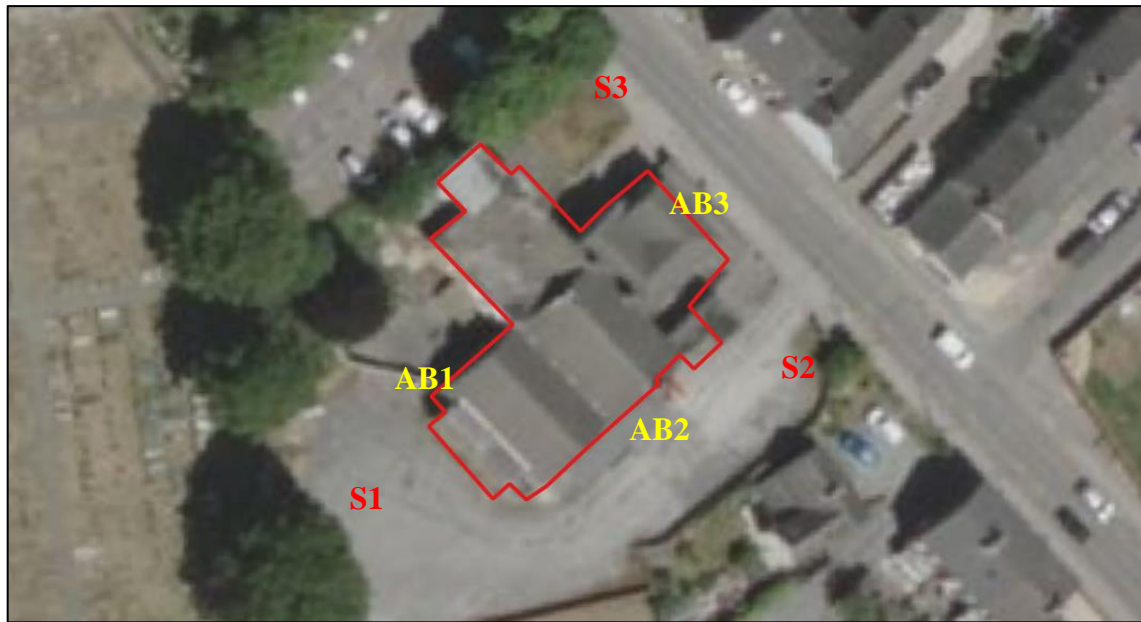
3.4.5. The aerial photograph below shows where the Surveyors (S) and Anabats (AB) were located throughout the survey.

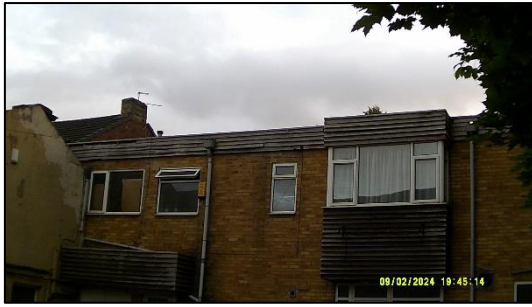
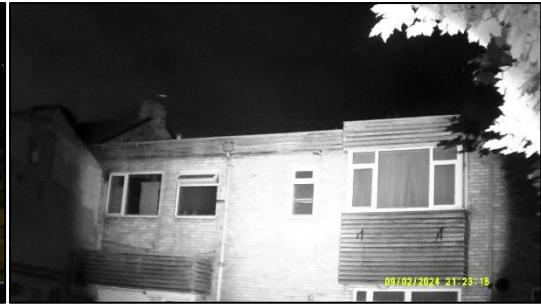
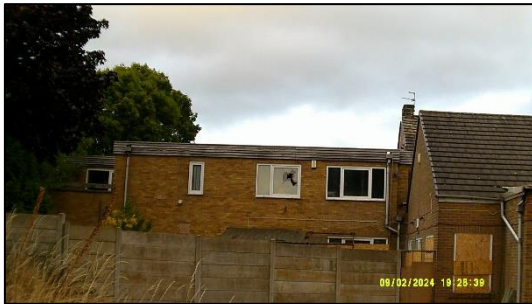
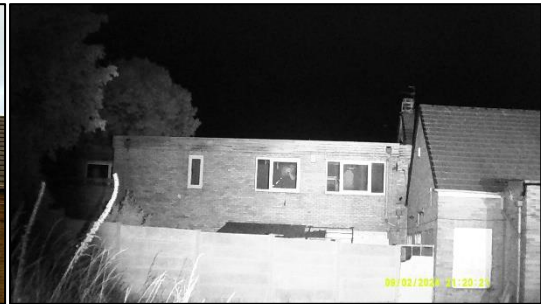
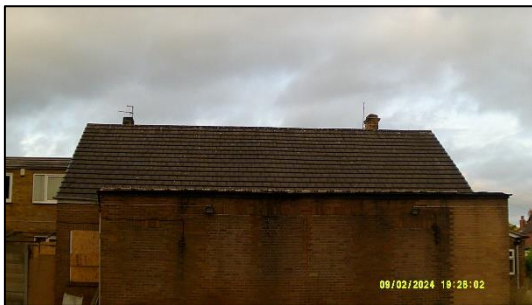
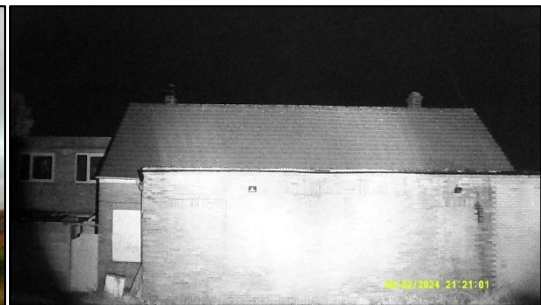
3.4.7. The below shows start and end still photographs which show the views of the cameras both at the beginning of the surveys as well as at the end of the surveys.
