Land off Work Bank Lane, Thurlstone

Bat Survey Report

5th April 2023

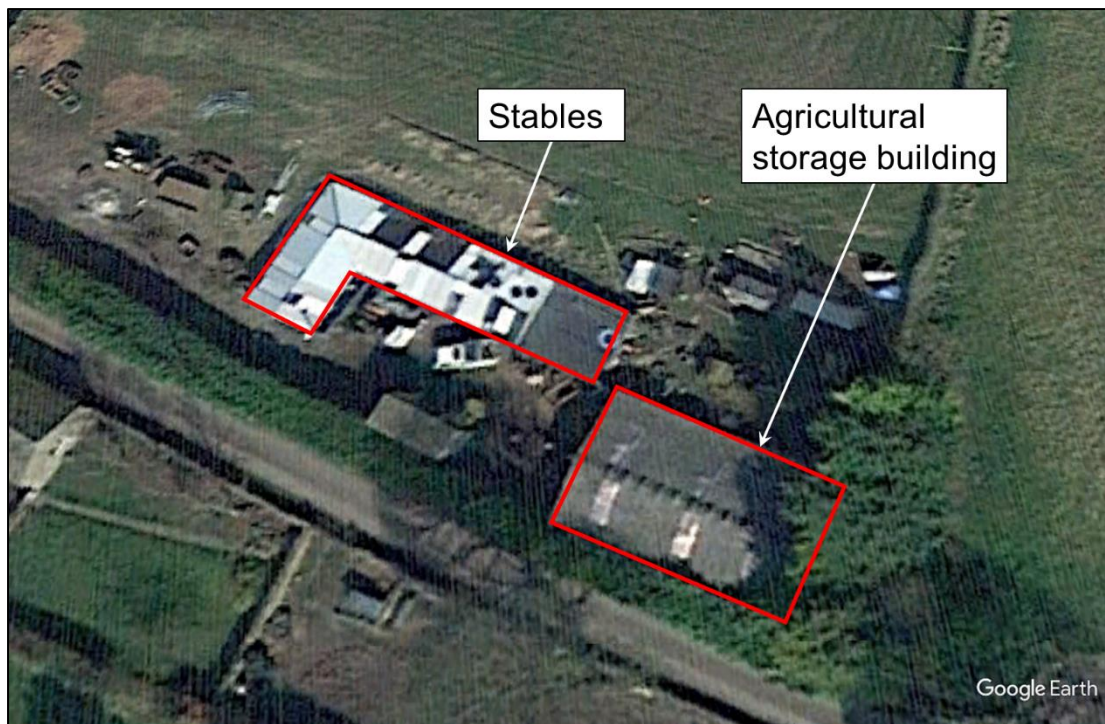
Figure 2. Building naming plan

5.2.1 No evidence of bat roosting was recorded on site. The buildings lacked potential bat roost features and were considered to offer negligible potential for current use by roosting bats. The building names and layout are shown in Figure 2, further descriptions are provided in this section of the report.

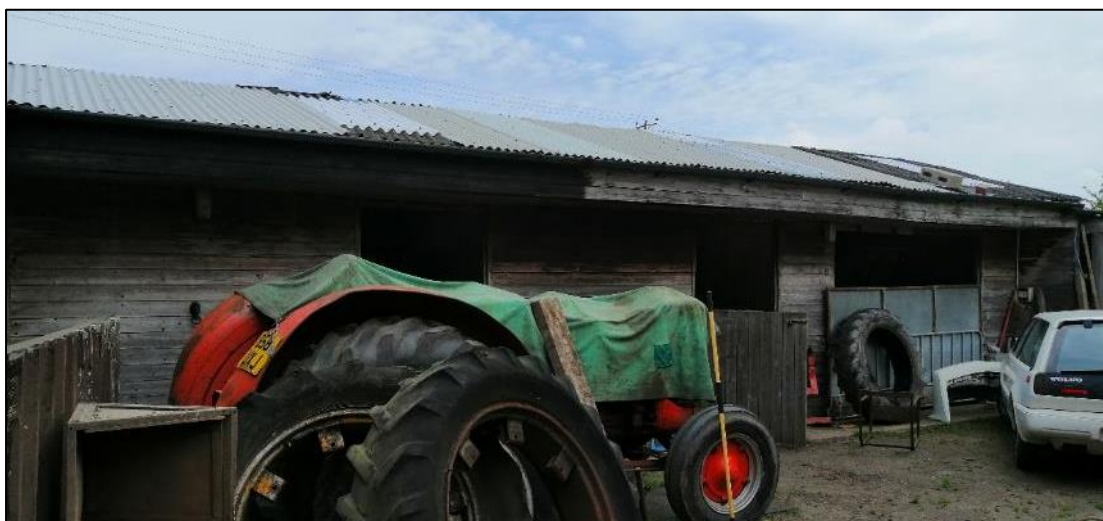
Plate 1. Front (south-southwest elevation)

5.2.2 This building, which was constructed between 2003-2009 consisted of a 'L' shaped stable with six compartments including one which was open fronted. The building was timber framed and wood clad beneath a multi-pitched roof covered largely in corrugated metal sheets. At one end the building comprised an open fronted lean-to with a mono pitched corrugated sheet metal roof, which was supported at the front with telegraph poles. The rear and sides of the lean-to had single-skin concrete block walls to 1.2 m (Plates 1-3).

- 5.2.3 The external cladding was intact and the buildings, including the attached lean-to, lacked features with potential to support roosting bats.

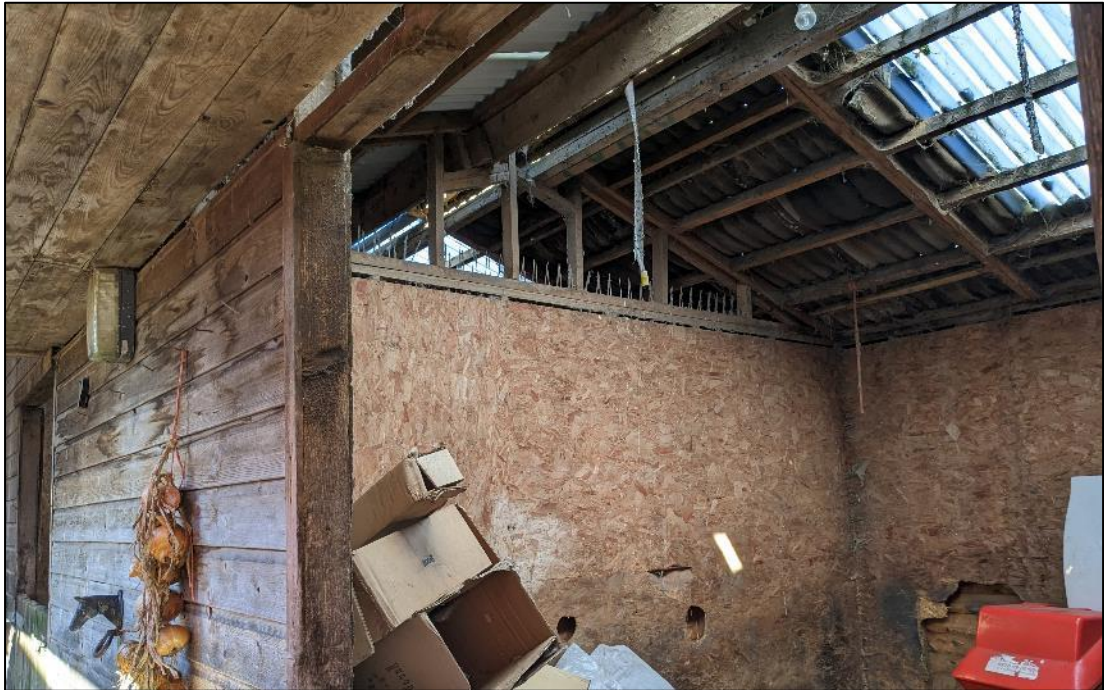
Plate 4. Interior of roof within stables

- 5.2.4 The interior of the stables was open to the underside of the roof covering, with the covering supported by timber roof trusses, purlins and rafters. There were sterling boarding attached to the inside of stables with a void formed between the external cladding and the lining boards. There were several damaged boards which potentially

allow bats access to the void (see Plate 5). However, these were thoroughly inspected, and found to be very 'cobwebby' and probably too wide for use by crevice dwelling bats. All the roof timbers were found to be heavily cobwebbed, and no signs of bats were found. One active swallow *Hirundo rustica* nest was noted during the 2022 survey (MBE, 2022).

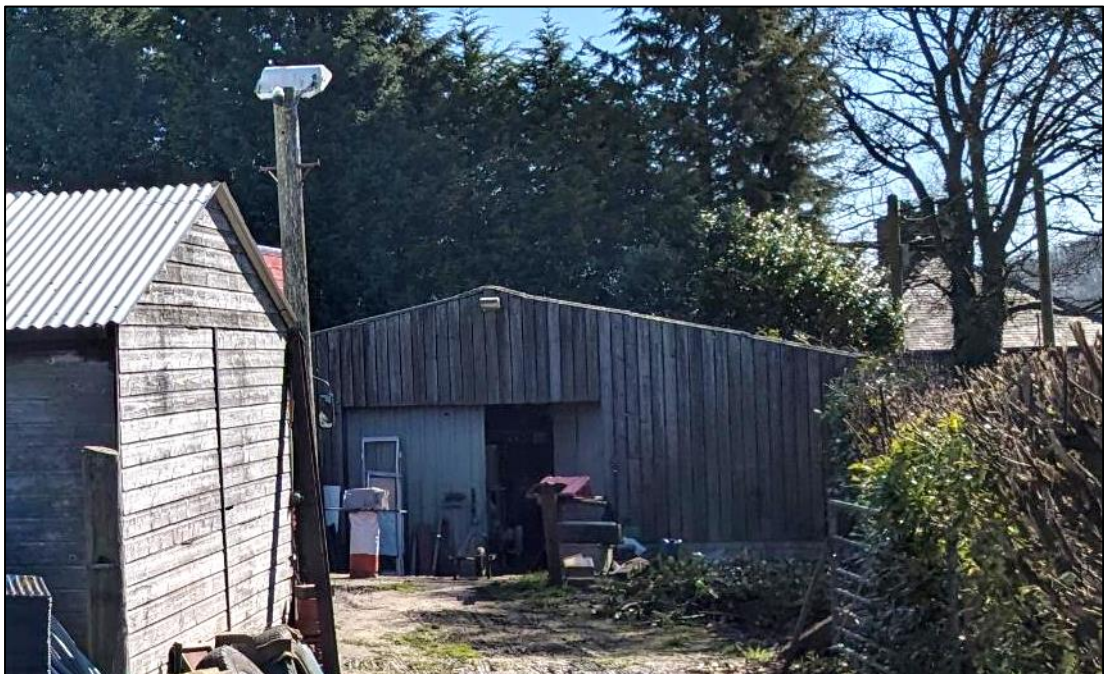
Plate 6. West elevation of agricultural storage building

- 5.2.5 This building comprised a steel-framed single storey agricultural storage building, constructed between 2003-2009, with a dual-pitched corrugated asbestos-cement sheet covered roof. The roof included skylights and vented ridge caps. Concrete block walls (hollow blocks) were present up to a height of c. 1.2 m with 'hit-and-miss' wood cladding above. Steel sheet covered double doors were present in the west elevation.

- 5.2.6 No potential bat roosting features were recorded from the exterior of the agricultural storage building, although it was noted that bats could potentially access the interior via spaces between the wooden cladding boards.

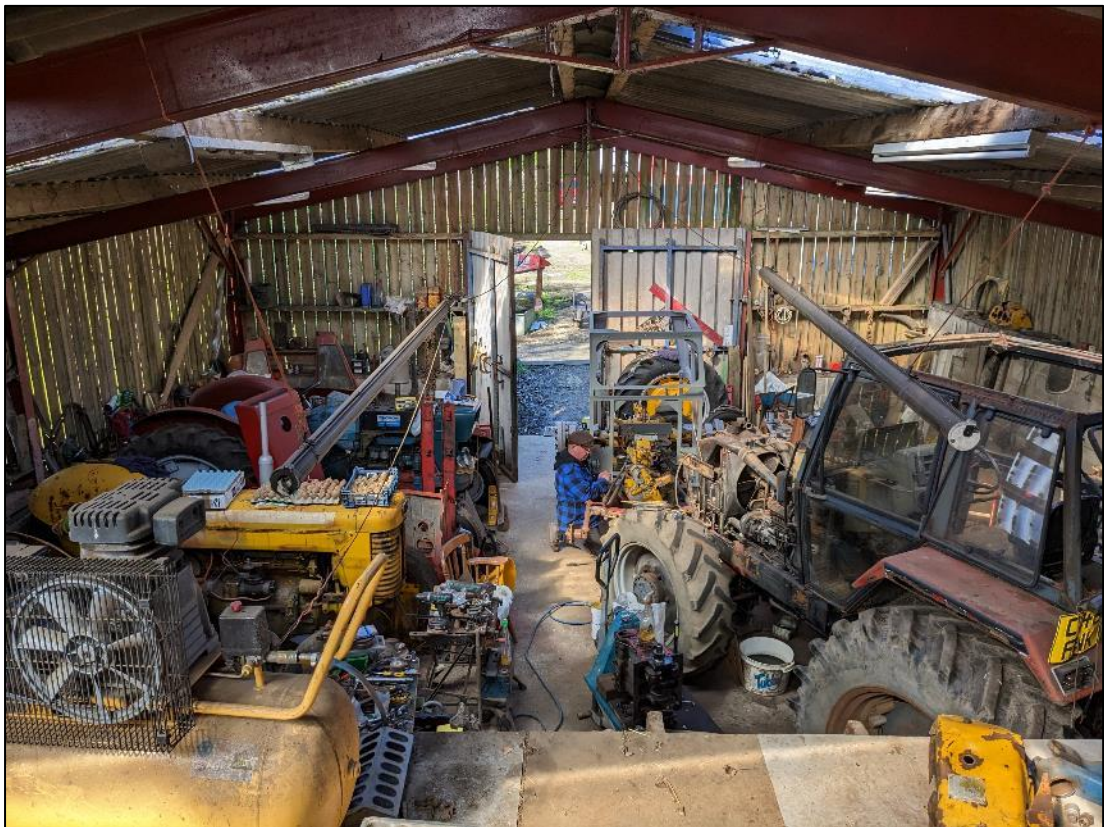
Figure 8. Interior of agricultural storage building

- 5.2.7 The unlined roof was suspended on steel beams and wooden purlins, with no roof void present. The building was in active use as an agricultural storage building, with a mezzanine floor present at the eastern end of the building. No signs of bat presence were found, and no suitable roosting locations were recorded from within the building. It was noted that horizontal wooden timbers covered the top of the blockwork walls, preventing any potential bat access into the hollow blocks.
