Northern Academy of Vocal Excellence, Barnsley

Bat Roost Suitability Assessment & Interim Emergence Survey

08/05/2024

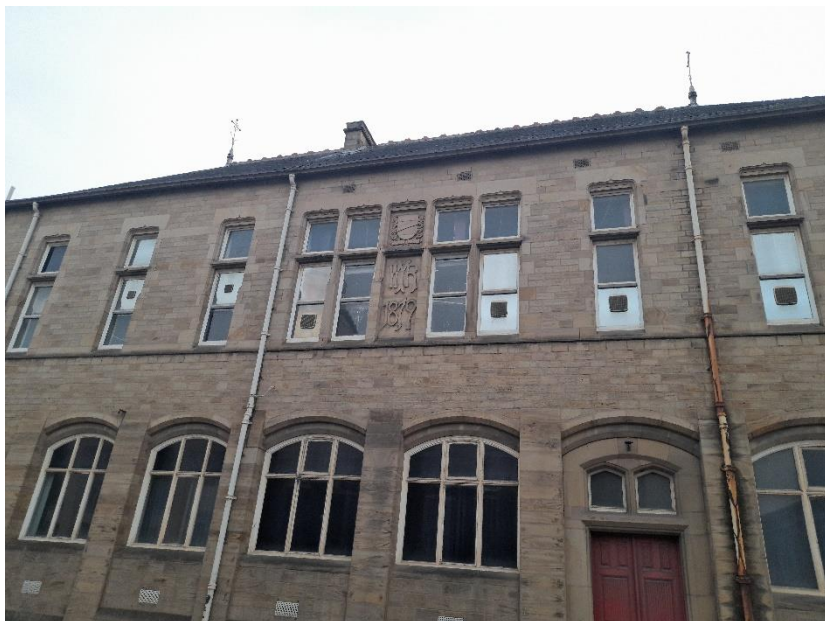
Figure 2 Surveyed building.

18. The Site comprises a single building of dressed sandstone construction, 2–3 storeys high, with numerous hipped or double-pitched slate-tiled roof sections. The building has a three-storey turret reminiscent of a belfry on its northeastern corner, with a steeply-pitched slate-tiled conical roof. Construction was completed in 1879, as evidenced by the engraving on the building's eastern elevation.

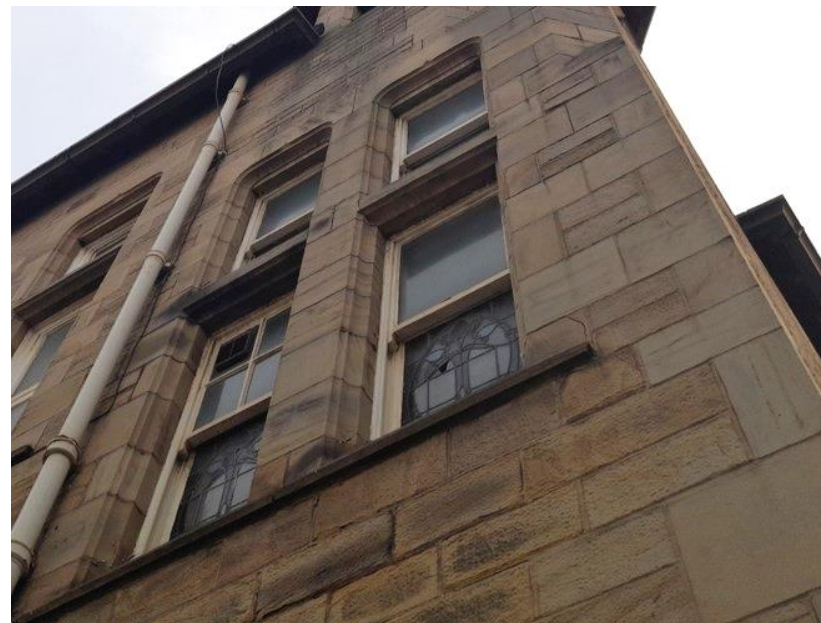
Figure 3 Missing glass in stained glass window.

19. The stone walls were found to be in generally good condition, although some areas of sandstone show erosion developed over time. No missing masonry or gaps in mortar were observed on any of the building's elevations.
20. The numerous windows and doors, of various designs, all sit within timber frames surrounded by decoratively-shaped sandstone sills and lintels. While the timber is beginning to rot in some places, all of the frames remain well-sealed with putty, offering no potential roost features (PRFs) for bats. A pane is

missing from one of the stained-glass windows beneath the turret, offering potential access for bats to the first floor of the building, but this is the only damage noted to any glass on the building.

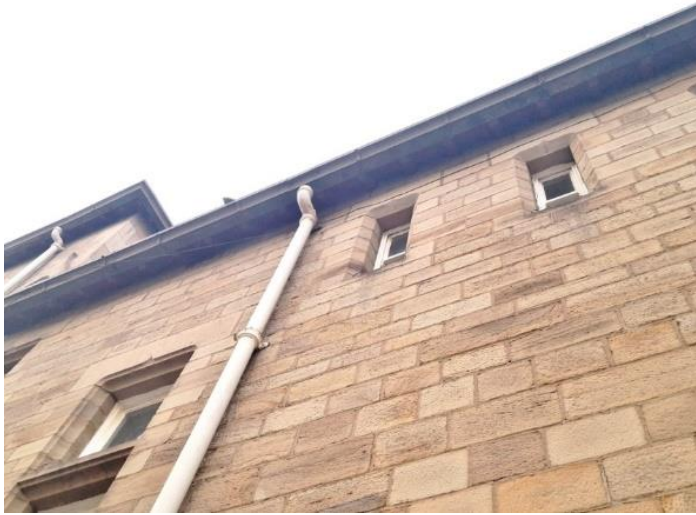
Figure 4 Overhanging eaves on south elevation, typical of all elevations; metal guttering also visible.

21. Open, overhanging eaves are present on all elevations of the building and may offer potential access to wall tops and internal roof voids.
22. While the roofs are in generally good condition, some of the tiles were noted to have slipped, offering PRFs for individual crevice-roosting bats.
23. Occasional peeling was noted of the lead flashing at the junctions of rooves and brickwork, offering further PRFs for individual bats.
24. Metal guttering runs along all faces of the building, but sits flush with the eaves, offering no additional gaps which may function as PRFs.

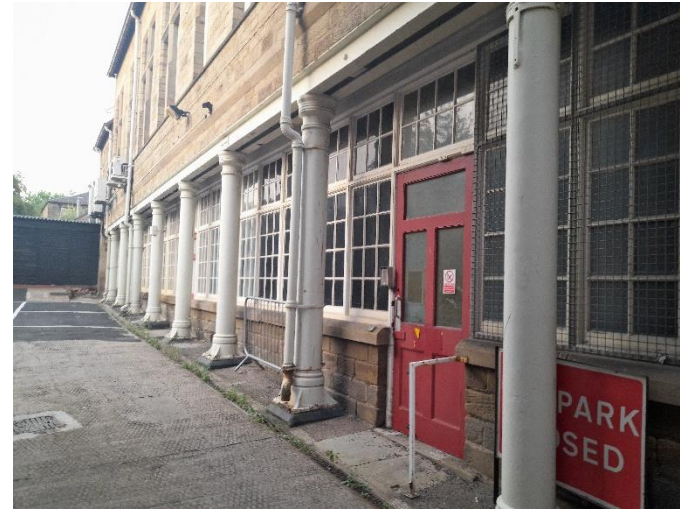
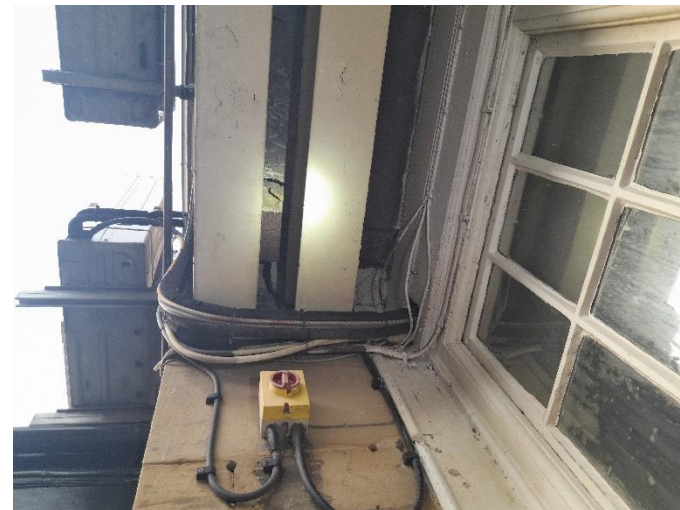
Figure 6 Colonnade; gaps between metal beams.

25. The western ground floor of the building supports a colonnade, with the building set slightly back relative to the upper floors. The columns support a pair of metal beams with concrete between, which is largely intact, but features two small gaps at the northern end which appear to lead up into a cavity wall space. This may act as a PRF for crevice-roosting species.

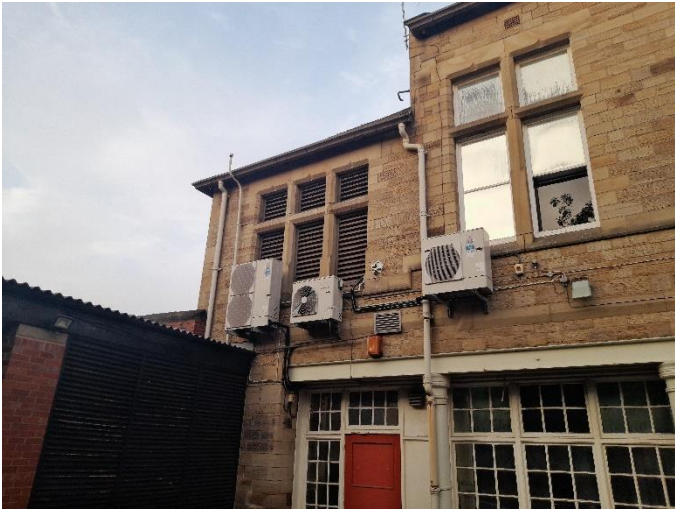
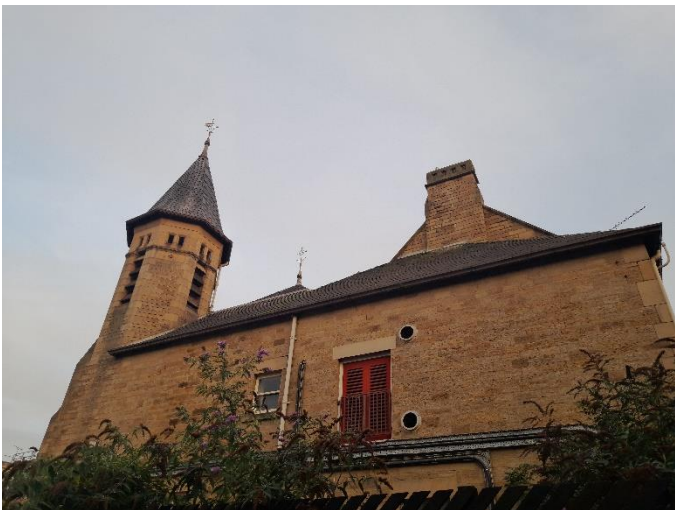
Figure 7 Louvre vents on western and northern elevations.

26. The western and northern elevations support several louvred vents and vented doors, with more present on the turret. These form PRFs for moderate numbers of crevice-roosting bats and may also provide access into the building's internal structure. Additional metal vents likely link to metal ducts inside the building, and so offer minimal roost suitability.

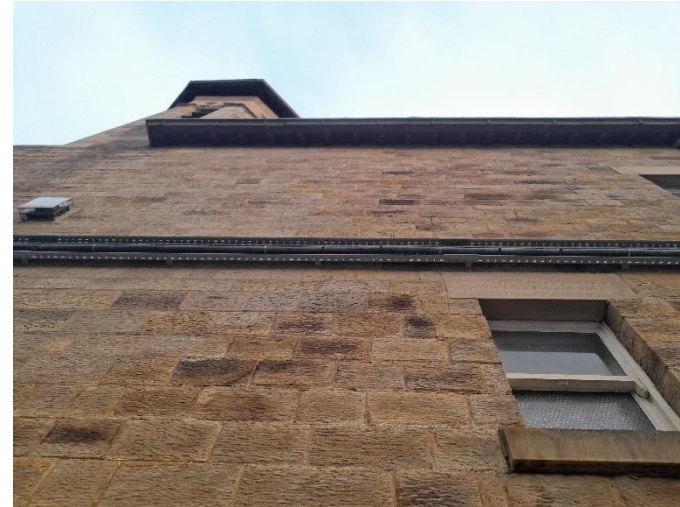
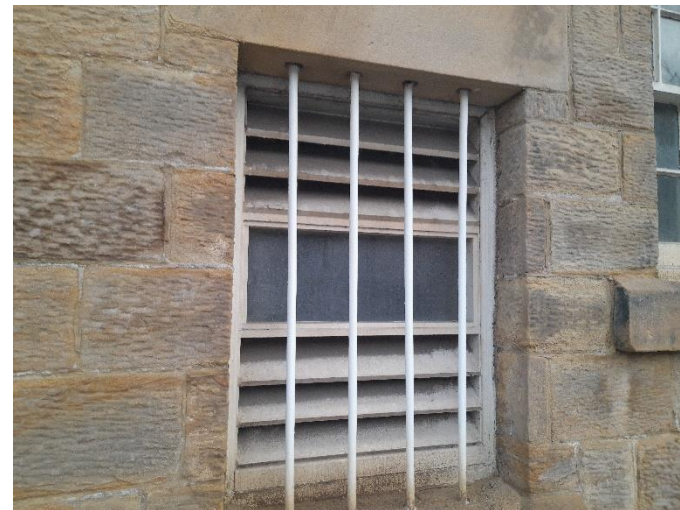
Figure 8 Duct and vented window on northern elevation.

27. The northern elevation also supports a metal duct, which is closely-fitted to the stonework and supports no PRFs; and a vented ground-floor window which, given its low elevation, is unlikely to act as a PRF.

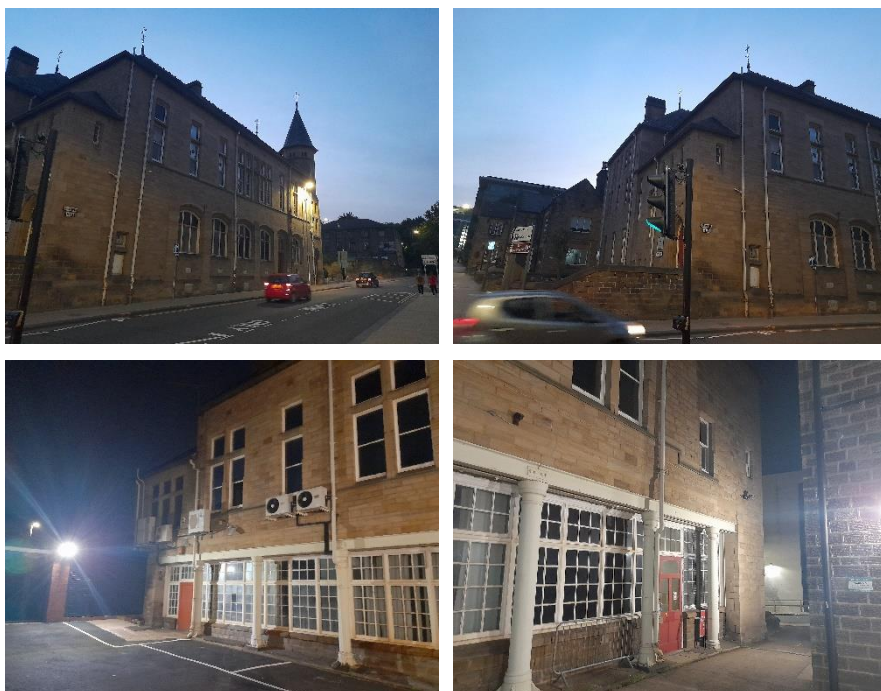
Figure 9 Nocturnal illumination around the building.

- 28. The building is moderately well-lit at night by nearby streetlamps. However, this lighting is focused primarily on the ground floor, with the upper floors and rooves largely unlit.
