# Preliminary Roost Assessment

10 Ballfield Lane, Kexborough, Barnsley, S75 5EF

This report is prepared to inform a planning application with Barnsley Metropolitan Borough Council. This proposal can be described as  
*"Demolition of existing takeaway building and erection of replacement commercial units"*

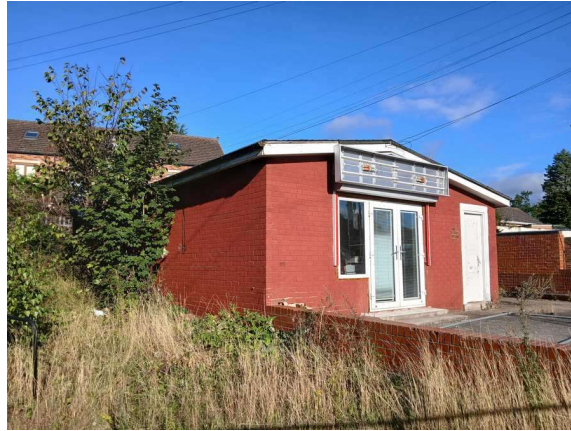
B1 is an abandoned takeaway, the interior of which has little habitat value for roosting bats, apart from the void space. From what little was visible, the void space contained access points for bats due to light ingress, but the remainder of the space was relatively dark. However, the space also appears to be subject to high levels of water ingress from the water marks present which reduces the likelihood of bats utilising the space. Much of the external building had no roosting features for bats, however the soffits did contain points of damage which could be utilised by bats (see appendix 1), although they also appeared damp which is sub-optimal.

B1 is assessed as being low roosting value.

*Building B1, facing north-west*

A Bat Mitigation Plan (BMP) should be produced in order to mitigate for the noise and vibrations from the works. Given the sub-optimal conditions caused by dampness of the wood, it is considered unlikely that bat roosts would be present within the works area and that further bat surveys would be disproportionate to the anticipated risk posed to bats. It is anticipated that any risk to bats can be reduced to an acceptably low level through the implementation of a Bat Mitigation Plan.

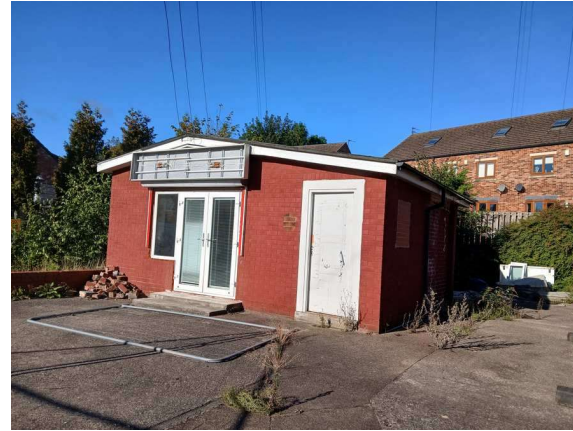
*Building B1, facing south-west*

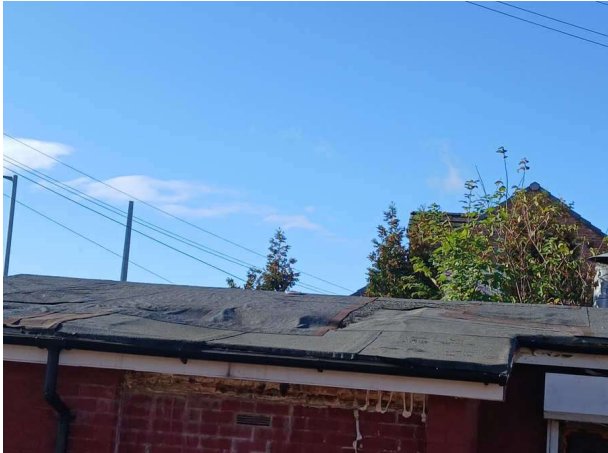
| Feature | Materials/Details | Condition / description / suitability | Photograph |
|---|---|---|---|
| Roof | Bitumen felt | <p><b>Condition/description</b></p> <p>The roof has multiple areas of damage and tears on the northern portion, possibly where parts of the loft space has collapsed due to lack of maintenance. The southern aspect was not visible due to elevation and space.</p> <p><b>Suitability/access/evidence of bats</b></p> <p>The tears on the roof provide access points into which crevice dwelling bats can gain entry for roosting opportunities. They may also lead into deeper cavities within and provide access to the interior of the building.</p> | <p><i>B1 roof, facing south</i></p> |

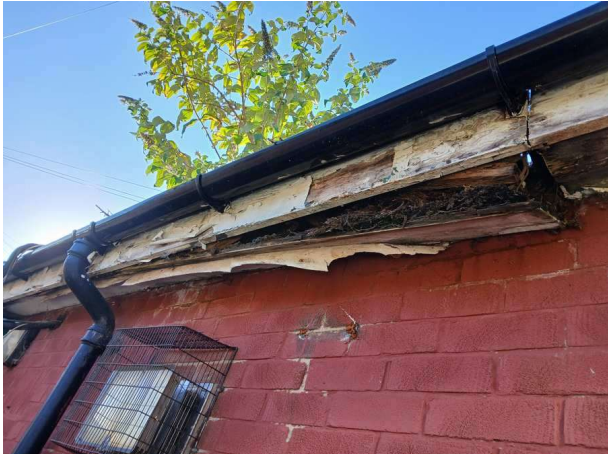
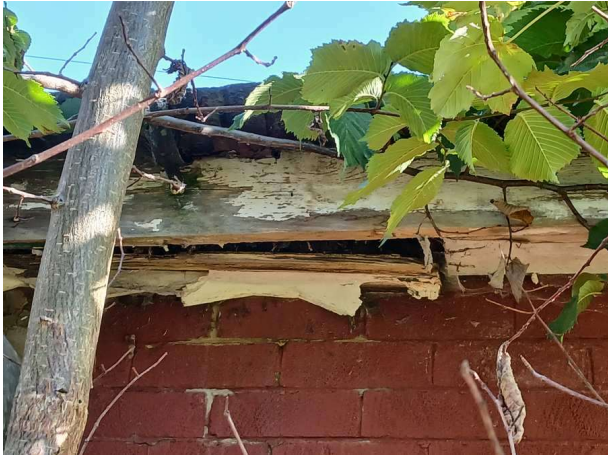
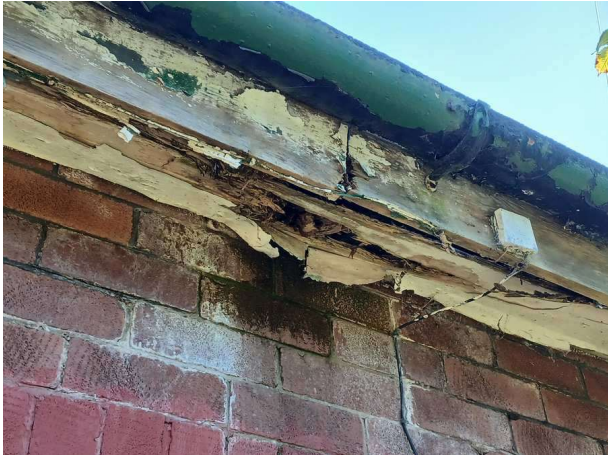
| Eaves | Timber board | <p><b>Condition/description</b></p> <p>The soffits ran along the entire perimeter of the building, most of which remained intact. However, at multiple points were areas of damage and rot, and appeared damp.</p> <p><b>Suitability/access/evidence of bats</b></p> <p>The areas of damage may provide roosting opportunities, however they are considered sub-optimal due to the visible dampness.</p> | <div></div> <p><i>B1 eaves, facing south</i></p> <div></div> <p><i>B1 eaves, facing north</i></p> |

| | | | <p><i>B1 eaves, facing north</i></p> |

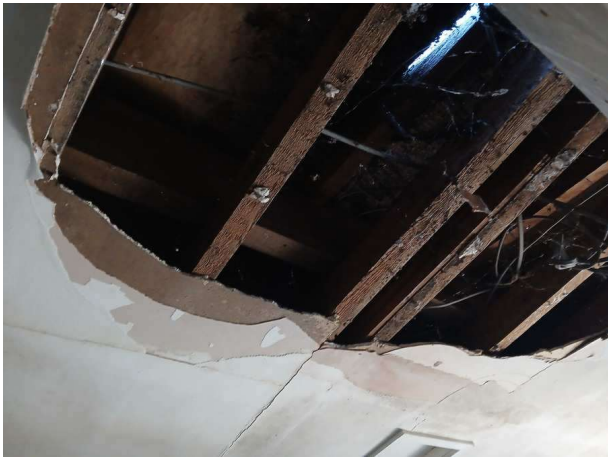
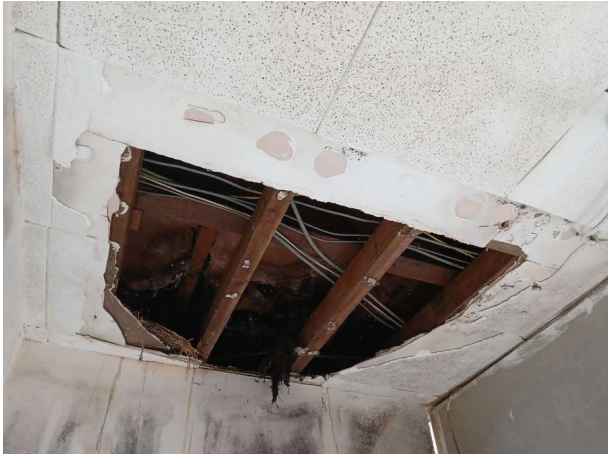
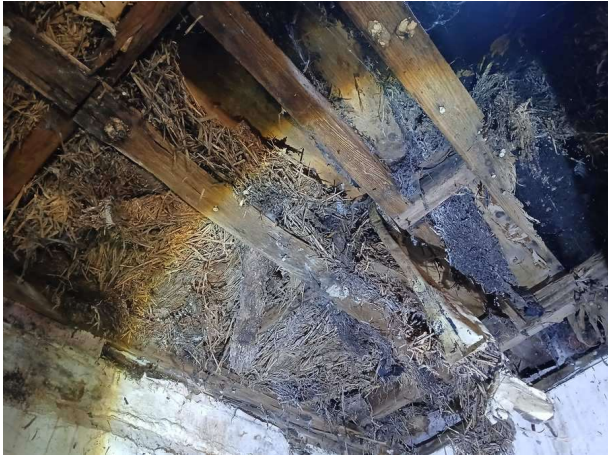
| Internal void 1 | Timber rafters | <p><b>Condition/description</b></p> <p>While not accessible, parts of the void space were visible from the interior of the building (which is where temperature and humidity readings were taken from) due to multiple large holes in the ceiling. The loft space contained areas light ingress, but were relatively dark compared to the much brighter building interior due to glass doors. However, the void space appeared damp due to water marks, indicating high levels of water ingress.</p> <p>Dimensions (approx): 10.3m long, 6m wide, approximately 0.3m high<br/>Temp: 19°C // Humidity: 65.7%</p> | <p><i>B1 internal void 1, demonstrating one of several points of light ingress</i></p> |

| | | <p><b>Suitability/access/evidence of bats</b></p> <p>The points of light ingress provide opportunities for bats to access the small loft space which may provide roosting opportunities for crevice dwelling species. However, there did not appear to be room for warm up flight from the lower elevations where the author of this report stood. Additionally, the void is considered sub-optimal due to the dampness. The lower interior of the building was relatively bright, which is likely to disturb crevice dwelling species. No evidence of bats was detected.</p> | <div><p><i>B1 internal void 1, another example of a ceiling hole</i></p><p><i>B1 internal void 1, an area where much of the ceiling was missing</i></p></div> |

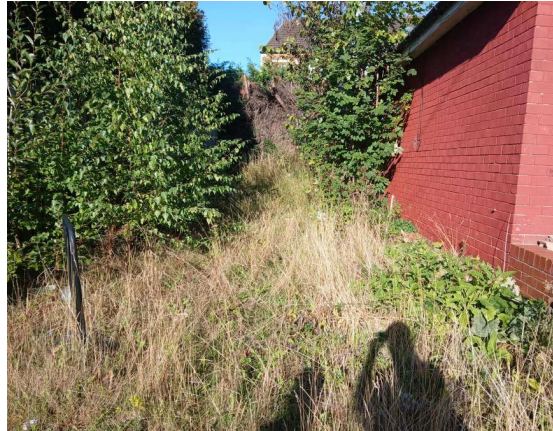
No habitat for schedule 1 birds was observed, however the vegetation on site is suitable for more common species.

*The majority of the vegetation on site.*

Any vegetation removal should be undertaken outside the period 1st March to 31st August. If this timeframe cannot be avoided, a close inspection of the vegetation should be undertaken immediately, by a qualified ecologist, prior to the commencement of work. All active nests will need to be retained until the young have fledged or an ecologist has confirmed the nesting attempt has concluded.
