# BAT SURVEY REPORT

**Church of Our Lady of Perpetual Succour, Station Road, Bolton  
Upon Dearne, Rotherham**

**Produced by:** Protected Species Surveys  
**Contact:** Email: [protectedsp surveys17@gmail.com](mailto:protectedsp surveys17@gmail.com)  
**Client:** Clay Architectural Designs Ltd  
**Location:** **Station Road, Bolton Upon Dearne, Rotherham**  
**Date:** January 2023 (Rev A)

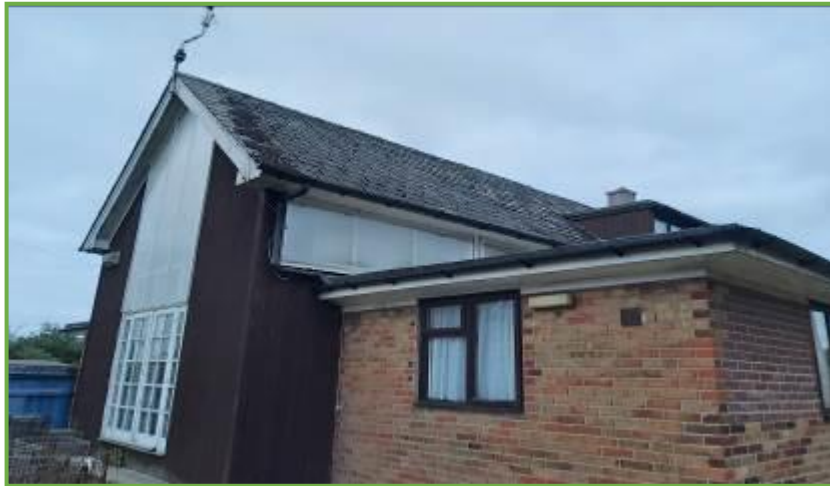
**Photo 1: External view of building**

- 3.2 The building (former church) comprised a one and two-storey, brick-built former modern church with a pitched clay tiled roof and clay ridge tiles (Photo 1). Other structural features of note comprised of four single-storey, brick-built adjoining annex sections with flat felted roofs on the eastern aspect of the building. Four dormer windows were present, two on the eastern aspect and two on the western aspect.
- 3.3 Potential bat access points were observed via gaps around the dormer window on the eastern aspect and beneath the clay ridge tiles.

- 4.4 The building assessment considered the former church building to offer low potential to support roosting bats. Therefore, in accordance with industry guidelines (BCT, 2016) a single nocturnal bat survey was carried out to determine the presence / absence of roosting bats. During the nocturnal survey period no bats were observed emerging or returning to the building. Bat activity was dominated by common pipistrelle commuting through the survey with occasional noctule commuting high over the site. No bats were observed emerging or entering the former church building.

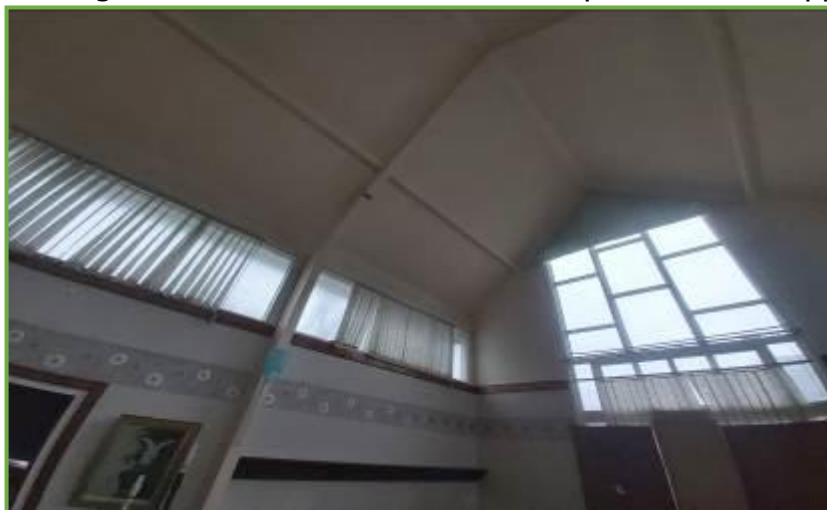
**Photo 2: Interior view showing roof void open to the ridge**

- 3.4 Internally the roof was open to the ridge with a small, enclosed roof void present (Photo 2). The roof void was enclosed and boarded up with sarking boarding and spray foam insulation. No internal / external evidence of use by bats was identified during the survey. The
- 3.5 building was considered to offer **low** potential to support roosting

bats.

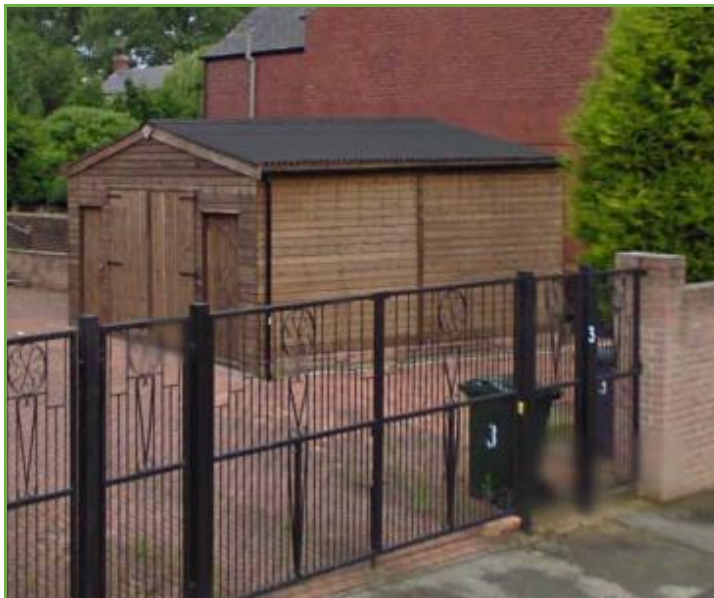
**Photo 3: View of timber shed within the grounds of the application site.**

- 3.6 A timber framed shed was present within the site boundary situated within the north-eastern corner of the application site. The building was in good condition and constructed of a single layer of timber panelling with a shallow single-skinned, pitched sheet metal corrugated sheet roof (Plate 3). The timber shed did not provide any suitable bat roosting features and was considered to offer **negligible** potential to support roosting bats.

- 4.3 The timber shed located within the north-eastern corner of the site was considered to offer negligible potential to support roosting bats. Therefore, bats are not an ecological constraint to the demolition of this structure.

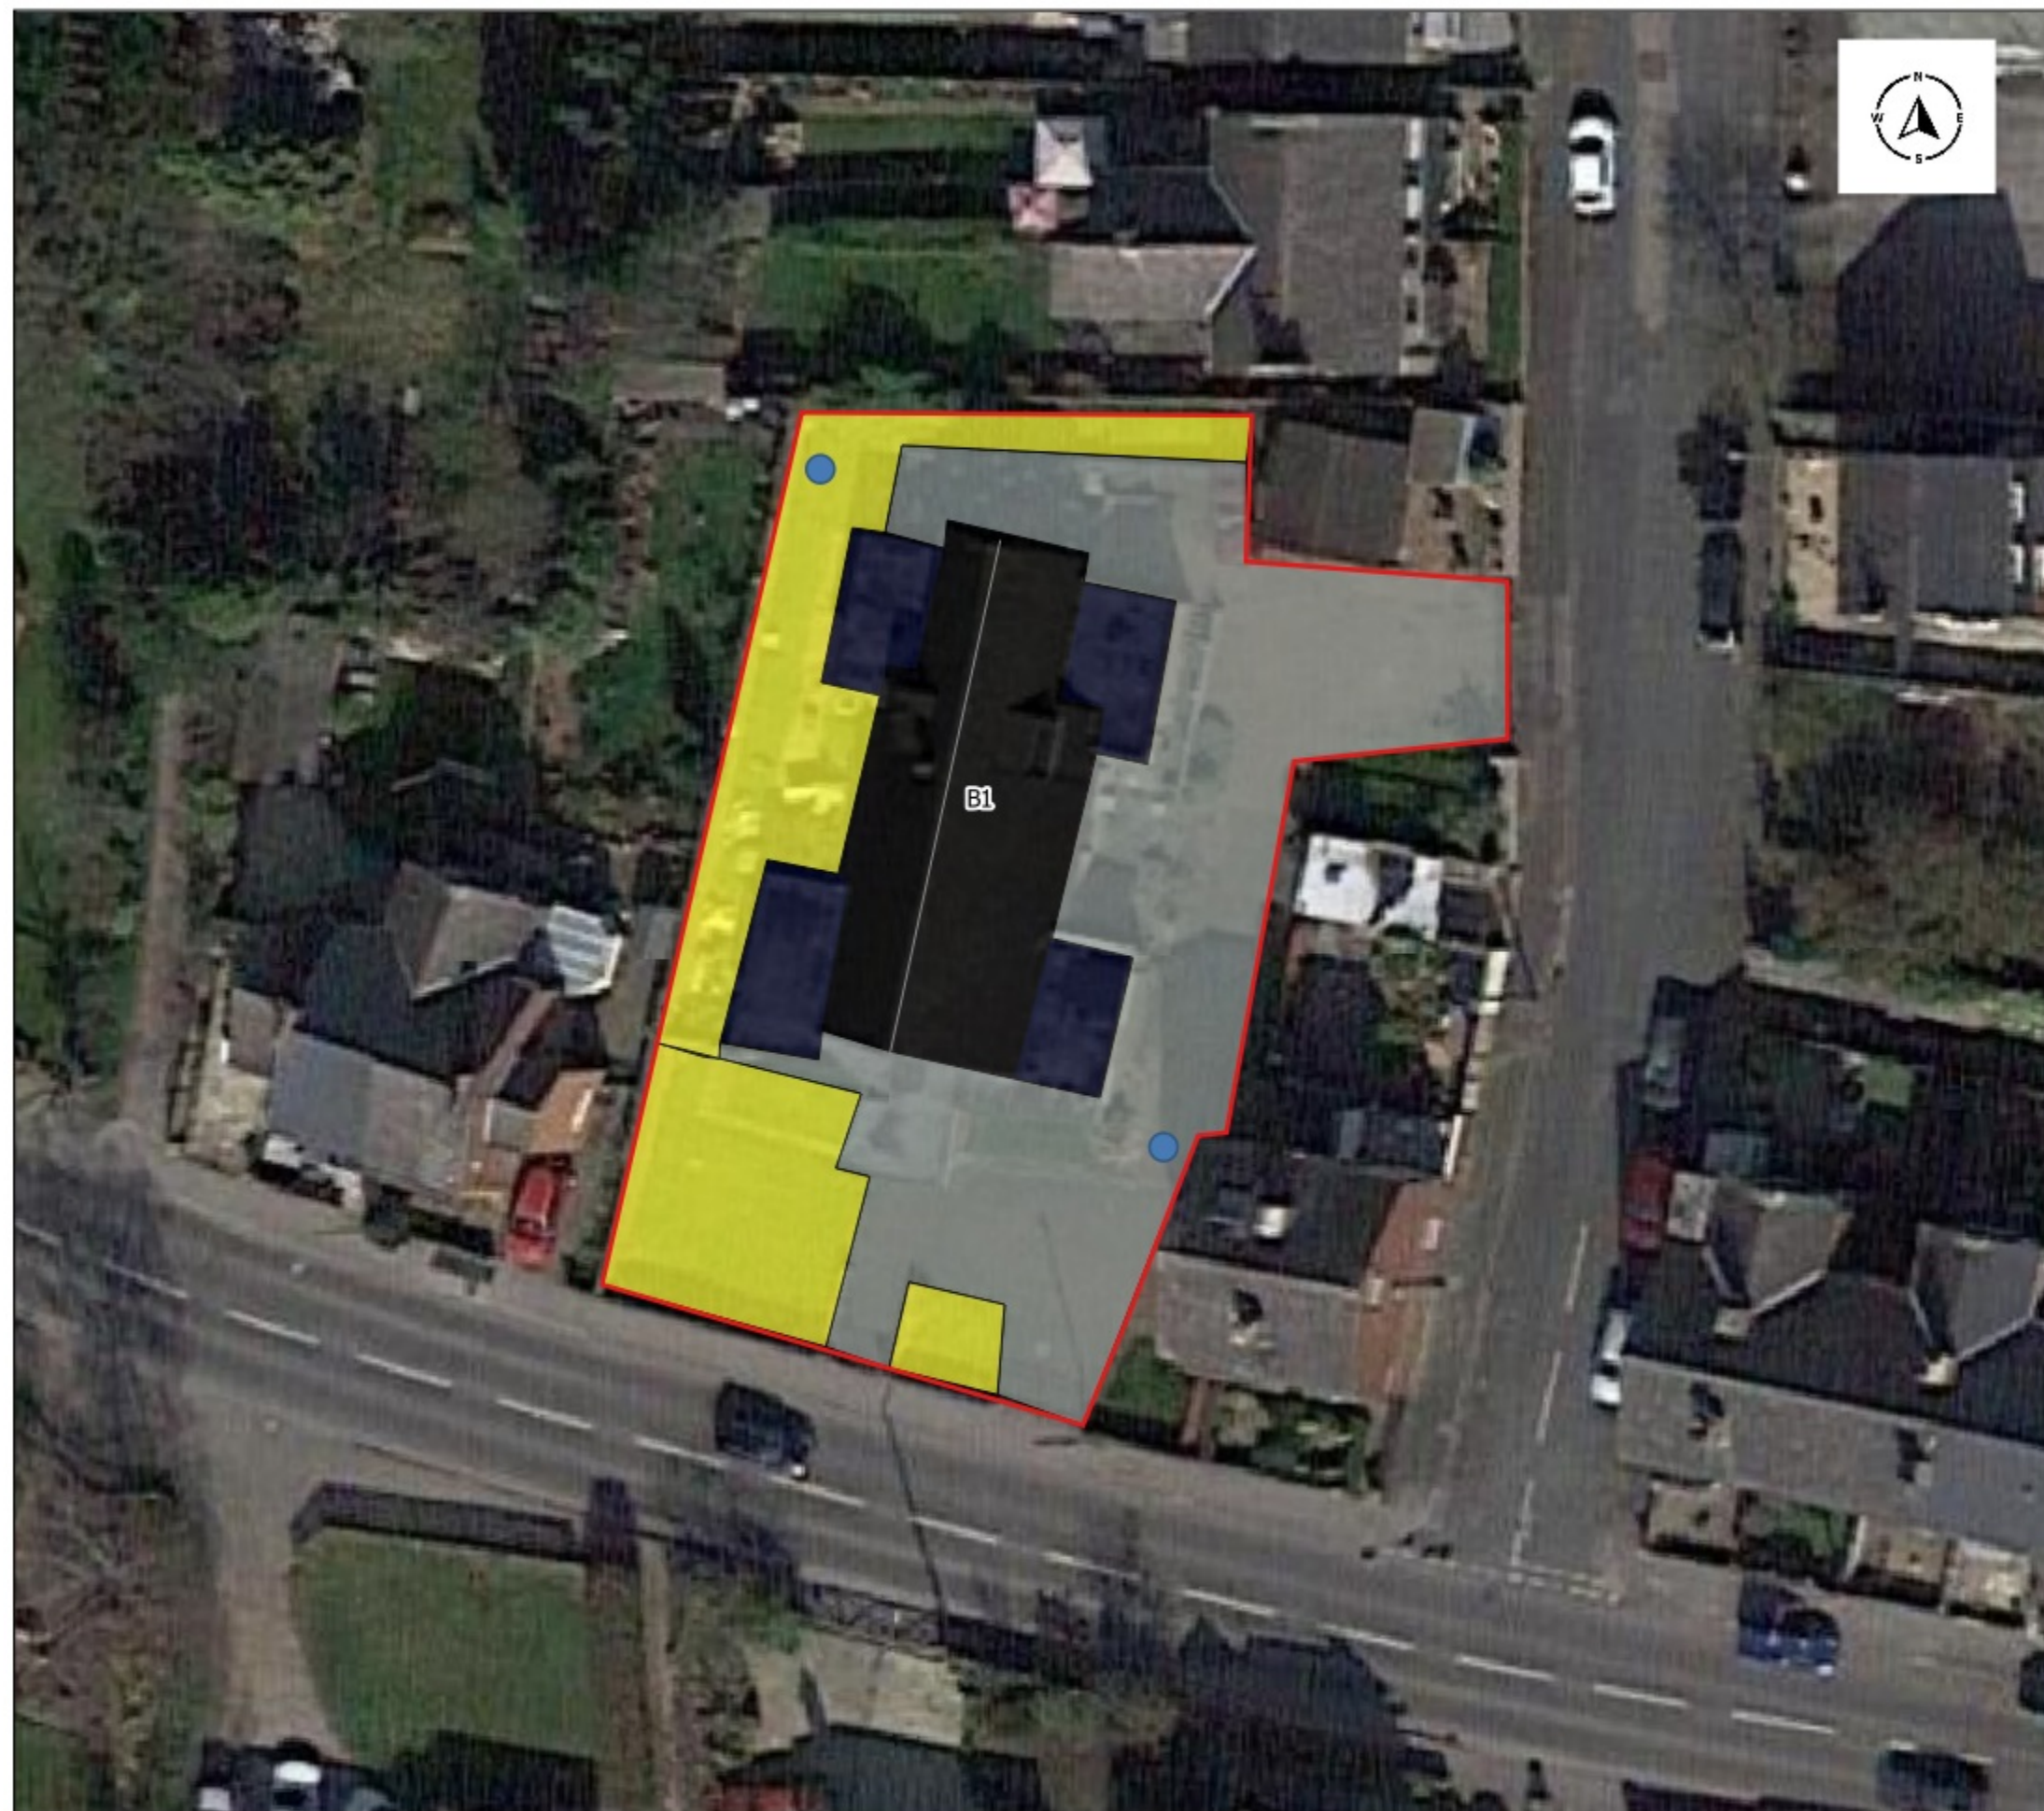
Figure 2 - Phase 1 Habitat Plan

**Nocturnal Survey***Dusk Survey 29<sup>th</sup> August 2022 (Figure 2)*

- 3.7 During the survey, the first bat recorded was a common pipistrelle commuting along the eastern aspect of the former church building entering the survey area from the south-east heading away from the building at 20:13. The next observation was also a common pipistrelle commuting over the survey area heading in an easterly direction at 20:34. Bat activity was largely dominated by common pipistrelle commuting through the survey area from adjacent gardens. A single noctule *Nyctalus noctula* was recorded commuting high over the survey area at 21:01. No bats were observed emerging or entering any of the on-site building (former church).
