## Proposed Residential Development Located South of Darton Lane, Staincross, Barnsley

Stage I Road Safety Audit

May 2024

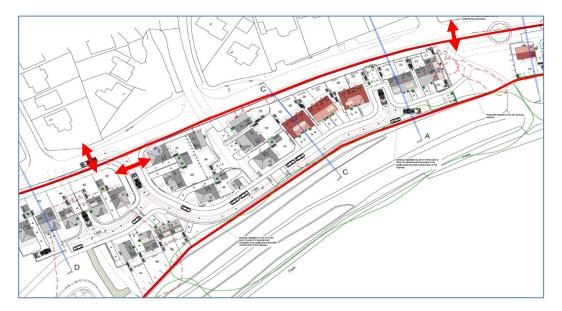
#### 2.1 Problem

**Location:** Side road junctions and pedestrian desire lines throughout the site and on Darton Lane

**Summary:** Risk of pedestrians tripping/falling over full height kerbs and sustaining injury due to absence of crossing facilities at side road junctions and main desire lines

No crossing facilities for pedestrians (e.g. dropped kerbs and tactile paving) are shown across side road junctions or across Darton Lane to serve key desire lines. The absence of these facilities may increase the risk of pedestrians tripping/falling over full height kerbs as they attempt to cross, and sustaining injury as a result. The absence of such facilities is also likely to make it difficult for elderly pedestrians and those with mobility/visual impairments to navigate the site and nearby services such as shops, schools and public transport.

It is recommended that on-desire line pedestrian crossing points consisting of dropped kerbs and tactile paving are provided across relevant junctions and at pedestrian desire lines.

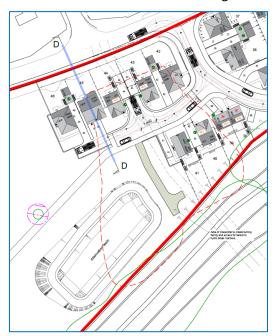
#### 2.2 Problem

**Location:** Surface water attenuation pond west of access road (near plot 46)

**Summary:** Risk of errant vehicles/pedestrians entering the watercourse area and sustaining injury (including possible drowning) due to lack of edge restraint

A surface water attenuation pond appears to be proposed reasonably close to an internal road. The Audit Team are unaware of the likely depth of the pond and how much water is likely to be routinely in the pond. However, the pond is close to a footway and it is reasonable to expect people to be regularly within close proximity of the pond. As an assumed open feature with no obvious edge restraint features, errant motorists/ pedestrians may not be adequately protected from entering the watercourse. Anyone entering the watercourse would be at risk of drowning and related injuries.

It is recommended that a risk assessment is undertaken in relation to the watercourse and, if deemed necessary, appropriate barrier treatments proportionate to the level of risk provided. If required, this could be as simple as a fence or hedgerow or, if established as appropriate, a road restraint system.

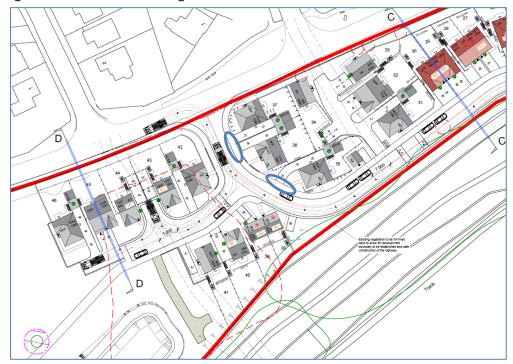
#### 2.3 **Problem**

Location: Various dropped kerb locations

**Summary:** Risk of pedestrian slips / falls due to steep gradient

The site topography means that the proposed carriageway / footway gradients within the site are significant. At the proposed informal dropped crossings/vehicle access locations, uphill sides could be greater than 10%, creating slip hazards and difficulties for pedestrians and people with reduced mobility. The potential gradients could be a particular problem for people in wheelchairs or mobility scooters when making the 90 degree turn to use the crossing.

It is recommended that double transition kerbs are installed on uphill sides where necessary to assist footway gradients.

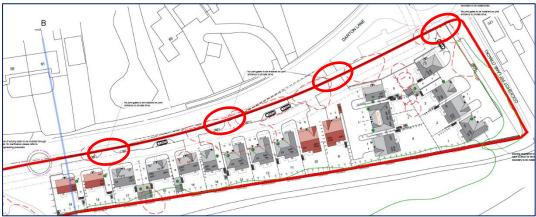
#### 2.4 **Problem**

Location: Proposed shared drive accesses from Darton Lane

Summary: Risk of Failure to Give Way (FTGW) collisions and vehicle / pedestrian conflicts

The site topography means that the proposed shared drive accesses abut the Darton Lane footway at a significant gradient. It is also unclear as to whether the existing brick retaining wall alongside Darton Lane will be retained. These arrangements could result in a number of road safety related issues:

- The proposed falls into the site if excessive, would increase the risk of pedestrian slips,
- An excessive approach gradient could increase potential for FTGW type collisions for vehicles exiting shared drives; and
- The existing wall at the rear of footway may impair visibility splays for vehicles exiting shared drives increasing the risk of FTGW type collisions and vehicle / pedestrian conflict.

It is recommended that the proposed shared drive accesses are designed with appropriate gradients and visibility splays.

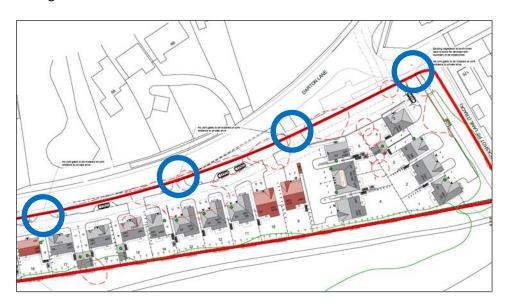
#### 2.5 **Problem**

Location: Proposed shared drive accesses from Darton Lane ed s38 Street

**Summary:** Risk of vehicle/vehicle collisions due to vehicles waiting at the gates protruding into Darton Lane

At the four shared drive accesses from Darton Lane, drawing annotations state that 'no joint gates to be installed on joint entrance to private drive'. It is unclear what 'no joint gates' are and how they would operate, but they appear to be located at the back of the Darton Lane footway. As such, a driver waiting to enter the site at the gates is likely to protrude into the westbound traffic lane whilst waiting for the gates to open, thereby increasing the risk of collision with westbound vehicles on Darton Lane.

It is recommended that either gates are not provided at the shared drives, or if they are provided that they are set sufficiently far back from Darton Lane so that a waiting vehicle does not protrude into the Darton Lane carriageway.
