## Report on Rotary Probing

Location: **WHARNCLIFFE SILKSTONE WMC**  
Worsbrough View, Tankersley, Barnsley, S75 3AH

Report No. J3586/16/E

Report date: September 2016

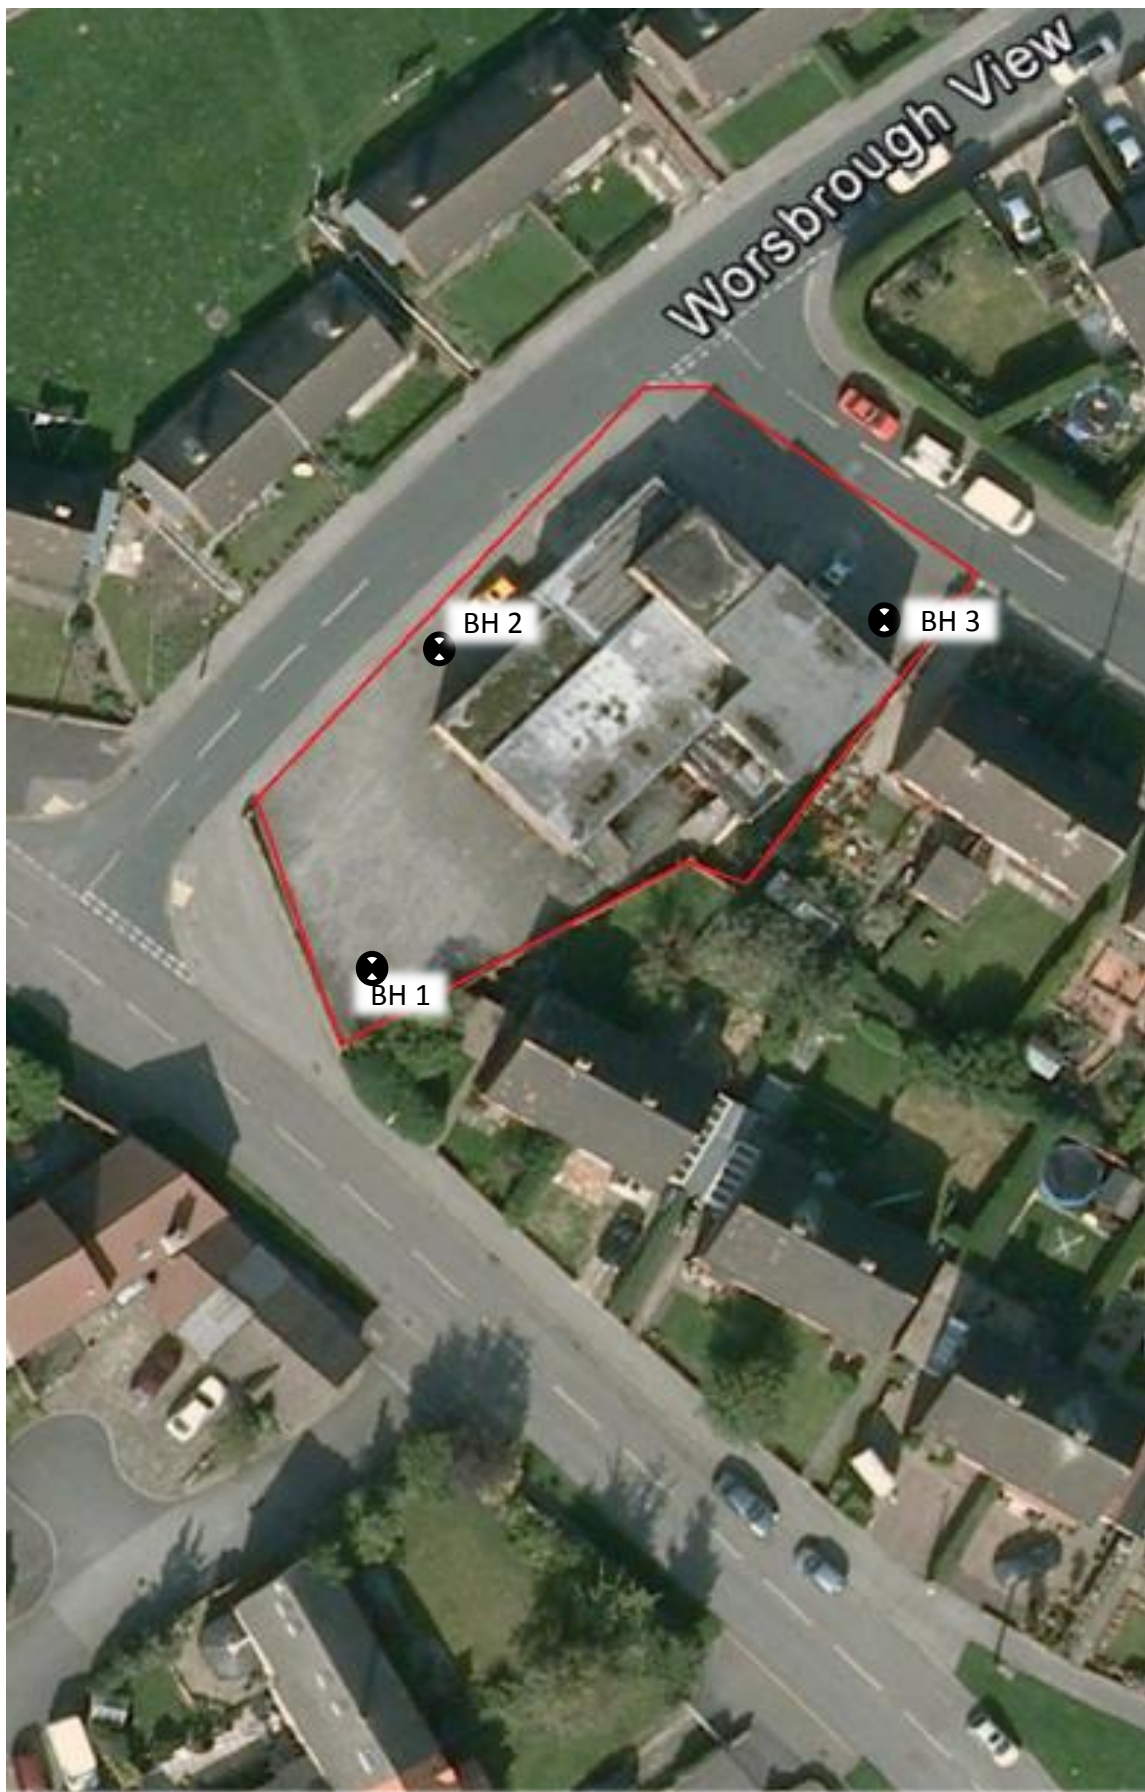
Title: **Investigation Location Plan**

Plan not to scale and investigation positions approximated from site operative's notes.

The boreholes were sunk using a track mounted rotary drilling rig using rotary open-hole drilling techniques and employing 140mm diameter drag and tricone roller bits. Where necessary, 150mm diameter casing was temporarily installed through the overburden to support the bore. The investigation was undertaken using water flush drilling techniques in accordance with the Coal Authority and Health and Safety Executive positioning statement. Drill chippings brought to surface in the flush returns were inspected by the driller on a screen, which forms part of the re-circulation tanks. In addition, representative disturbed samples of the arisings were taken at regular depth intervals and sealed in plastic containers. These samples were returned to the laboratory for further inspection. The borehole positions are shown on the site plan, which is presented in Appendix 2 and the strata conditions are presented on the borehole records in Appendix 3.
