**ARBORICULTURAL IMPACT ASSESSMENT
to BS 5837:2012
at
Royd Moor Farm
Royd Moor Road
Thurlstone
South Yorkshire
S36 7RD**

Client:
Kingsman Homes Ltd

JCA Ref:
22820b/ChC

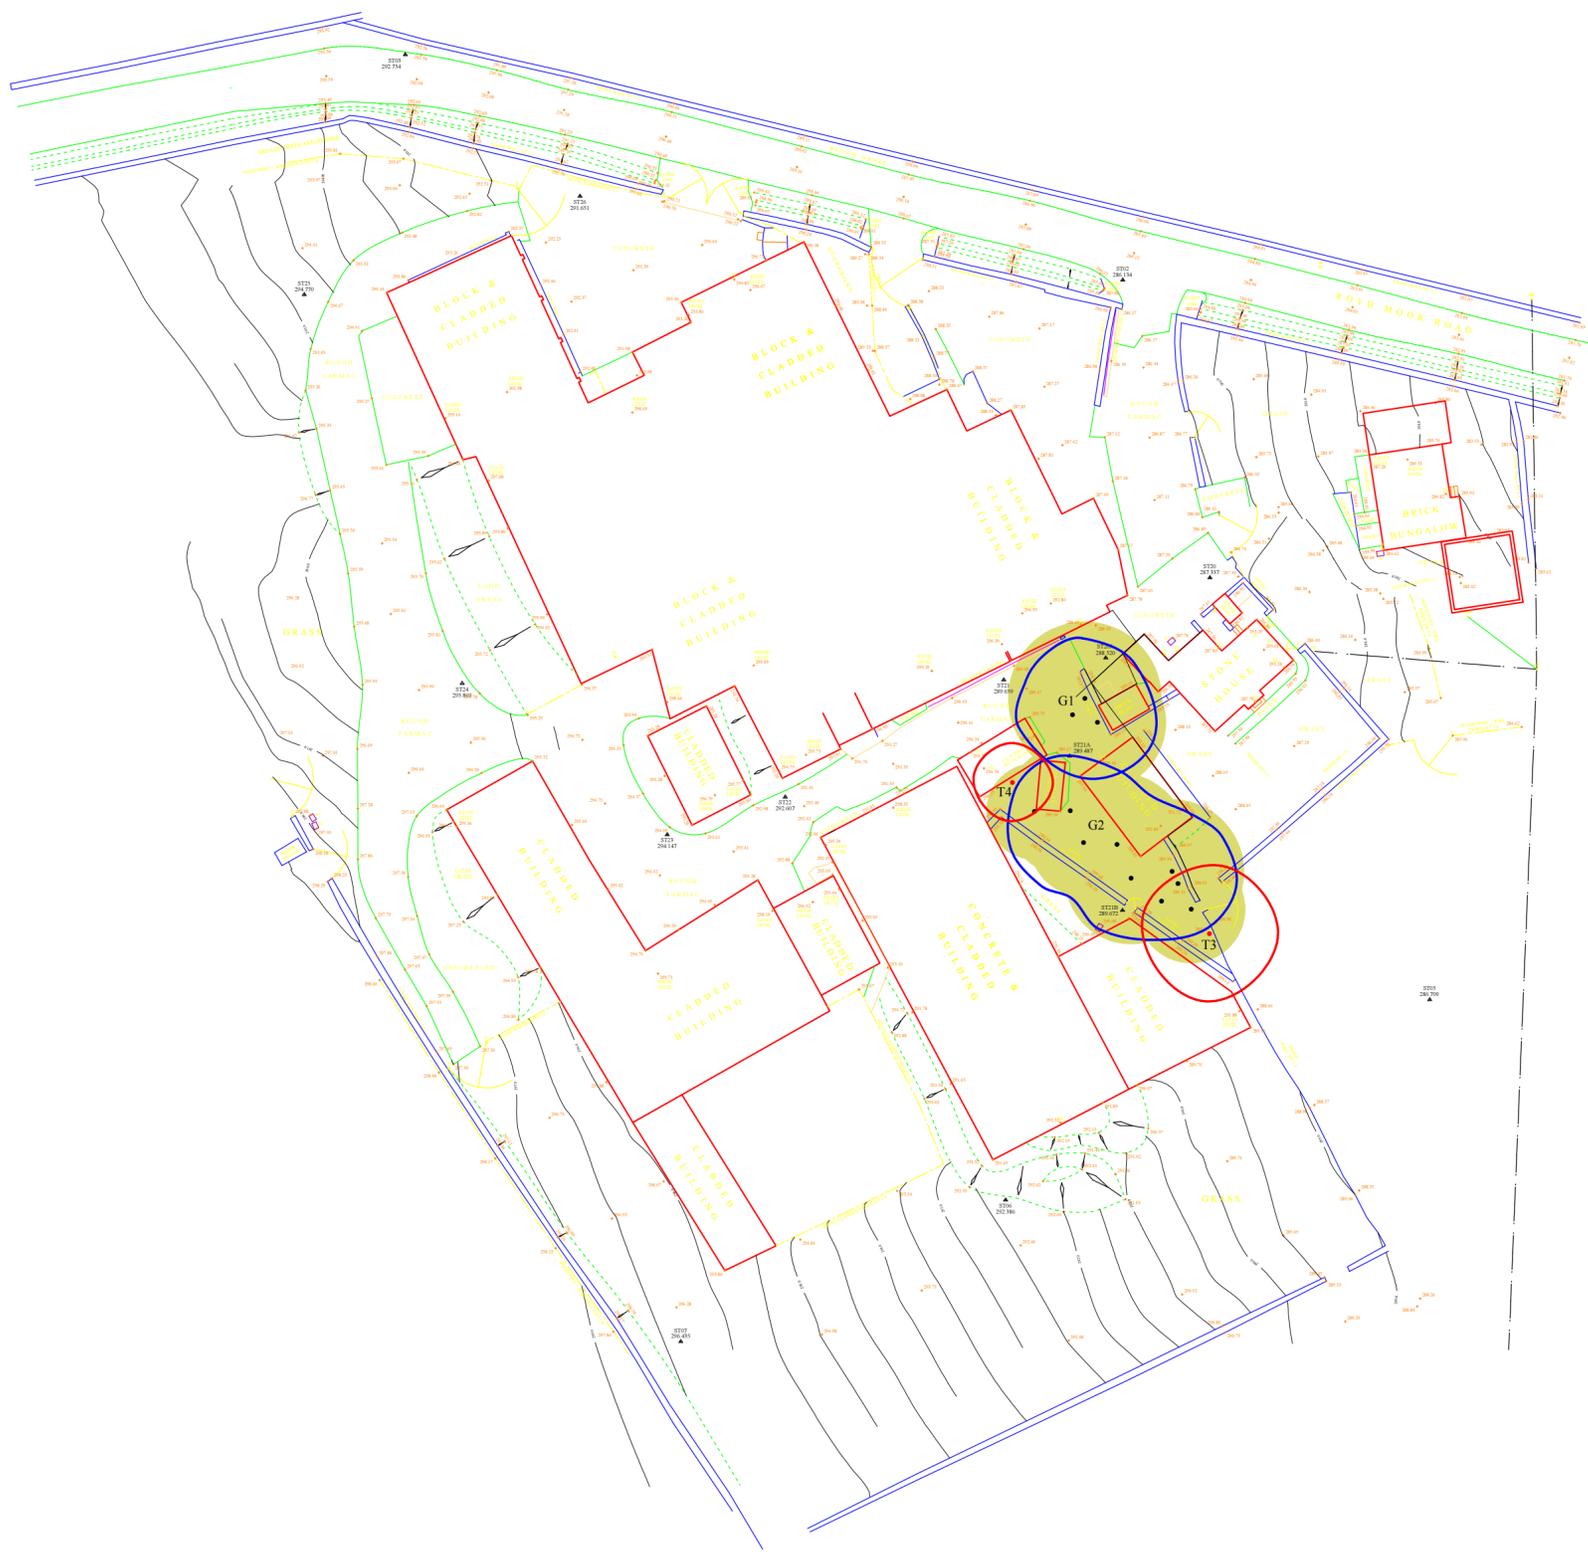
**Appendix 5:
Tree Constraints Plan**

Root Protection Area: RPA

THE ROOT PROTECTION AREA SHOULD IDEALLY REMAIN UNDISTURBED IF THE TREE IS TO BE RETAINED.

THE DEVELOPMENT PROPOSALS SHOULD THEREFORE BE DESIGNED TO AVOID THE RPA OF ANY TREE WHICH IS TO BE RETAINED.

IF IT IS NECESSARY FOR THE DEVELOPMENT TO ENCOACH INTO THE RPA OF A TREE WHICH IS TO BE RETAINED THEN SPECIALIST CONSTRUCTION TECHNIQUES AND MATERIALS MUST BE CONSIDERED.

- 2.1 The tree information recorded during the original survey is detailed in the tables at **Appendix 1**. A full explanation of the tables can be found at **Appendix 2**. Please refer also to the Tree Constraints Plan at **Appendix 5** for tree locations.

- 4.6 The protection of retained trees can be achieved by the creation of a Construction Exclusion Zone based on the Root Protection Area of a tree. The Root Protection Area of each tree or group is marked on the Tree Constraints Plan at **Appendix 5**.

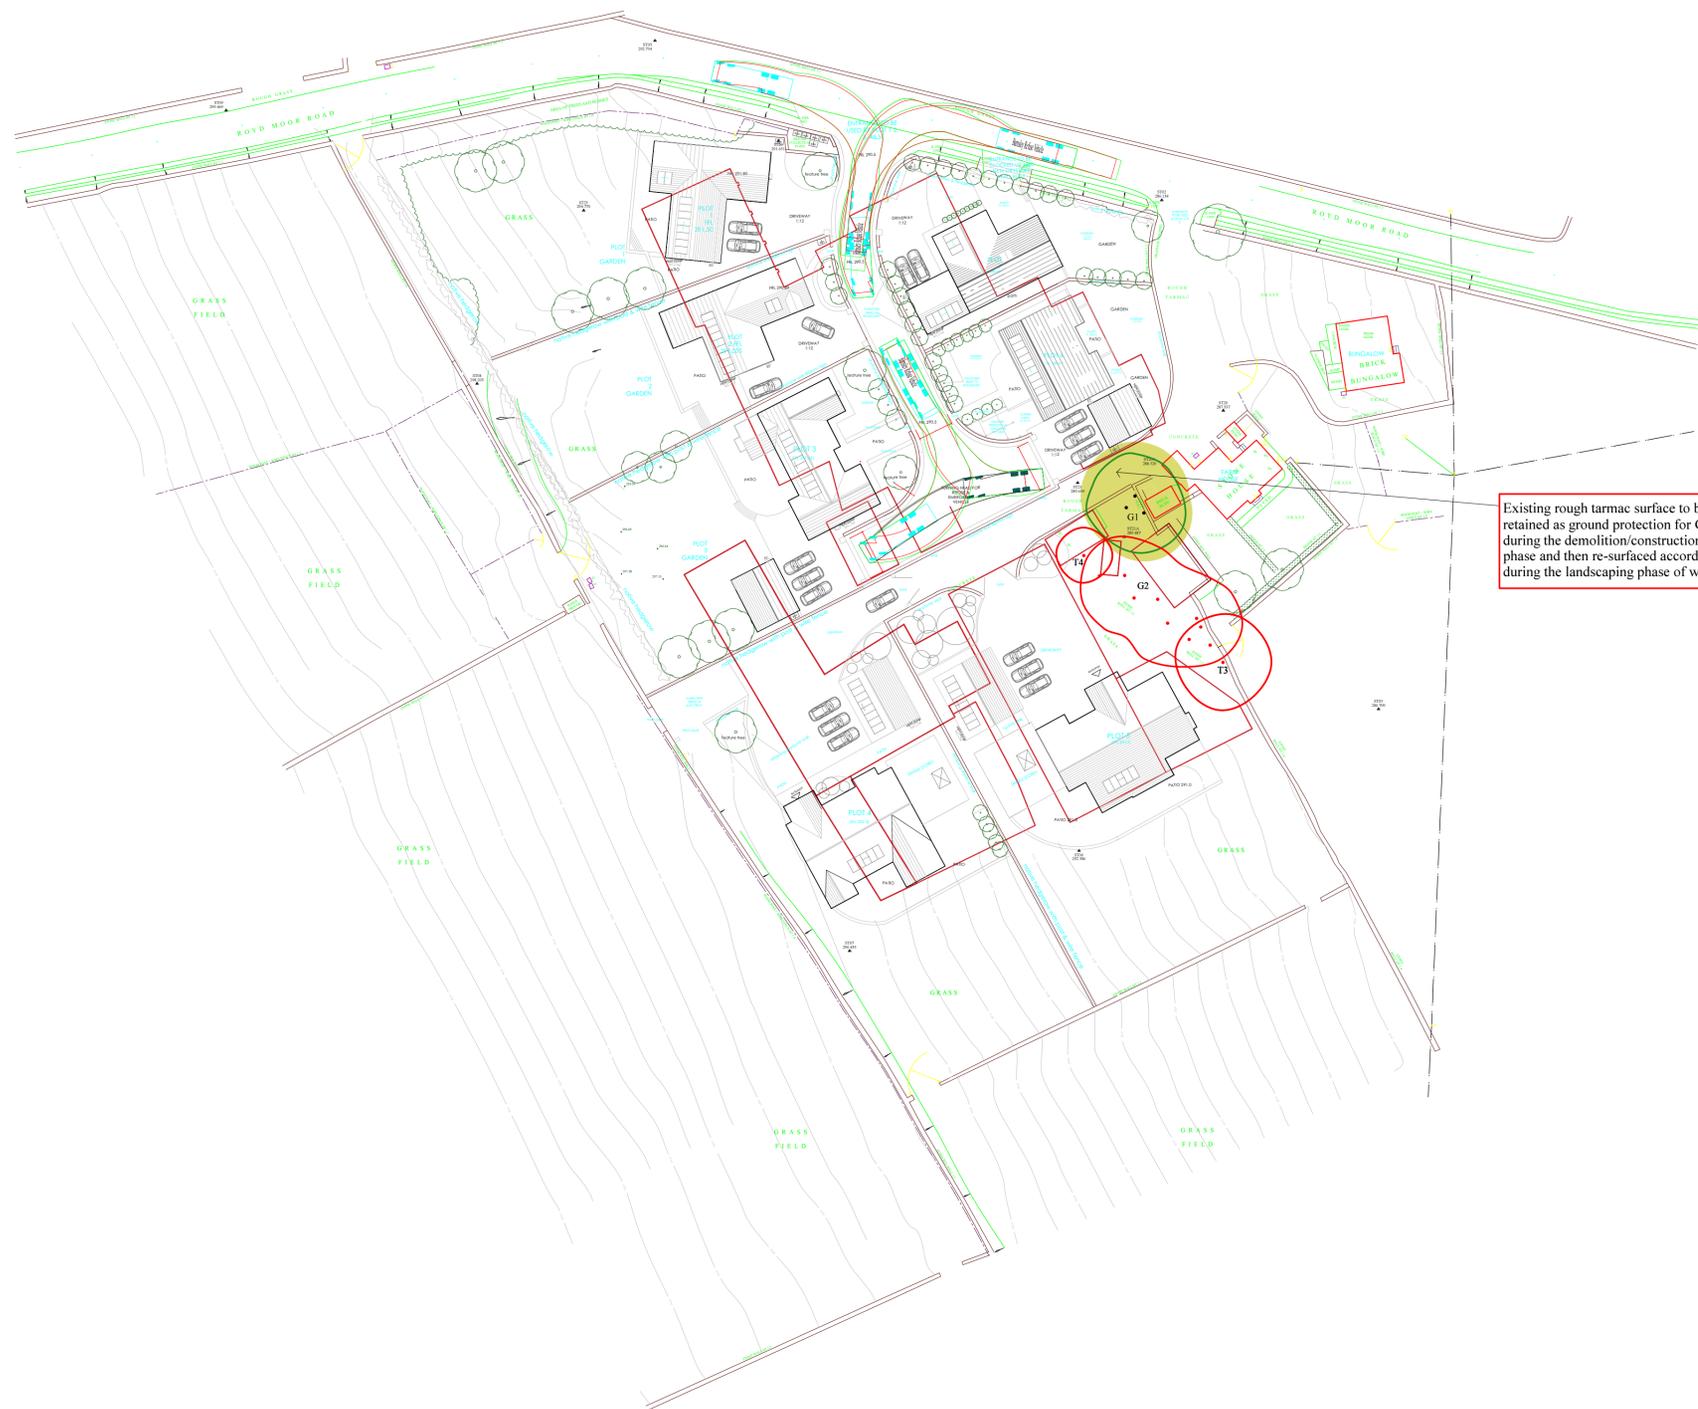
Existing rough tarmac surface to be retained as ground protection for G1 during the demolition/construction phase and then re-surfaced accordingly during the landscaping phase of work.

3.5.3.1 The new driveway will need to be constructed within the RPA of **G1**. In this case, the proposed surface is situated within the footprint of an existing rough tarmac surface. The existing surface should therefore be retained, (as detailed at **Section 3.5.2**) in situ to prevent damage to tree roots. It may then be resurfaced as appropriate, providing that the base is retained and no excavation takes place within the RPA.

- 4.3 The arboricultural implications of the development have been considered and are discussed in **Section 3**.
- 4.4 **Nine** trees (**G2**) in total require removal in order to facilitate the proposed development. Trees requiring removal are shown in red on the Arboricultural Implications Plan at **Appendix 6**, where the proposals can also be viewed.
