**REPORT ON  
SITE INVESTIGATION  
AT  
SHEFFIELD ROAD  
PENISTONE**

**Geotechnical  
Developments (UK) Ltd**

Report No: P4682NW/S84  
Date: 12<sup>th</sup> December 2007  
Status: Validated Issue 1

Prepared on behalf of Willstock Construction Ltd

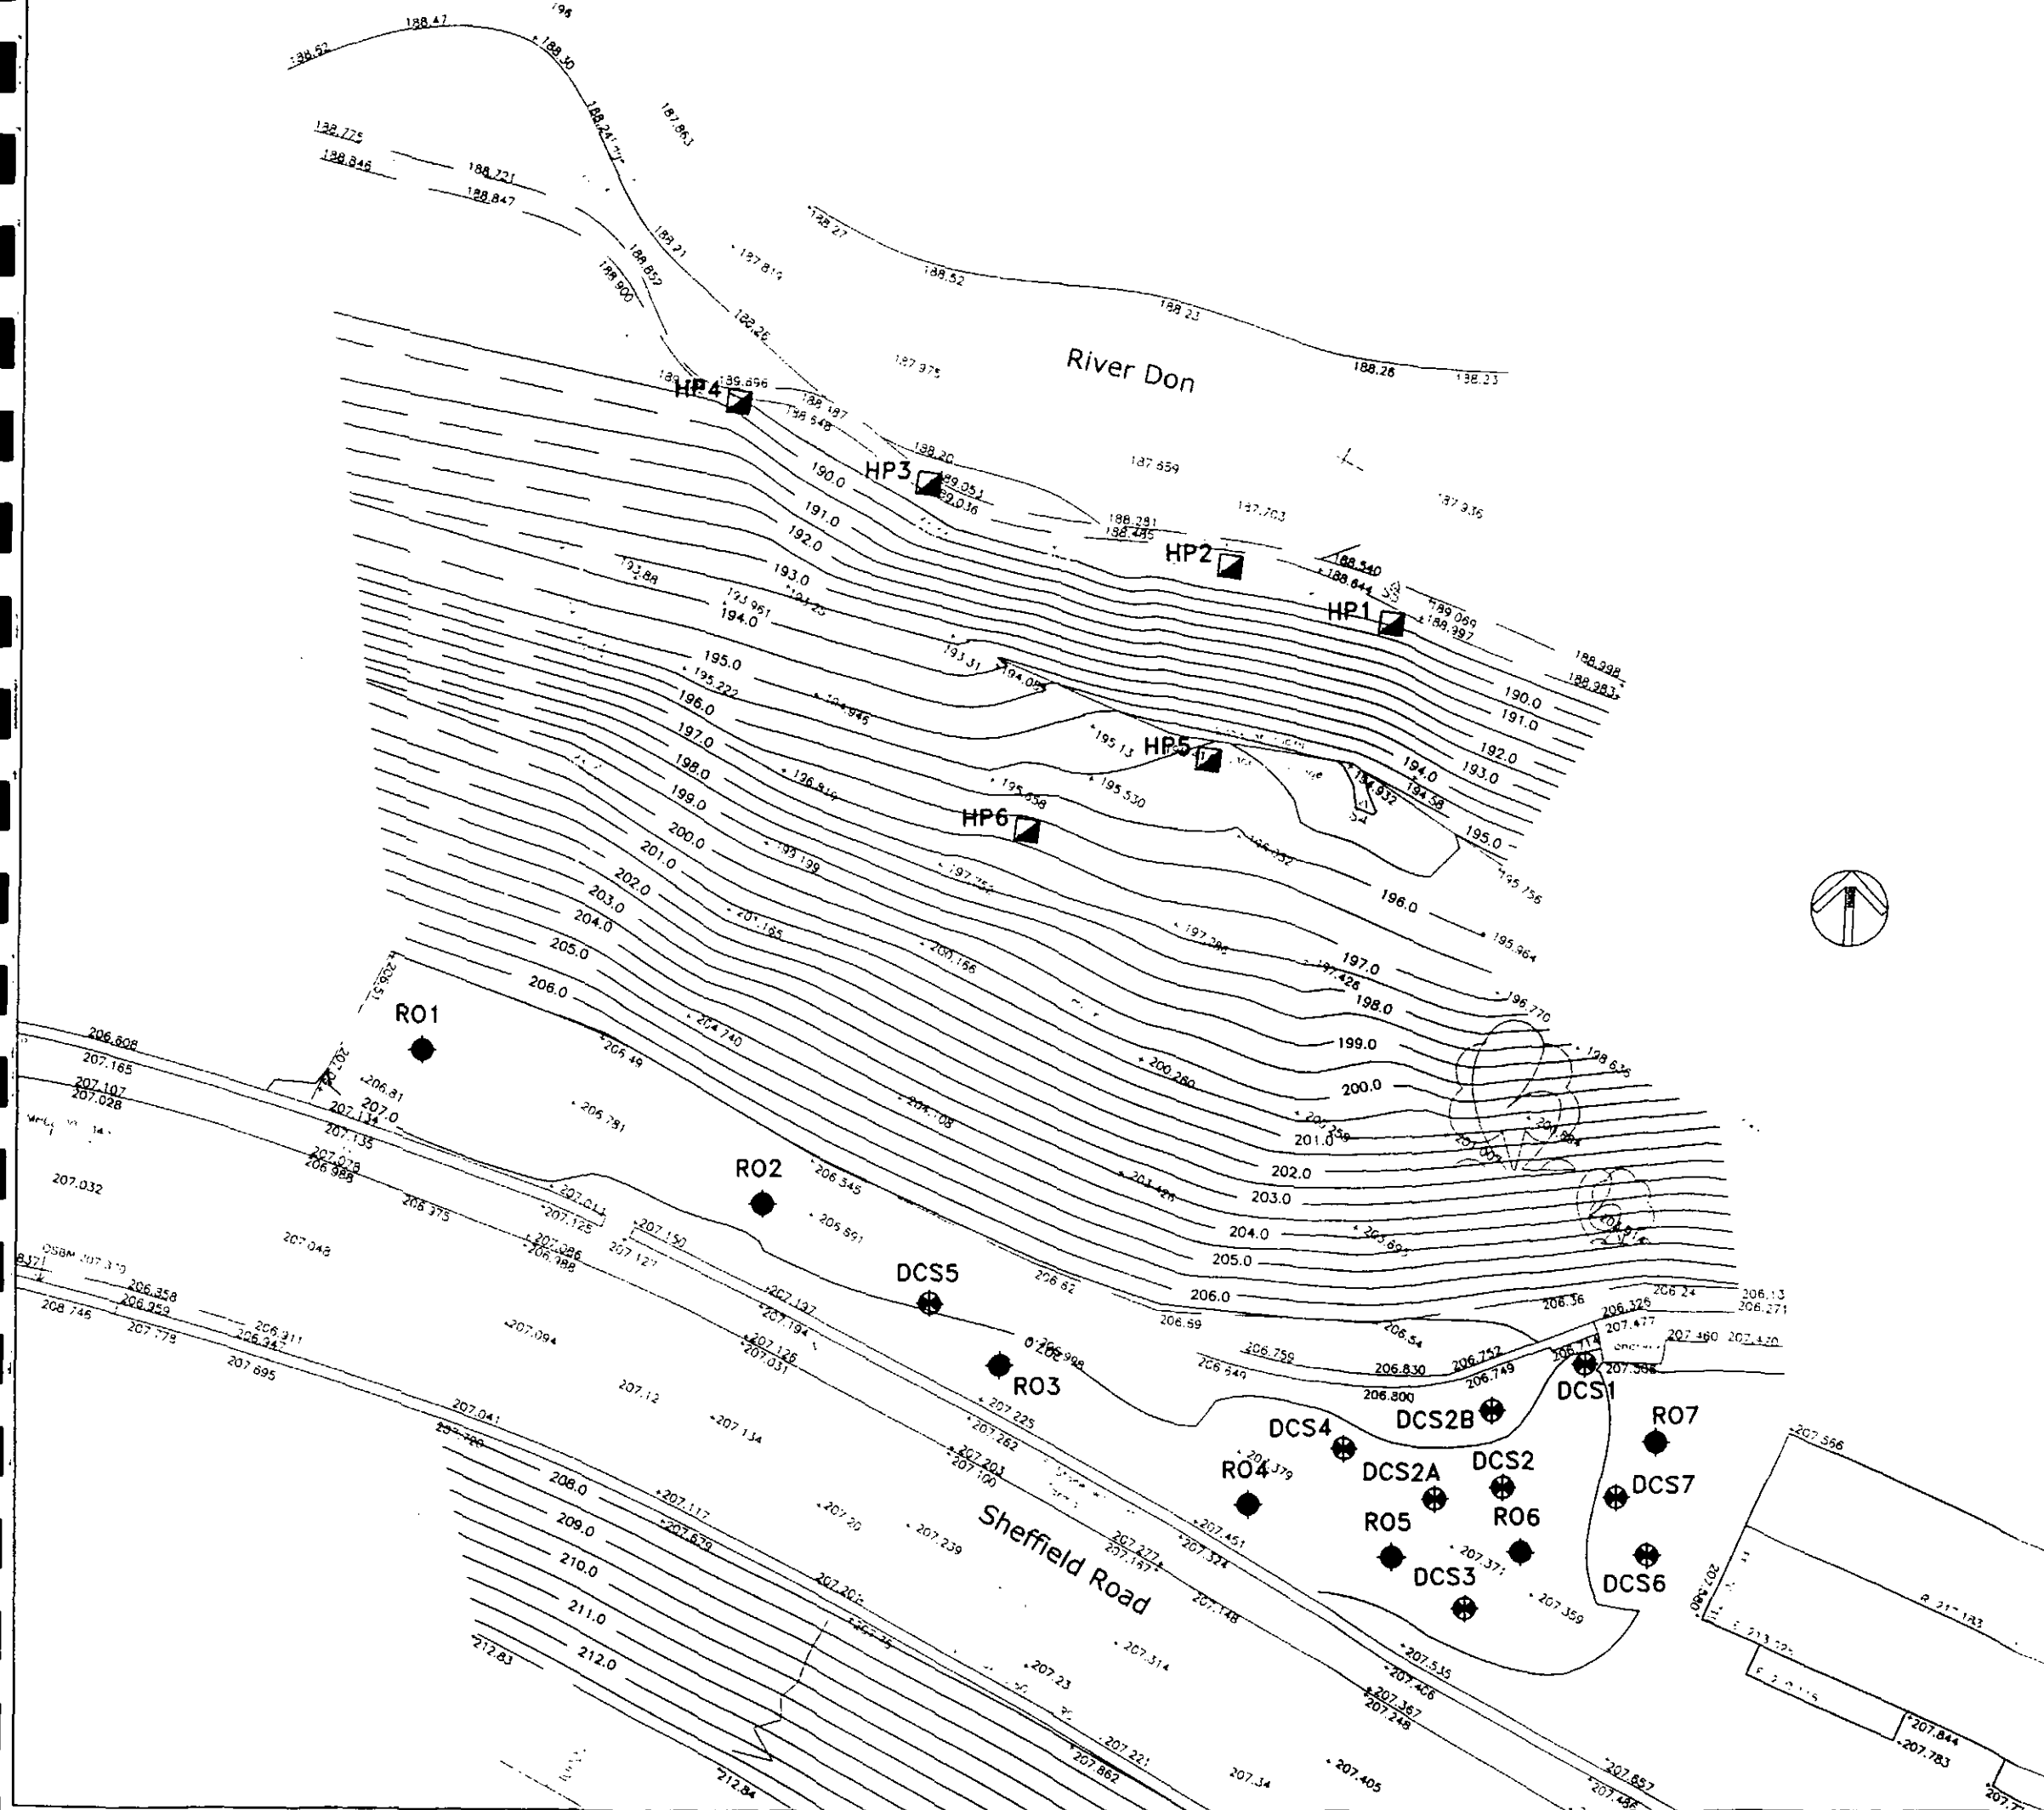
Drawing No. P4682NW/S84/01 Revision: A

Dynamic Continuous  
Sampler Borehole.  
Geotechnical Developments (UK) Ltd.  
September 2007

Rotary Core Borehole.  
Geotechnical Developments (UK) Ltd.  
October 2007
