**Phase 1 Geoenvironmental Risk Assessment and  
Phase 2 Ground Investigation**

**COTE LANE  
THURGOLAND, BARNSELY**

**Alfa Homes Ltd**

Report Number 3819

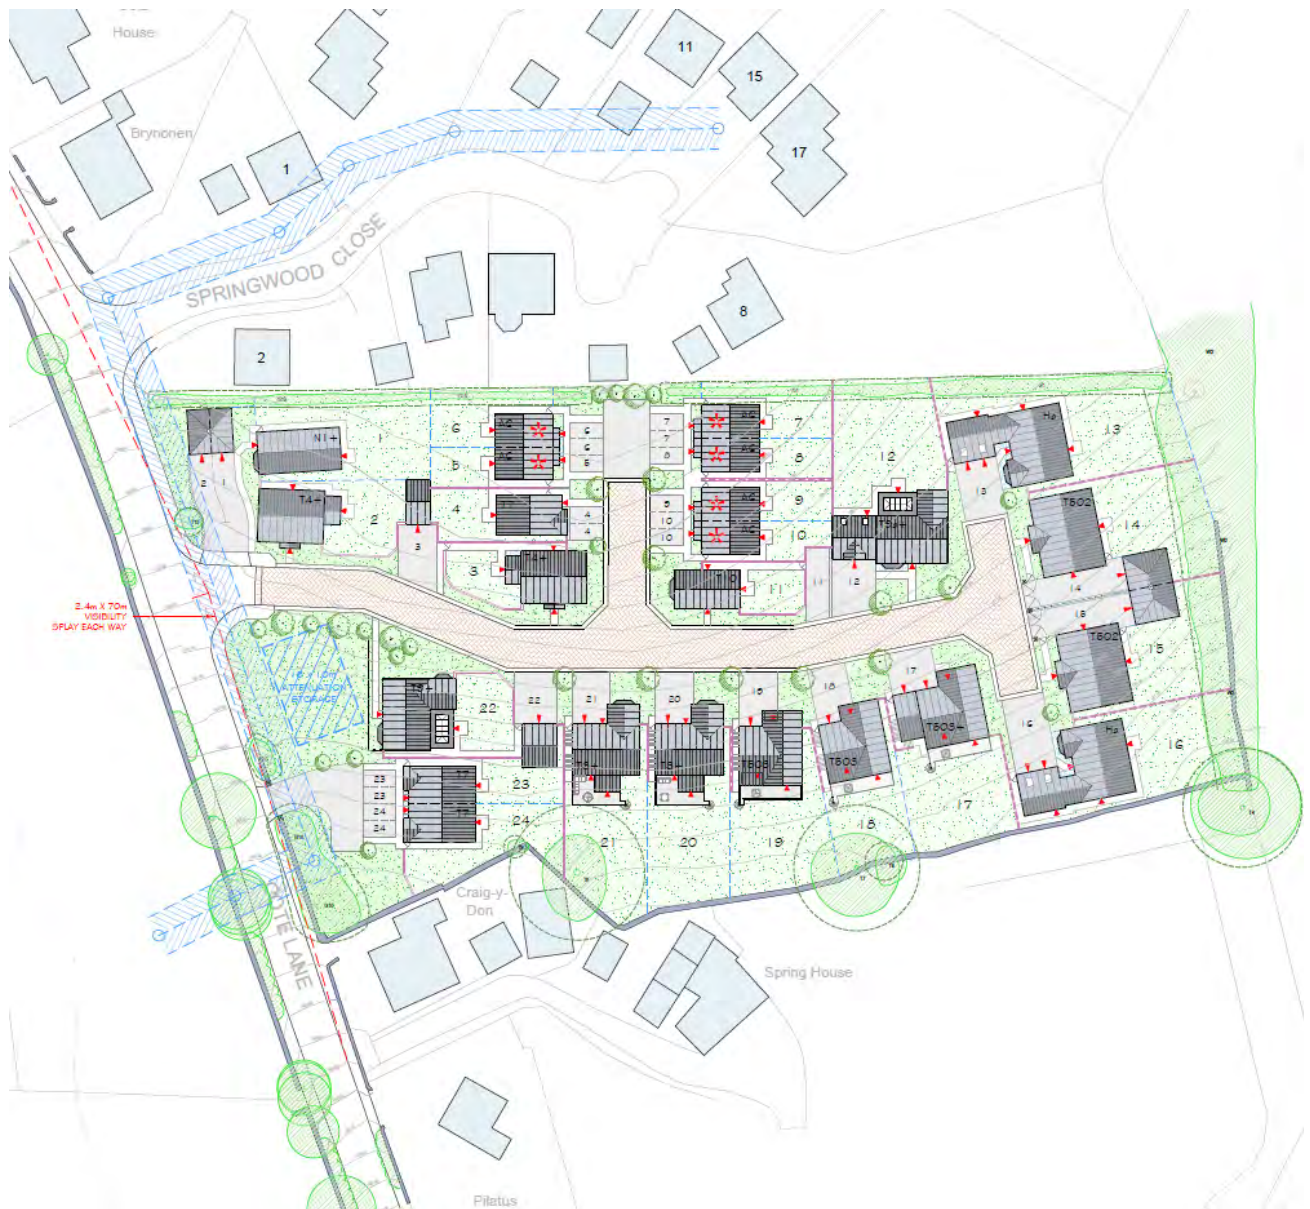
Figure: 3

**Cote Lane, Thurgoland**  
Site Plan with Development Proposals
