Firethorn Developments Limited

# Gateway 36 Development Site – Phase 3

External Yard Settlement Monitoring Validation

323064-R02 (00)

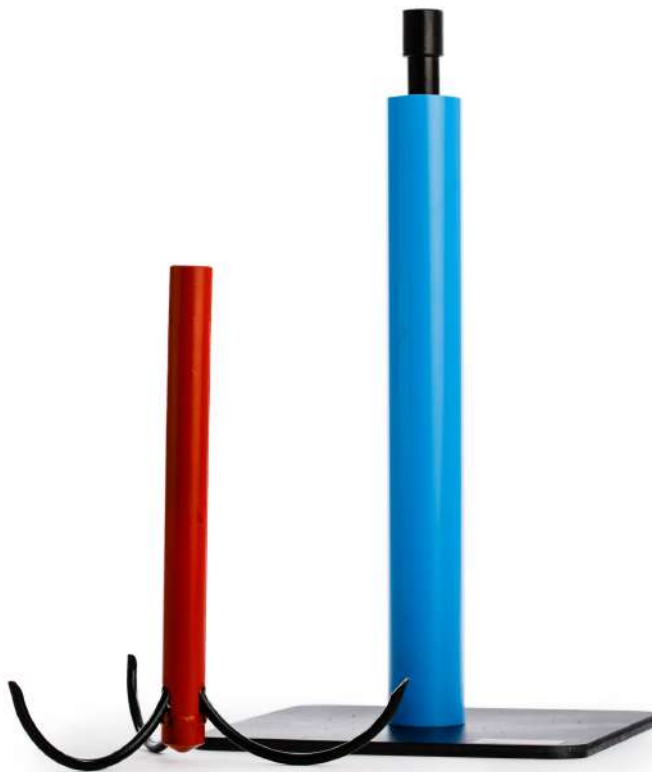
## Rod Settlement System GEO-XR

Geosense® GEO-XR single point rod settlement system is used to monitor sub-surface settlement or heave of ground

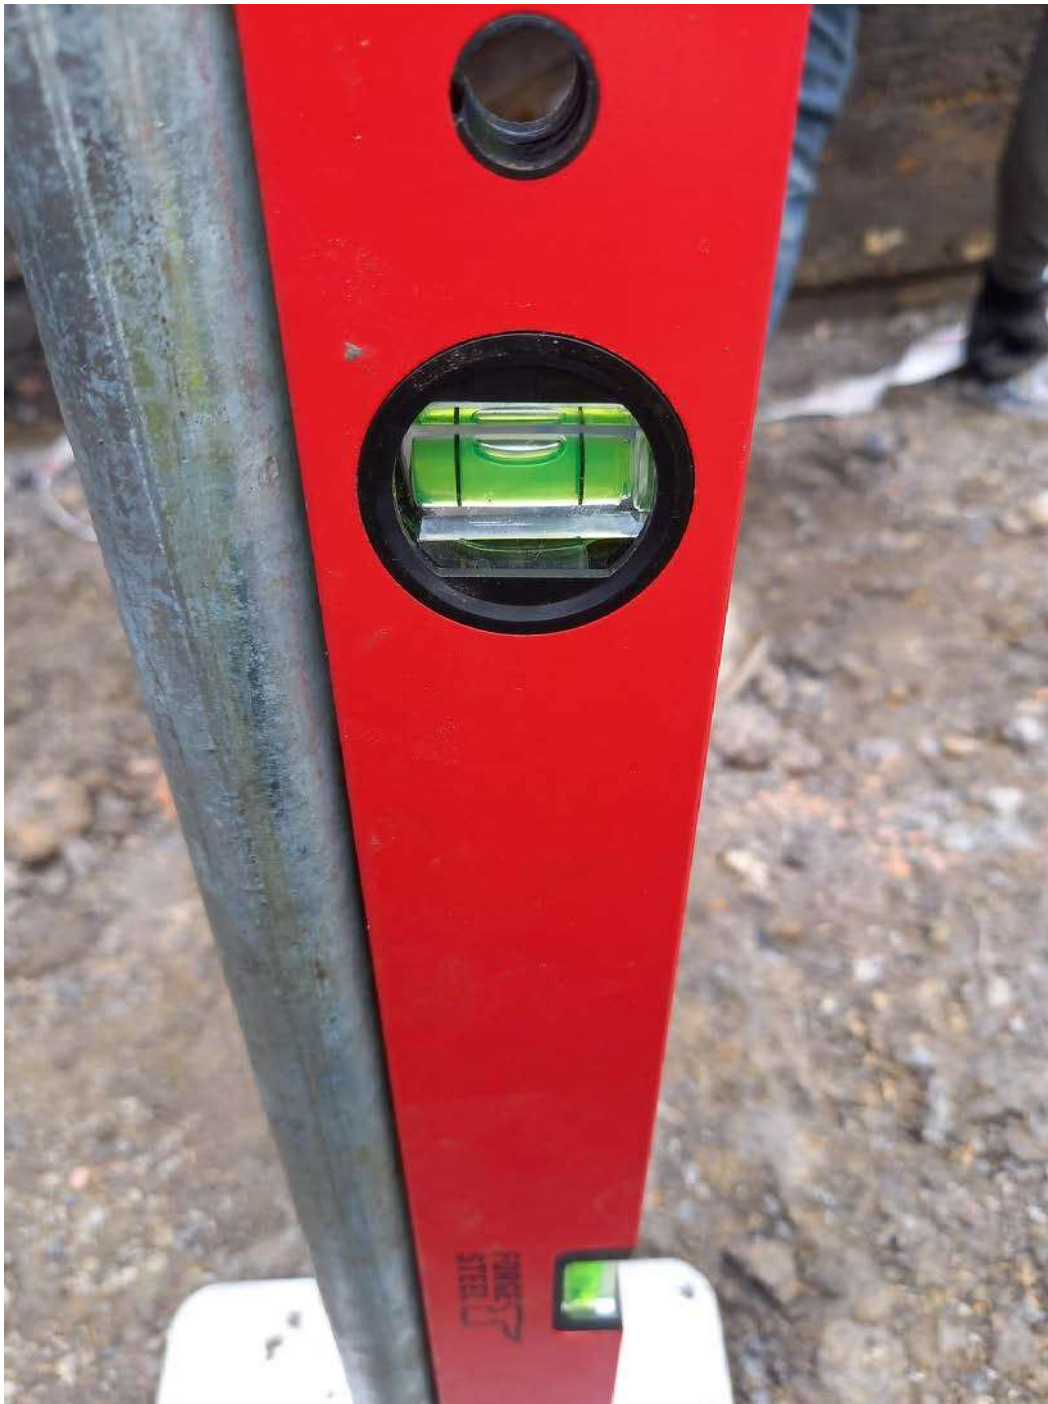
Photograph No 1: Taken on 18 August 2022 – Example of confirmation that the base plates the monitoring rods were installed on were levelled before installation was completed.

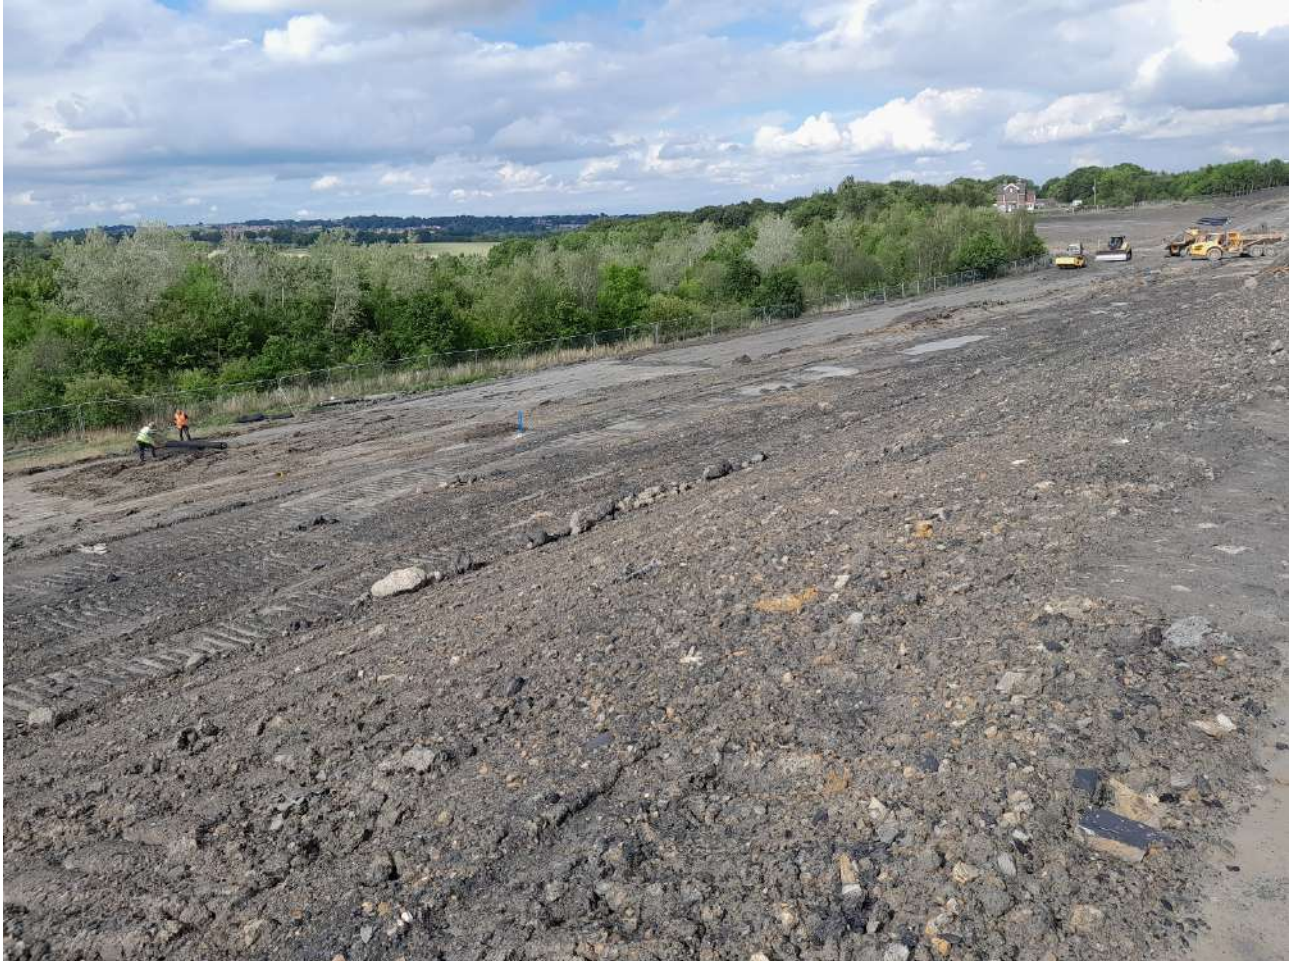
Photograph No 2: Taken on 23 August 2022 – Monitoring rod (blue tubing) locations in background on proposed External Yard Area.

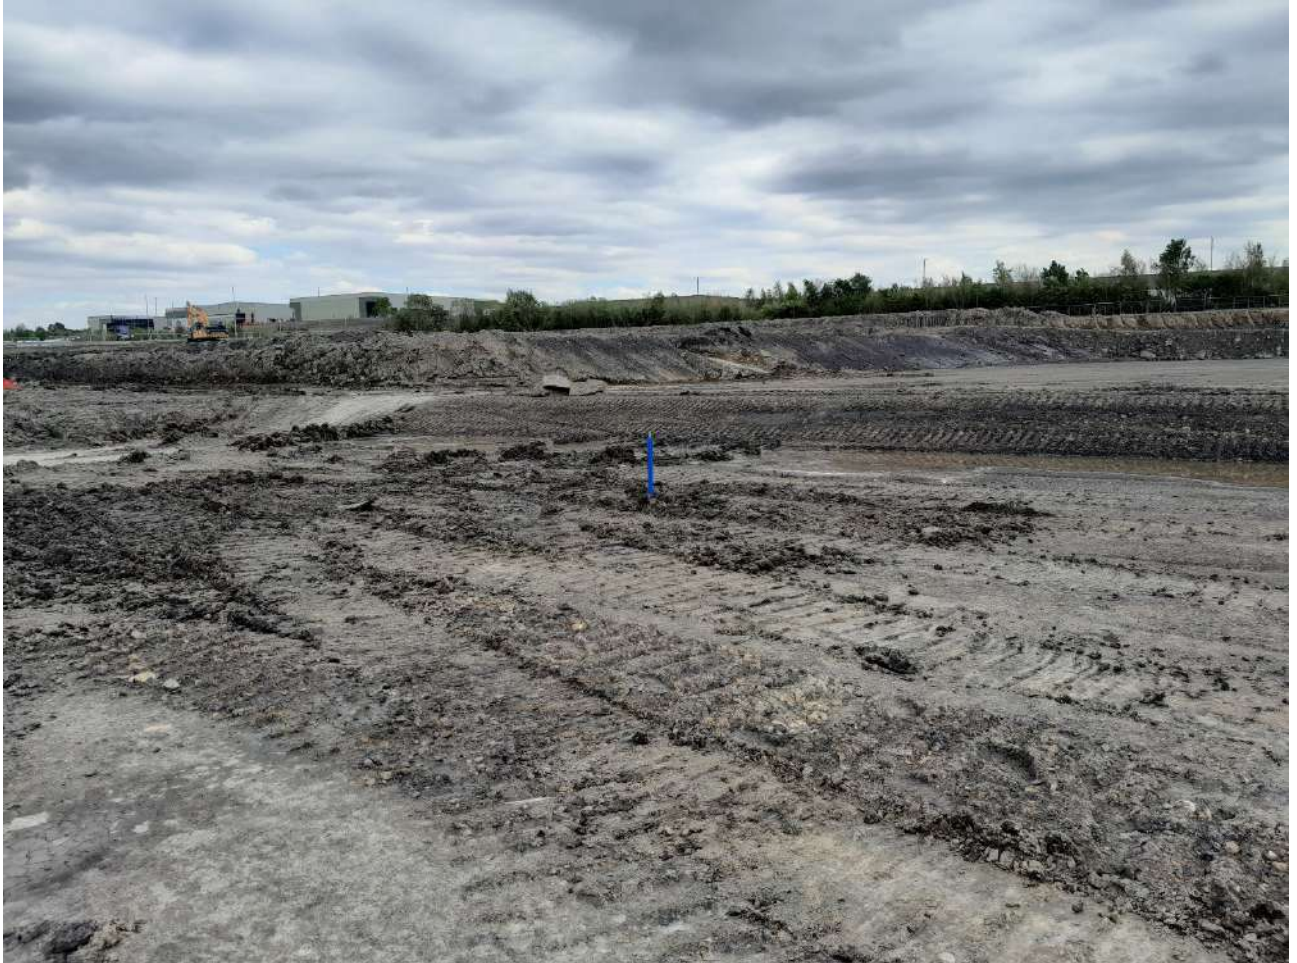
Photograph No 3: taken on 26 August 2022 – Levelling of the External Yard Area with Monitoring Rod in place.

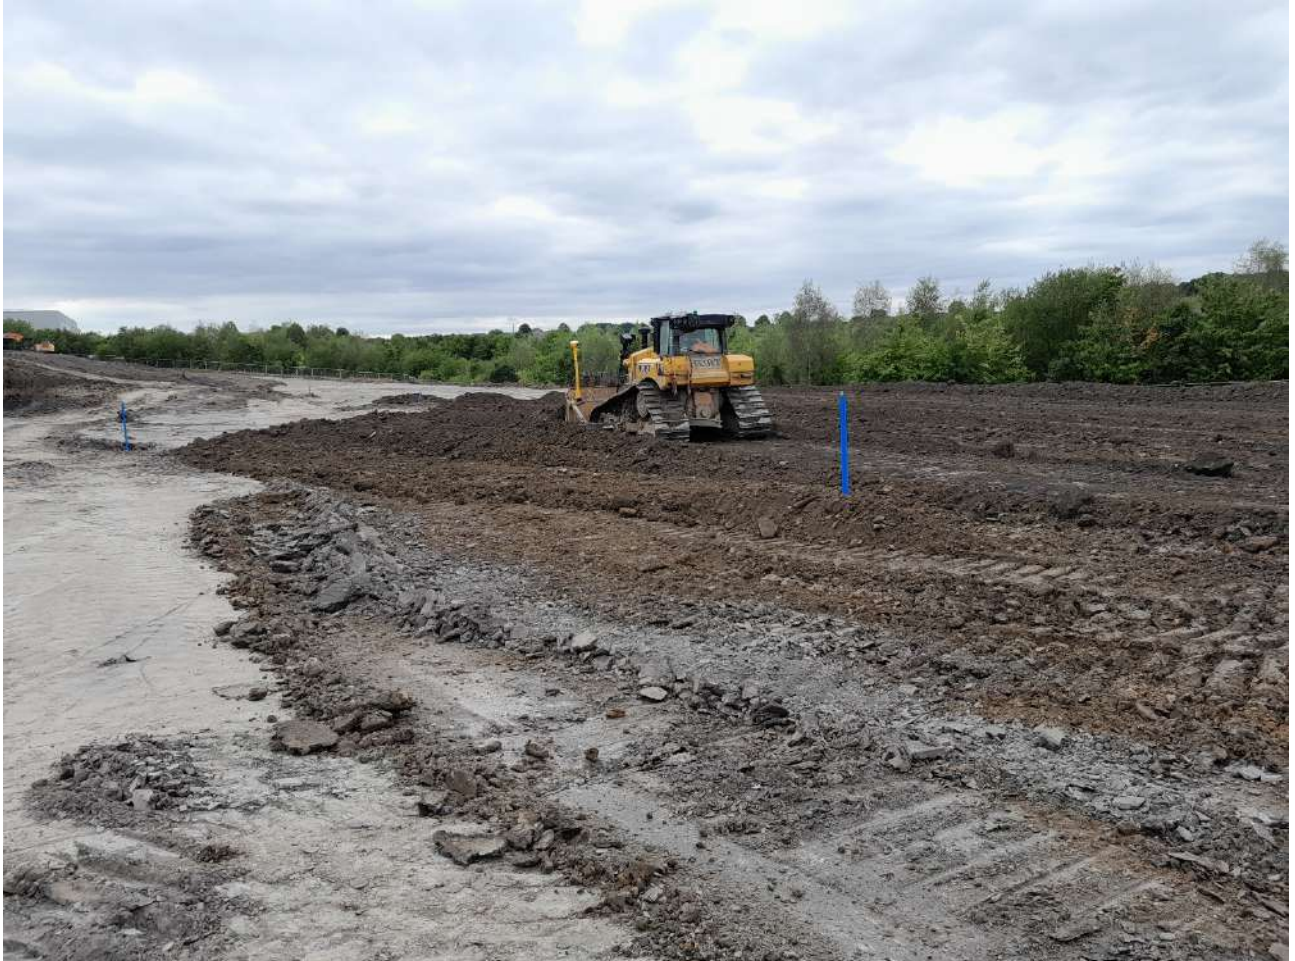
Photograph No 4: taken on 26 August 2022 – Shows a bulldozer working on increasing the levels of the surcharge and the monitoring rods with their extension tubing.

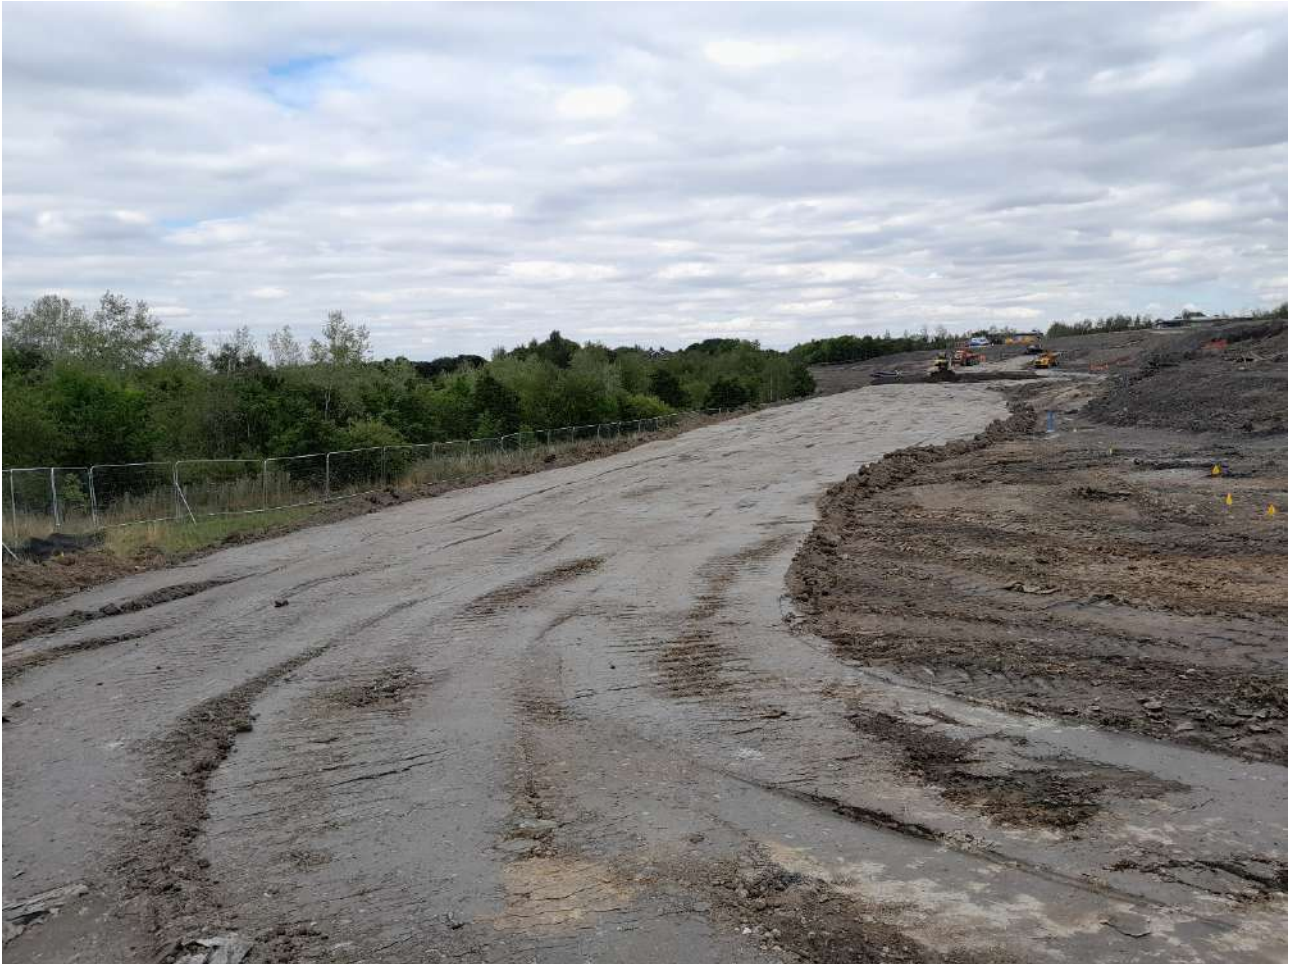
Photograph No 5: taken on 26 August 2022 – This shows how the surcharge had been brought to level and then rolled, with the yellow flags on the right of the photograph marking the required level.

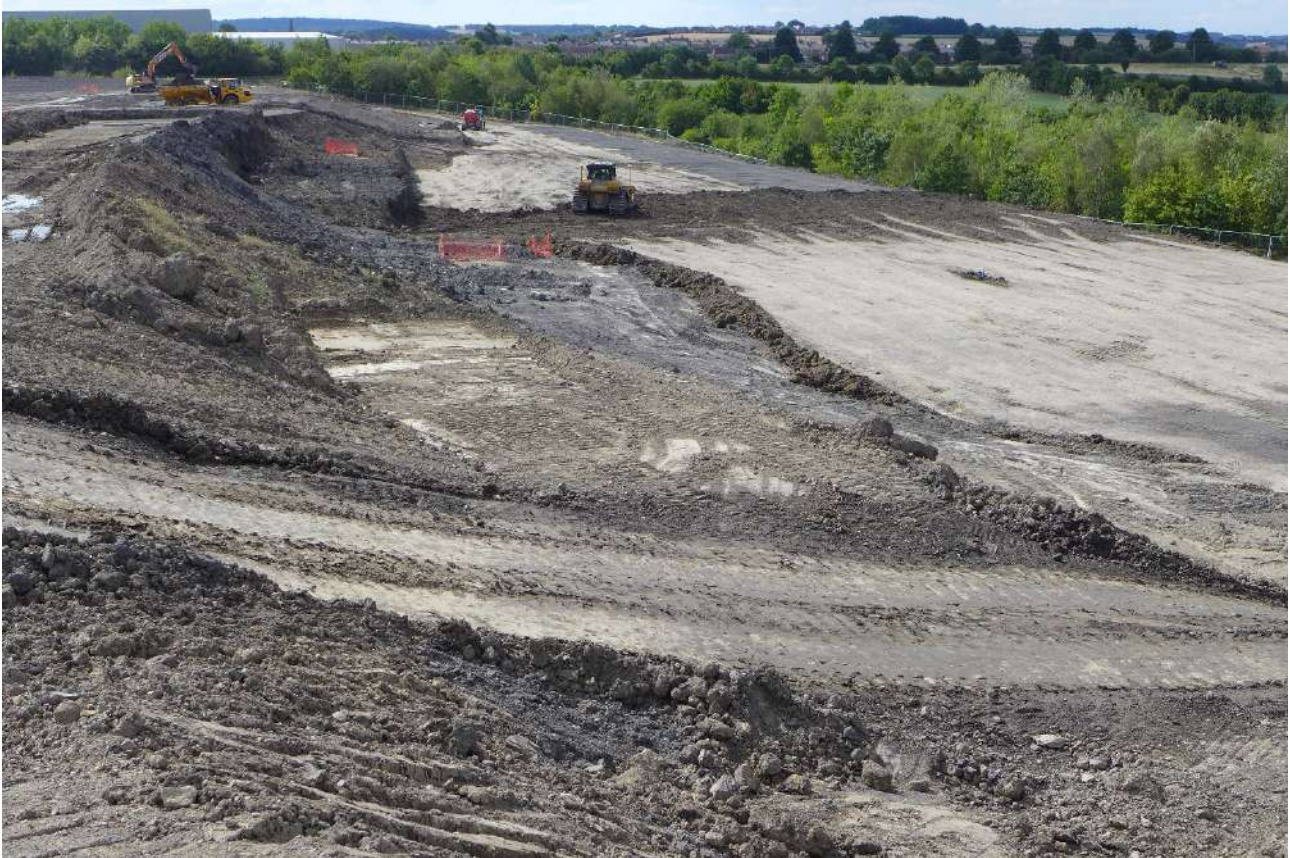
Photograph No 6: taken on 01 September 2022 – Continued work on increasing the levels in the External Yard Area, with monitoring rod in the centre of the rolled area.

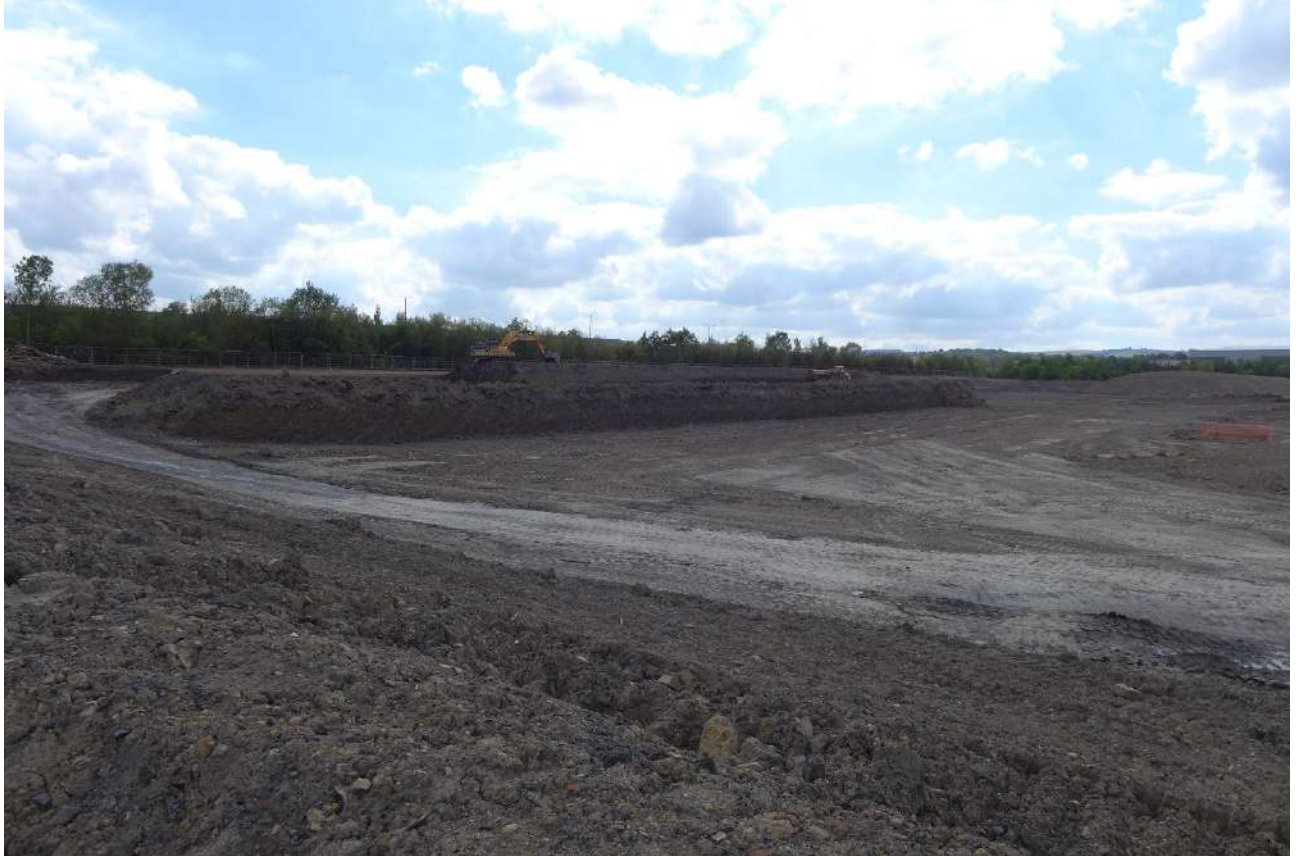
Photograph No 7: taken on 05 September 2022 – Removal of surcharge for engineered fill.

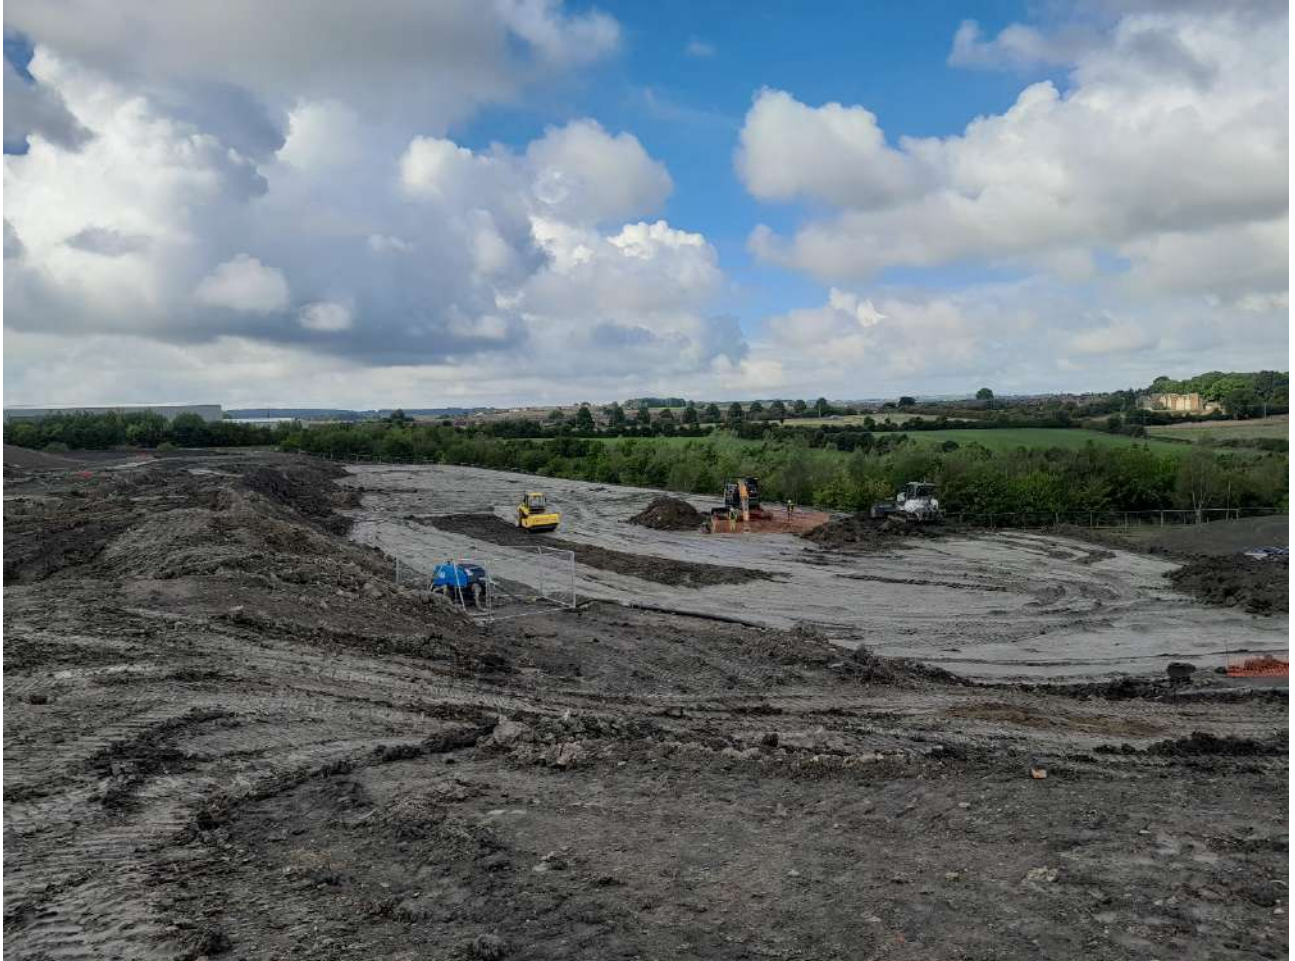
Photograph No 8: taken on 9 September 2022 – Continued work on increasing the levels with an orange barrier indicating the position of the monitoring rod.

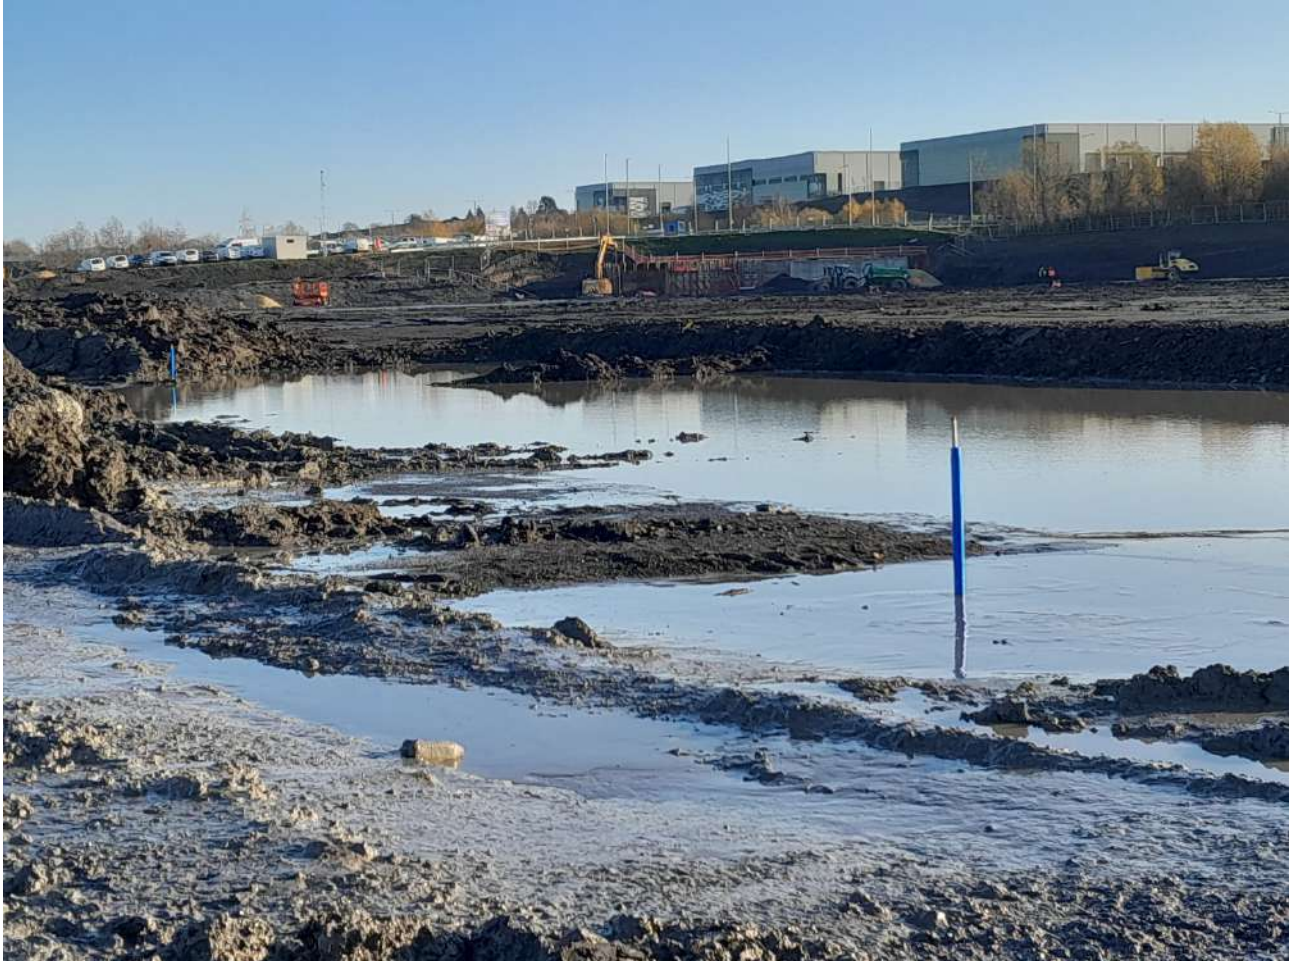
Photograph No 9: taken on 28 November 2022 – Monitoring visit showing monitoring rods in-situ after raising of ground levels.
