## Ecology Report

Rear courtyard - Coopers Art Gallery  
Church Street  
Barnsley  
S70 2AH

Revised May 2014

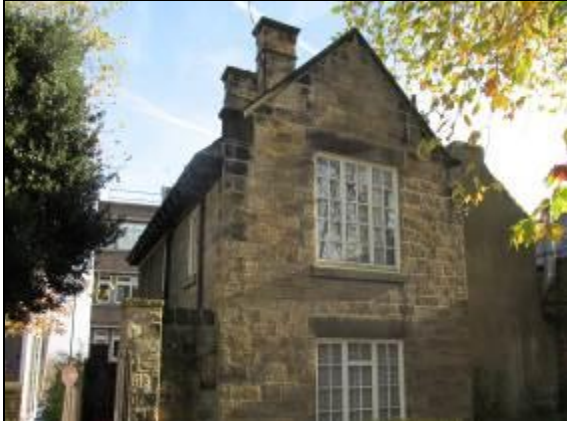
**Photo 1:** Building 1 – See Fig 1

All buildings facing onto the courtyard appeared to be in good condition with all external pointing intact with no gaps or missing masonry.

No lifted or broken/missing roof tiles were observed and the visible ridge tiles and lead flashing was tight with no suitable bat access.

The eaves / soffits of Building 1 were easily inspected from the ground and were clean, in good condition with no suitable gaps observed.

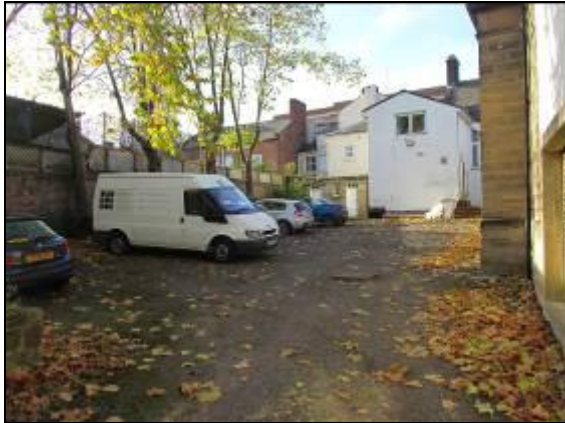
**Photo 7:** From Eastgate towards the gallery

The survey site is a very small enclosed area (0.1ha) of hard standing which is used as a car park by the gallery staff.

There is a belt of six mature London plane along the southern boundary and a small group of five mature holly trees *Ilex aquifolium* and two mature London plane trees at the Eastgate entrance of the courtyard.

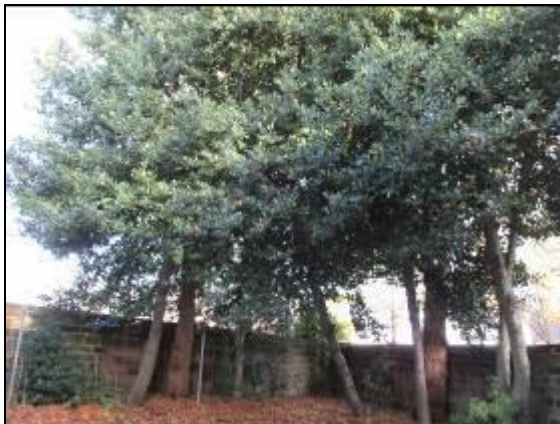
**Photo 9:** Holly trees at Eastgate entrance

All trees were in in good condition (in relation to features suitable for bats) with no large, veteran trees present. None of the trees supported holes, cracks, crevices, large areas of lifted bark or coverings of ivy.

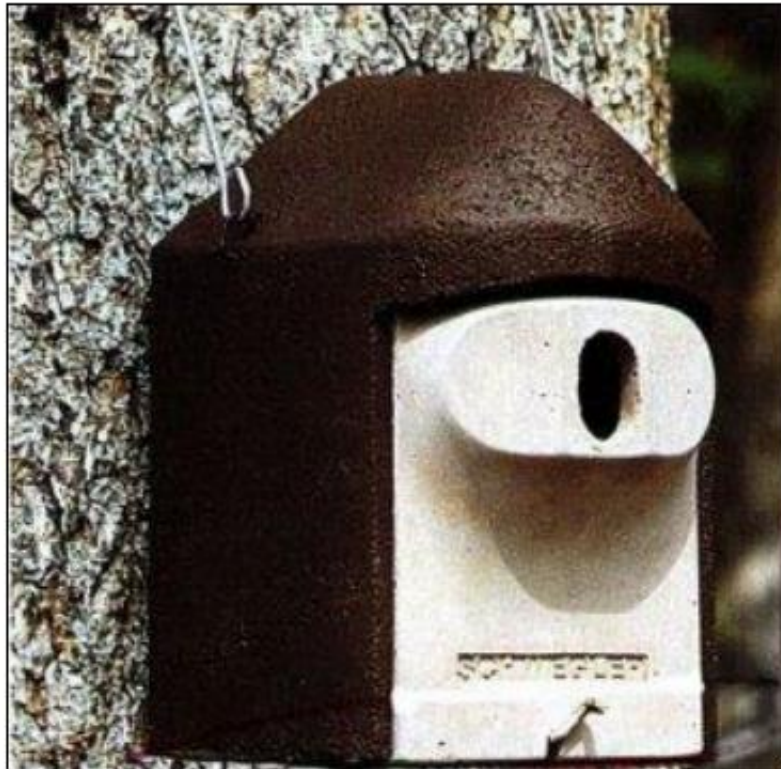
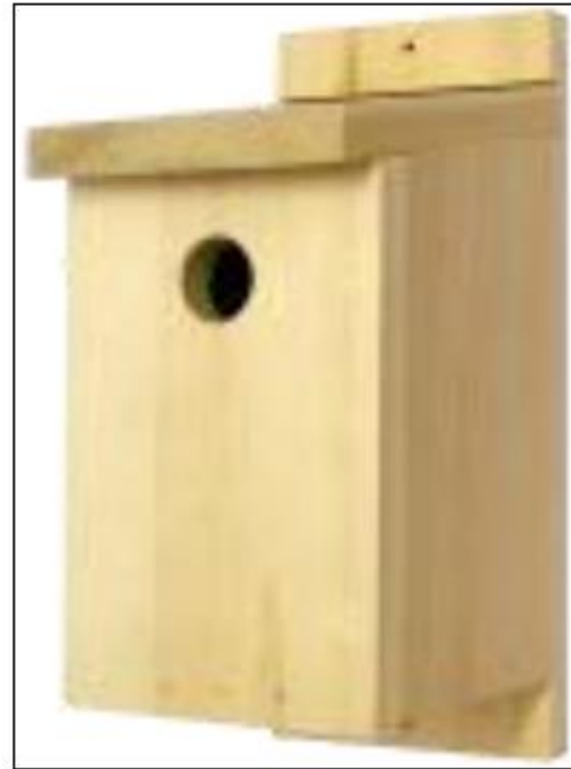
**Figure 3:**

GR2 Bird and Bat Box

Traditional General Purpose Bird Box

Examples of Nest boxes fitting into trees

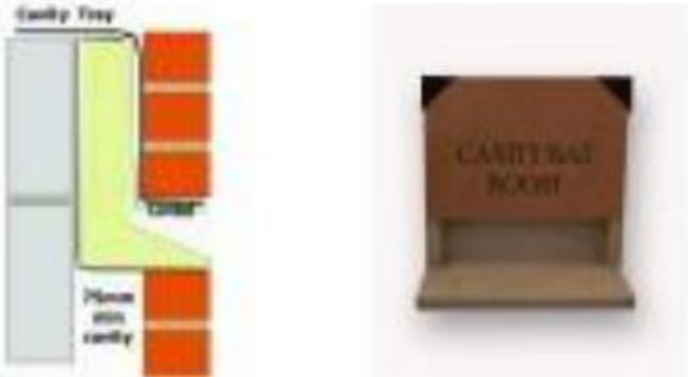
| <p><b>Figure 4:</b> Examples of Integrated Bat Boxes</p> <p><b>Site:</b> Rear courtyard, Coopers Art Gallery, Barnsley</p> | <p align="center"><b><u>Oatlands Ecology</u></b></p> <p align="center">13 Oatlands Drive, Otley W. Yorkshire LS21 2AY<br/> <b>Tel:</b> 07413 203574, <b>Email:</b> <a href="mailto:info@oatlands-ecology.co.uk">info@oatlands-ecology.co.uk</a><br/> <b>Web:</b> <a href="http://www.oatlands-ecology.co.uk">www.oatlands-ecology.co.uk</a></p> |
