Malt Kiln Farm, High Street, Royston

Bat Survey Report

17th December 2019

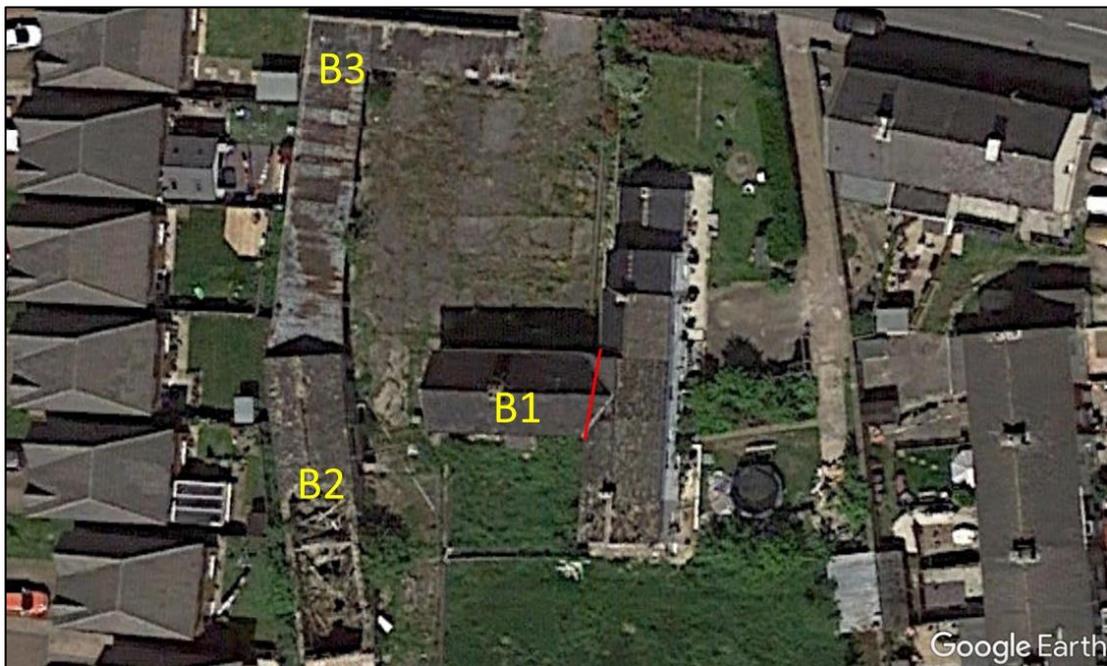
Figure 2. Building layout

5.2.2 The surveyed buildings comprise a listed farmhouse (B1), a barn (B2) and a 'L' shaped open fronted farm building (B3). For ease of understanding the building numbers are shown in Figure 2).

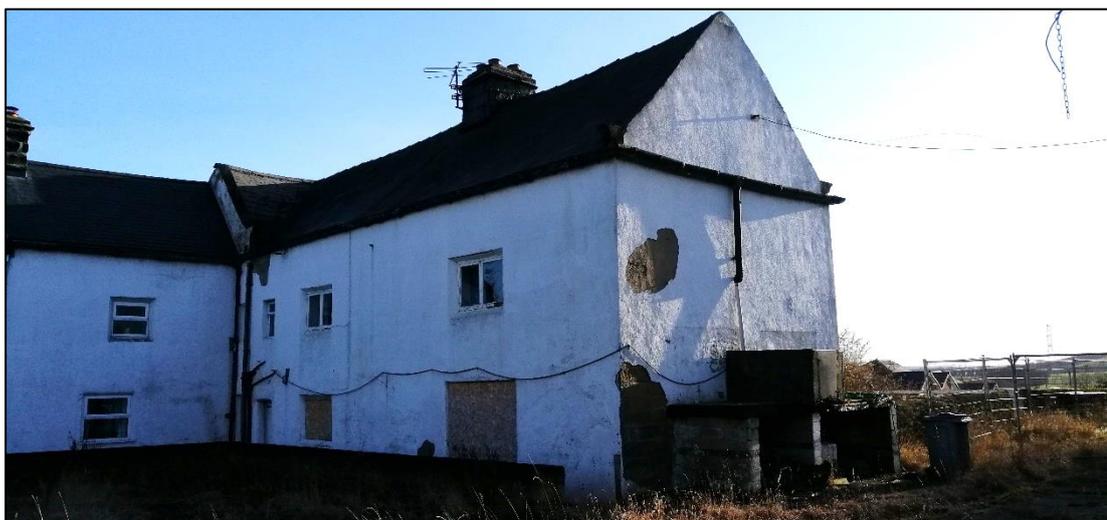
Plate 1. Farmhouse (B1)

5.2.3 Malt Kiln farmhouse (B1) comprises the western wing of a larger Grade II Listed 'T' shaped building, the original section of which dates back to the 17th Century. The two-storey building is stone built beneath a pitched Welsh slate roof which has been covered in bitumen. The building has single paned wood framed windows throughout and the external masonry is cement rendered. A very large stone-built chimney stack exits the centre of the roof (see Plates 1 & 2).

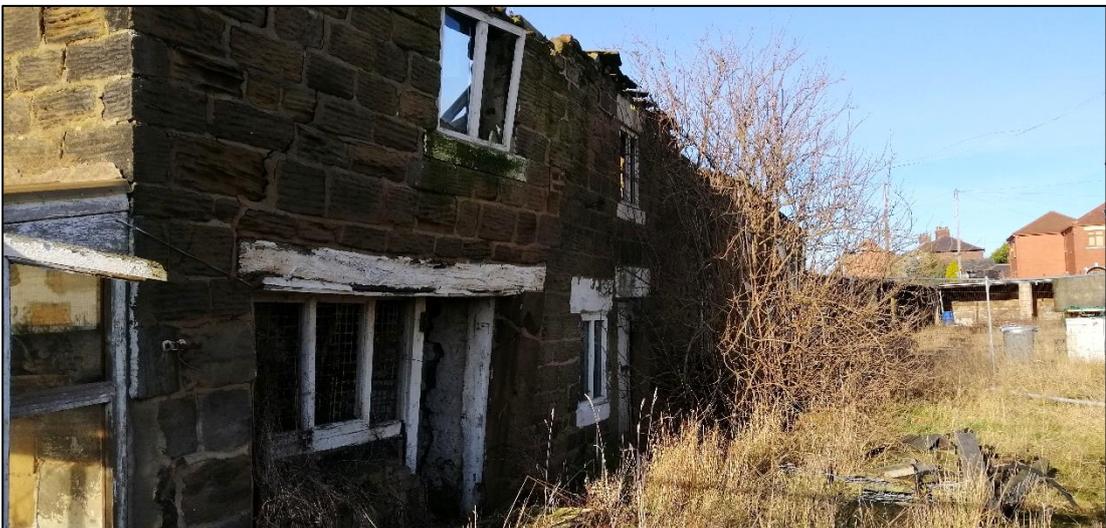
5.2.4 Building 2 (B2) comprises a c1800s rectangular two-storey stone built derelict barn beneath a pitched stone slate roof (only 40% of the roof exists). The building has single pane wood framed windows throughout and the southern section is in a dangerous condition with one external wall likely to collapse at any time soon (see Plates 3 & 4).

Plate 3. Section of B2 with no roof and collapsing wall

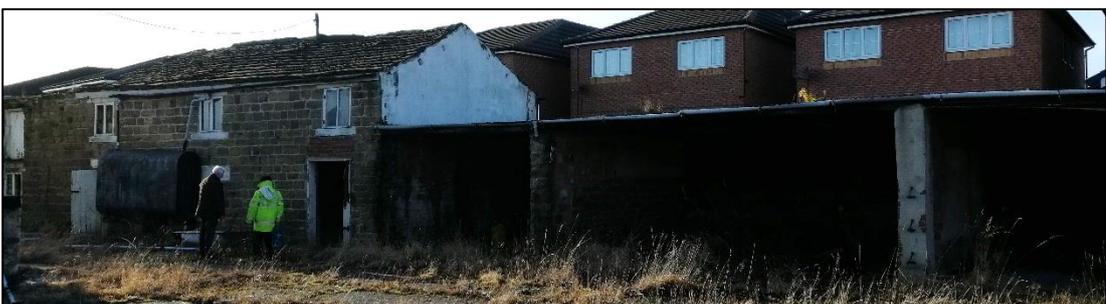
5.2.5 Building 3 (B3) is an 'L' shaped open fronted outbuilding with many compartments formally used for agricultural use. It is stone built with a shallow mono-pitched corrugated galvanised sheet metal roof. Some of the compartment walls are built of concrete blocks and the pillars are built of a combination of brick or blocks (see Plates 4, 5 & 10).

Plate 4. North section of B2 with roof, section of B3 on right

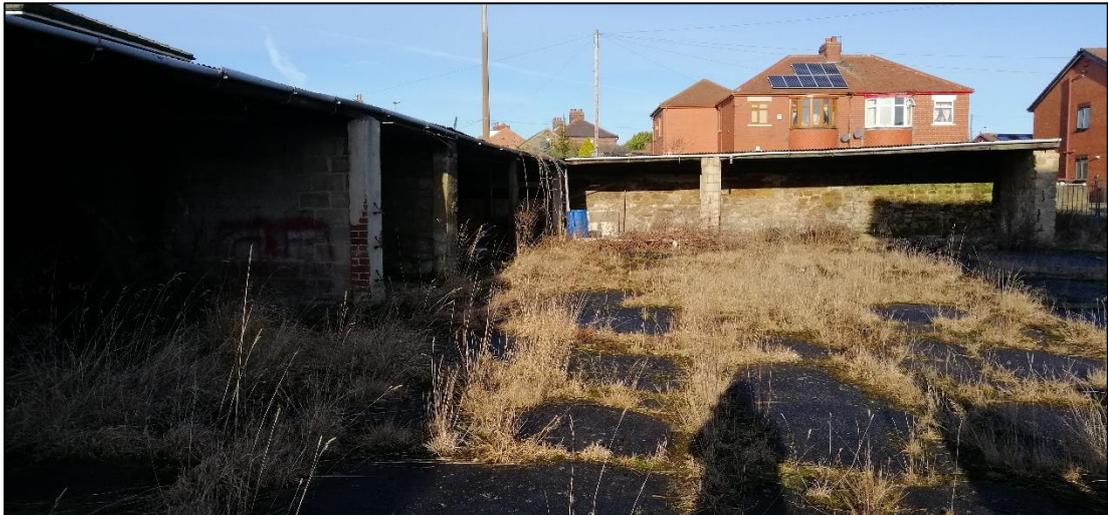
Plate 5. B3 looking north

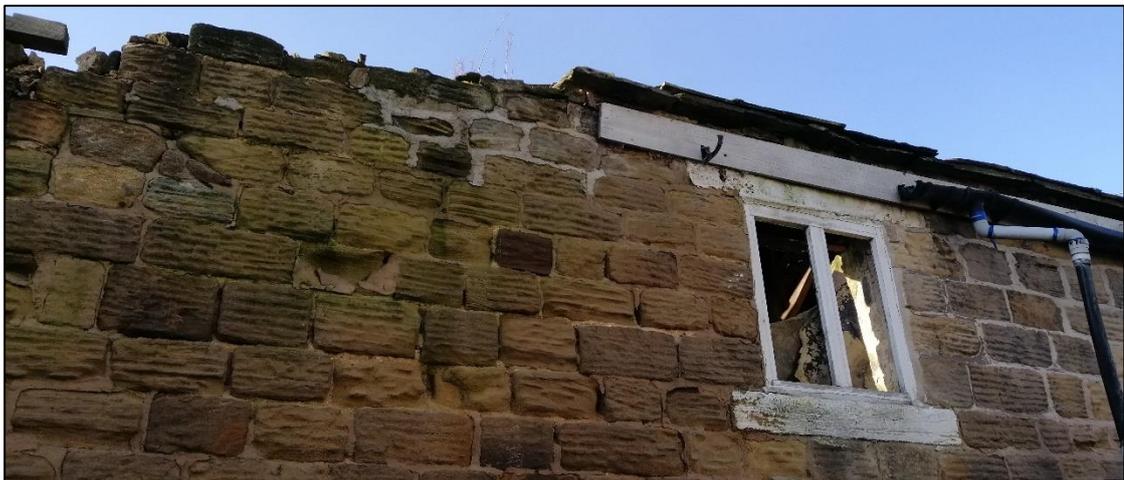
- 5.2.6 Bat roost features identified on B1 during the preliminary roost appraisal are restricted to the wall top, whilst bat roost features identified on the exterior of B2 include: several holes in the mortar joints of masonry in the southern section (see Plate 6), potential access to the wall top under the eaves on both the east and west elevations and gaps around one window frame on the north section. The external walls of B3 lack features with potential to accommodate bats.

Plate 6. Holes in the mortar joints of masonry on this section of B2 are unlikely to be utilised by roosting bats because of the ingress of water from above

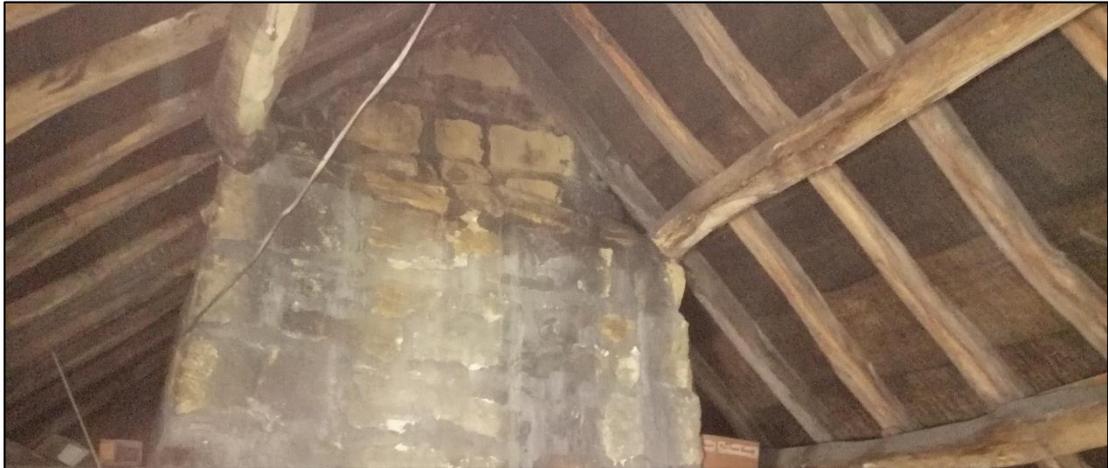
- 5.2.7 There is a stairway to the roof void of B1. The roof void has a height to the ridge of 3m and there is Type 1F felt beneath the slates. The roof is supported by king-post roof trusses, purlins, rafters and battens and there is a very large stone flue in the centre (see Plate 7). There is no insulation at ceiling height and there is potential access for bats via the wall top at eaves level. The space was not particularly 'cobwebby', but nevertheless, no signs of bats were found.

Plate 7. Inside of B1 showing large stone flue (Type 1F Felt beneath slates)

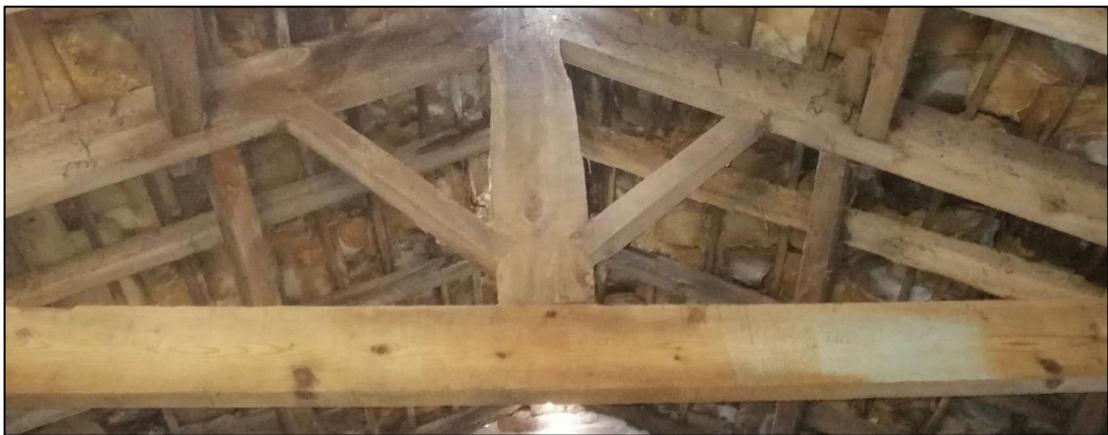
5.2.8 The northern section of B2 has kingpost roof trusses, purlins, rafters and battens with no membrane beneath the slates. Plate 8 was taken through a hole in the first floor as it was not possible to access the upper floor for reasons of health and safety (rotten floor). The first floor in the southern section which has no roof and is now so rotten that it is collapsing (see Plate 9). No signs of bats were found in lintels above doorways or in the areas where access was possible.

Plate 8. Inside of north section of B2 (no membrane beneath slates)

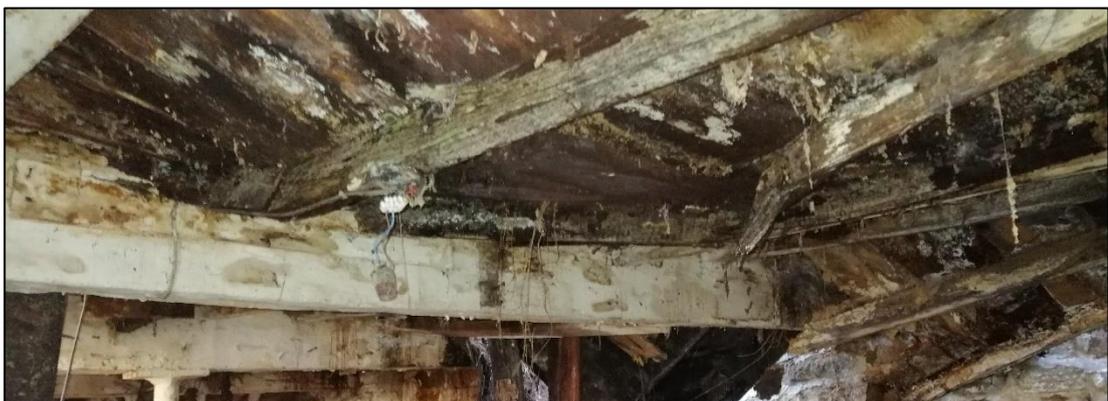
Plate 9. Inside south section of B2 (collapsing ceiling)

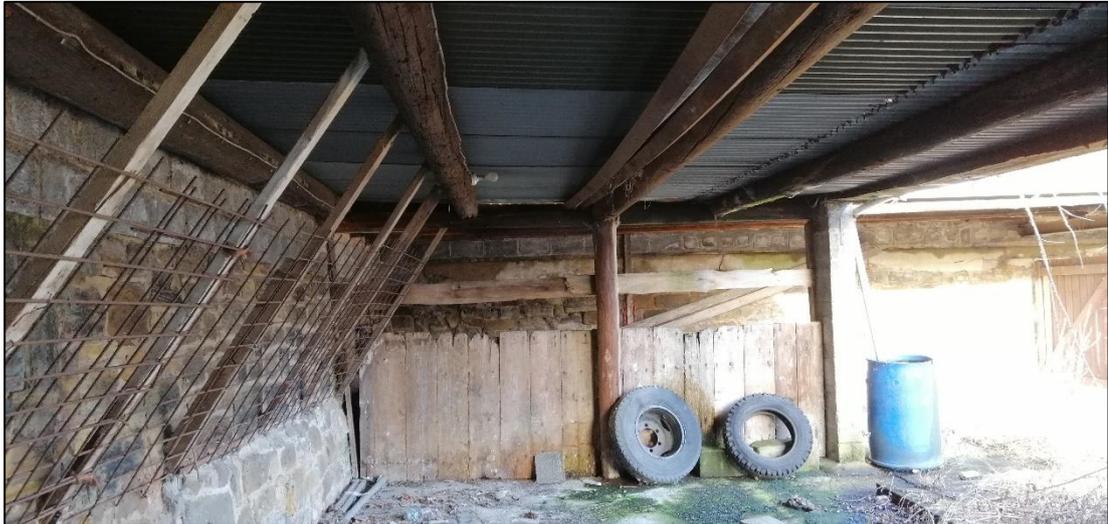
Plate 10. Inside of northwest corner of B3

- 5.2.9 Features with potential to accommodate roosting bats on B3 are restricted to several holes low down in the mortar joints and a gap behind a roof timber near the rear wall of the west section. The holes in masonry were found to be largely debris filled and very damp and no signs of bats were found.
