# TREE SURVEY TO BS5837:2005

Job FAIRFIELD HOUSE, BARNSELY

Title  
TREE SURVEY

Title **TREE CONSTRAINTS PLAN  
AND TREE PROTECTION PLAN**

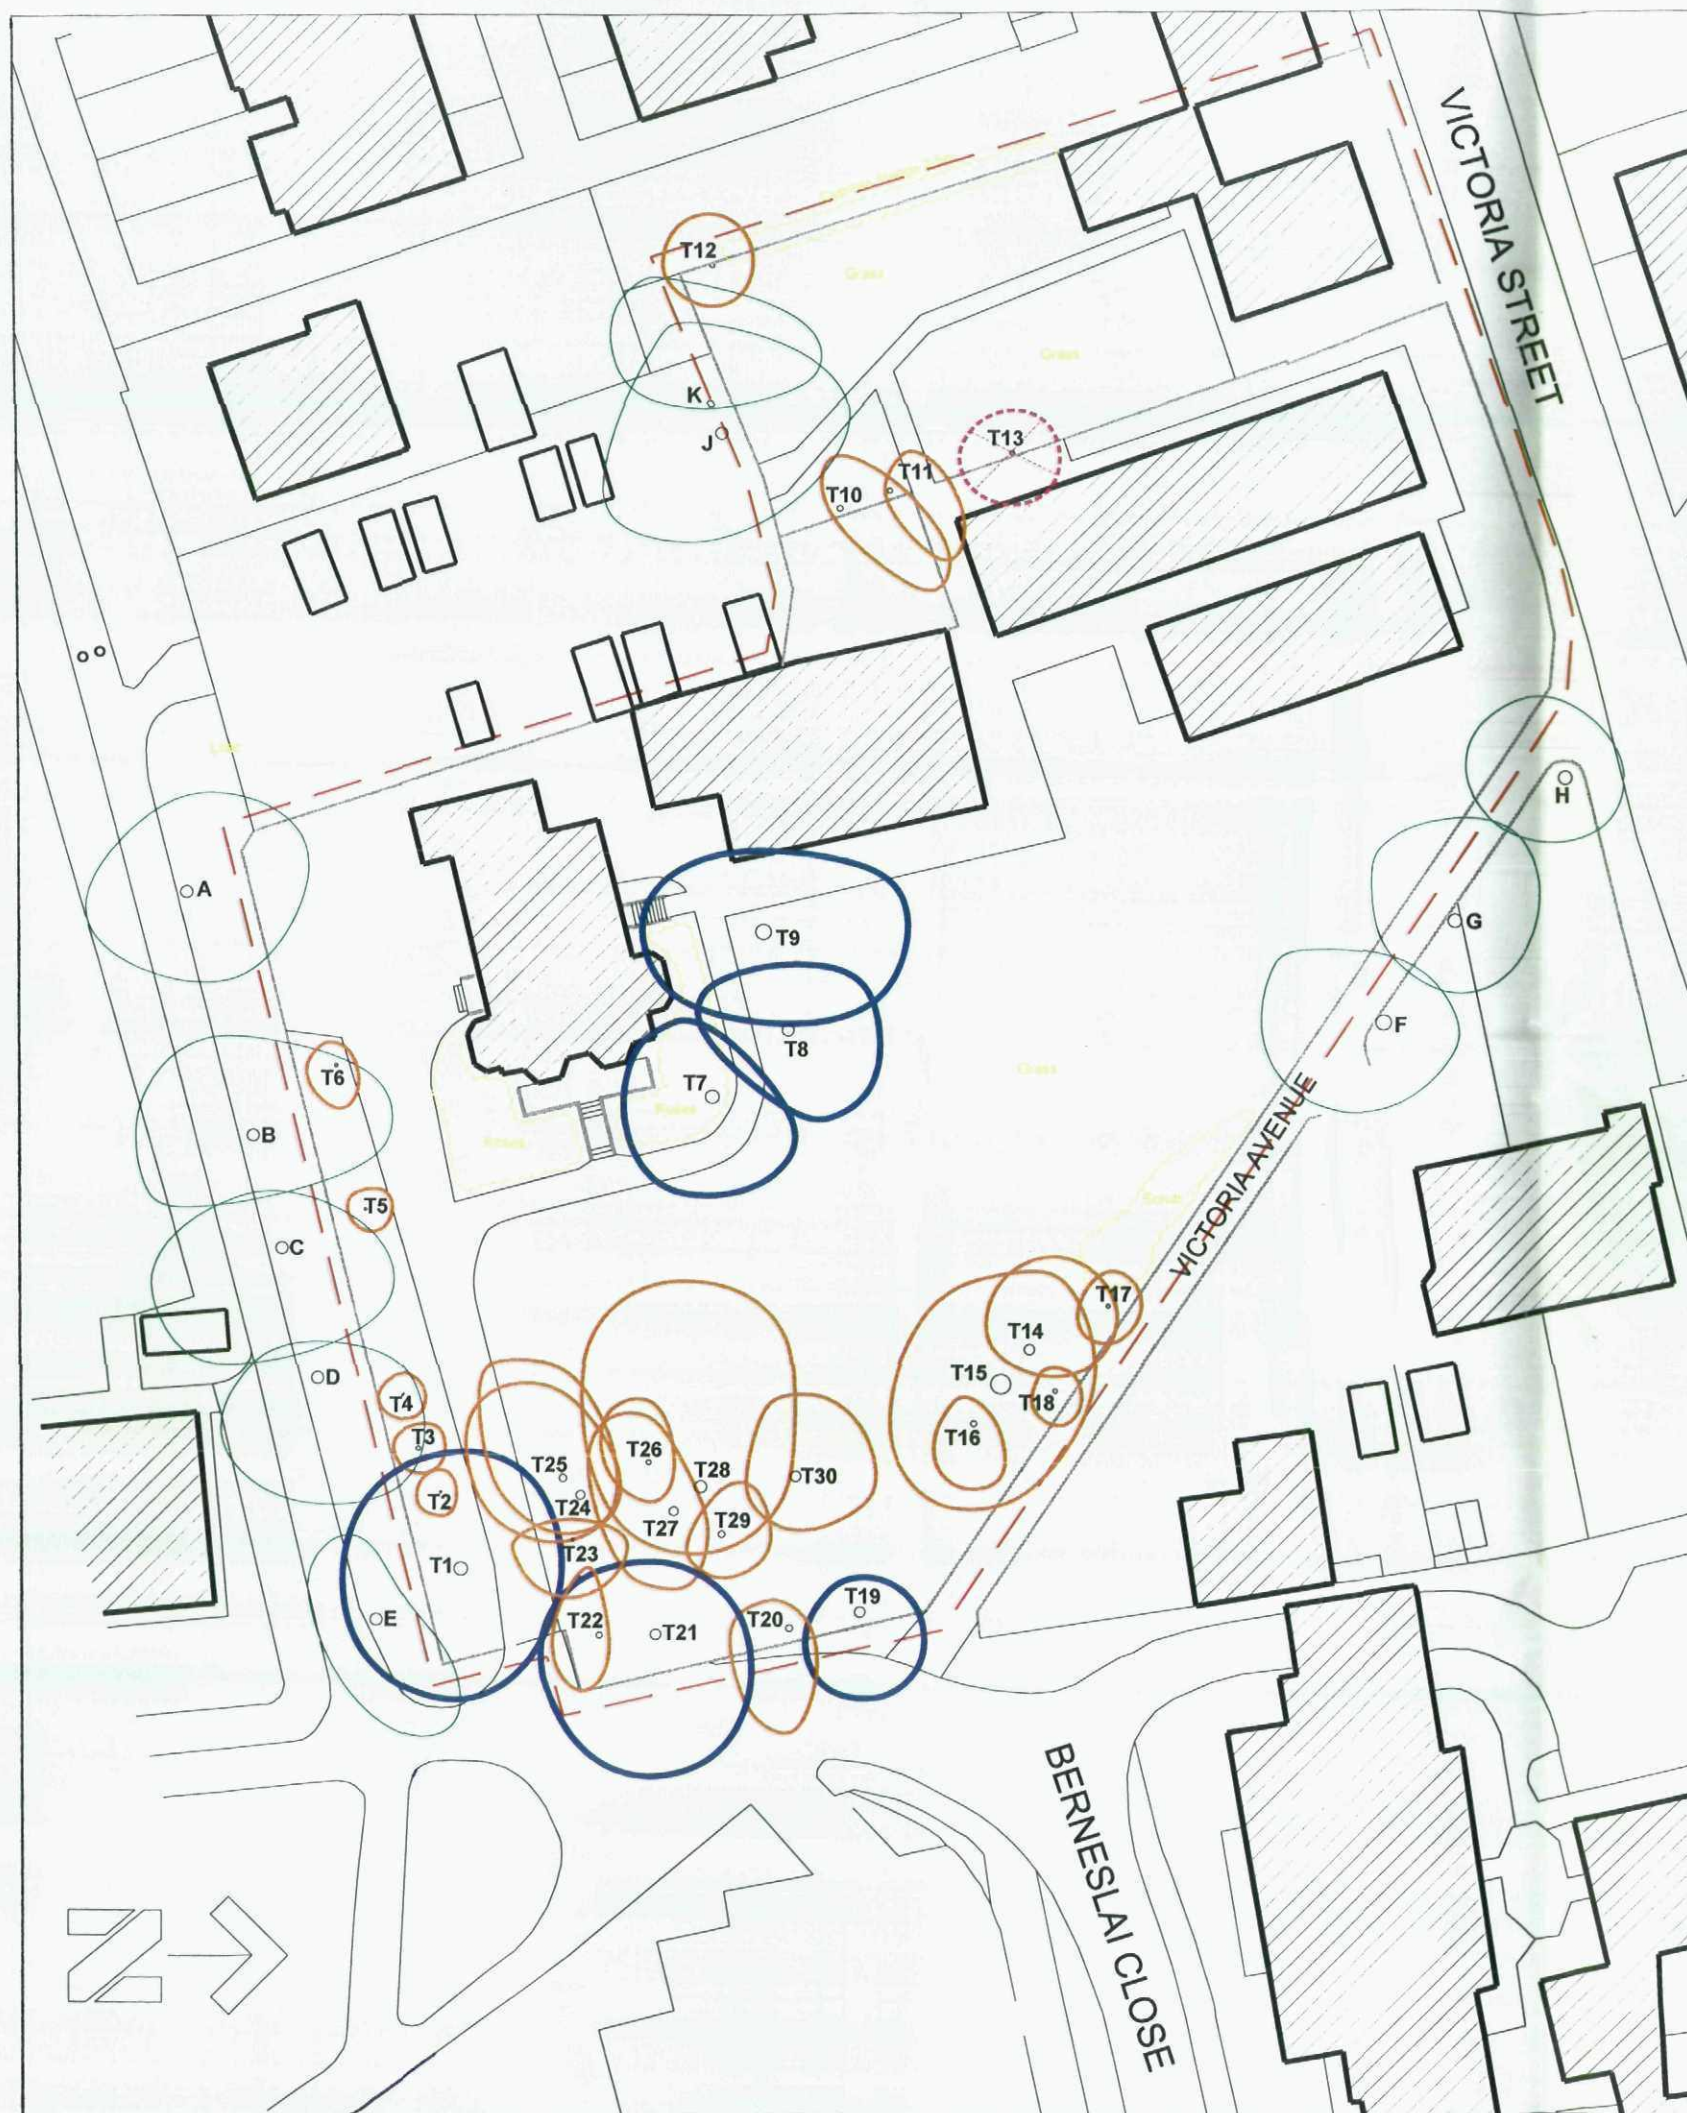
| 1:500 | NN | APR 07 | 211 | FHB 01 | A |

In accordance with BS5837:2005 'Trees in relation to construction', offsite trees within a distance equal to 12X stem diameter from boundary should be surveyed. In accordance with good working practise, all trees within 12m of the site boundary have been surveyed.

This survey records amenity quality and desirability of tree retention in relation to proposed construction by visual inspection from ground level where accessible.

Tree heights and spread approximate. The diameter of single stem trees is taken at 1.5m above ground level. Diameter of multistemmed trees is either measured at ground level (gl), or each multistem is measured at 1.5m above ground level and calculated to give a notional diameter (N) as if all multistems were fused into one stem.

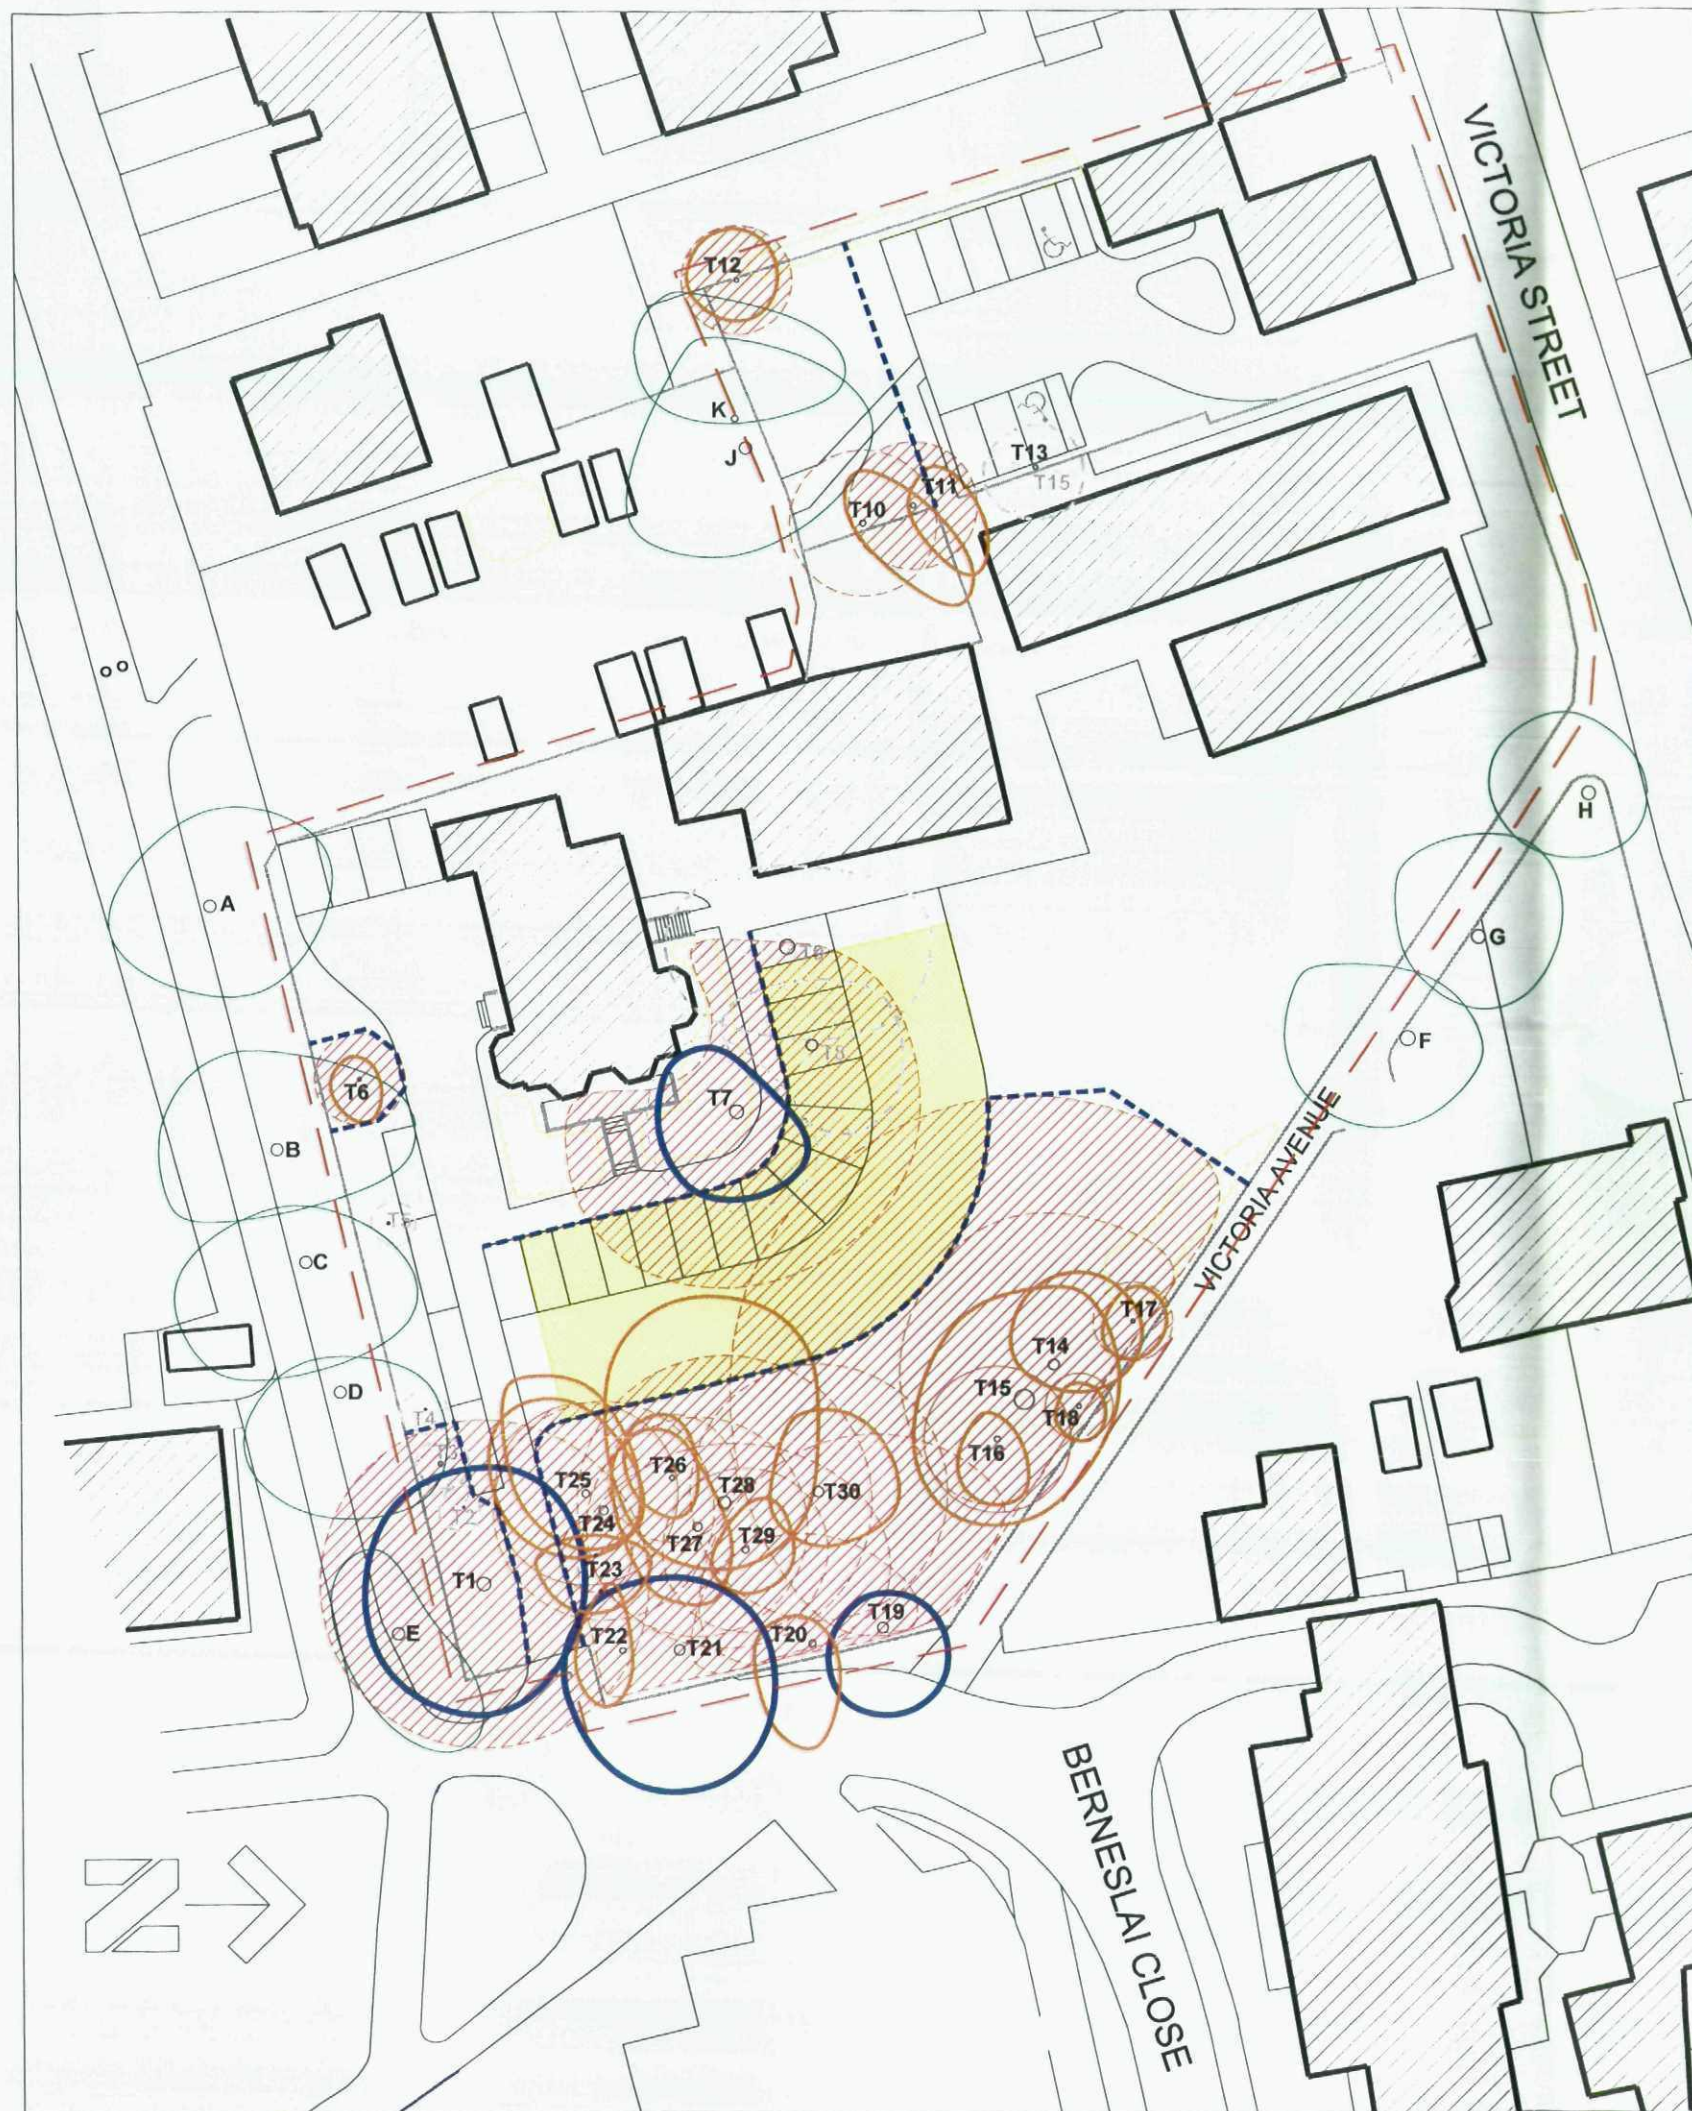
| scale | drawn | date | job number | number | revision |
|---|---|---|---|---|---|
| 1:500 | NN | APR 07 | 211 | FHB 02 | A |

**ROOT PROTECTION AREA (RPA)**  
Root Protection Areas have been calculated on the following basis:  
Single stems: Area equivalent to circle of radius 12 x stem diameter at 1.5m

Root Protection Areas shaped due to obstruction to root spread e.g. retaining wall, water course.

RPA of pollarded or topped trees has been reduced to an area appropriate to actual canopy spread.

- Scaffold Protective Fence as BS5837:2005 Figure 2
- Permeable paving to BS2837:2005 Section 11.4 No dig construction: geoweb cellular confinement system filled with washed aggregate, surfaced with Ecoblock 80 grass paving system. See Drawing FHB 04 for Details.

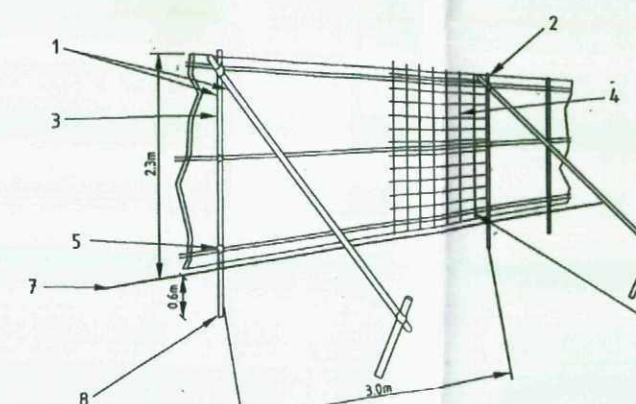
BS5837:2005 Figure 2

- 1 Scaffold poles
- 2 Uprights, to be driven into ground
- 3 Panels, secured to uprights with wire ties and where necessary scaffold clamps
- 4 Weldmesh, wired to the uprights and horizontals
- 5 Clamp
- 6 Wire, twisted and secured
- 7 Ground level
- 8 Approx 0.6 m driven into the ground
