**PROPOSED RE-COMMISSIONING
OF LAVATORIES
AT BULLHOUSE CHAPEL,
BULLHOUSE LANE,
MILLHOUSE GROOM,
PENISTONE,
SHEFFIELD S36 9NF
FOR
THE TRUSTEES OF BULLHOUSE PROTESTANT CHAPEL**

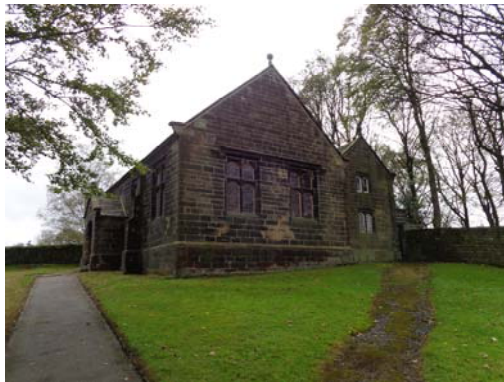
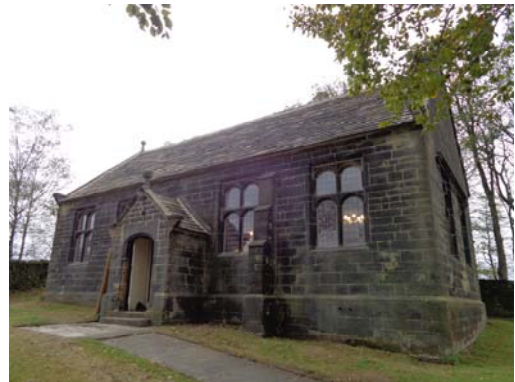
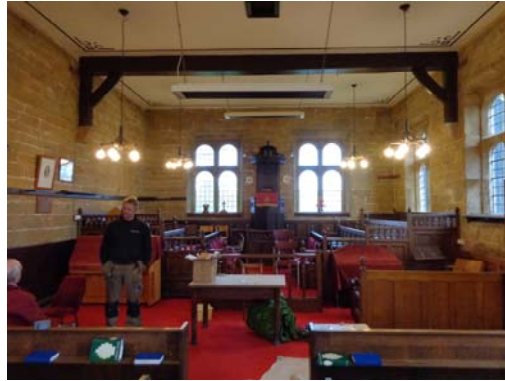
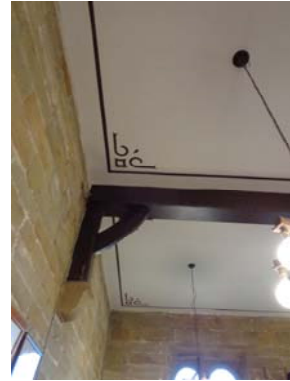
- 1.01 Andrew Shepherd, Architect is instructed by the Trustees to take forward earlier sketch proposals as developed by others to upgrade to modern standards the existing lavatories within the curtilage of the Chapel. Those proposals re shown on drawings E/01 – Existing Drawings, P/01 – Proposed Alterations & P/02A – Proposed Site Plan.
- 1.02 The Chapel is a designated heritage asset, and a copy of the “listing description” is attached. It is a delightful survivor of a past era (photographs 1-4).

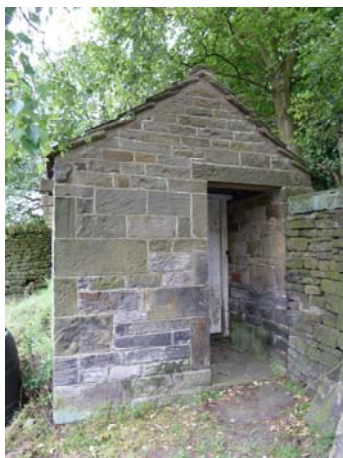
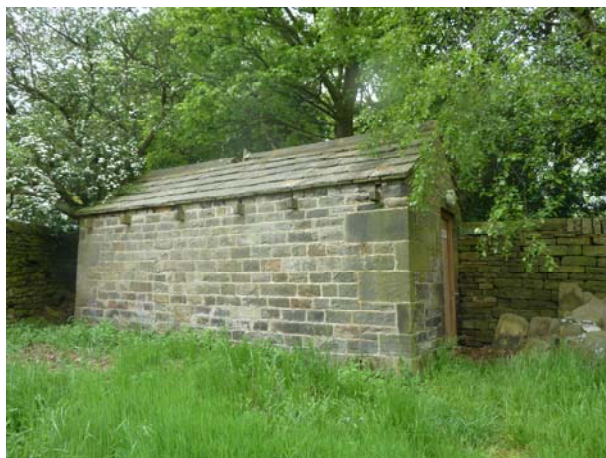
2.02 In the extreme South West corner of the small Churchyard curtilage there is an existing lavatory "block" (photographs 5-6). One part of the building has been fitted out to operate a single lavatory, but this is inadequate in size and function.

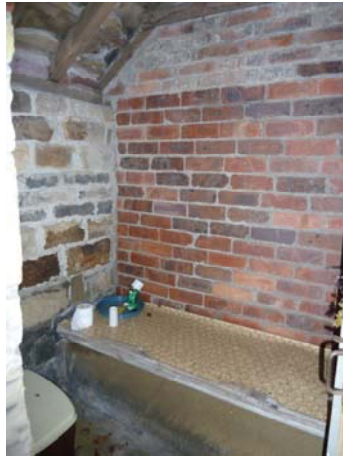
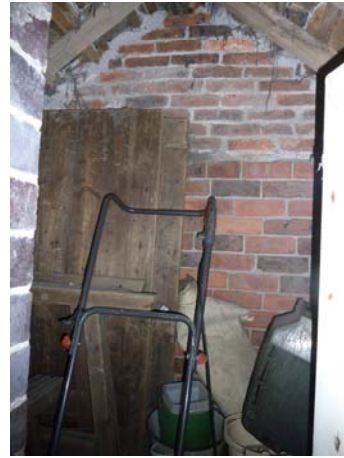
That fitting out happily has retained the two separate (for men and women) “three seaters”! (Photographs 7 & 8).

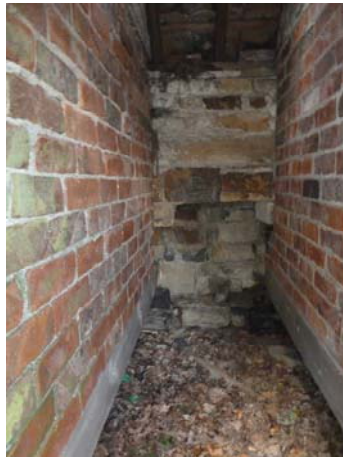
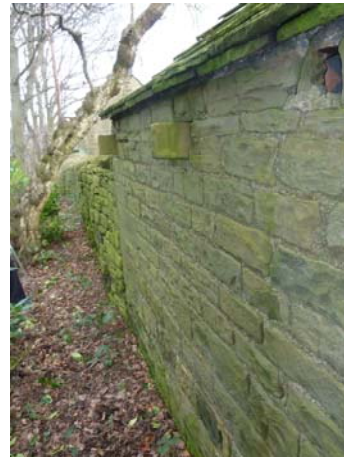
2.03 There is an open space “back to back” with these, from which it is presumed that the discharged matter rotted down and was eventually removed. There is no “proper” drainage (photographs 9 & 10).

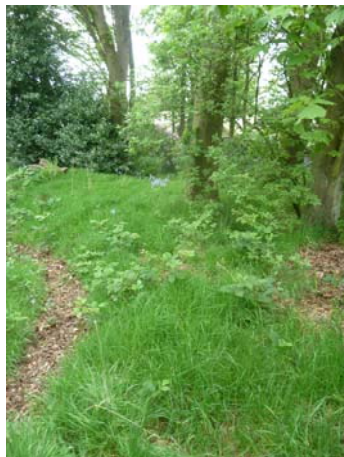
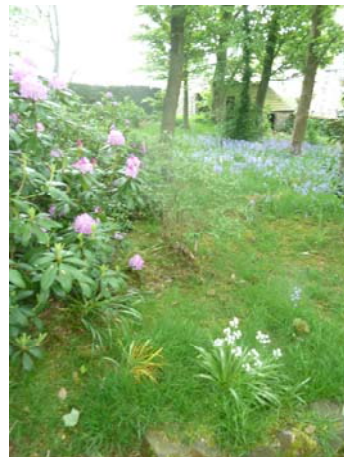
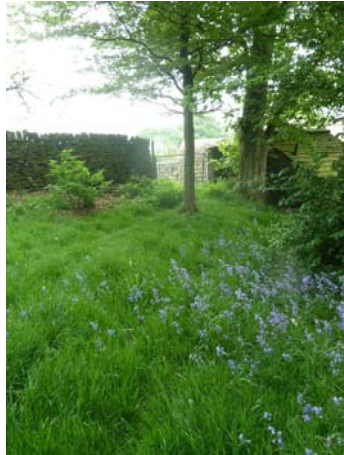
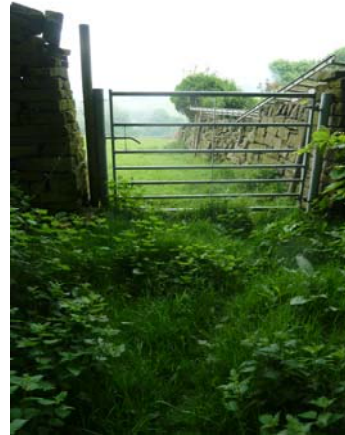
3.03 The drainage connection is to be taken from the west side of the existing building and run in UPVC pipes through the Rock Garden of the Hall (photographs 11-14).

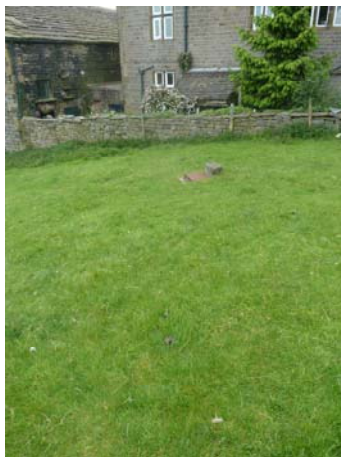
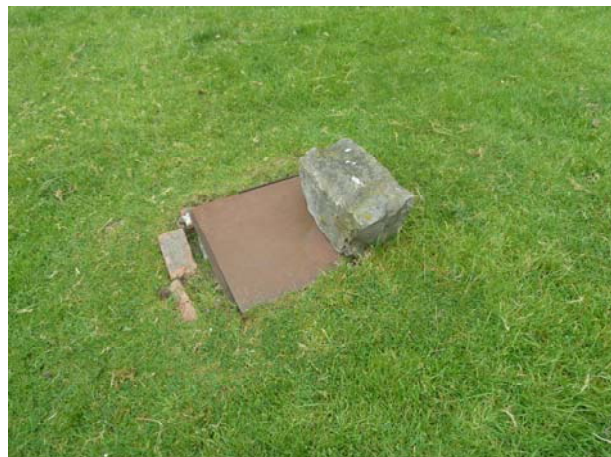
It is hoped, in view of the unknown but obviously root riddled nature of the subground that this can be “moled” mechanically, changing direction with propriety up to inspection chambers as required, to discharge eventually as desired into a field to the North West of the Hall, within which the existing connector manhole is located (photographs 15 & 16).
