Ground Investigation Report

Proposed floodlit artificial 3G pitch
Dorothy Hyman Sports Centre, Barnsley
May 2023

Document Title: Ground Investigation Report
Document no.: STV5991-G01 Rev A
Date: May 2023
Client: The Football Foundation

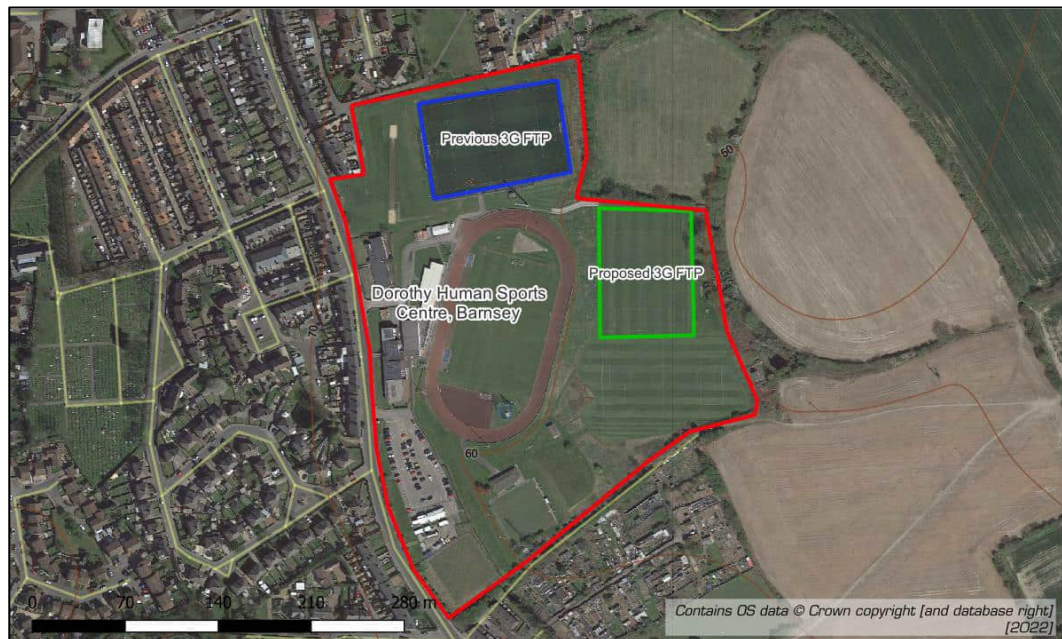
Figure 1-1: Site location plan, with proposed FTP marked in green, existing in blue

2.2.3 Soiltechnics have previously undertaken fieldwork in December 2016 for the existing FTP to the northwest marked in blue on the location plan in Figure 1-1. Previous investigation indicated Made Ground deposits up to 0.55m bgl (where fully penetrated) overlying weathered Mexborough Rock formation, however, this area is not shown to be within the mapped extents of artificial ground.

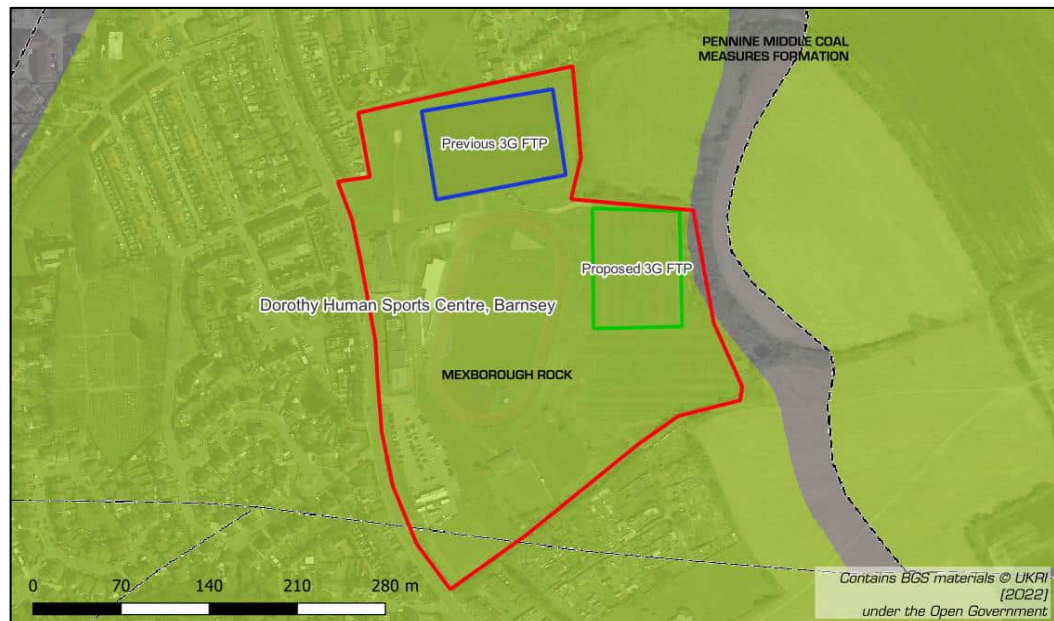
Figure 2-3: Bedrock deposits (proposed FTP in green)

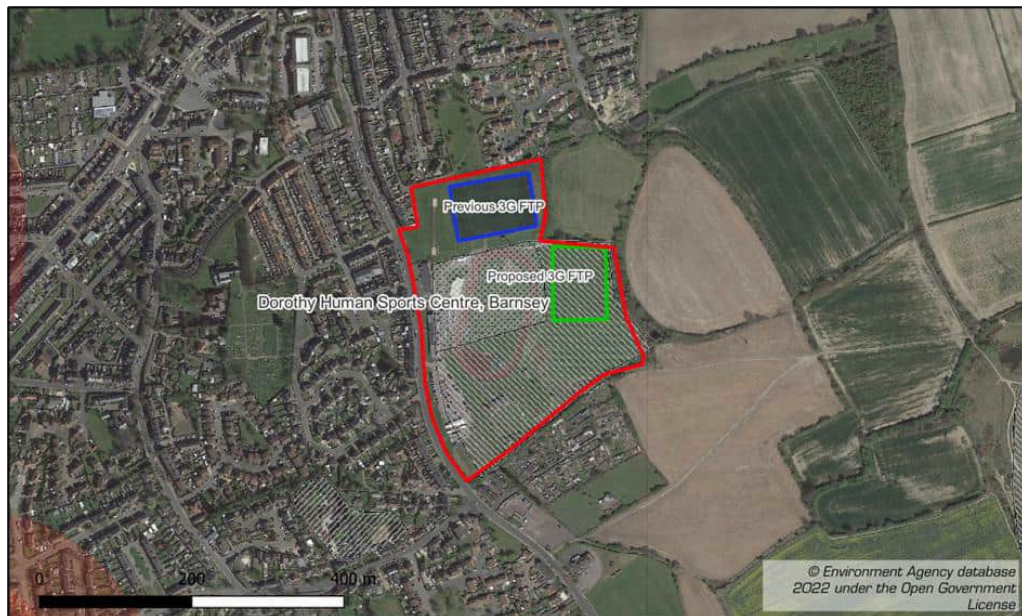
- 2.5.1 Open-source Environment Agency landfill mapping data shows the closest landfill to the site to be approximately 0.5km to the southwest.
- 2.5.2 Artificial ground is mapped beneath the proposed FTP, however, given the nature of the development (pitch with no enclosed spaces), the risk from ground gases is considered to be low.

Figure 2-6: Proximity to landfill sites (outline of nearest former landfill in red hatching)

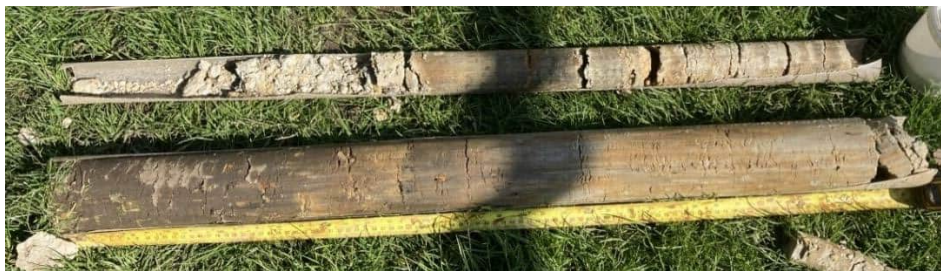
- 4.1.5 Photographs representing the typical ground conditions are presented in Figures 4-1 and 4-2 below.

Figure 4-1: Photo of soil profile at WS01

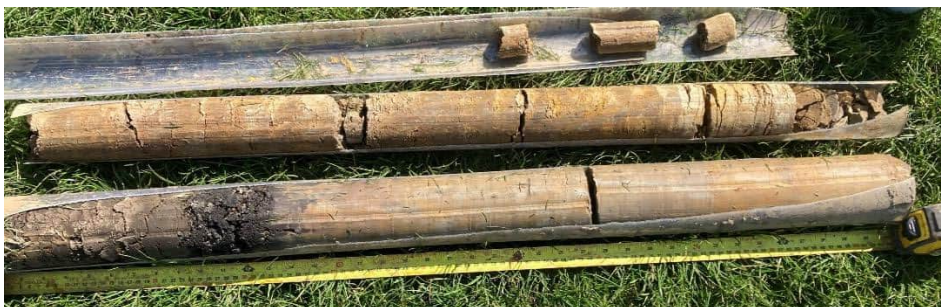
Figure 4-2: Photo of soil profile at WS07

- 4.1.4 Despite being absent from the BGS records, naturally derived deposits of suspected Devensian Till were noted underlying Topsoil in WS03-WS05 & WS07 along the eastern and southern FTP boundary to a maximum depth of 2.1m. Deposits generally comprised soft to stiff, orangish brown/grey clayey sand and gravelly clays, occasionally organic in places.

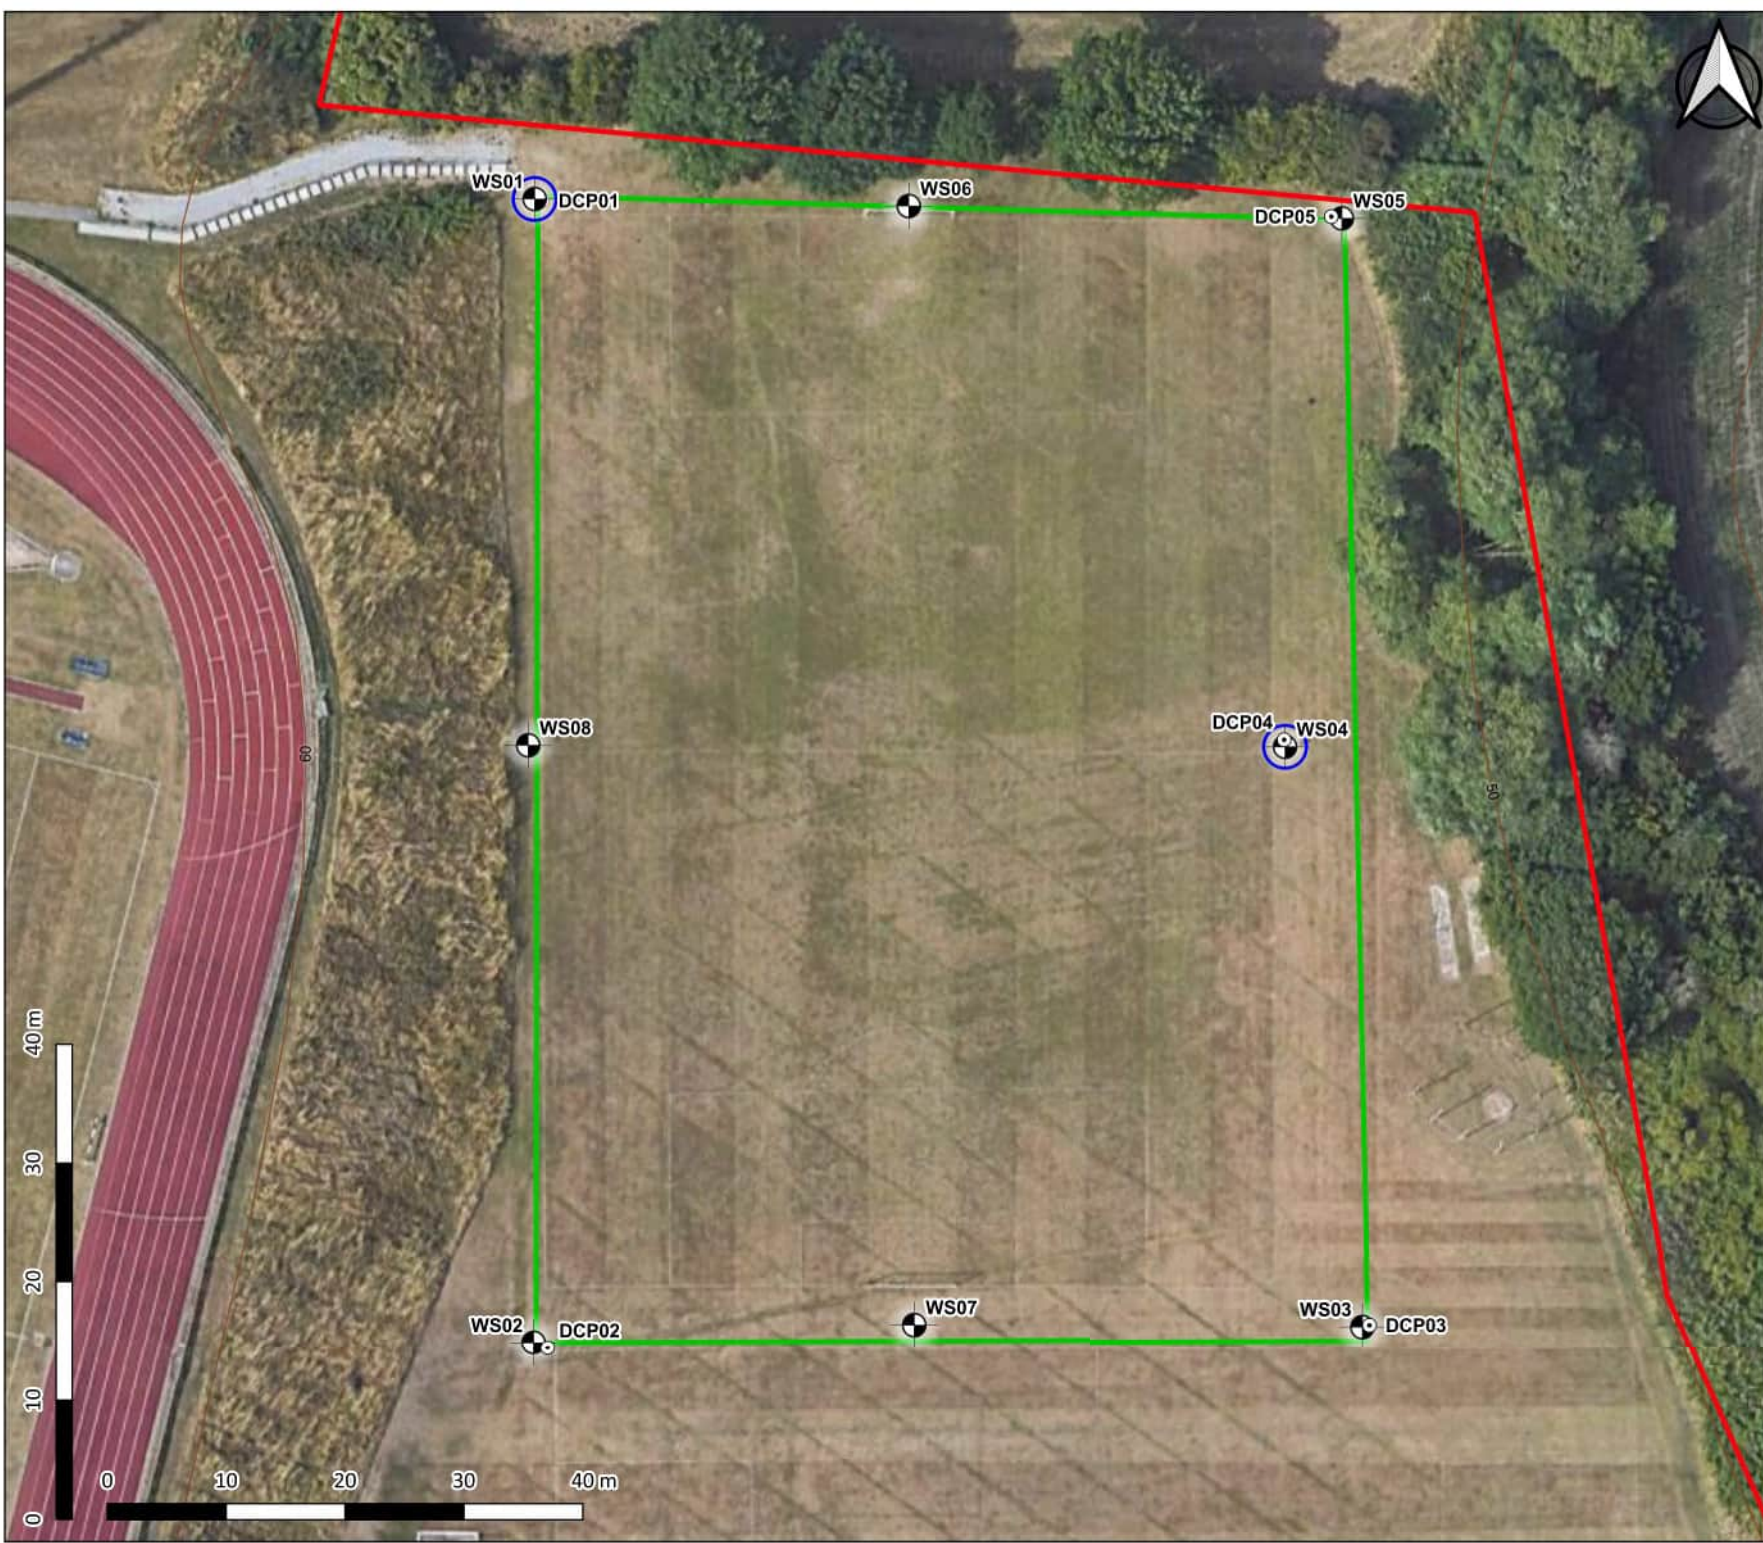
- WLS
- Soakaway / Permeability Testing
- DCP (CBR)
- Site Boundary
- Proposed FTP Area

Title	Produced by	Date	Reference
Exploratory hole location plan	Soiltechnics	May 23	Drawing 01

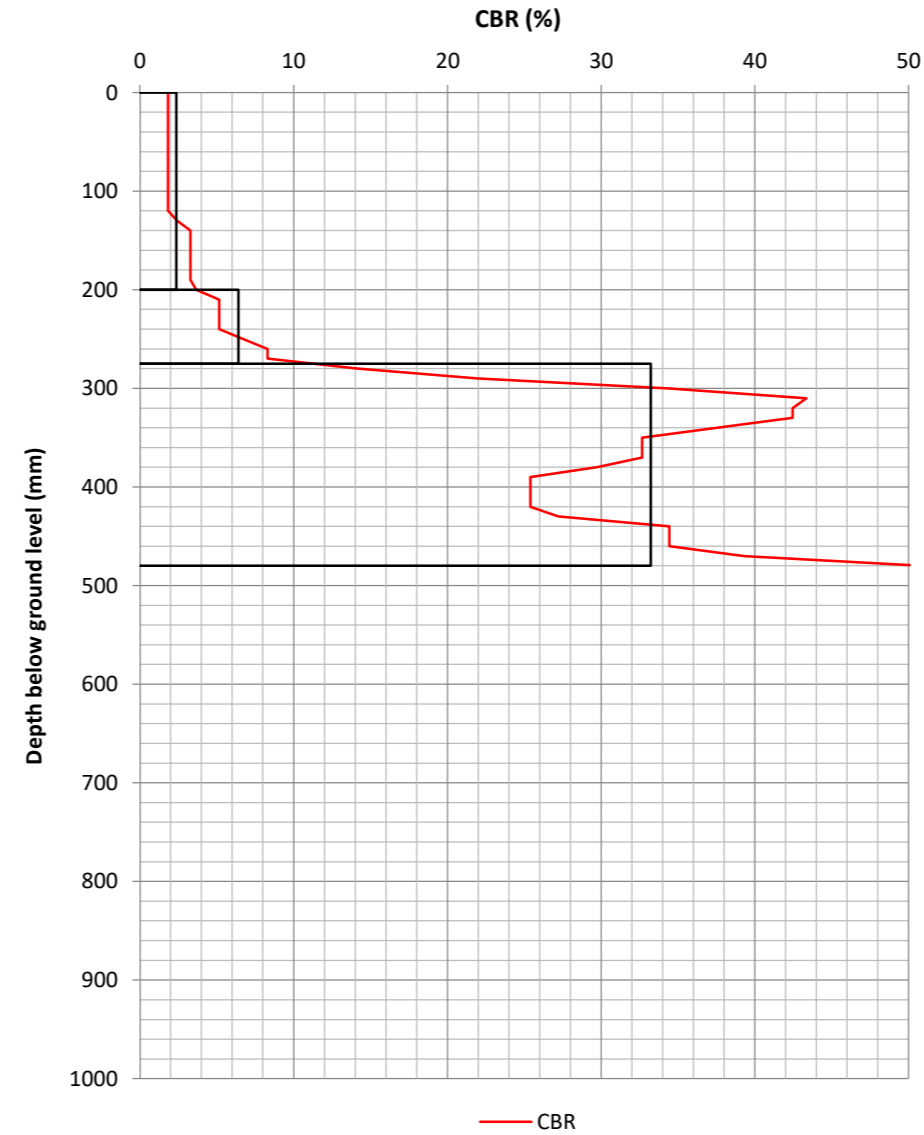
Plot showing number of blows against depth

Plot showing CBR (%) against depth

7.4.4 Based on the anticipated founding depth and DCP results, a CBR design value of 4% can be adopted for soils that are likely to be representative of those which remain at or near pitch formation levels. The placement and extent of conditioning applied to any fill placed at the site will dictate the CBR value used in design.
