Preliminary Roost Assessment

Colley Croft, Birk Avenue, Kendray, Barnsley S703AH

This report is prepared to inform a planning application with Barnsley Metropolitan Borough Council. The proposed development can be described as; *The extension and refurbishment of an existing brick-built warehouse. Works will include the addition of a first floor above the existing single-storey section, internal renovations, and associated roof works.*

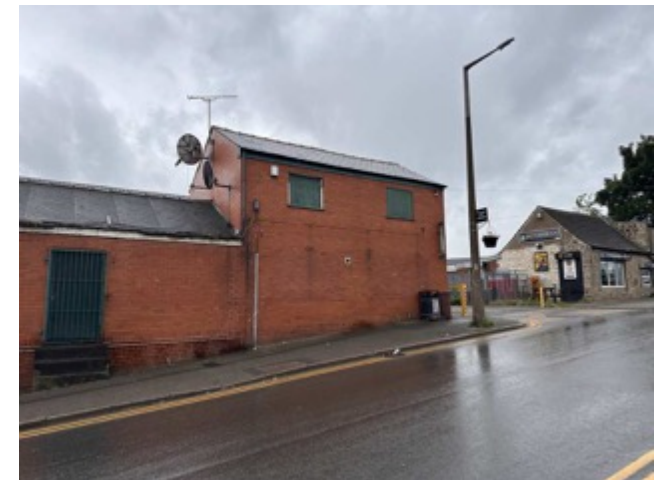
Building B1

B1 comprises the entirety of the on-site and is of brick construction. The building consists of a two-storey section with a single-storey rear extension, both of which are covered by pitched gabled roofs clad in slate tiles. No enclosed loft void is present, with the roof structure exposed internally at first-floor level. The roof structure lacks bitumen felt or similar lining material, leaving the underside of the roof tiles exposed. No light ingress was visible internally between the tiles or around the closed timber-framed windows.

Externally, the brickwork was generally in good condition, with only minor deterioration to the mortar. One roof elevation is covered by a bitumen felt-style membrane over the roof tiles. Although weathered, this membrane remains intact and does not provide opportunities for crevice-dwelling bats to access or utilise the roof structure.

Given the absence of suitable roost features and no evidence of current or historic bat use, B1 is assessed as providing **negligible suitability** for roosting bats.

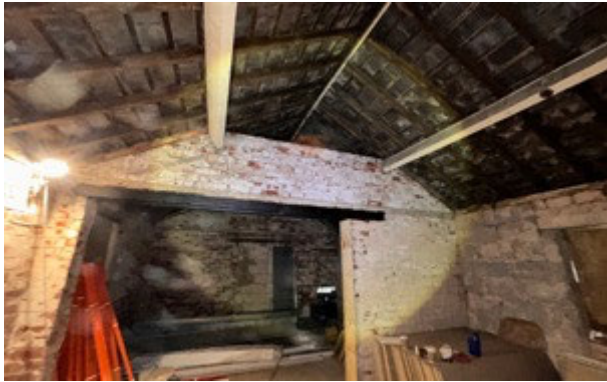
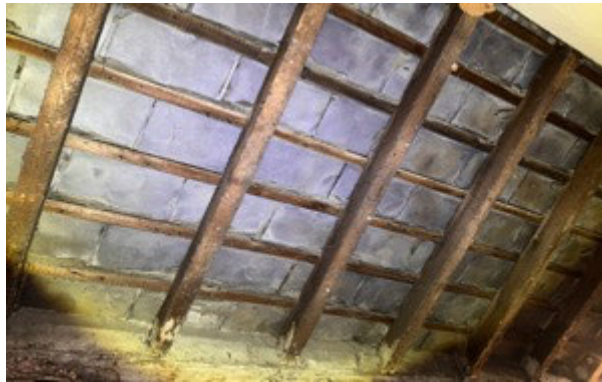
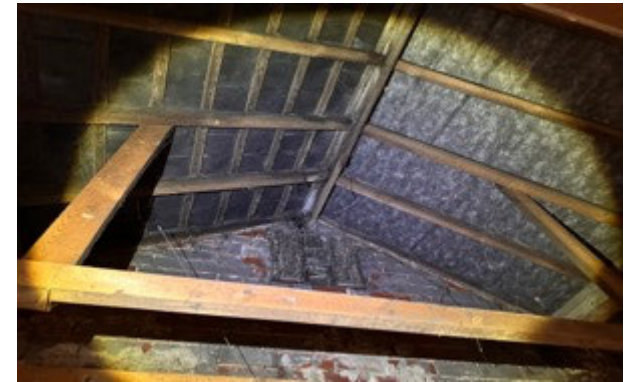
Images 1-3: Internal space of B1 (first floor space)

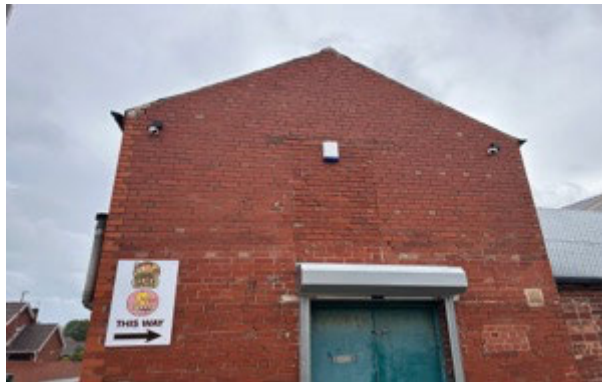
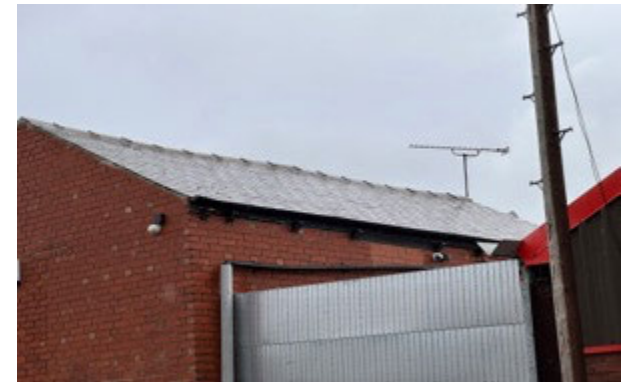
Images 4-6: Internal space of B1 - ground floor section (left) – western elevation (centre) – southern elevation (right)

The installation of a single bat box at the site will provide additional roosting habitat for bats. The bat boxes will be attached to the southern elevation of the building. Suitable bat boxes include Habibat Bat Box, Ibstock Enclosed Bat Box or similar alternative brand. Bat boxes should be positioned 3-5m above ground level facing in a south or south-westerly direction with a clear flight path to and from the entrance, away from artificial light.

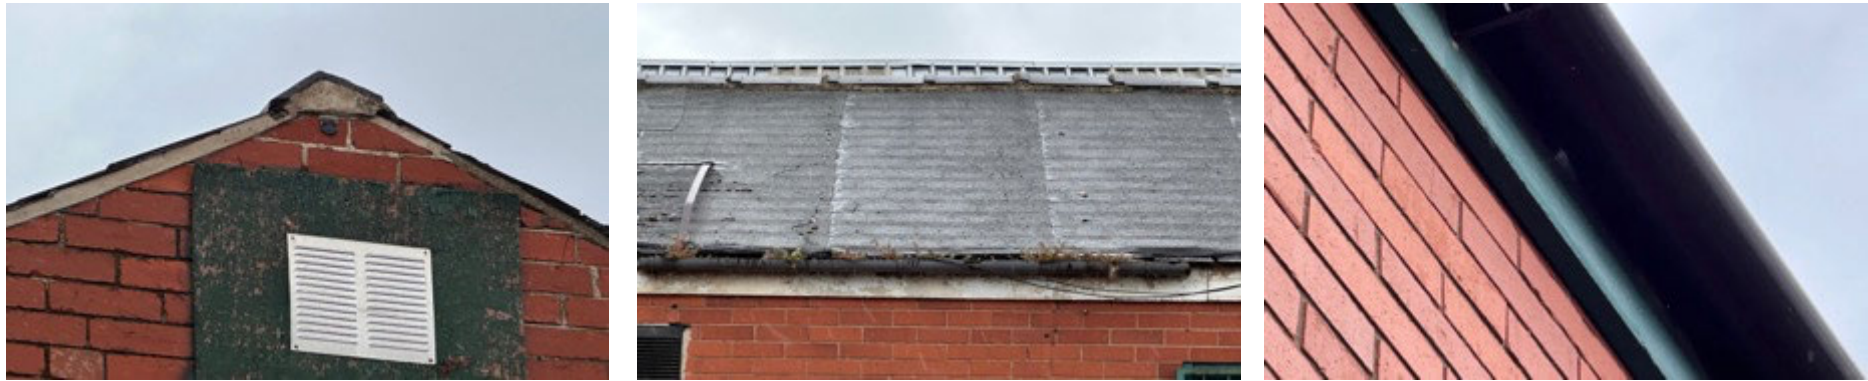
Images 7-9: North elevation of B1 (left) – north elevation roof structure with bitumen style lining (centre) – example of the intact barge boards (right)
