**1, TIVY DALE DRIVE, CAWTHORNE,  
SOUTH YORKSHIRE**

**PRELIMINARY ROOST ASSESSMENT AND  
BAT SURVEY.**

**Ref No: 230684**

**Date: 25<sup>th</sup> August 2023.**

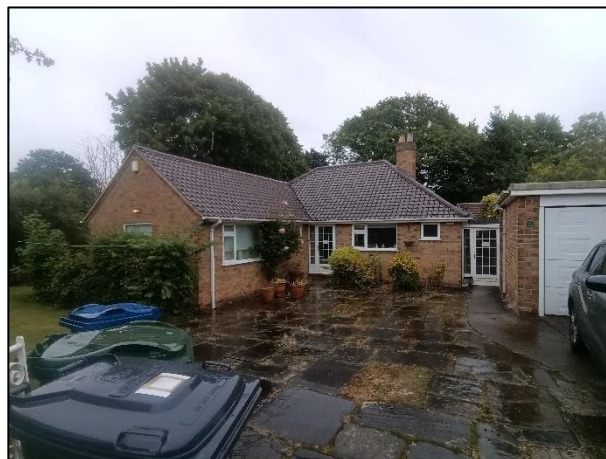
3.2.2. The photograph below shows the northeastern elevation of the building.

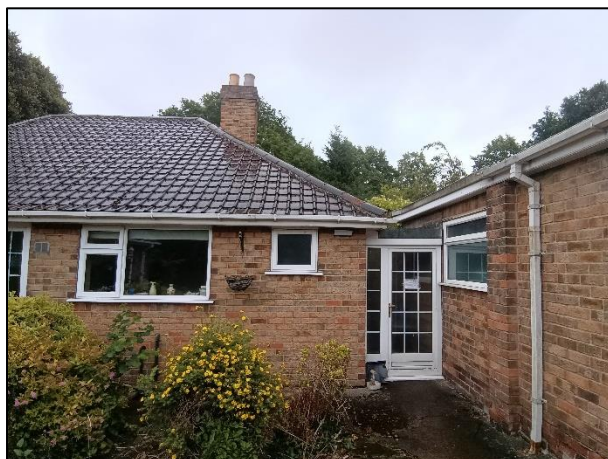
3.3.1. The building has cavity walls, constructed of brick and mortar. The brickwork was in a good state of repair with no gaps or missing bricks. The building had PVC windows, fascia and soffit boards. The main building was conjoined with the garage by a small flat-roofed porch, with PVC and glass door and bitumen felt roofing.

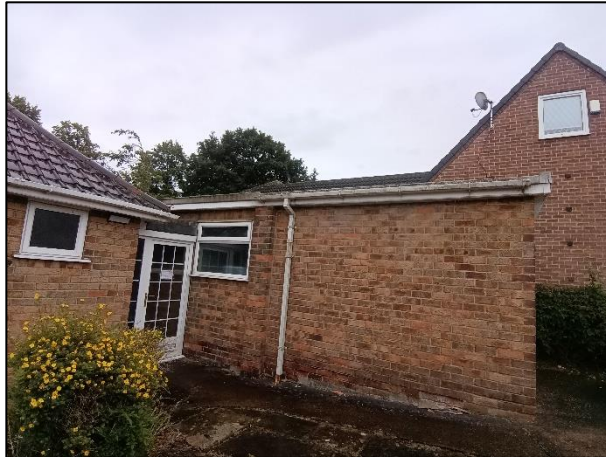
3.3.2. The garage building was to the southeast of the main building and was also built of brick and mortar, with PVC windows, fascia and soffit boards.

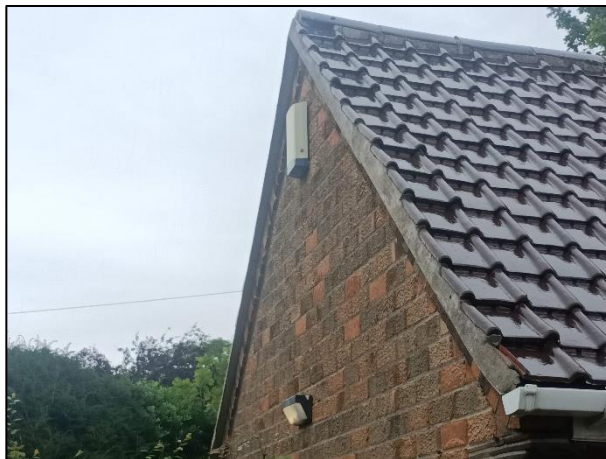
3.3.3 The roof of the main building and the garage were pitched roofs, covered with interlocking tiles and ridge tiles. There were no missing tiles noted during the survey, although there were gaps beneath the pantiles and some of the ridge tiles and there were some lifted pantiles.

3.3.5. The building was assessed to have ‘Low’ potential for roosting bats, in line with Bat Conservation Trusts “Good Practice Guidelines” due to the lifted tiles and gaps beneath the tiles that provide opportunities for individual, crevice dwelling bats to roost.

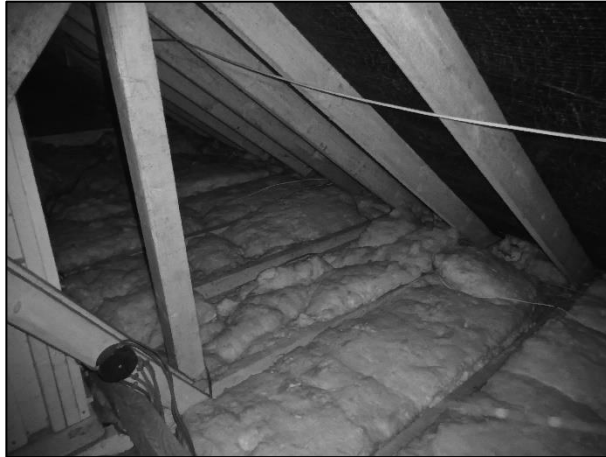
3.3.4. Internally, the loft space had a rafter and purlin structure, with a woven fabric liner beneath the tiles. There were no gaps in the roof liner through which daylight could be seen. There was rockwool insulation on the floor of the loft space, between the joists and some areas of the loft were fully boarded with no field signs found.

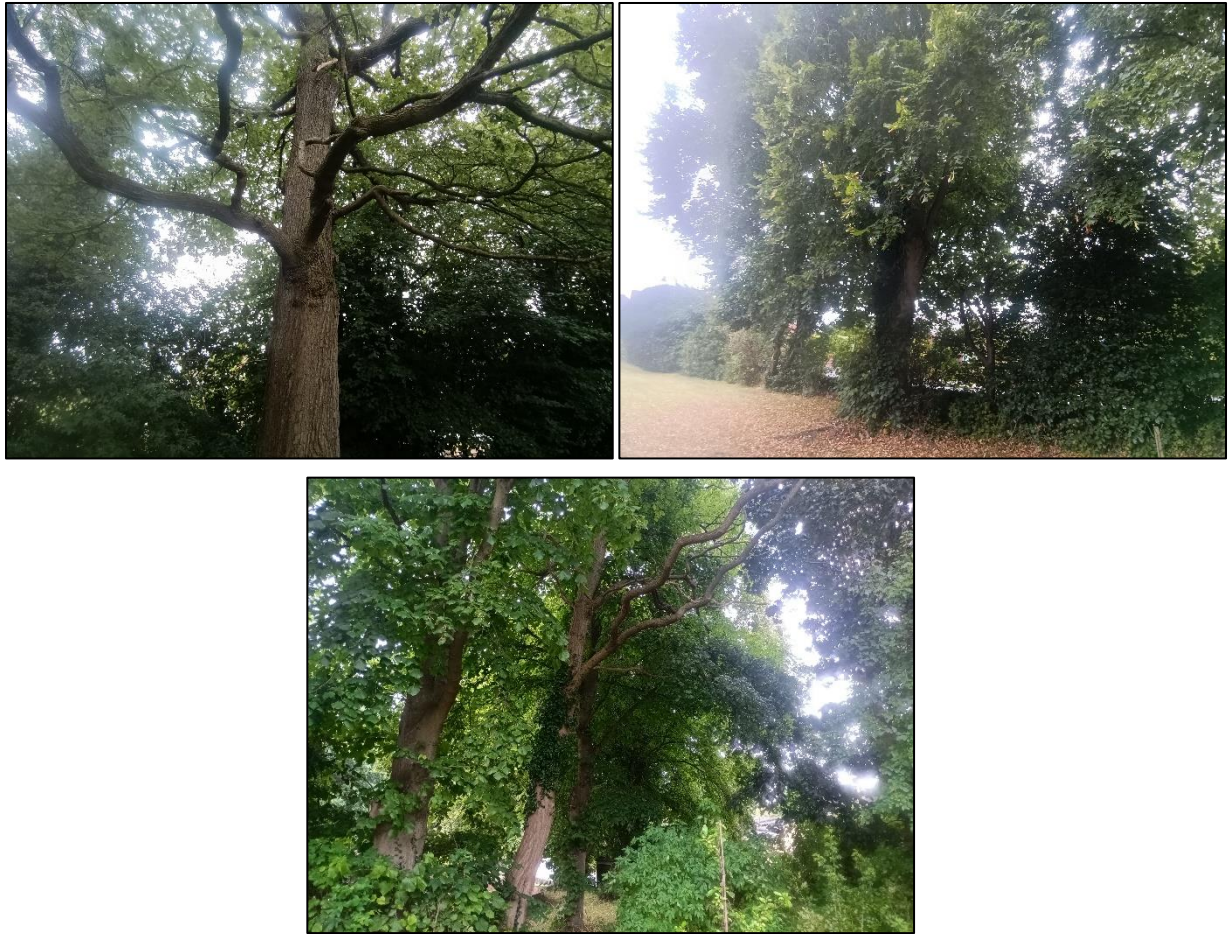
3.3.7. There were several large oak trees within the garden of the property that also held ‘low’ potential for roosting bats. These trees could not be fully assessed from the ground and are of a size and age where they may be concealing features suitable for bats.

5.2. It is recommended that the mature trees within the garden area are retained to continue to provide potential roosting opportunities and commuting and foraging opportunities for bats.

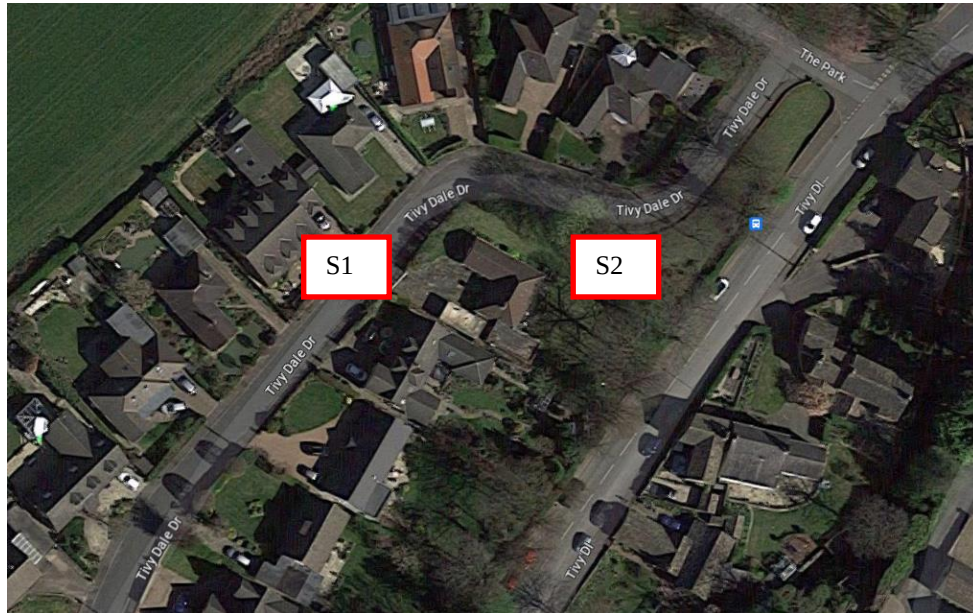
3.4.3. The positions of the surveyors and the static Anabats are shown on the aerial photograph below where S is a surveyor.
