## Proposed Residential Development The Old Quarry, Common Road, Brierley

## Appendices

David Taylor BA (Hons) DMS MRTPI MCMI  
Report ref: 10.29 (3) PS  
March 2012

**ARBORICULTURAL REPORT  
to BS 5837:2005  
at  
Common Road  
Brierley  
Barnsley  
South Yorkshire  
S72 9EA**

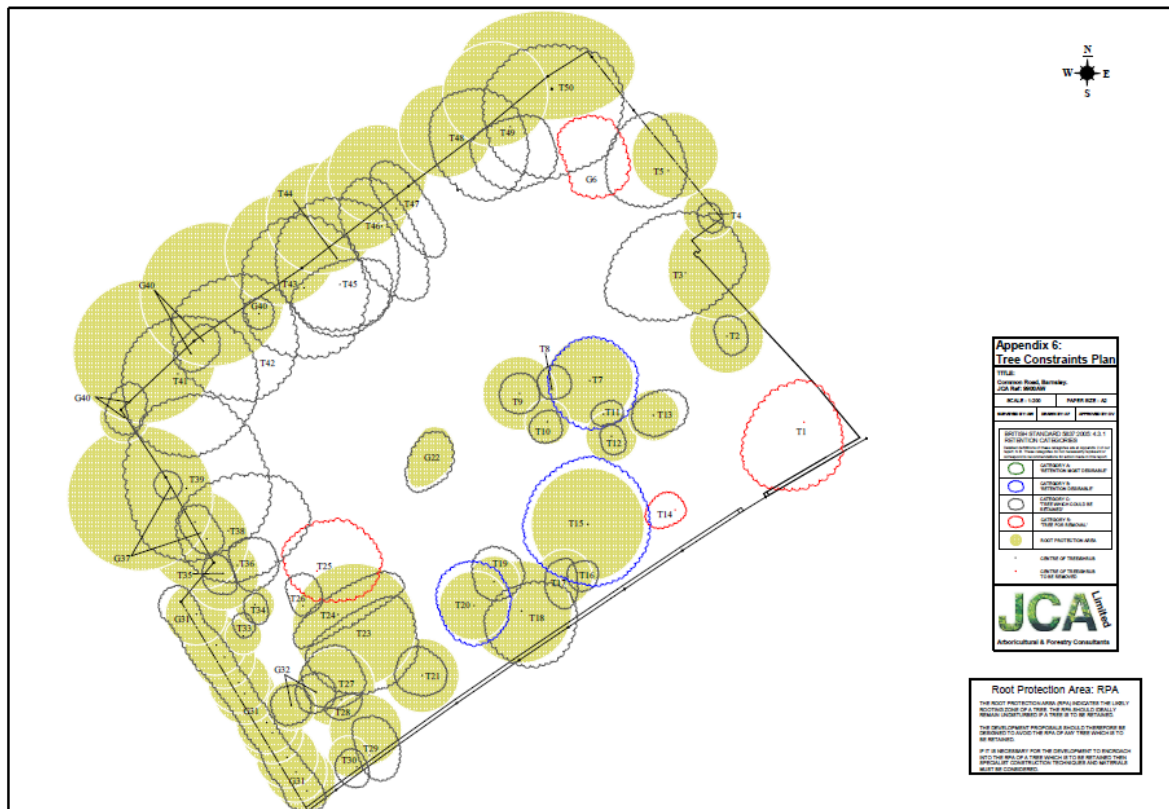
## Appendix 6: Tree Constraints Plan

- 4.1 Full details of all individual trees surveyed are recorded in the tables at **Appendix 1**. A full explanation of the tables can be found at **Appendix 2**. Please refer also to the Tree Constraints Plan at **Appendix 6** for tree locations.
