Grimethorpe, Barnsley

Geo-Environmental Desk Study Assessment

Report Reference: B034815.DS.2

Date: October 2023

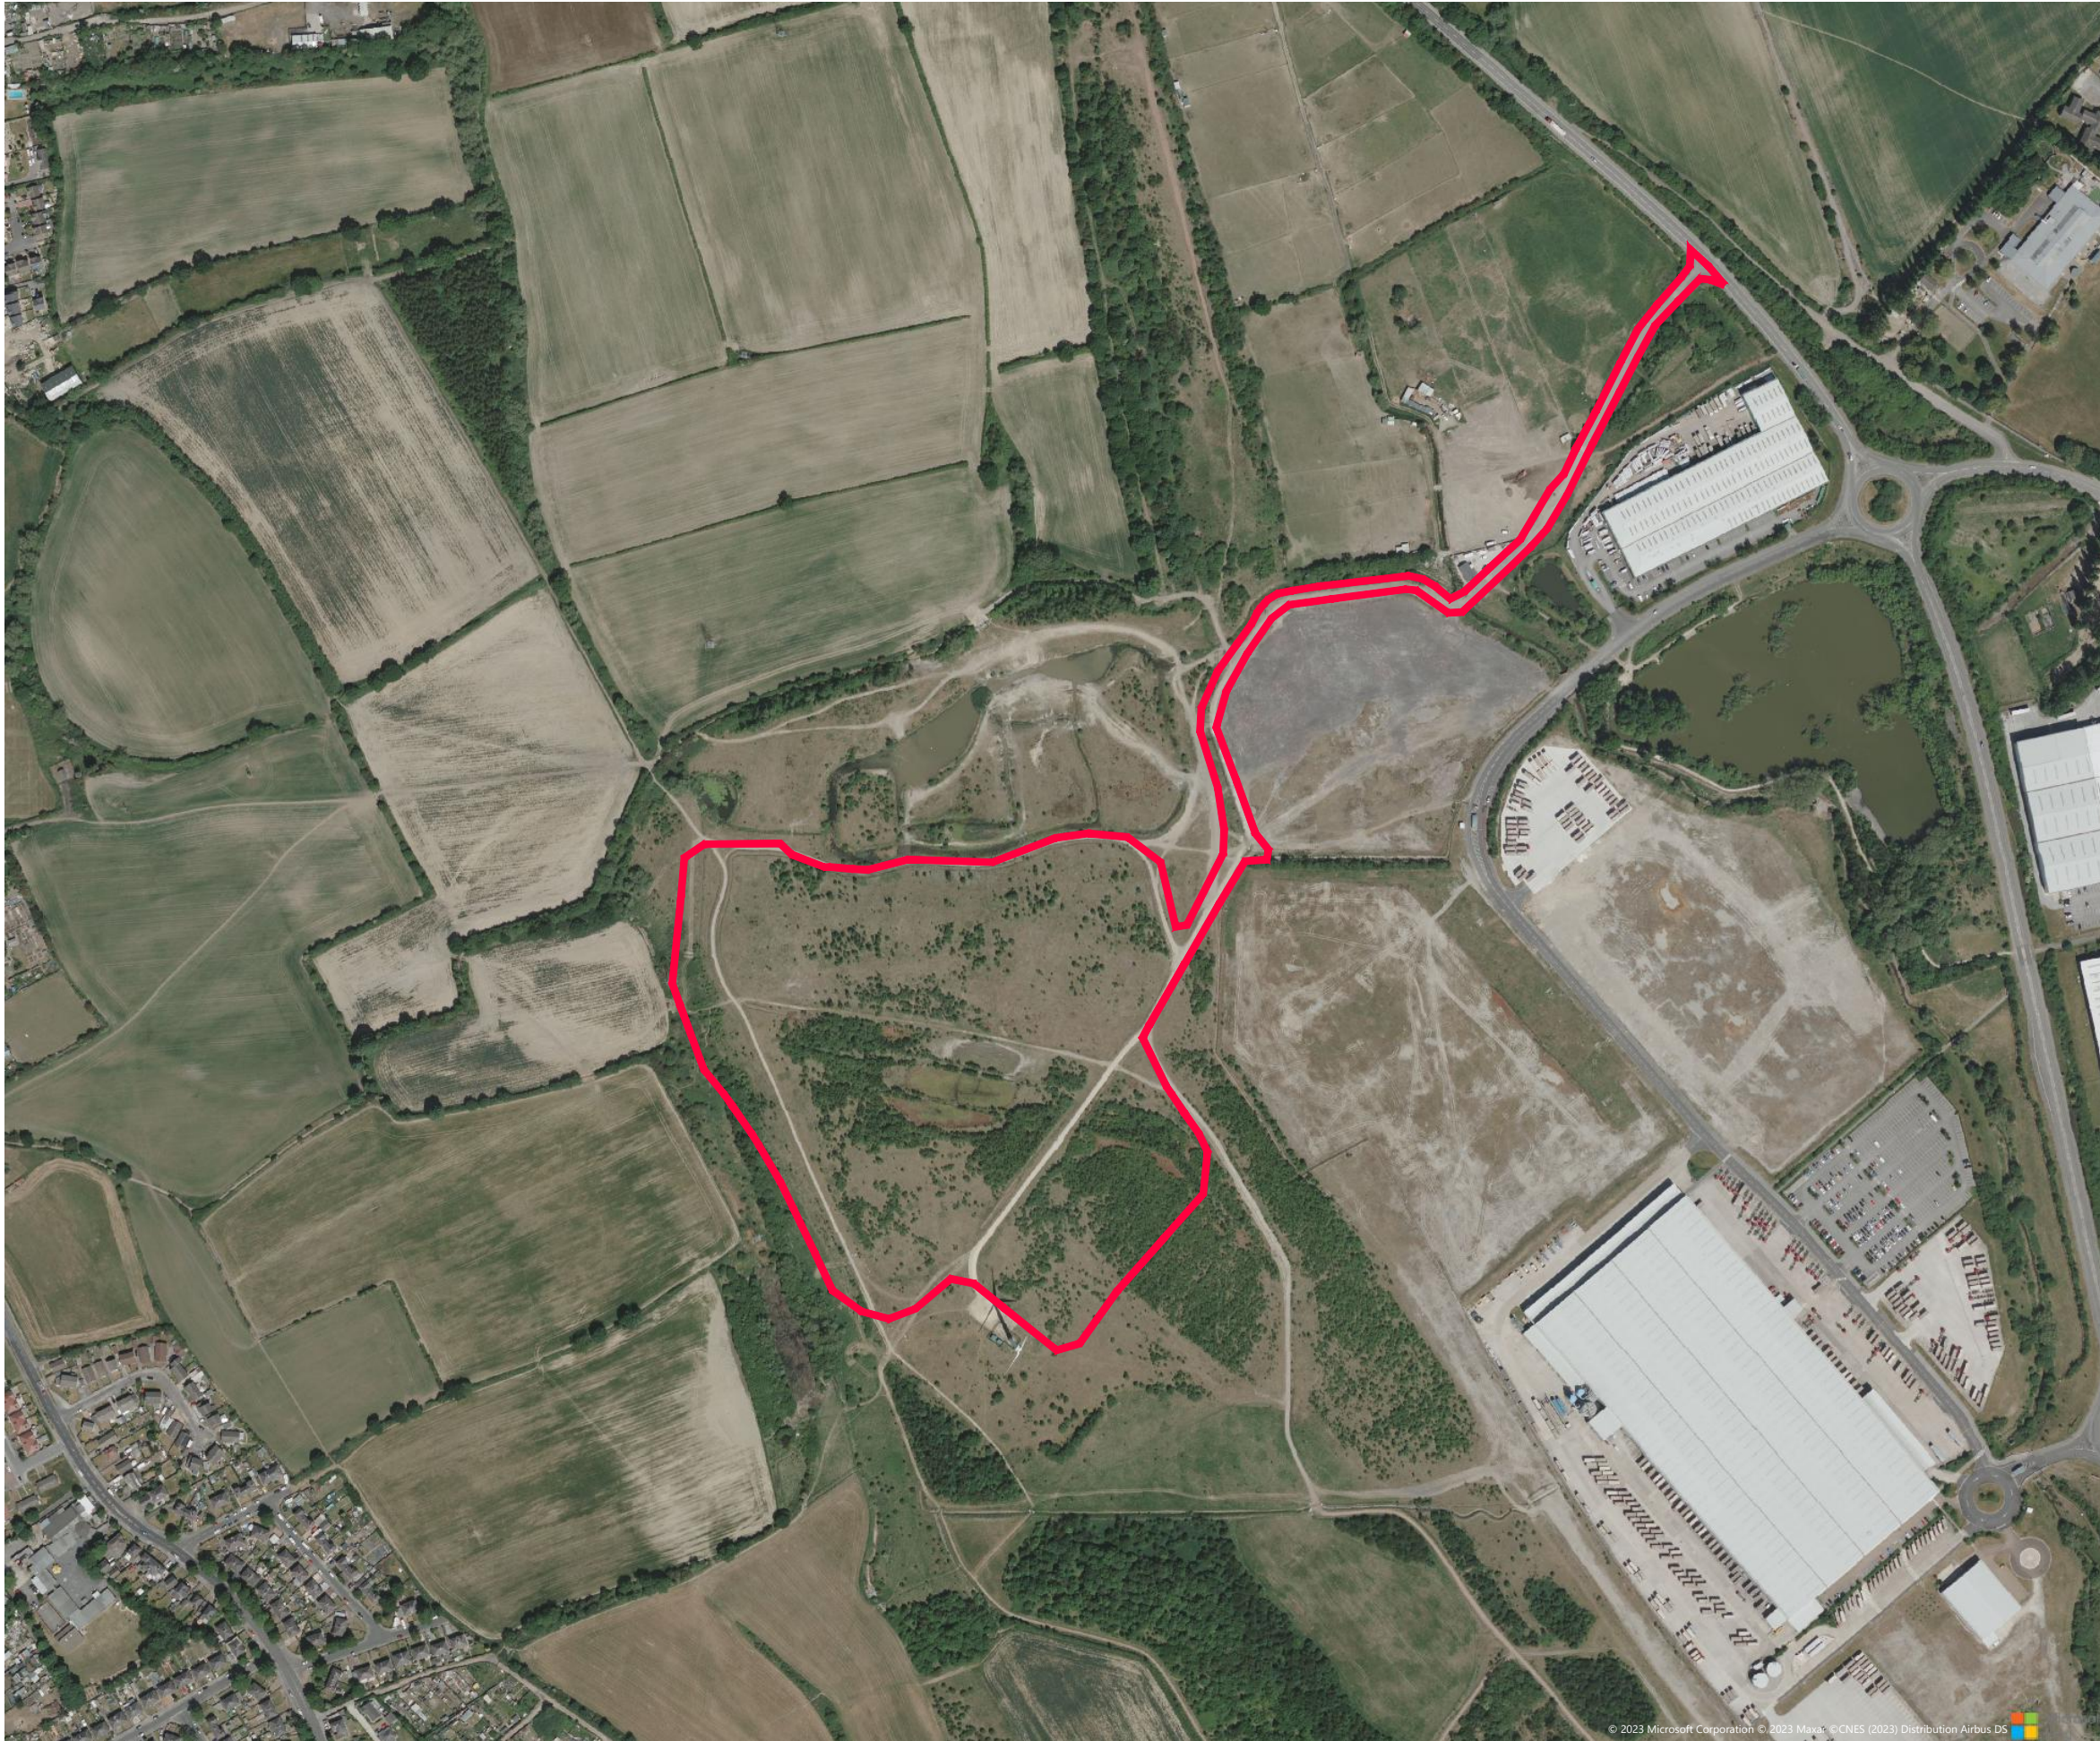
B034815-TTE-00-XX-DR-U-0002-02 (Redline Boundary Plan)

The whole of the site can be accessed by foot or by vehicle from Ferry Moor Lane to the Northeast of the site. The site is mainly bound by farmland and fields, however to the east, there are large industrial warehouse units present. The site boundary plan is detailed on B034815-TTE-00-XX-DR-U-0002-02.

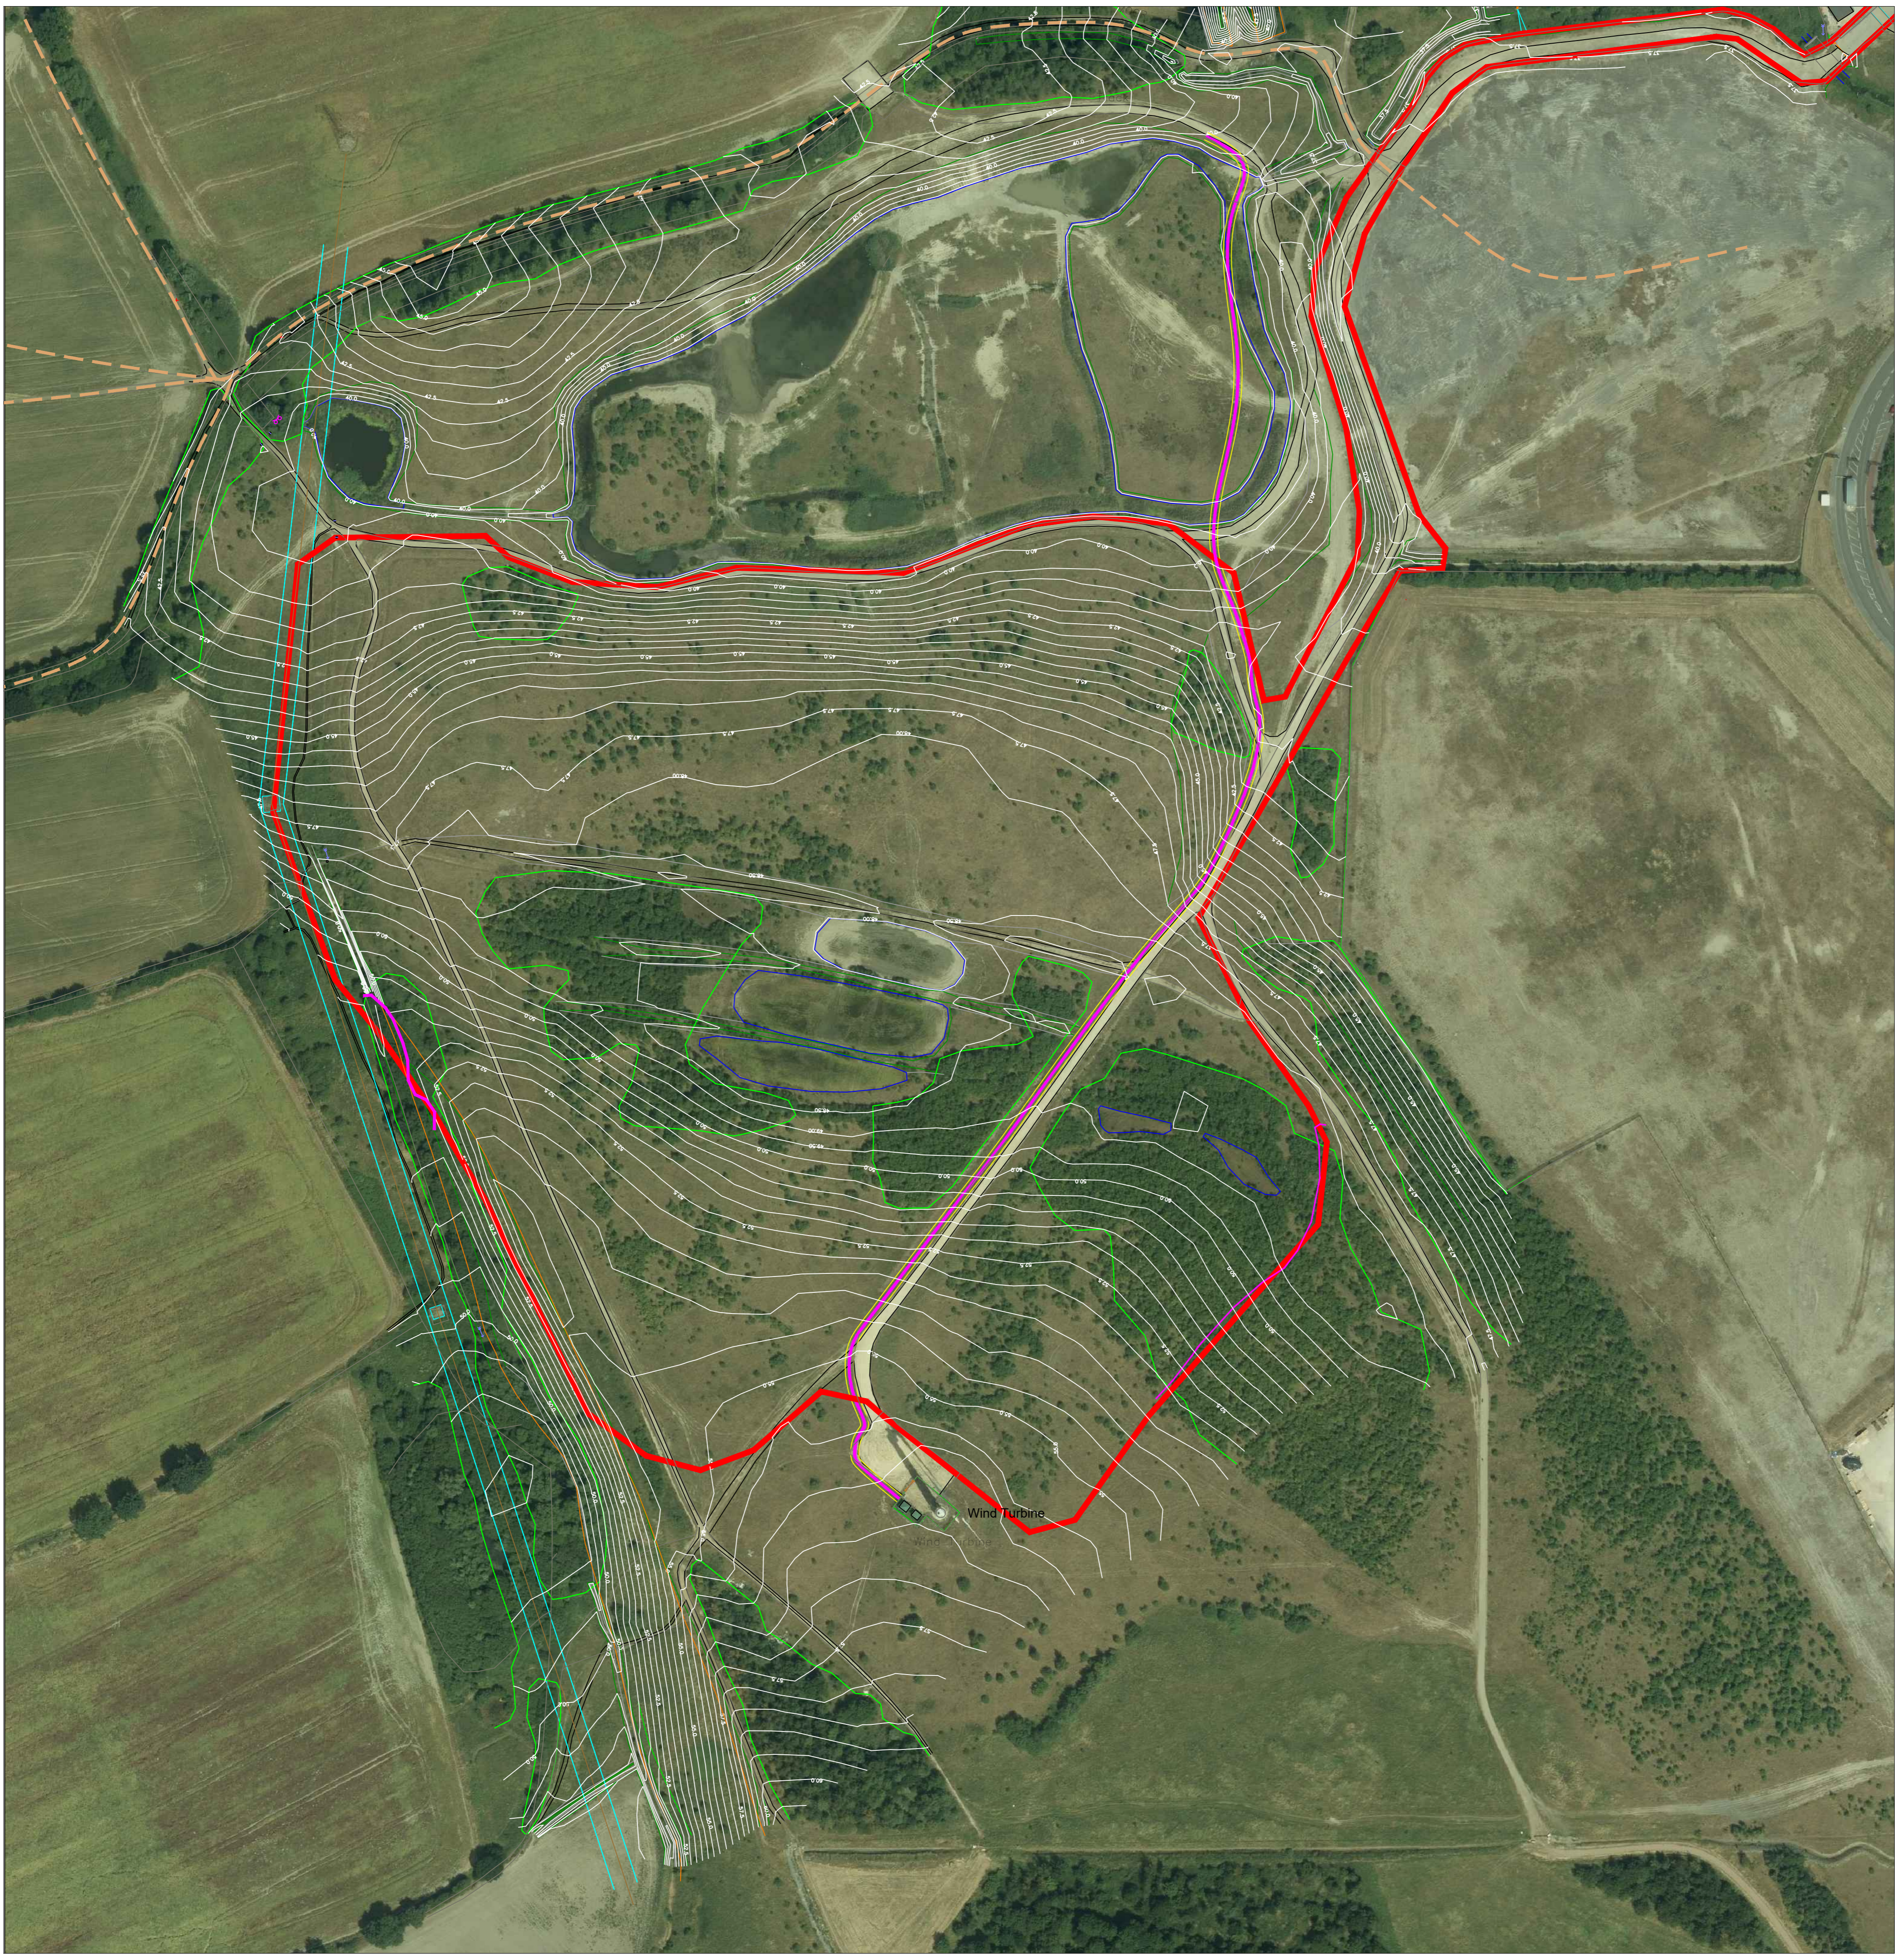
Drawing Name: Existing Site Survey

Existing contours for the site are shown on the Existing Site Survey drawing included in the Third Party Drawings. The site access in the north-east is at approximately 37mAOD and accesses the site at c41.5mAOD in the northeast corner of the site. The northern area is a slope upward from approximately 40mAOD at the northern boundary to 48mAOD in the centre of the site.

To the south of the flat area, the main site area rises from 48mAOD to c56mAOD at the southern boundary. The southwest corner of the site falls steeply from site levels between c52.5mAOD and 55mAOD to 50mAOD to the west.

Drawing No. 901.02A/ Existing Site Levels dated 14th September 2023 by Weller Designs Ltd.

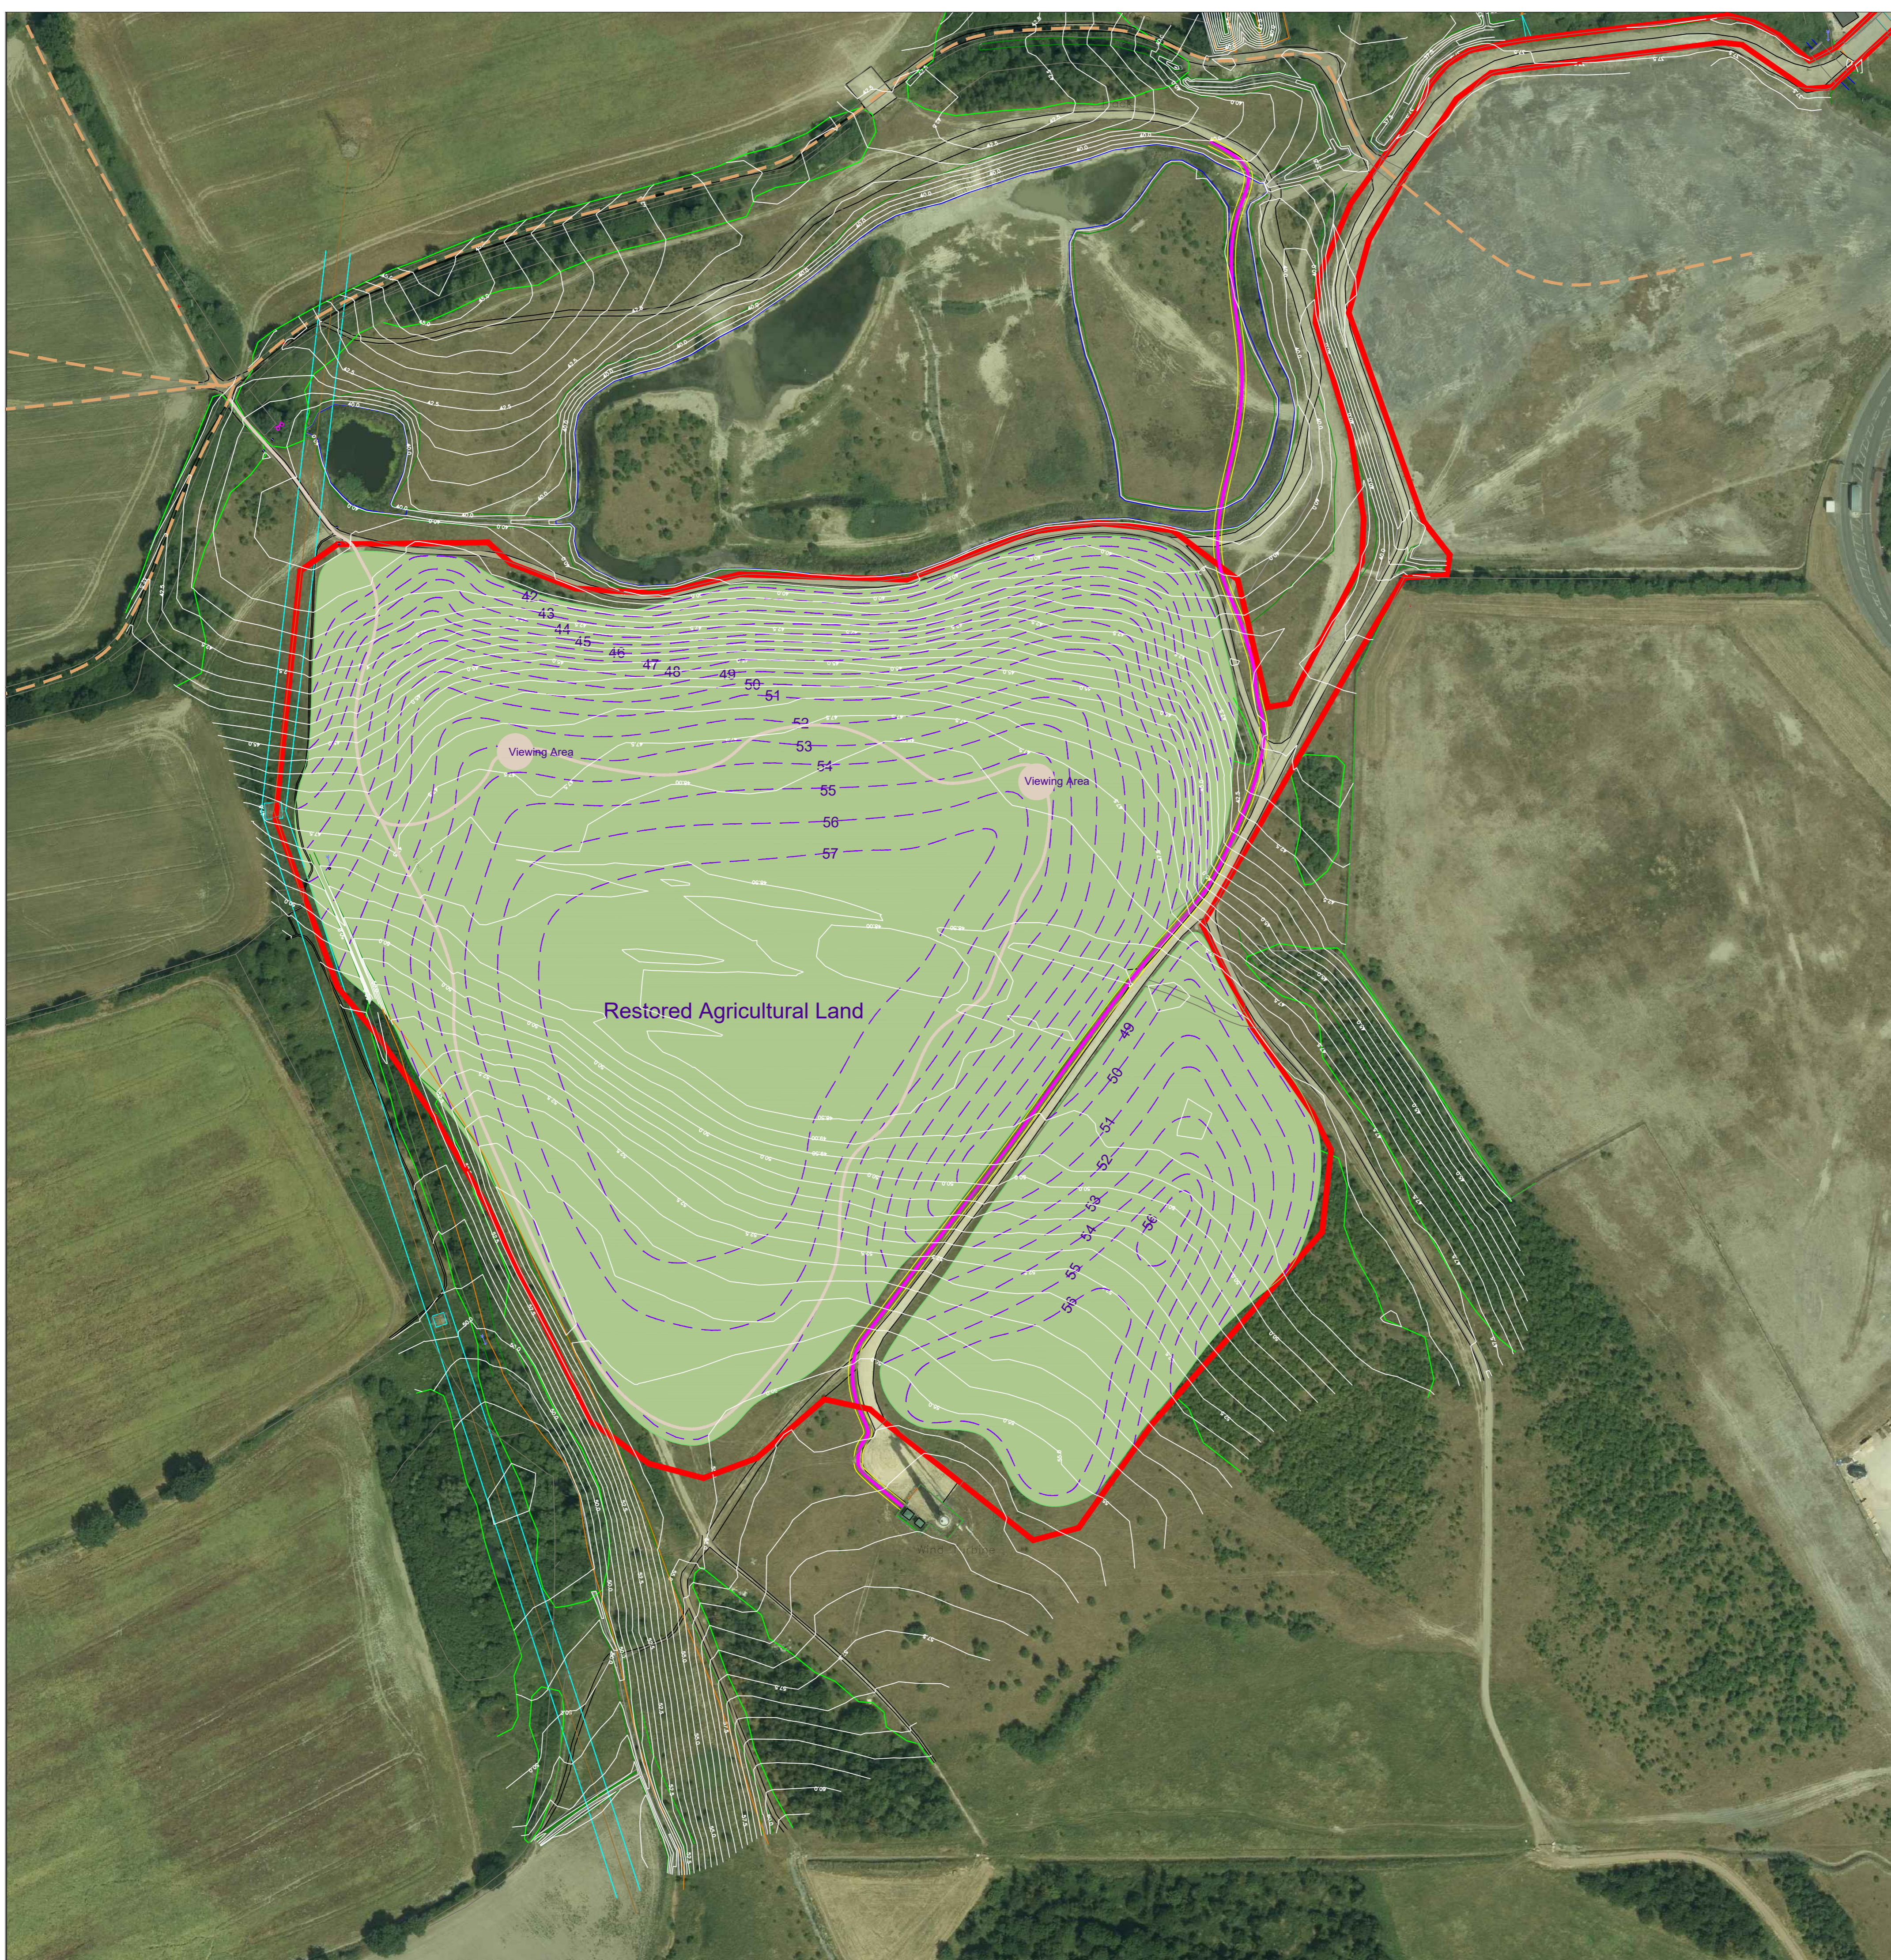
Drawing Name: Grading Plan

The proposed development is to return the site to productive use by improving the soil profile so that it is suitable for agriculture and outdoor recreational uses in a restored landscape to include new tree plantations and enhanced biodiversity. The restoration of the site will be achieved through the importation of 430,300m³ of soil and inert materials under an Environment Agency (EA) Permit as a waste recovery operation.

Drawing No. 901.03A/Grading Plan dated 14th September 2023 by Weller Designs Ltd.
