**LAND BETWEEN CROMFORD AVENUE AND BLACKEATH ROAD,
(ALSO KNOWN AS LAND AT HADDON ROAD)
ATHERSLEY SOUTH,
BARNSELY, S71 3SY**

REPORT ON PHASE 2 GEO-ENVIRONMENTAL INVESTIGATION

Report Ref: 24246/P2/0

Dated: June 2025

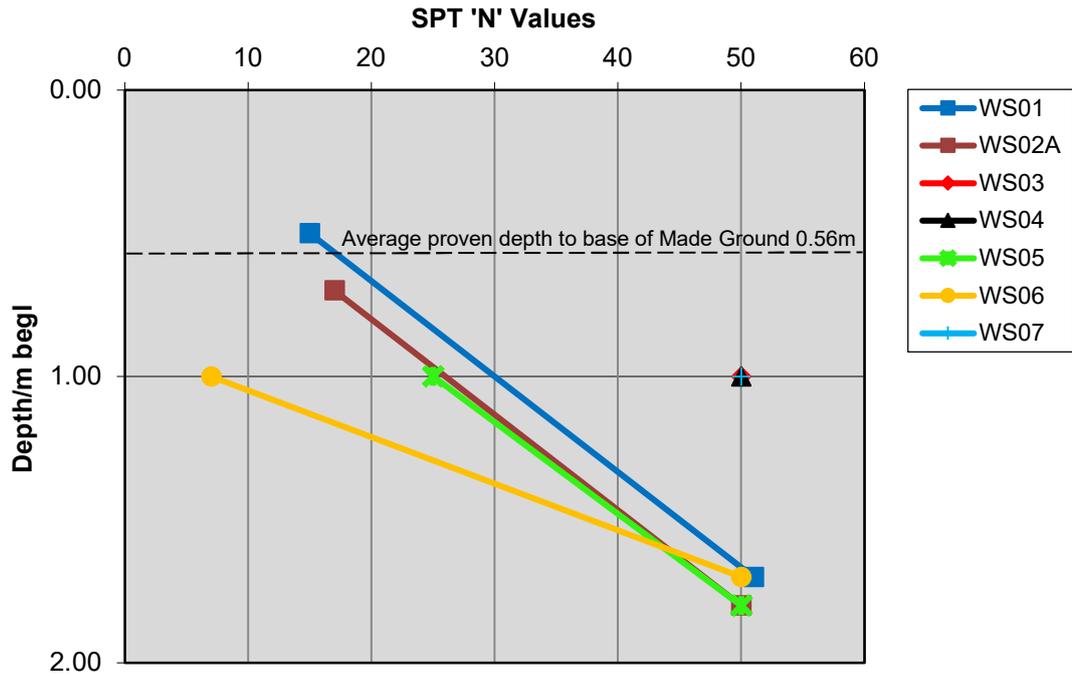
Standard Penetration Tests (SPTs) were carried out at intervals appropriate to the depth of the holes or the depth to bedrock and commenced within the natural strata at depths of 0.50-1.00m begl. The SPT 'N' values are recorded on the exploratory hole logs provided in Appendix B and are shown graphically on the following page.

The N values recorded within the natural soils ranged between 7 and 25 indicating a loose to medium dense granular material or soft to stiff cohesive material at depths ranging between 0.50 and 1.00m begl. The N values recorded within the sandstone bedrock at depths of 1.00-1.80m begl exceeded the maximum of 50 and are consistent with the field descriptions of weathered sandstone.

The natural soils underlying the Made Ground are predominantly granular in nature but have a variable strength with SPT results for depths between 0.50 and 1.00m begl indicating a loose to medium dense material.

The natural soils underlying the Made Ground are predominantly granular in nature but have a variable strength with SPT results for depths between 0.50 and 1.00m begl indicating a loose to medium dense material which will be unsuitable as a founding medium.

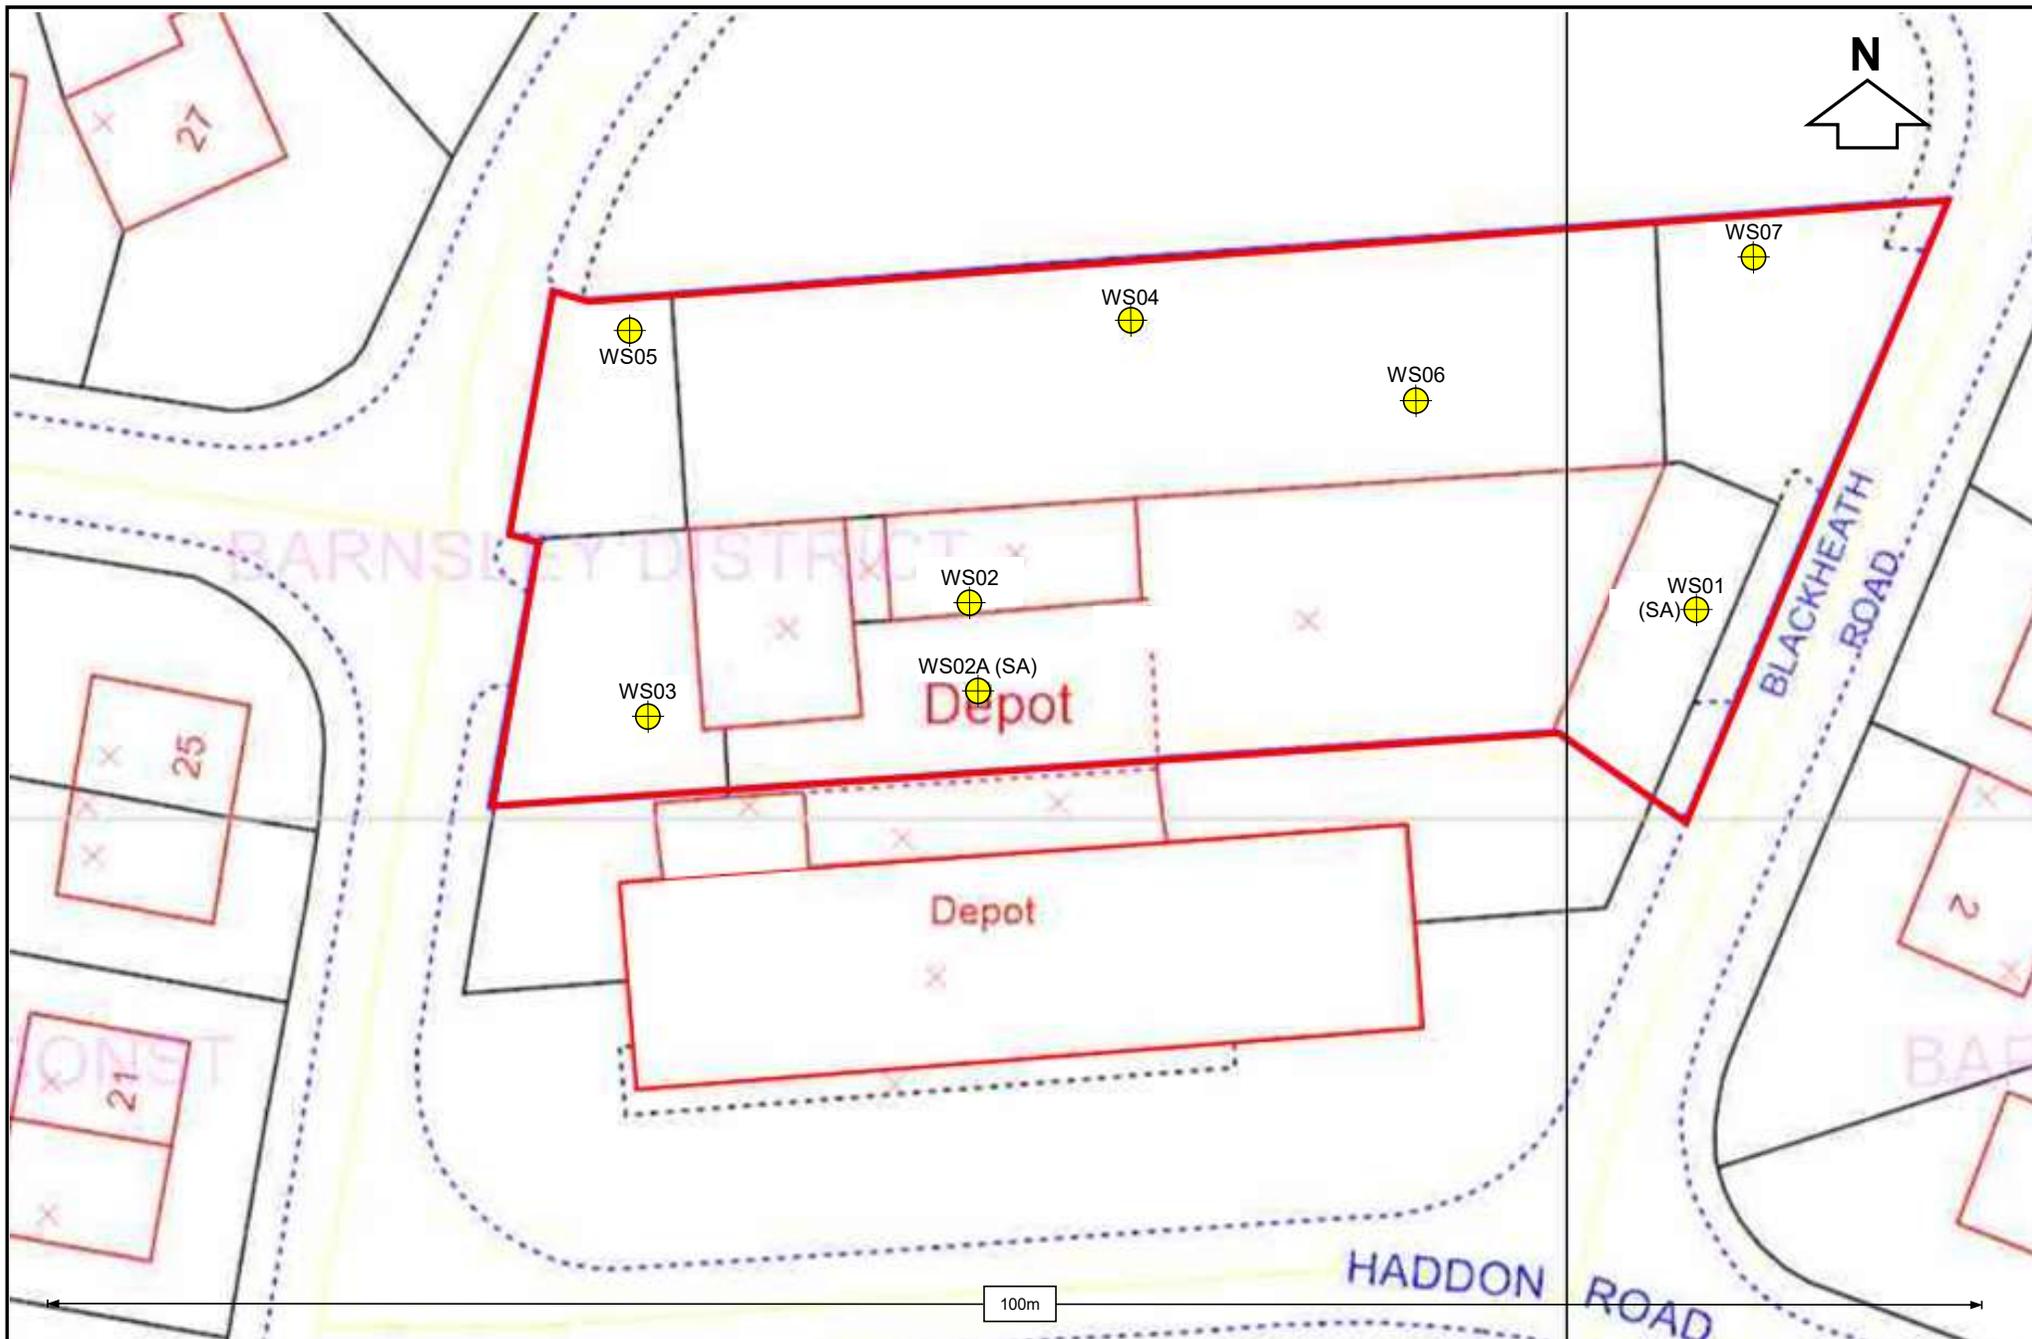
Fig: 2

Title:
Exploration Hole Locations - Existing Layout

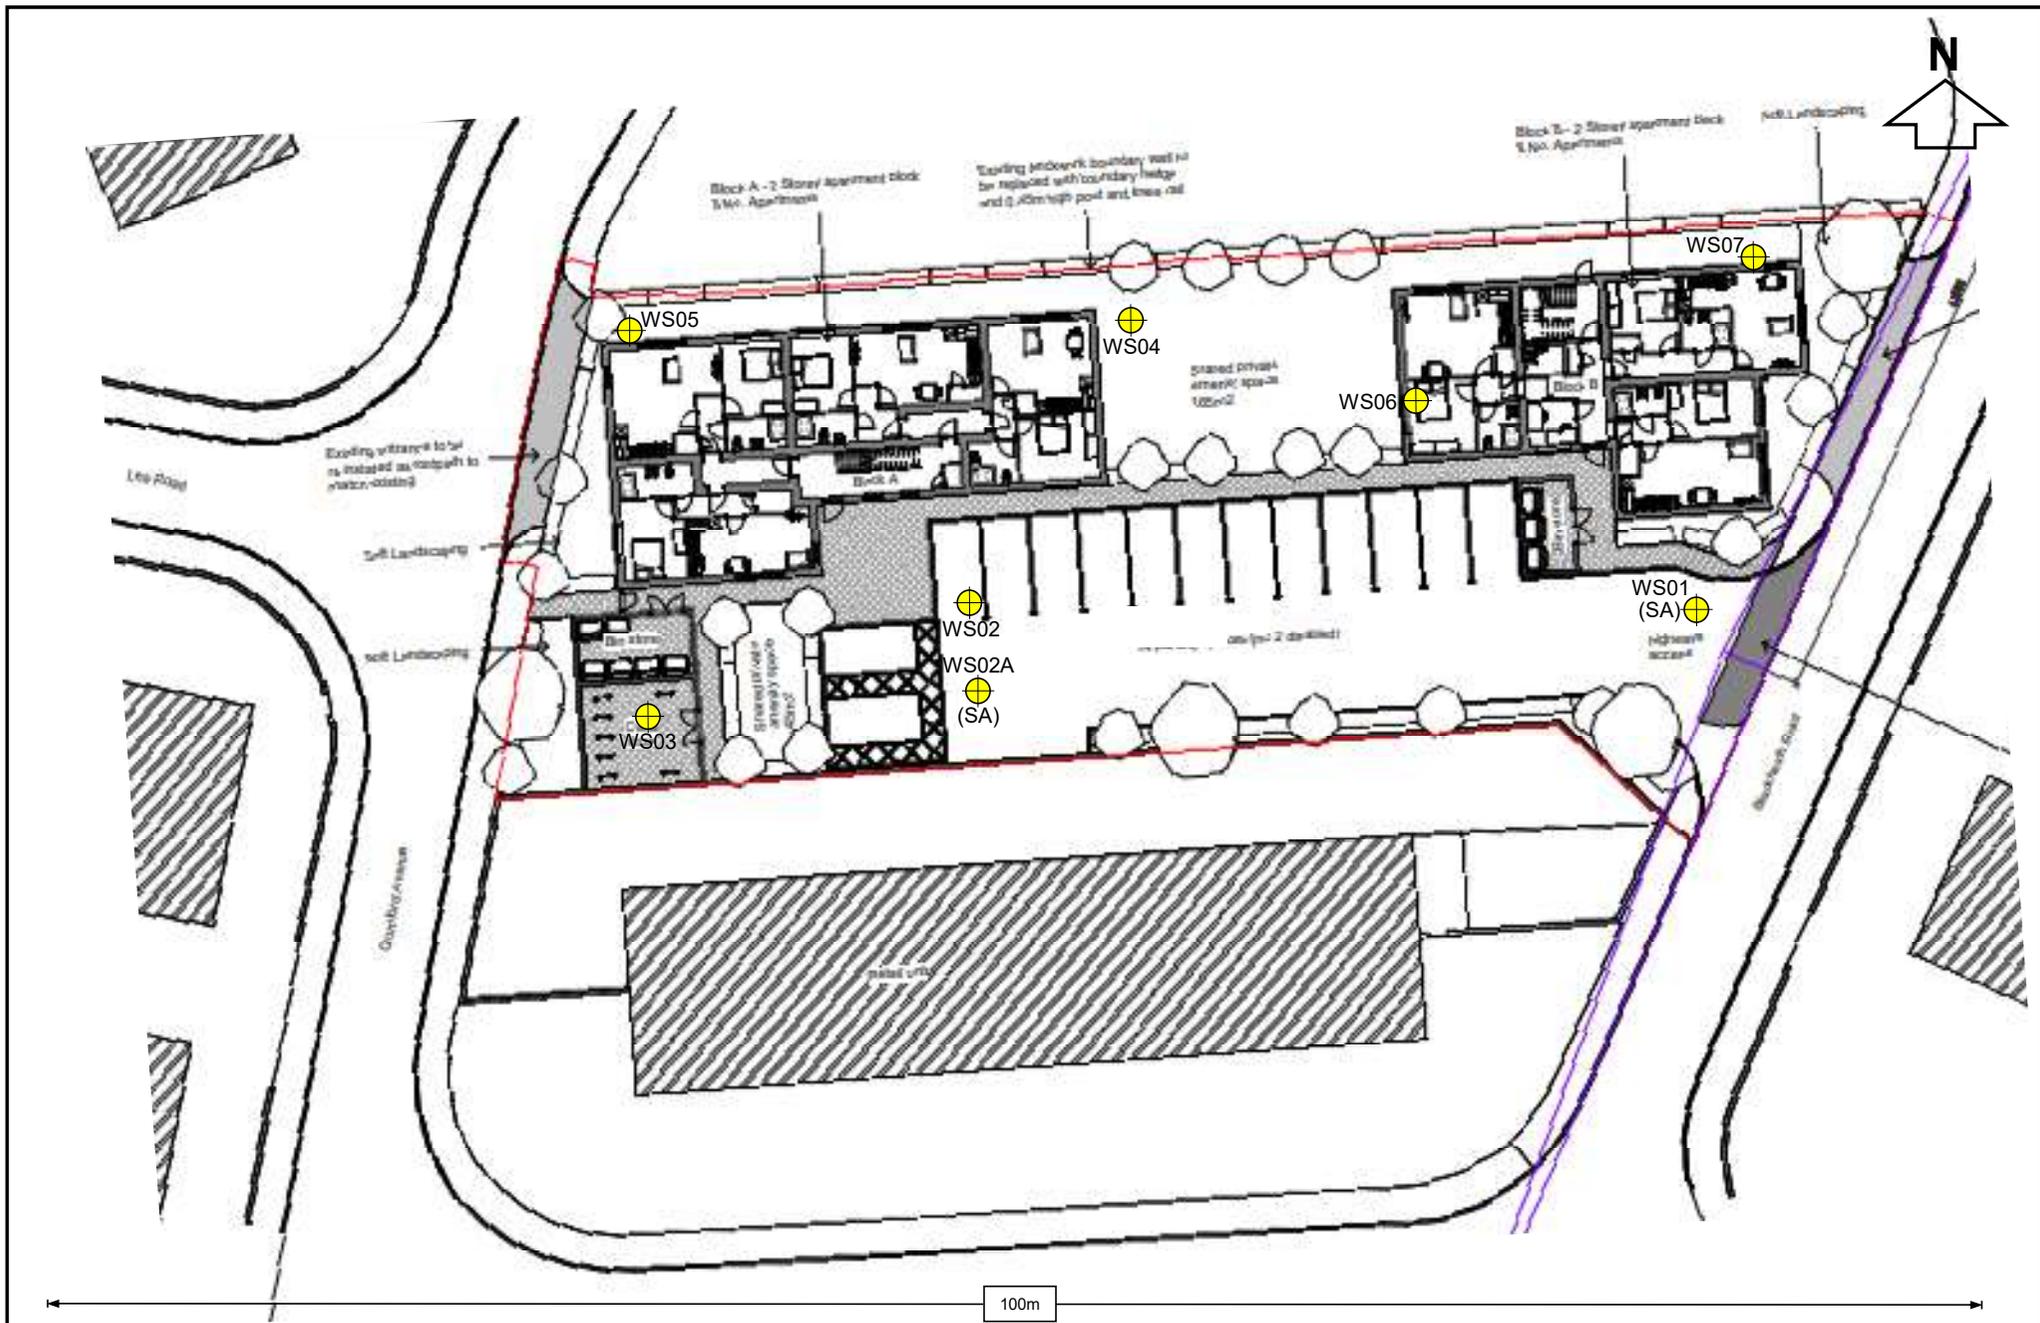
Figure 3: Exploration Hole Locations – Proposed Layout

Base plan taken from Ropergate Architecture Proposed Siteplan, drawing ref. HR- RA- XX- XX- DR- A- (03)04/A, dated 31/05/2024

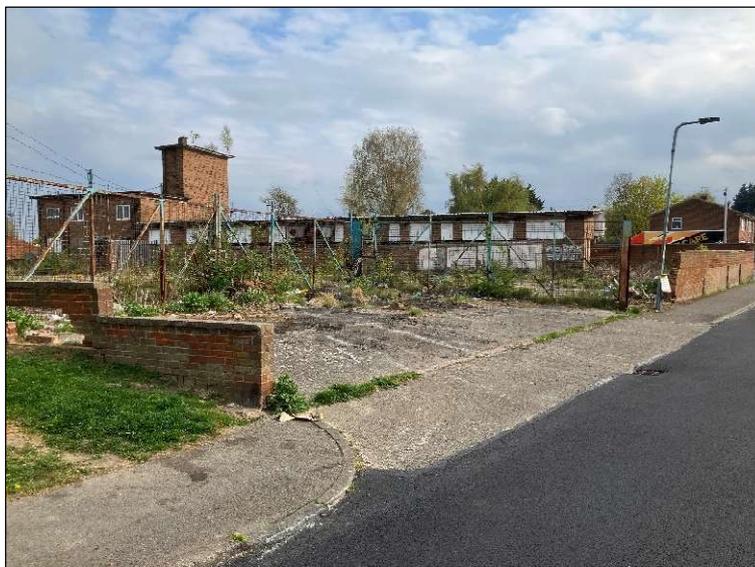
Photo 1: Site Condition – View of the Cromford Avenue frontage looking southeast, showing former site entrance.

The site is an area of vacant land and at the time of the recent investigation (see photos 1-6 in Appendix C) was observed to comprise mostly concrete hardstanding with some smaller areas of asphalt surfacing and sporadic low level vegetation mostly extending along joints in the hardstanding. Low levels of litter and a small number of discarded items / materials were also noted.

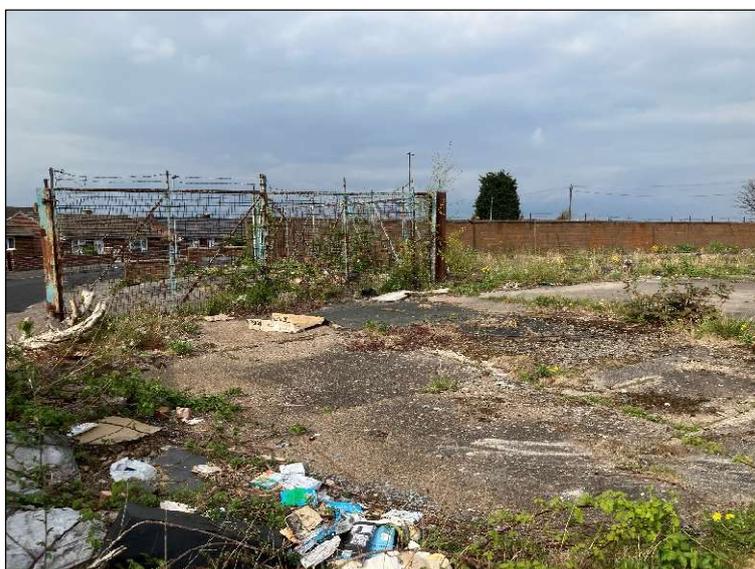
Photo 2: Site Condition – View north along the western edge of the site.

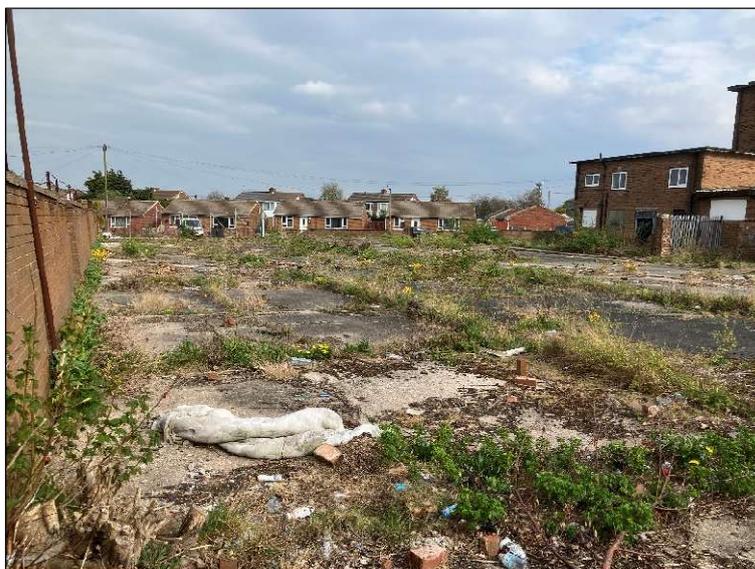
Photo 3: Site Condition – View across the site looking east from near the northwestern corner showing northern site boundary (left).

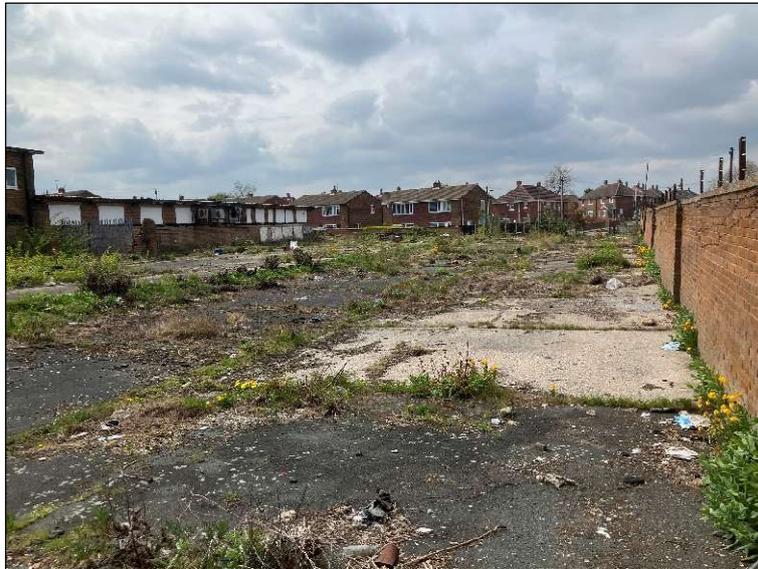
Photo 4: Site Condition – View across the site looking west from near the northeastern corner showing northern site boundary (right).

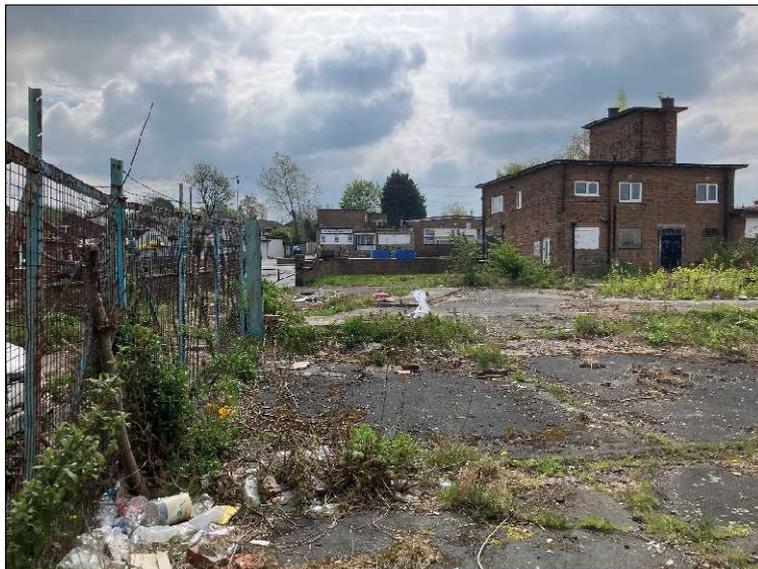
Photo 5: Site Condition – View south along the eastern edge of the site towards Haddon Road from near the northeastern corner.

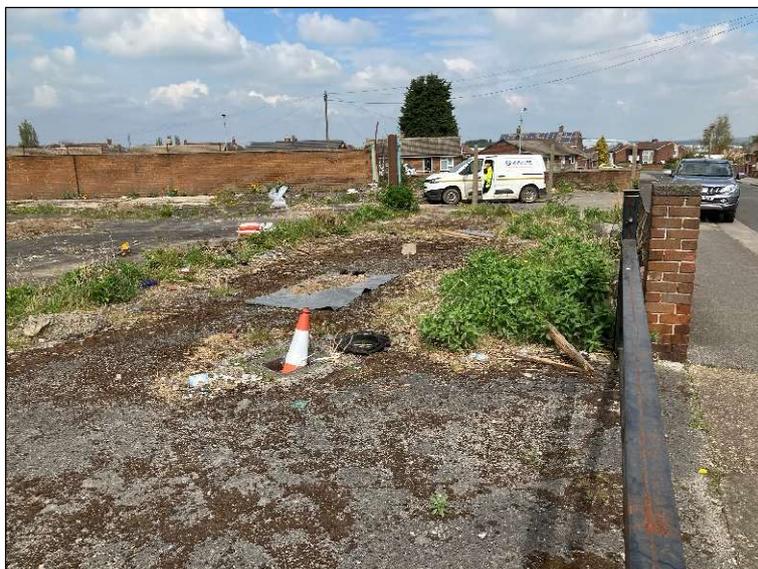
Photo 6: Site Condition – View north along the eastern site boundary with Blackheath Road.

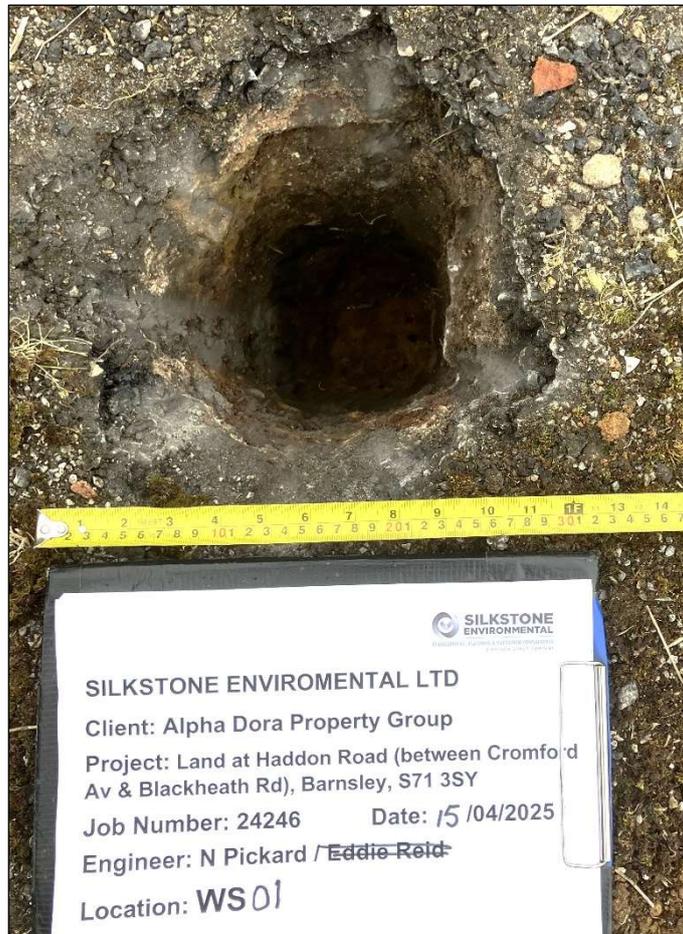
Photo 7: 15/04/2025 WS01 – Hand dug inspection pit excavated prior to windowless sampling.

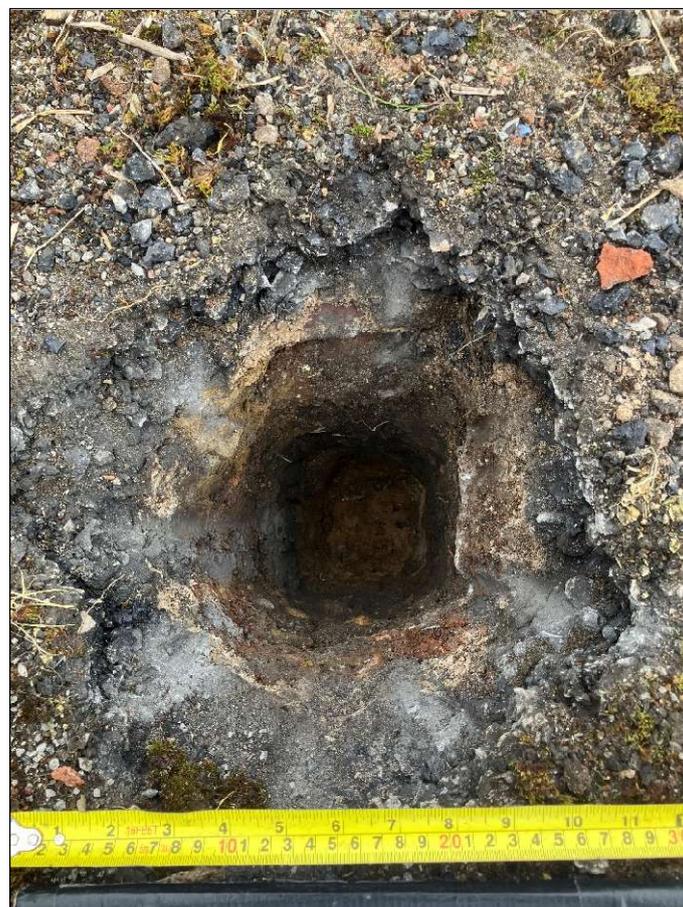
Photo 8: 15/04/2025 WS01 – Close up of hand dug pit.

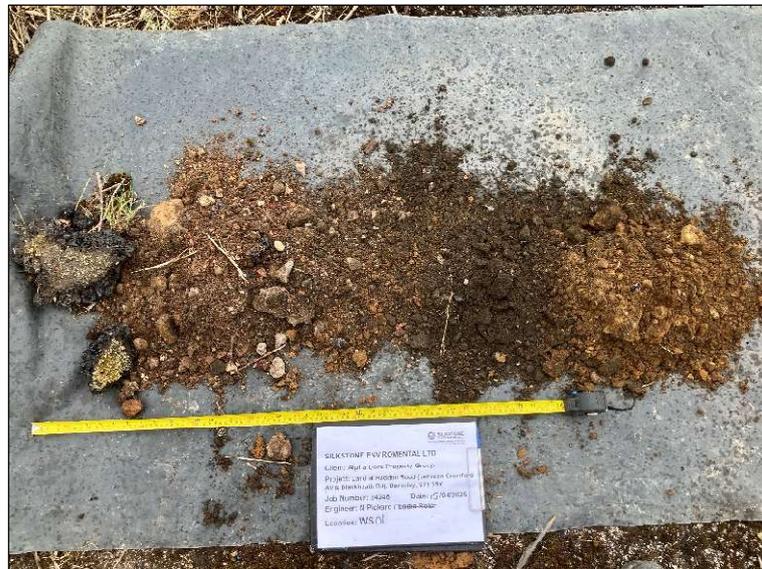
Photo 9: 15/04/2025 WS01 – Soils recovered from hand dug pit to 0.53m begl (depth progressing from left to right). Tape is extended to 1.00m.

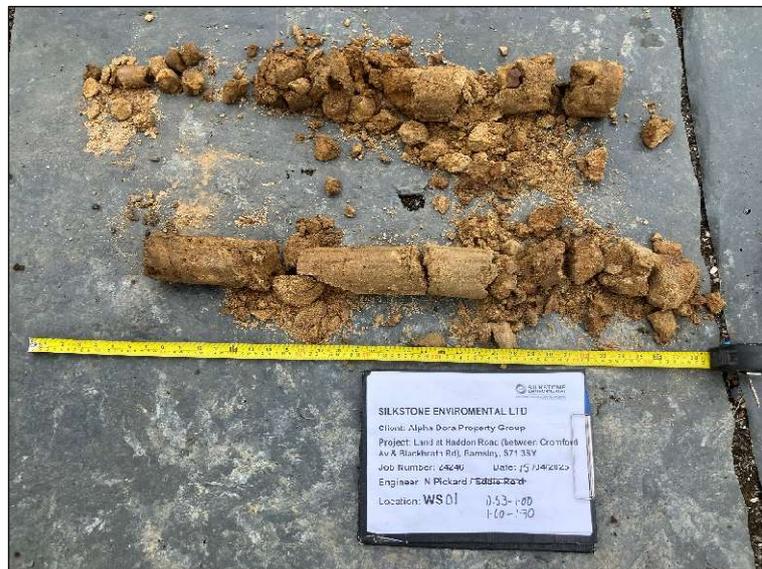
Photo 10: 15/04/2025 WS01 – Recovered soil cores following penetration by windowless sampling to 1.70m begl (depth progressing left to right and from top (0.53-1.00m) to bottom (1.00-1.70m)).

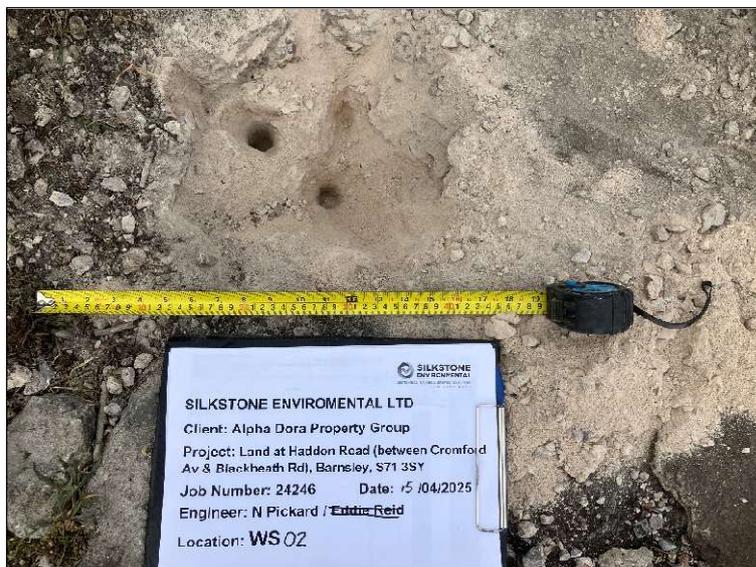
Photo 11: 15/04/2025 WS02 – Hand dug inspection pit aborted in reinforced concrete at 0.25m begl.

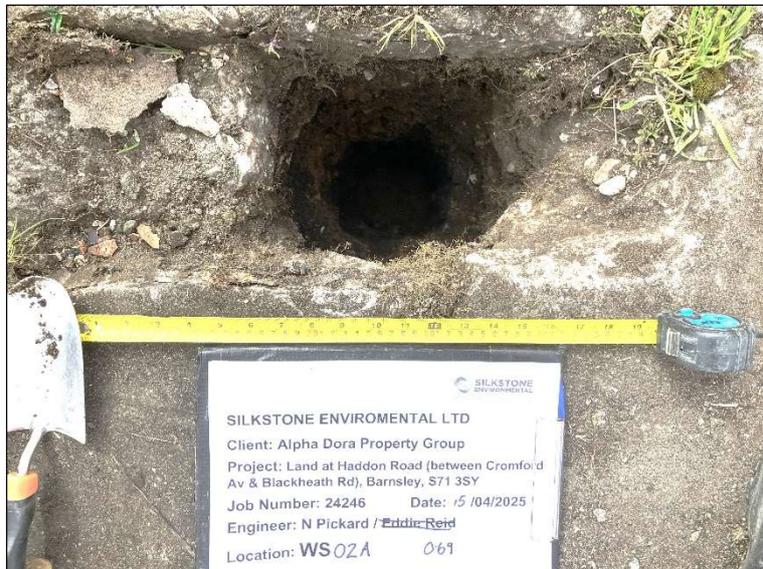
Photo 12: 15/04/2025 WS02A – Hand dug inspection pit.

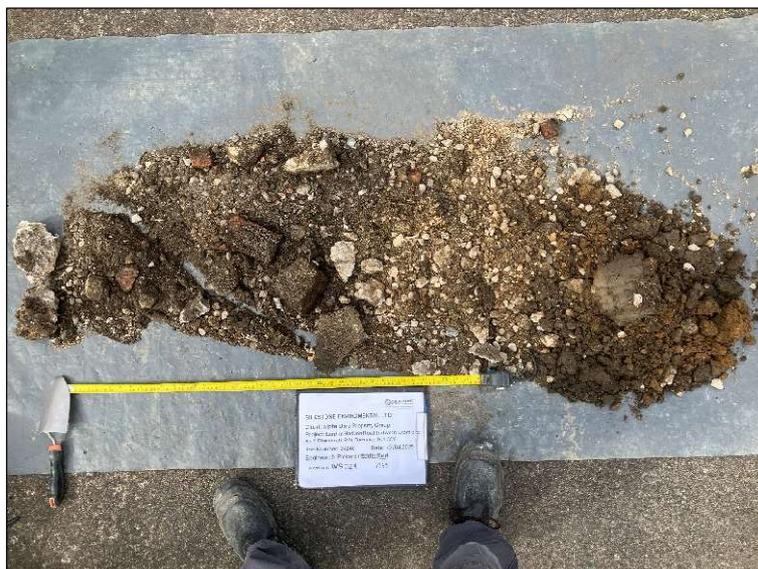
Photo 14: 15/04/2025 WS02A – Soils recovered from hand dug pit to 0.69m begl (depth progressing from left to right). Tape is extended to 1.00m.

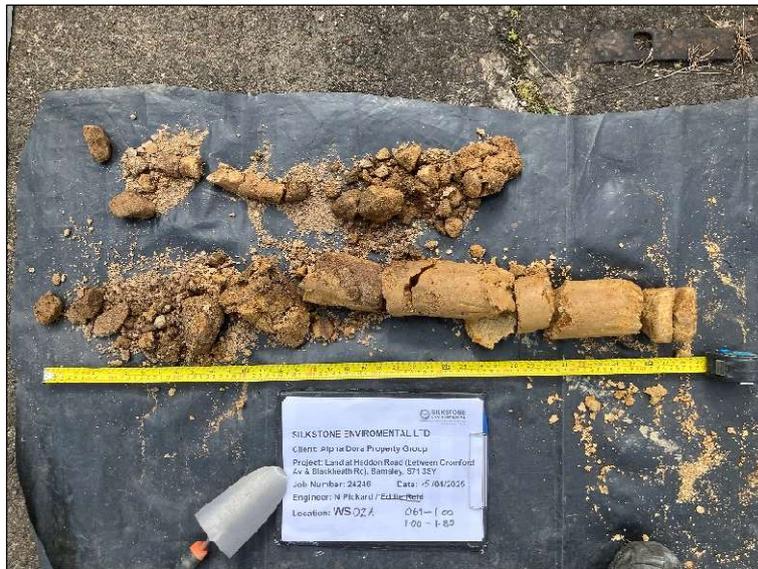
Photo 15: 15/04/2025 WS02A – Recovered soil cores following penetration by windowless sampling to 1.80m begl (depth progressing left to right and from top to bottom).

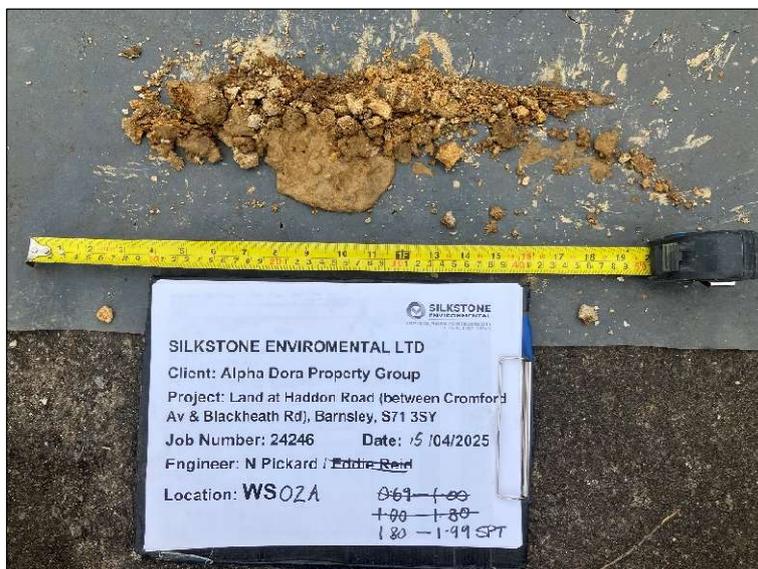
Photo 16: 15/04/2025 WS02A – Recovered SPT sample following refusal at 1.99m begl (depth progressing left to right). The observed wet section of sample resulted from the soakaway testing.

A localised pocket of wet strata was also observed in the soil recovered from 1.80-1.99m begl at WS02A, but this is believed to have been residual water remaining from the permeability testing conducted at this location prior to the continuation of windowless sampling.

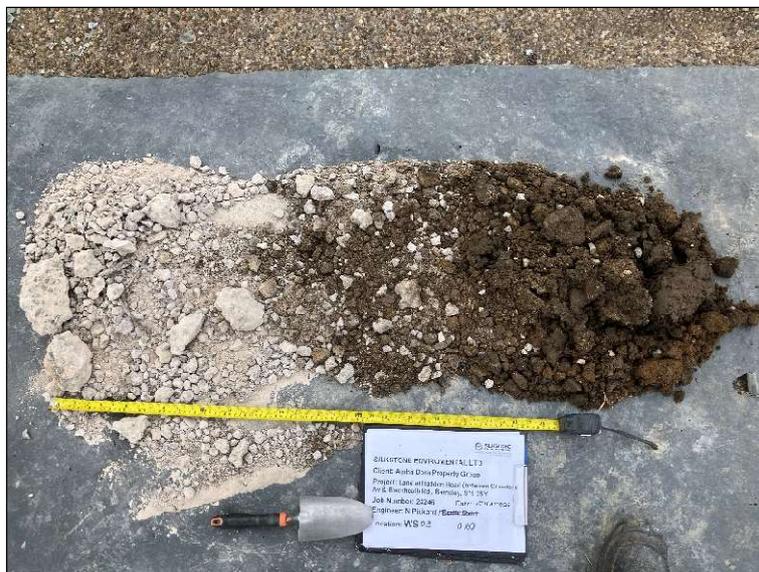
Photo 19: 15/04/2025 WS03 – Soils recovered from hand dug pit to 0.60m begl (depth progressing from left to right). Tape is extended to 1.00m.

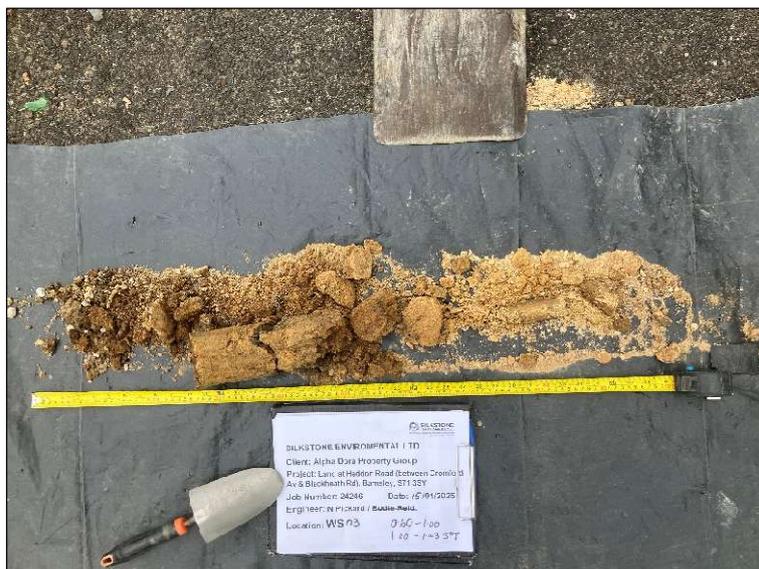
Photo 20: 15/04/2025 WS03 – Recovered soil cores following penetration by windowless sampling to 1.00m begl and SPT refusal at 1.43m begl (depth progressing left to right). Tape is extended to 1.00m.

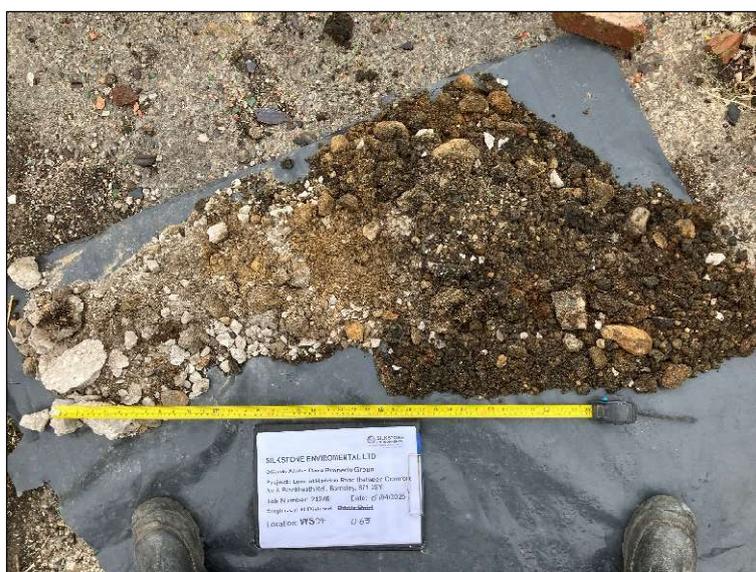
Photo 23: 15/04/2025 WS04 – Soils recovered from hand dug pit to 0.63m begl (depth progressing from left to right). Tape is extended to 1.00m.

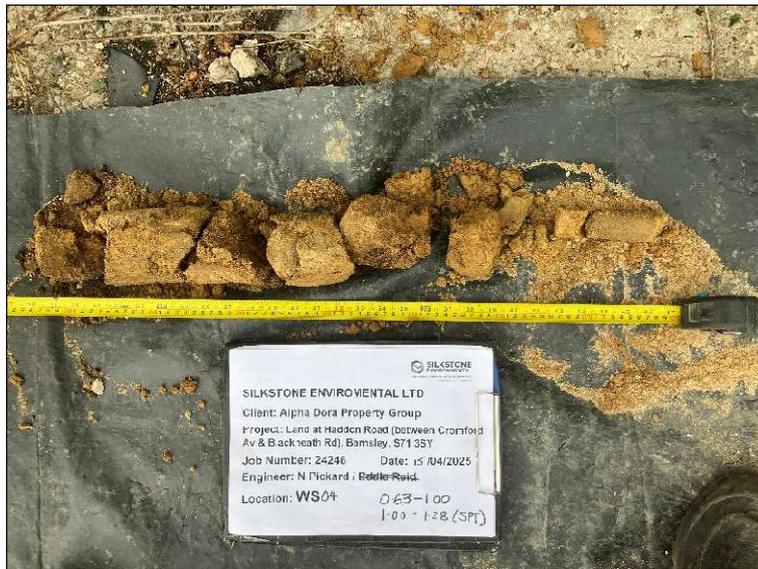
Photo 24: 15/04/2025 WS04 – Recovered soil cores following penetration by windowless sampling to 1.00m begl and SPT refusal at 1.28m begl (depth progressing left to right). Tape is extended to 1.00m.

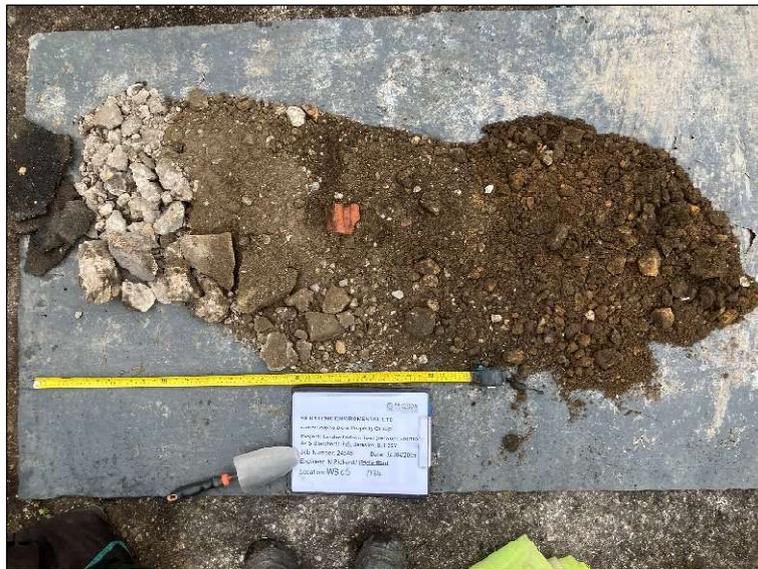
Photo 27: 16/04/2025 WS05 – Soils recovered from hand dug pit to 0.74m begl (depth progressing from left to right). Tape is extended to 1.00m.

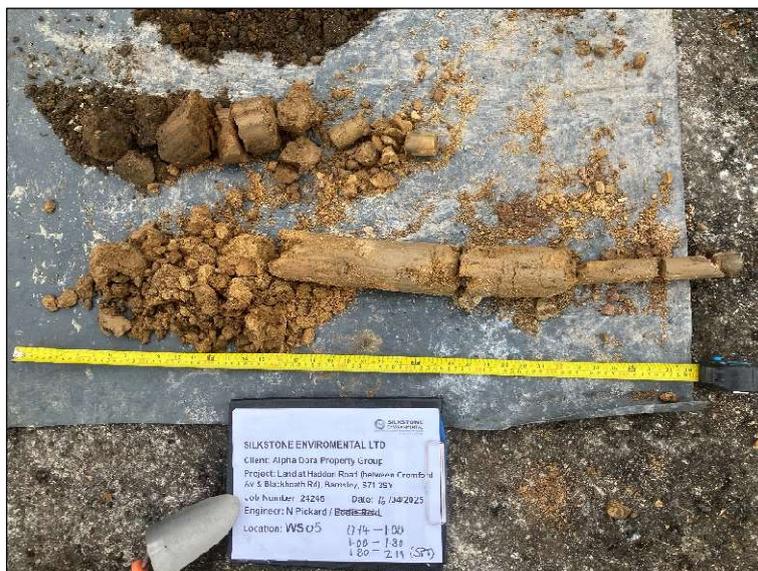
Photo 29: 16/04/2025 WS05 – Recovered soil cores following penetration by windowless sampling to 1.80m begl and SPT refusal at 2.19m begl (depth progressing left to right and from top to bottom).

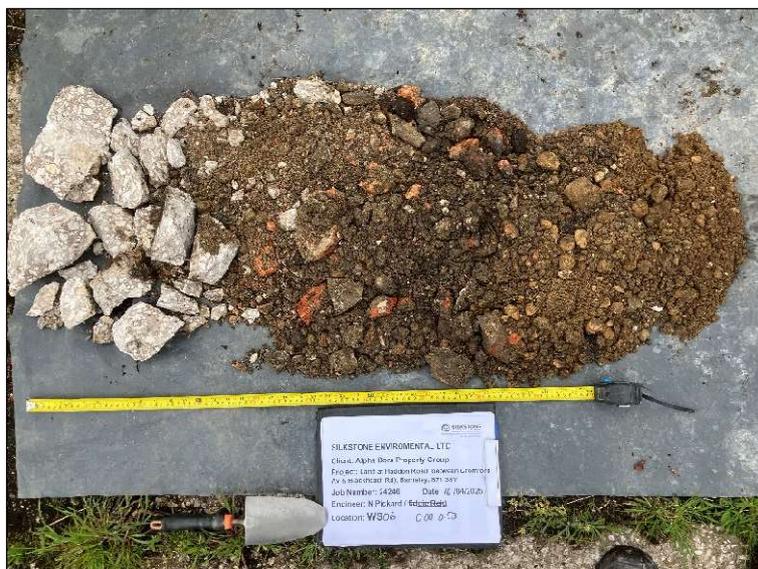
Photo 32: 16/04/2025 WS06 – Soils recovered from hand dug pit to 0.53m begl (depth progressing from left to right). Tape is extended to 1.00m.

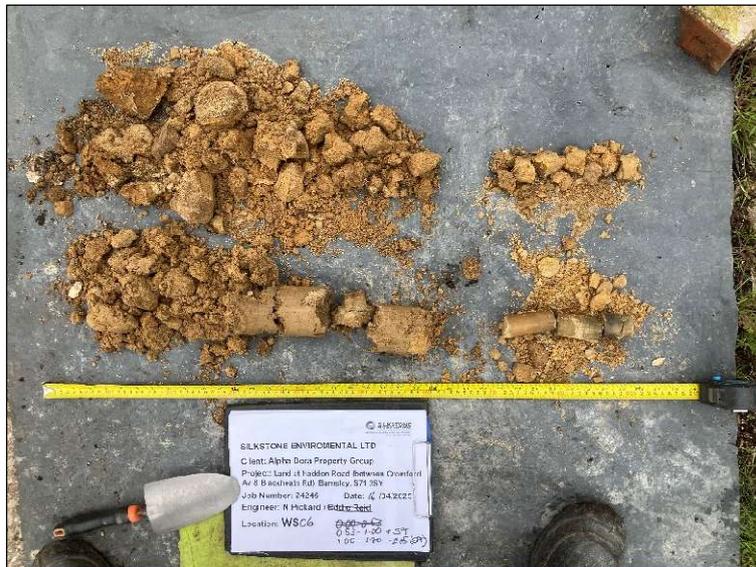
Photo 33: 16/04/2025 WS06 – Recovered soil cores following penetration by windowless sampling to 1.70m begl and SPT refusal at 2.05m begl (depth progressing left to right and from top to bottom).

Whilst some moist strata was recorded at one location (WS06 at 1.35-1.70m begl), no groundwater ingress was recorded during the investigation.

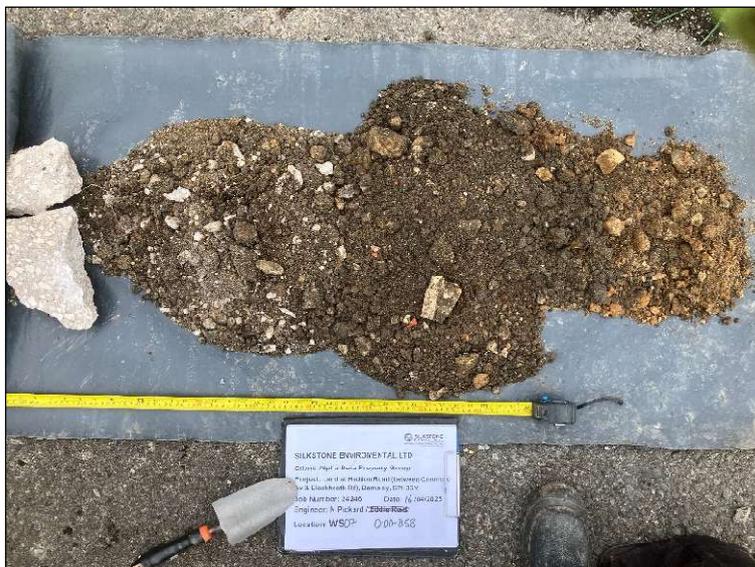
Photo 36: 16/04/2025 WS07 – Soils recovered from hand dug pit to 0.58m begl (depth progressing from left to right). Tape is extended to 1.00m.

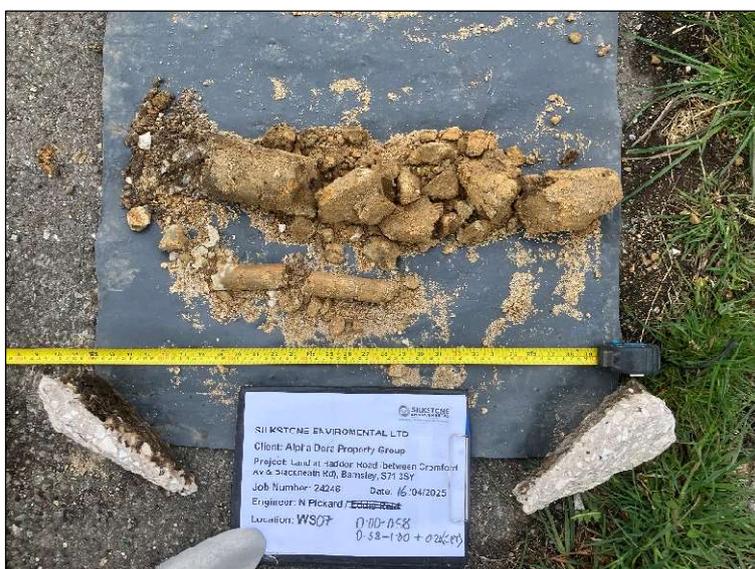
Photo 37: 16/04/2025 WS07 – Recovered soil cores following penetration by windowless sampling to 1.00m begl (top) and SPT refusal at 1.28m begl (bottom), depth progressing from left to right.

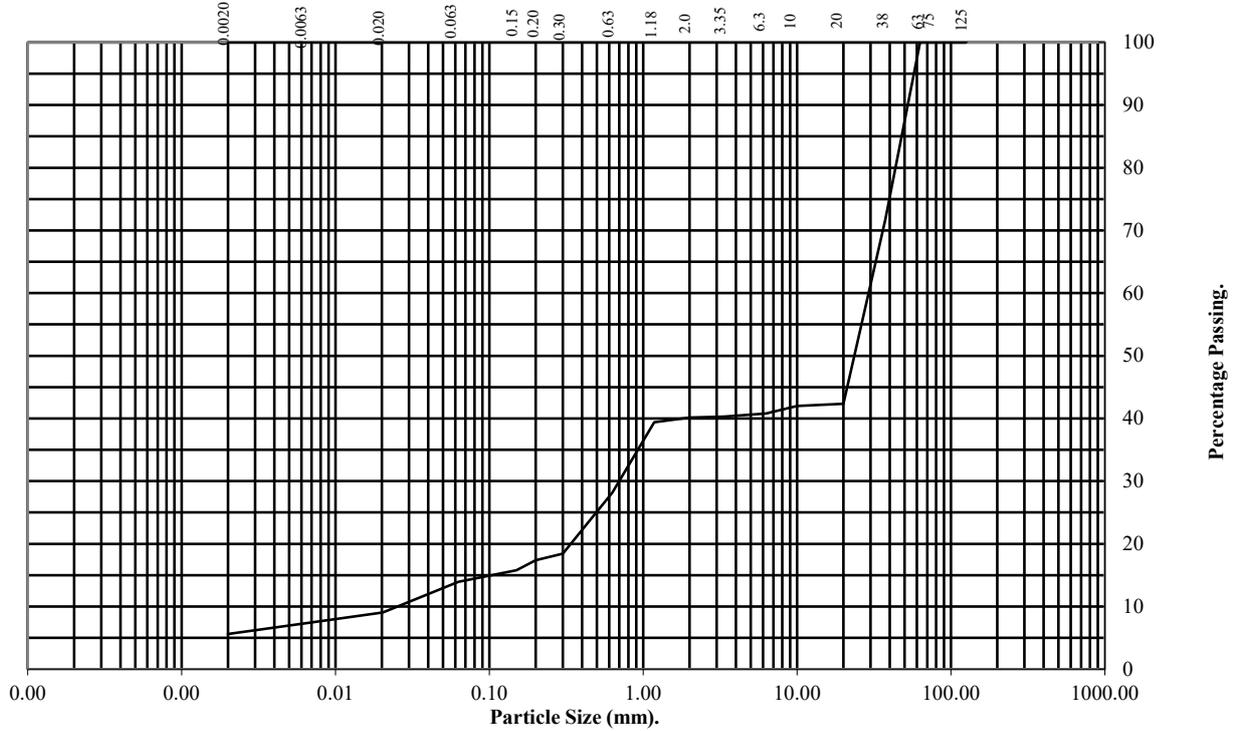
BS Test Sieve (mm)	Percentage Passing
125	100
75	100
63	100
37.5	72
20	42
10	42
6.3	41
3.35	40
2	40
1.18	39
0.63	28
0.3	18
0.2	17
0.15	16
0.063	14

Particle Diameter	Percentage Passing
0.020	9
0.0063	7
0.0020	6
<i>Particle Density - 2.65 Mg/m3 assumed</i>

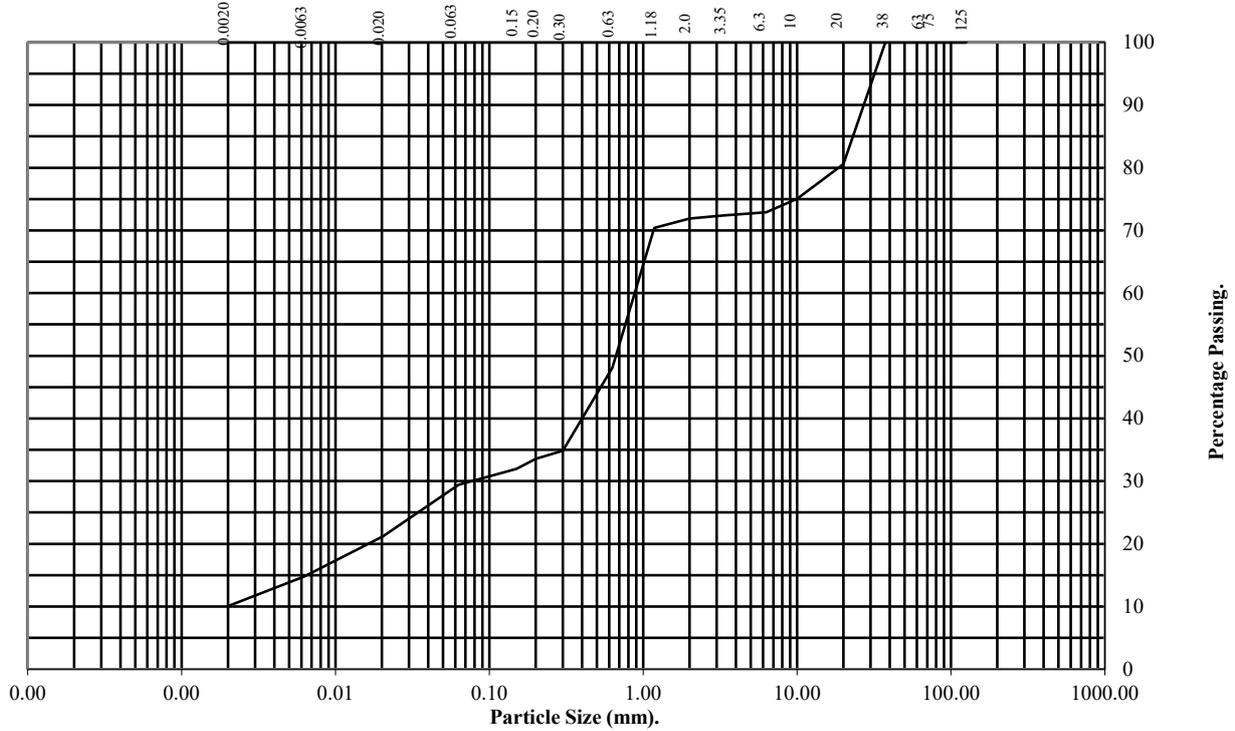
BS Test Sieve (mm)	Percentage Passing
125	100
75	100
63	100
37.5	100
20	81
10	75
6.3	73
3.35	72
2	72
1.18	70
0.63	48
0.3	35
0.2	34
0.15	32
0.063	29

Particle Diameter	Percentage Passing
0.020	21
0.0063	15
0.0020	10
<i>Particle Density - 2.65 Mg/m3 assumed</i>

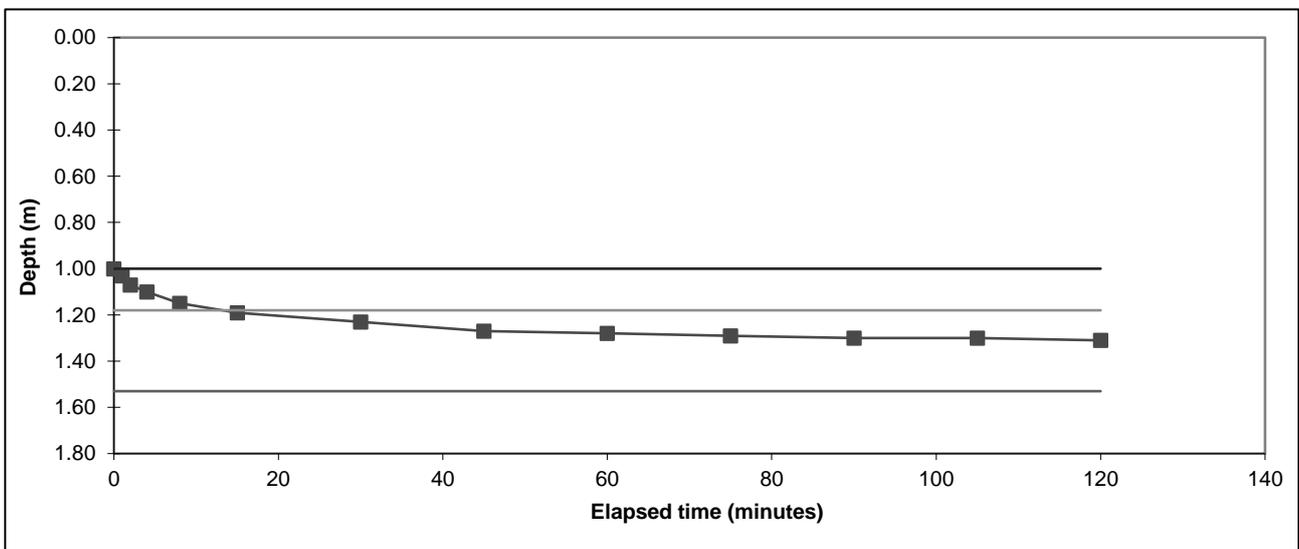
Trial Pit No:	WS01	Test No:	1	Date:	15/04/2025
Length (m):	0.700	Datum Height:			m agl
Width (m):	0.70	Granular infill:	None		
Depth (m):	1.70	Porosity of infill:	1		(assumed)

Elapsed time (minutes)	Water Depth (m below datum)	Elapsed time (minutes)	Water Depth (m below datum)
0	1.000		
1	1.030		
2	1.070		
4	1.100		
8	1.150		
15	1.190		
30	1.230		
45	1.270		
60	1.280		
75	1.290		
90	1.300		
105	1.300		
120	1.310

Start water depth for analysis (mbgl):	1.00		
75% effective depth (mbgl):	1.18	Elapsed time (mins):	13.3
50% effective depth (mbgl):	1.35		
25% effective depth (mbgl):	1.53	Elapsed time (mins):	#N/A
Base of soakage zone (mbgl):	1.70		
Volume outflow between 75% and 25% effective depth (m ³):			
Mean surface area of outflow (m ²):			1.47
(side area at 50% effective depth + base area)			
Time for outflow between 75% and 25% effective depth (mins):

Soil infiltration rate (m/s):	Test incomplete as 25% effective depth not achieved. Unable to reliably determine soil infiltration rate.
--------------------------------------	--

Hole ID	Response Zone (m)	Test	Infiltration Rate (m/s)	Level of Permeability	Drainage Conditions	Comments
WS01	1.00-1.70	1	-	Practically impermeable		Infiltration rate could not be calculated due to very slow reduction in water level.
WS02A	1.00-1.80	1	-

The testing at the two differing locations within the site during the investigation has shown very slow infiltration rates which means that the soils are unsuitable for soakaway drainage based on the tests conducted.
