**LAND BETWEEN CROMFORD AVENUE AND BLACKEATH ROAD,
(ALSO KNOWN AS LAND AT HADDON ROAD)
ATHERSLEY SOUTH,
BARNSELY, S71 3SY**

REPORT ON PHASE 2 GEO-ENVIRONMENTAL INVESTIGATION

Report Ref: 24246/P2/0

Dated: June 2025

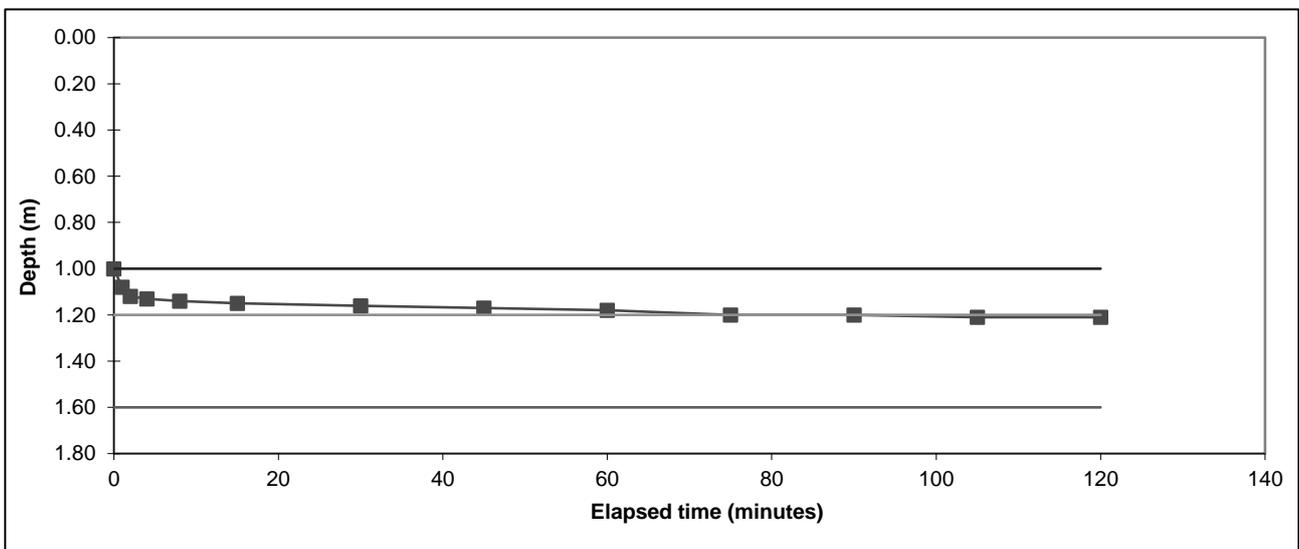
Trial Pit No:	WS02A	Test No:	1	Date:	15/04/2025
Length (m):	0.700	Datum Height:			m agl
Width (m):	0.70	Granular infill:	None		
Depth (m):	1.80	Porosity of infill:	1		(assumed)

Elapsed time (minutes)	Water Depth (m below datum)	Elapsed time (minutes)	Water Depth (m below datum)
0	1.000		
1	1.080		
2	1.120		
4	1.130		
8	1.140		
15	1.150		
30	1.160		
45	1.170		
60	1.180		
75	1.200		
90	1.200		
105	1.210		
120	1.210

Start water depth for analysis (mbgl):	1.00	Elapsed time (mins):	90.0
75% effective depth (mbgl):	1.20		
50% effective depth (mbgl):	1.40	Elapsed time (mins):	#N/A
25% effective depth (mbgl):	1.60		
Base of soakage zone (mbgl):	1.80		
Volume outflow between 75% and 25% effective depth (m ³):			
Mean surface area of outflow (m ²):		1.61	
(side area at 50% effective depth + base area)			
Time for outflow between 75% and 25% effective depth (mins):

Soil infiltration rate (m/s):	Test incomplete as 25% effective depth not achieved. Unable to reliably determine soil infiltration rate.
--------------------------------------	--

Hole ID	Response Zone (m)	Test	Infiltration Rate (m/s)	Level of Permeability	Drainage Conditions	Comments
WS01	1.00-1.70	1	-	Practically impermeable		Infiltration rate could not be calculated due to very slow reduction in water level.
WS02A	1.00-1.80	1	-

The testing at the two differing locations within the site during the investigation has shown very slow infiltration rates which means that the soils are unsuitable for soakaway drainage based on the tests conducted.
