CROWN AND ANCHOR, BARUGH GREEN.

OS REF: SE 31308 08505.

BAT SURVEY.

Ref No: 250735.

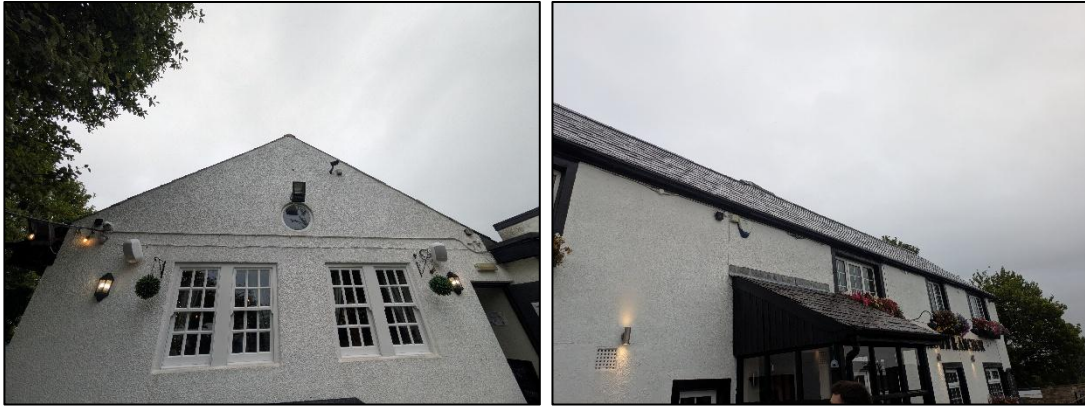
3.3.1. The building comprises a two-storey building with extensions to the sides and rear, all of which have rendered walls. The walls are in good condition with no cracks, gaps or crevices suitable for roosting bats.

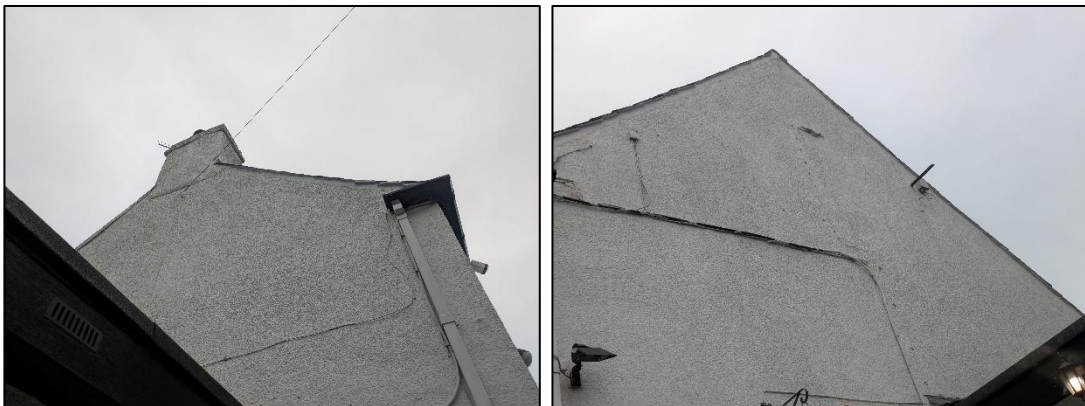
3.3.2. Gable ends were present at the northeast and southwest ends of the two storey building, as well as at the northwestern end of the rear single-storey extension. All were in good condition and the roof was well-sealed to the walls, providing no potential roost features for bats.

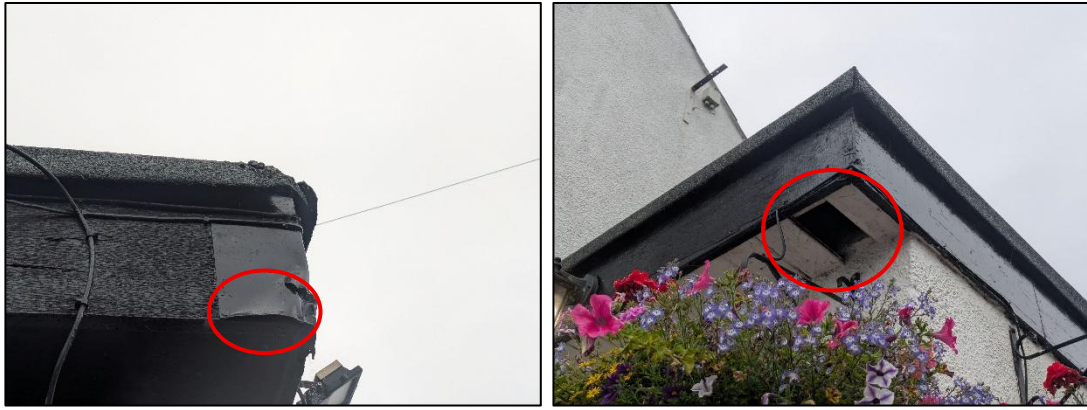
3.3.3. Both soffits and fascias were present on different parts of the building, and both were mostly in good condition. However, two potential roost features were identified, shown in the photographs below. One feature consisted of a small gap behind a plastic repair to fascia, and the other consisted of a missing board on a soffit beneath a flat roof, potentially leading to a small cavity.

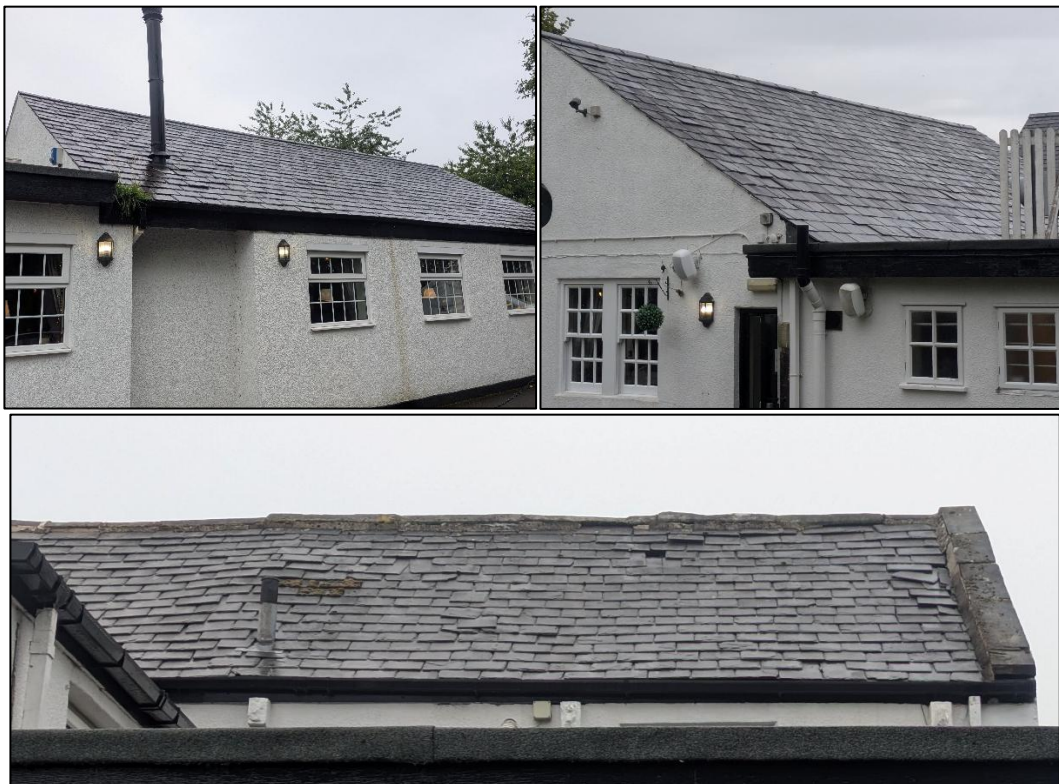
3.3.4. The roof of the main two-storey part of building and two single-storey extensions have pitched roofs covered by slate tiles, shown in the photos below. Missing and slipped tiles were identified throughout, providing potential roost features for bats. Small areas of missing mortar were present underneath the ridge tiles on the main part of the building.

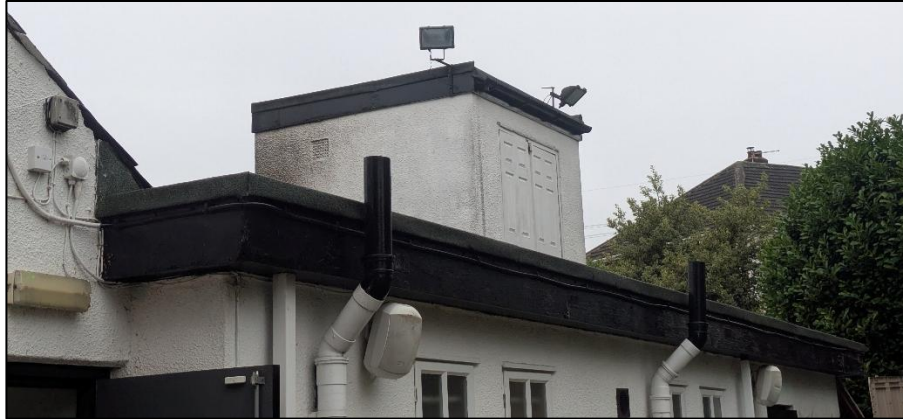
3.3.5. A flat roof covered by roofing felt was present on one extension on the north of the building. This did not provide any roosting potential for bats.

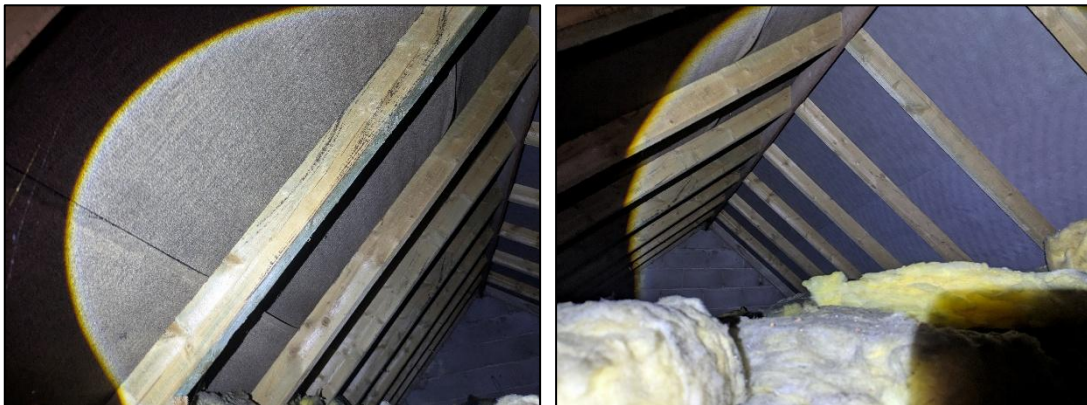
3.3.6. The loft space was accessed within the two-storey section of the building where possible. The loft space was lined with a breathable membrane which was in good condition with no visible access points into the loft space. No bats or field evidence was found inside the loft space.

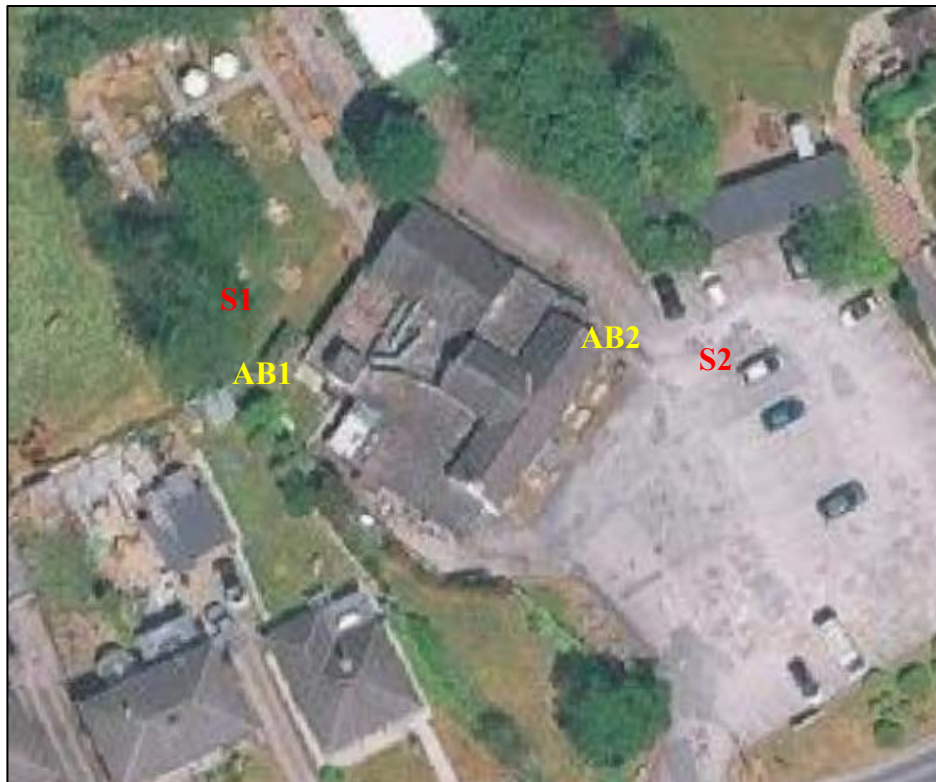
3.4.5. The aerial photograph below shows where the Surveyors (S) and Anabats (AB) were located throughout the survey.

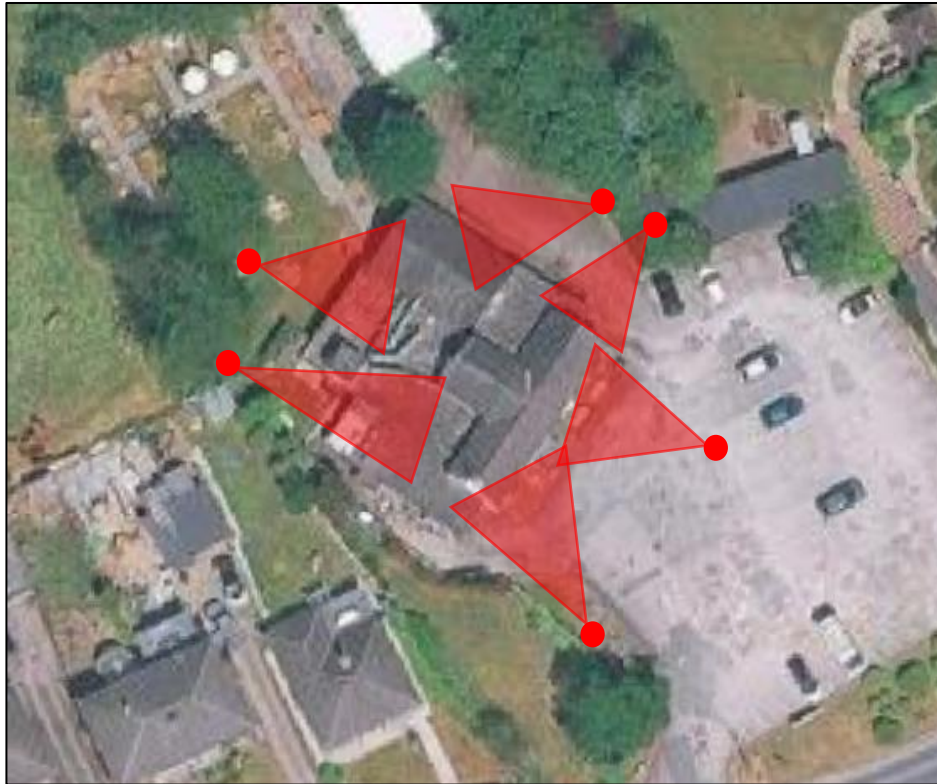
3.4.6. The aerial photograph below shows where the cameras were positioned along with their approximate field of view.

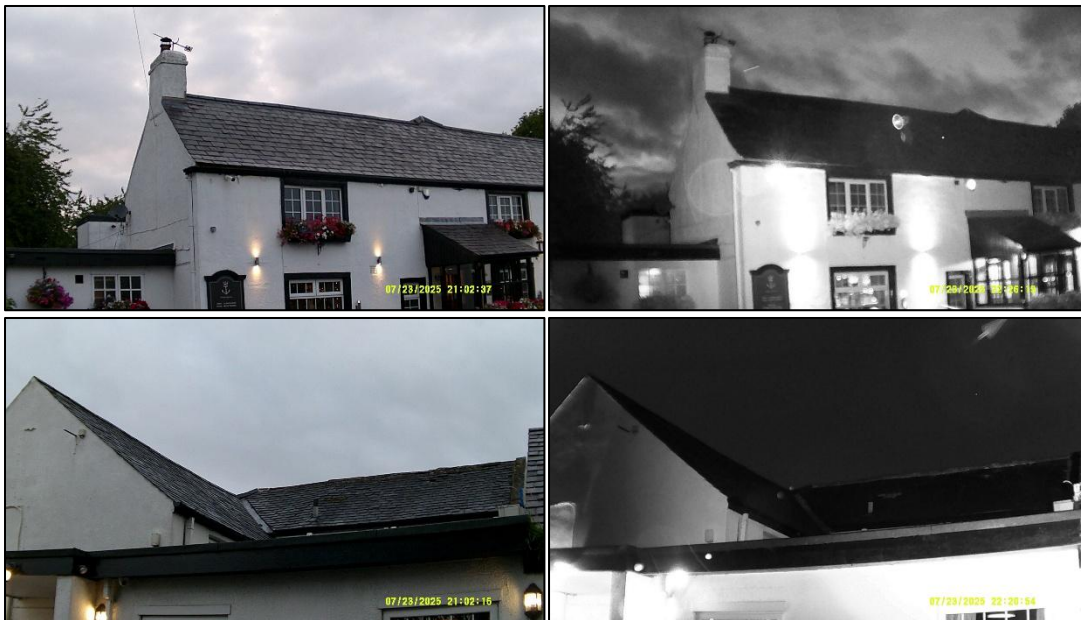
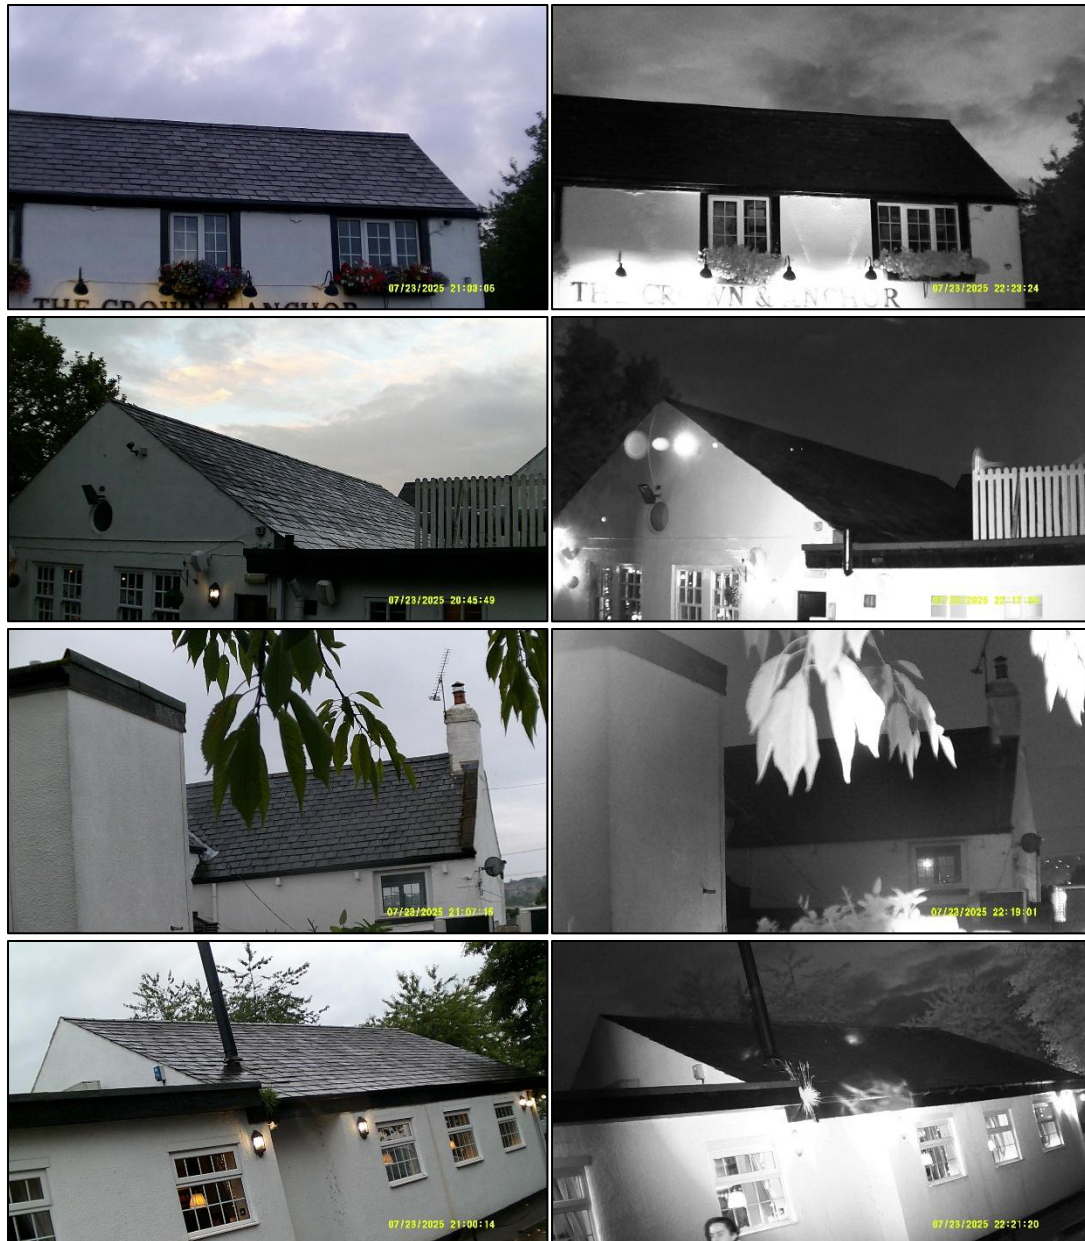
3.4.7. The below shows start and end still photographs which show the views of the cameras both at the beginning of the survey as well as at the end of the survey.
