**CROMWELL WOOD ESTATE COMPANY LIMITED**  
**T/A Cromwell Mining Consultants**

**Plot of Land for 10 Dwellings - Grove Street Worsborough near Barnsley S70 4SN**

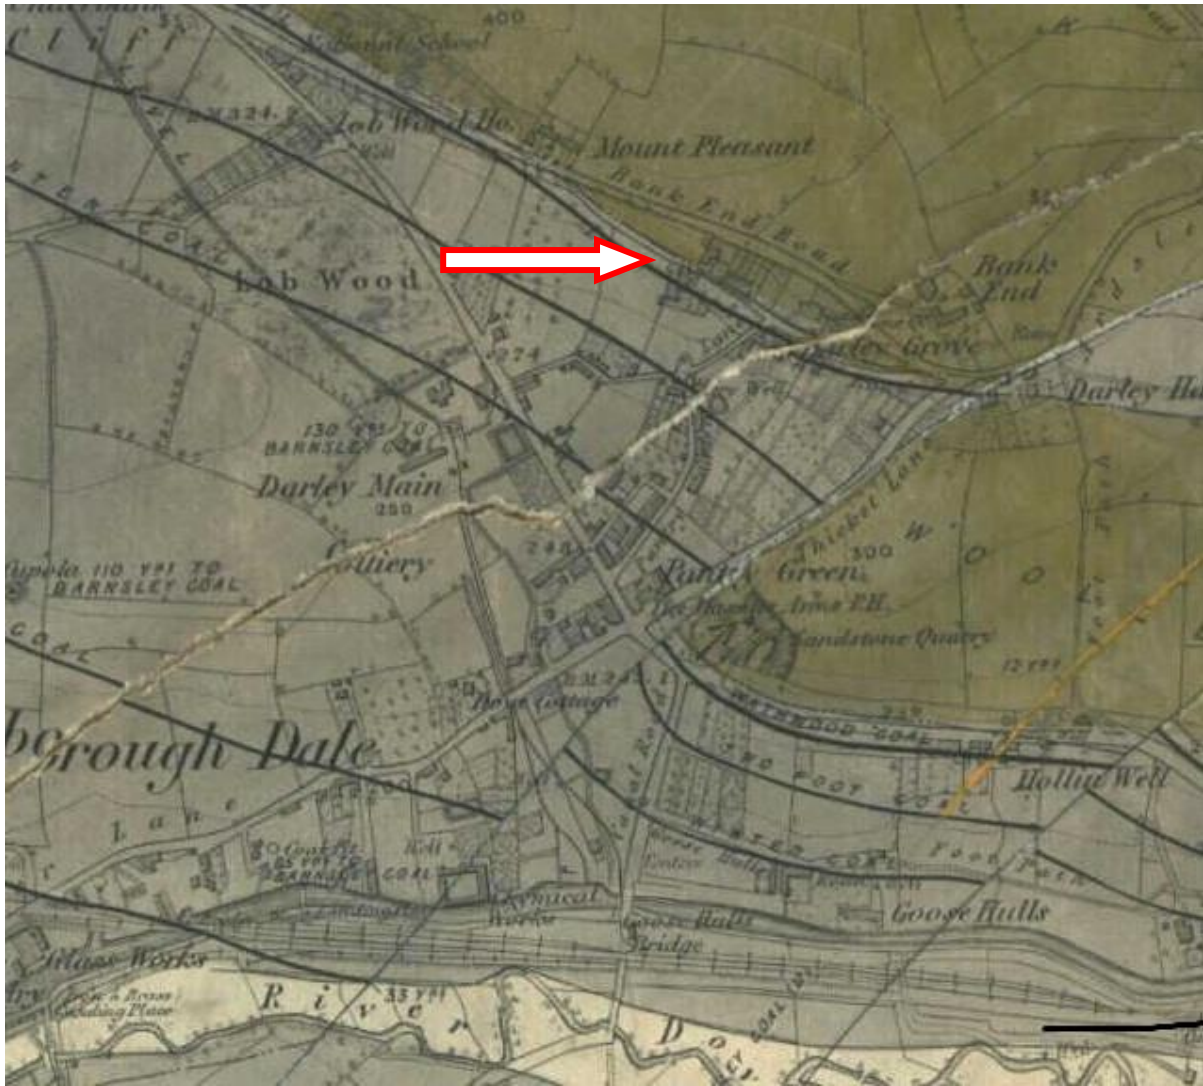
# BLOCK PLAN OF THE SITE WITH BOREHOLE LOCATIONS

Figure 1 showing the 1<sup>st</sup> Edition Geology Sheet 274 with the site shown by the red arrow. Note the shaft to the south west of the site is possibly Darley Main Pit. Note it is 130 yards to the Barnsley Coal and the Winter Coal is further up the hill from the Colliery so cannot have been worked from this colliery. Note the fault to the east that throws the Rock down and displaces the 3 seams south.

- 1.3 It is well documented that there were shallow coal mine workings in the area especially around what is Barrow Colliery, Wombwell Main and older collieries such as Darley Main NGR 435870,404070 and Lewden Bridge, NGR 436730, 403720. These mines are shown on the first edition geological plan 274 in appendix 2.

houses shown on the maps in the phase 1 desk top study, subject to the coal mining investigation. The coordinates will be taken off the plan manually by measurement and will be set out from the boundaries of the site so the borehole locations can be set out outside the property foundation footprint with the first borehole drilled in the centre of the plots 1 and 2 the second one in plot 5 and the third in plot 9.

- 2.11 The first edition geological map 274 for the coalfield shows small collieries at Worsborough and it is noted that the depth to the Barnsley Seam is 130 yards at the valley bottom where Darley Main and Bell Ing Collieries are located which were sunk near the outcrop of the Kents Thick and Kents Thin seam also known as the Beamshaw beds. Faults are shown on the geological plan in appendix 2 to the east and west of Grove Street and it is clear that the eastern one is a down throw fault as the Woolley Edge Rock is further down the hill. The fault will have presented a barrier to working the seams under Grove Street from the collieries to the west, east and south. Darley Main was well established by the time the geology was surveyed in 1866 to 1878 and was sunk to the Barnsley seam. There are numerous small mines in Worsborough Vale to the south of the subject site located in what is now Darley Yard off the High Street and a housing estate to the east. The desk top coal mining risk assessment is included in planning application and the SYMAS report in appendix 3 of this method statement.
